FORD CFT30/CVT TRANSMISSION TURBINE SHAFT SEALING RING CHANGE

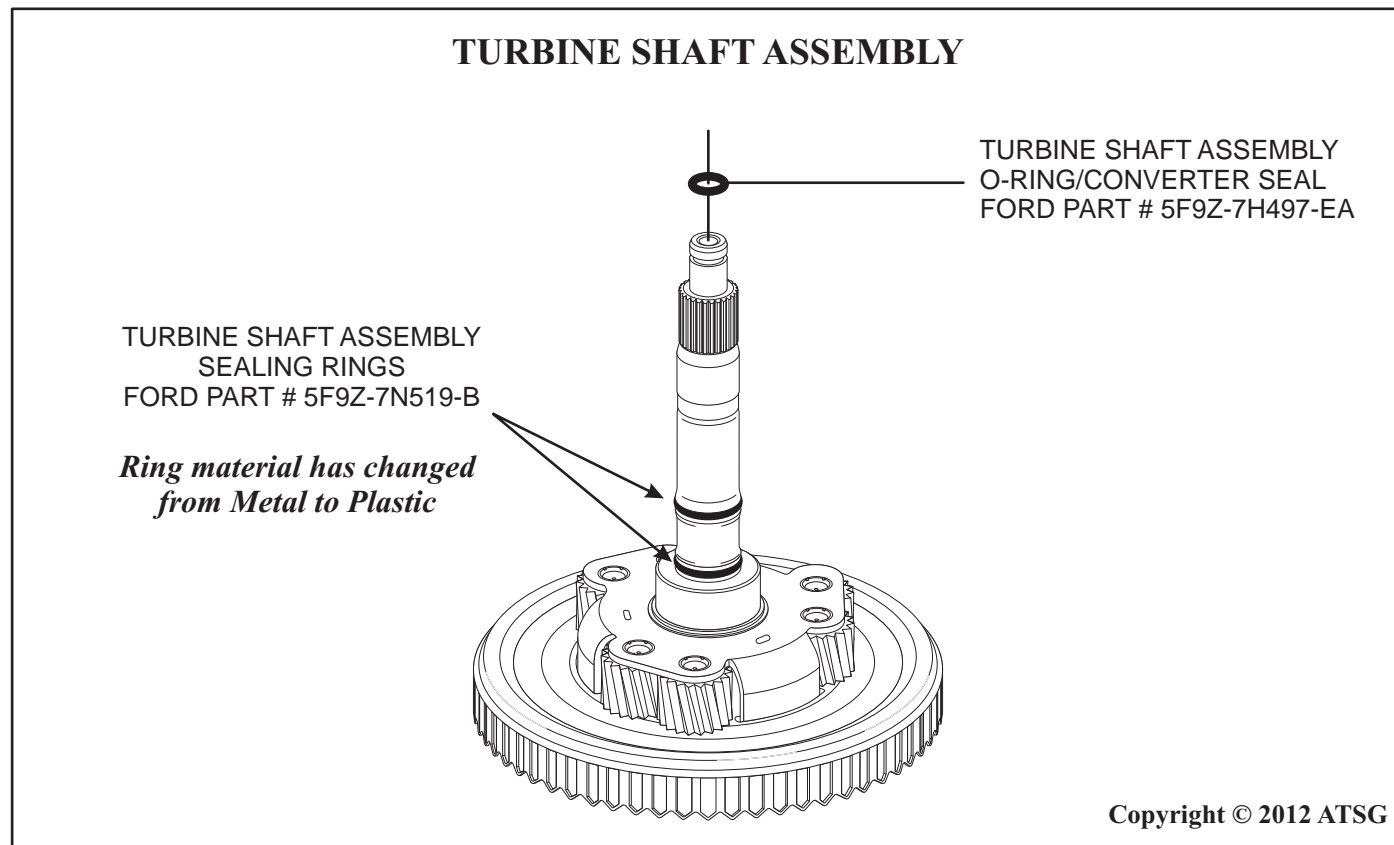
Figure 1

CHANGE: As a running change, the two sealing rings on the turbine shaft, as shown in Figure 1, have changed from a metal ring to a plastic ring.

The new design will service the previous design.

TURBINE SHAFT SEALING RING (Ford part number).....5F9Z-7N519-B
