Technical Service Information

ACURA MDX IN-LINE FILTER DIRECTION

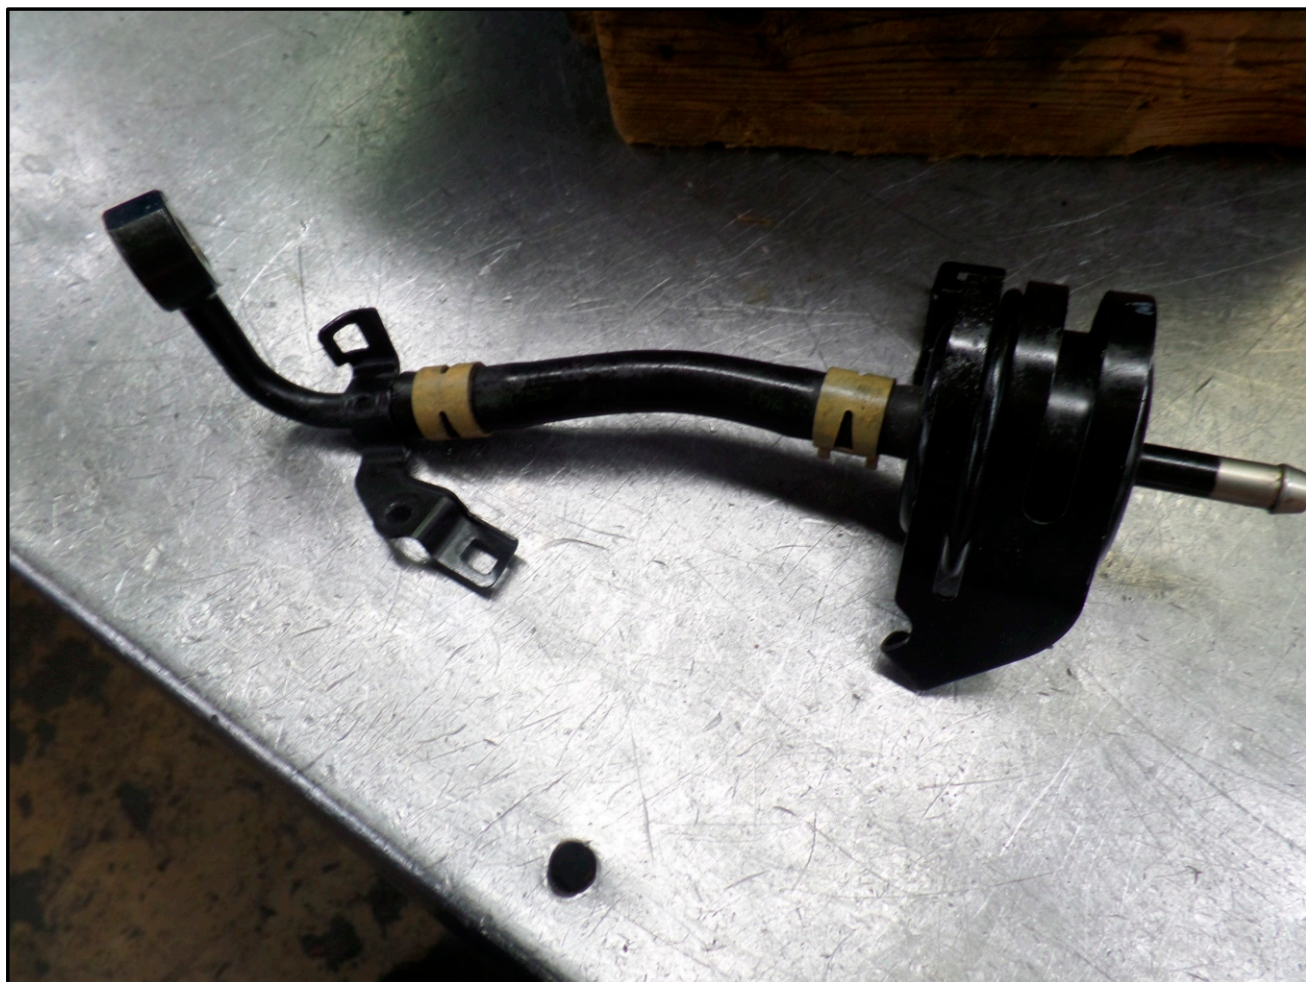
Figure 1

CAUSE: A quality aftermarket filter is purchased to be used instead of an O.E. in-line cooler filter assembly. The aftermarket filter has an arrow on it to identify the flow of the filter for proper installation. But the O.E. filter assembly does not have any markings to identify flow direction (figure 1).

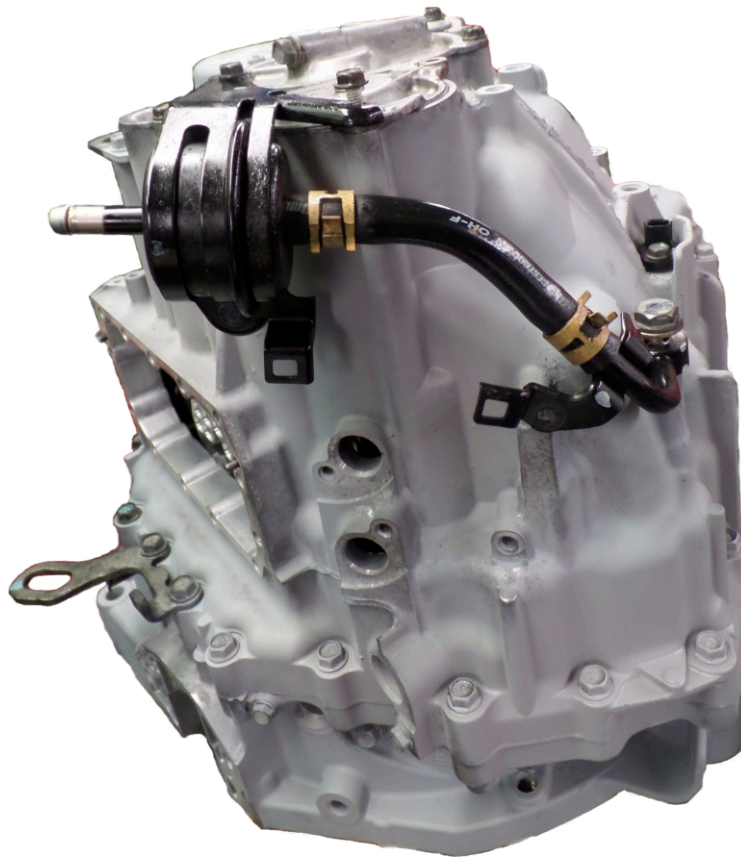
Figure 2

CORRECTION: The filter is located on the return line (figure 2). The arrow on the filter should be installed so it points to the transmission (figure 3).
