## MINI CVT

### STUCK IN LOW GEAR AFTER REPAIRS OR REBUILD

## Technical Service Information

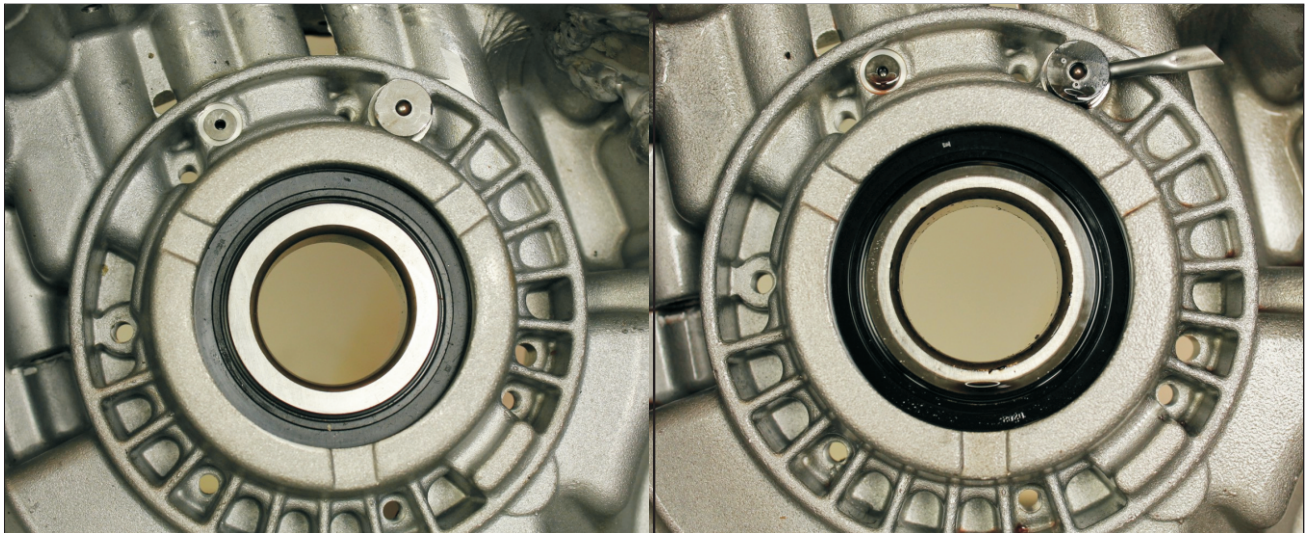
1. One possible cause is the valve body assembly was not installed onto the transmission correctly. This can jam the pulley follower lever onto the pulley follower bolt head.
2. Another reason could be that the Primary Pulley Pitot tube mounted inside the transmission was damaged during disassembly or reassembly. Figure 1 shows a broken Pitot on the left and a good Pitot tube on the right.

1. For proper installation of the valve body and pulley follower lever, refer to page 21.
2. Install a new Pitot tube. Use the following procedures to remove the pulley assembly properly so as to not damage the primary pulley Pitot tube.

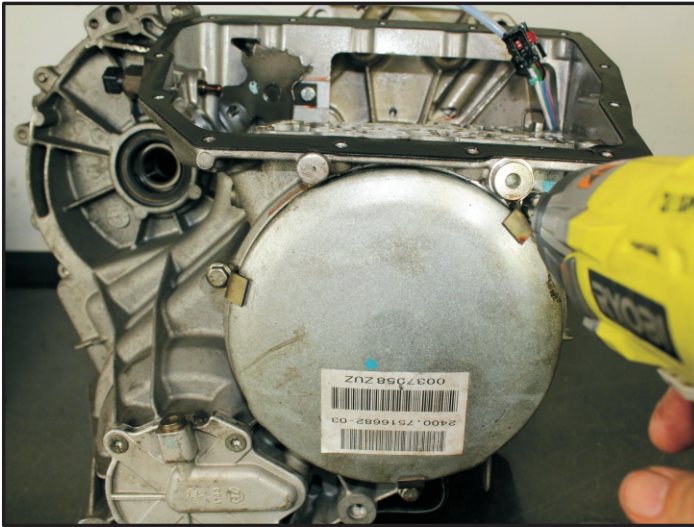
Figure 2

- a. With the valve body already removed, pop the pump cover as seen in figure 2.
  - b. Rotate the Pitot tube chamber mounted on the pump drive shaft so that one of the slots reveals the engine speed sensing Pitot tube attaching bolt (figure 3).

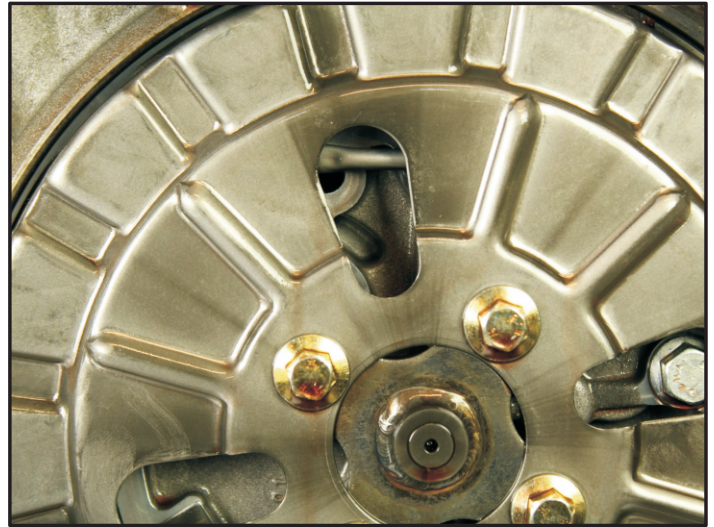
Figure 5

- c. Remove the bolt and use a pick to rotate the Pitot tube bolt bracket flange as seen in figure 4.
  - d. Rotate the chamber so that you can verify the Pitot tube tip is out of the slinger pocket as seen in figure 5.

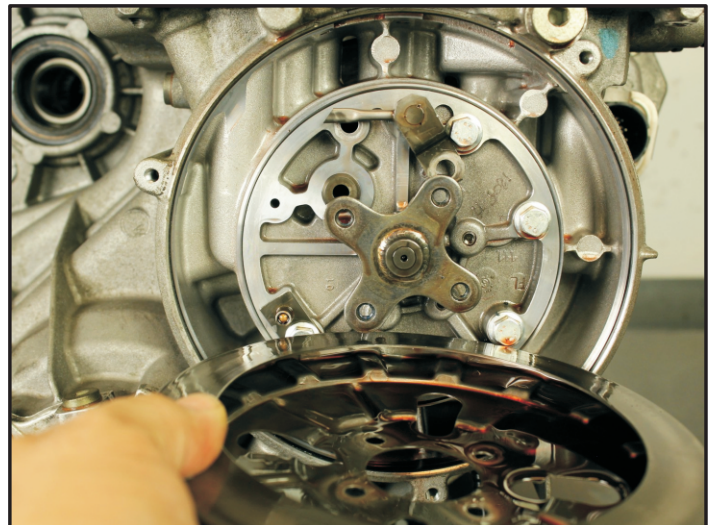
Figure 6

- e. Now remove the 4 bolts that retains the chamber to the pump drive shaft (figure 6).
  - f. Remove the pump (figure 7). It should pop forward due to a beveled cushion plate sitting at the bottom of the pump pocket (figures 8).

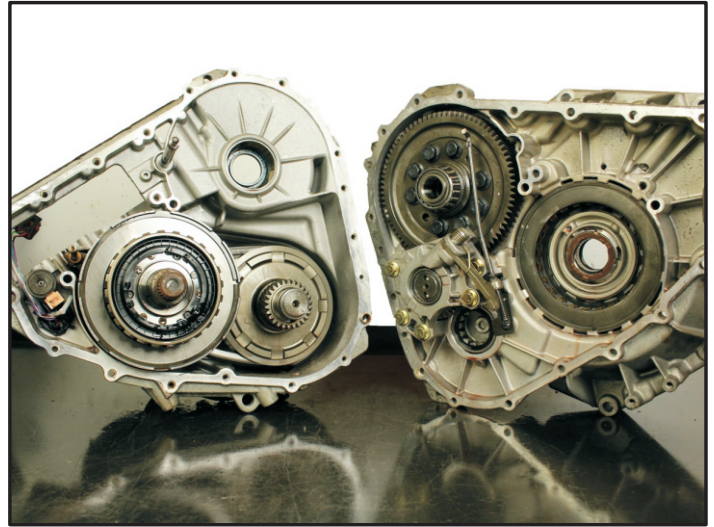
Figure 11

- j. Remove the case attaching bolts and carefully separate the two case halves (figure 11).
  - k. Remove the primary and secondary pulley nuts (figure 12).

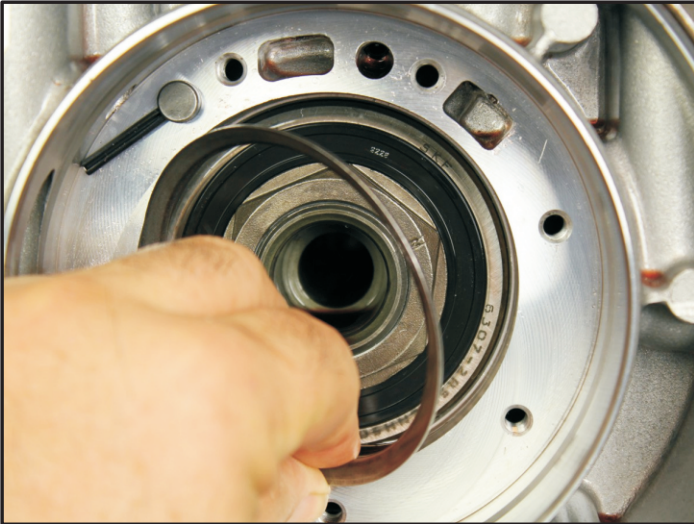
Figure 9

- h. This beveled cushion plate sits into the bottom of the pump pocket like a bowl not like a dome (figure 9).
  - i. Separate the park rod from the manual detent lever (figure 10).

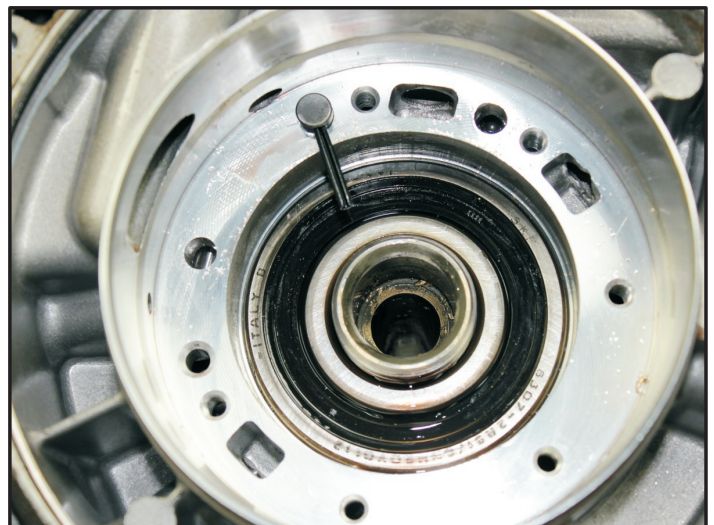
Figure 13

- l. Rotate the primary pulley Pitot tube counterclockwise as seen in figure 13.
  - m. Place wire ties on the push belt and then carefully drive the primary and secondary pulleys out of the case while keeping the Pitot tube in proper position (figure 14).

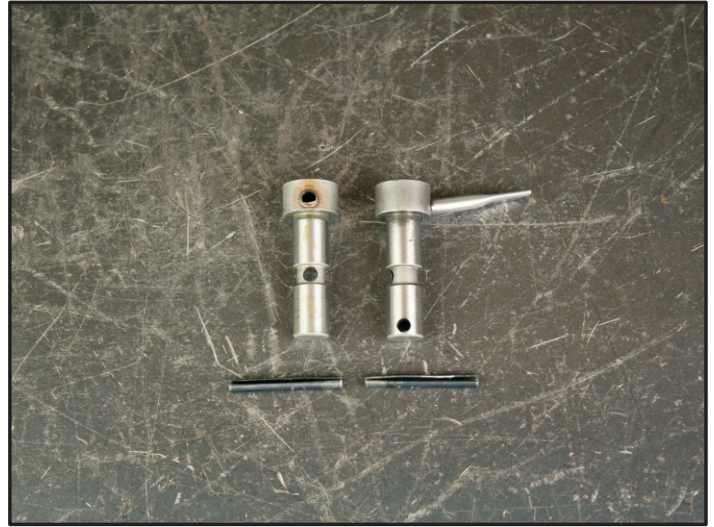
Figure 16

- n. Looking into the case, check the Pitot to be sure it has not been damaged (figure 15). If it has, carefully pull the roll pin out of the Pitot tube shaft and change the Pitot tube (figure 16).
