Technical Service Information

GM 10L80/90 VALVE BODY PART UNIQUE NUMBER

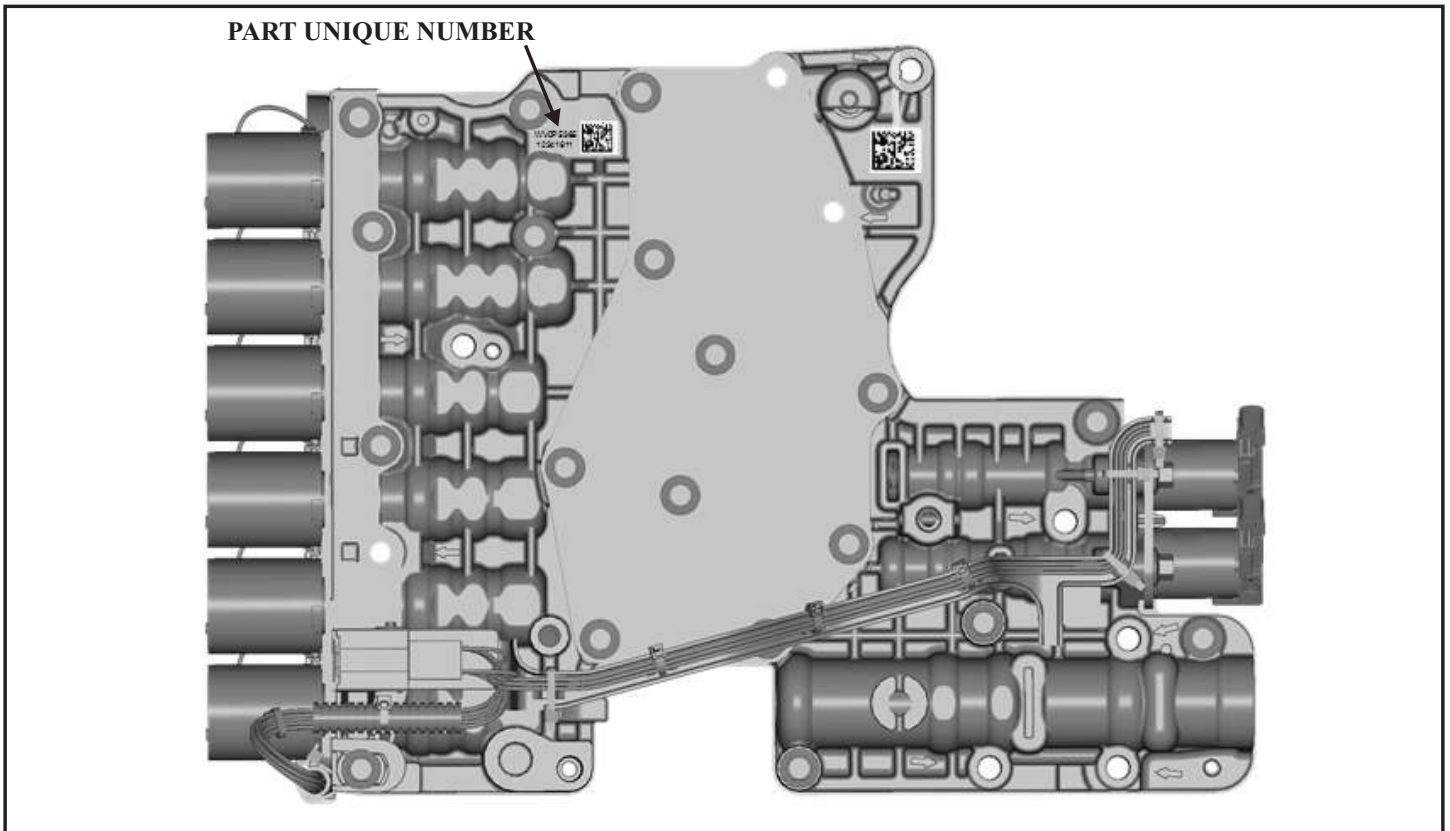
Figure 1

CORRECTION: The GM 10L80/90 ten speed transmission available on Camaro and a various Chevrolet and GMC models have a valve body Part Unique Number. This number is located on the valve body as seen in figure 1. Notice the PUN has a number 0 and a letter O, take note of the difference so the PUN is entered correctly for successful programming as seen in figure 2.

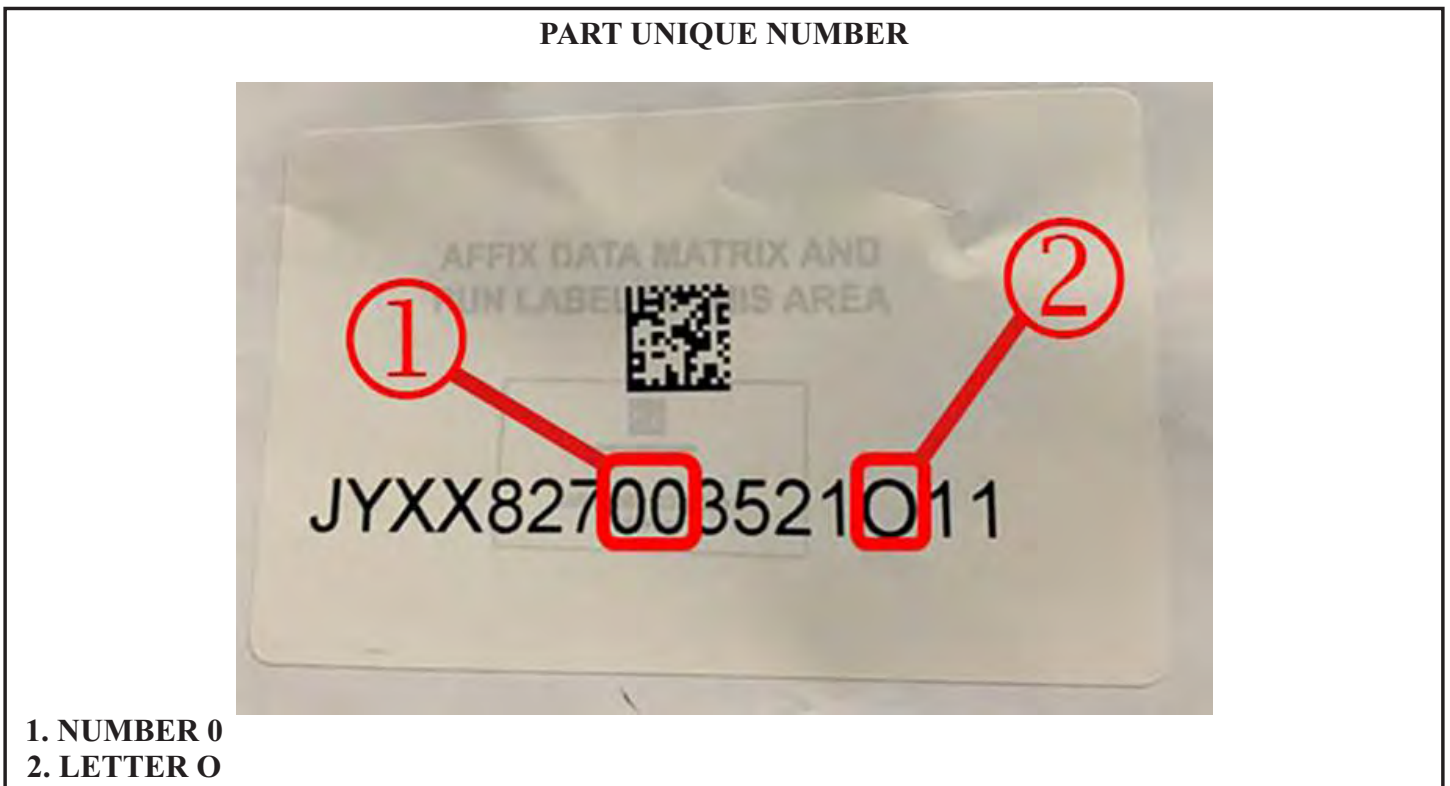
Figure 2

CAUSE: The PUN number can contain the number 0 and the letter O, it is important to distinguish between the number 0 and the letter O so the PUN number will be entered incorrectly to successfully complete the initialization procedure.
