## **GM/FORD 6T40 SERIES/6F35**

### **TURBINE SHAFT INTERCHANGE**

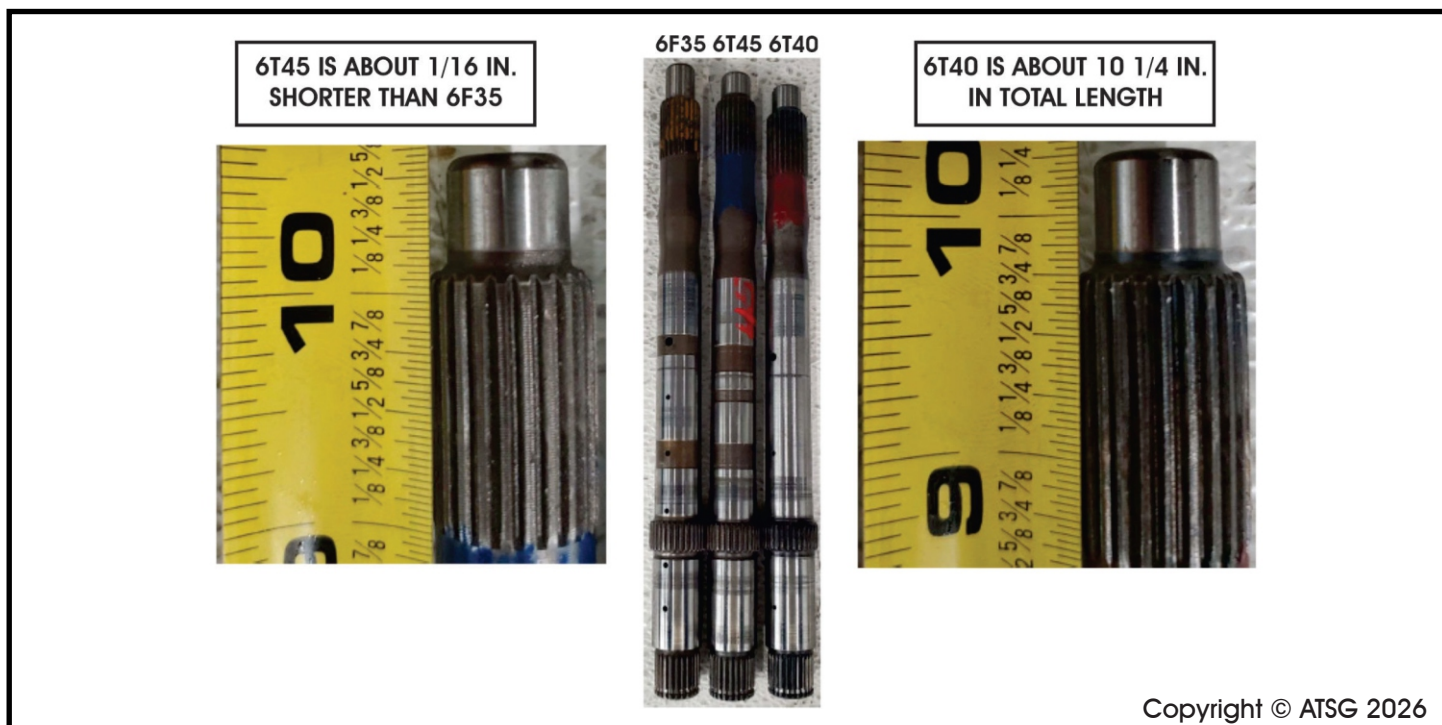
**Figure 4**

The 6T45 turbine shaft is approximately 1/16 inch shorter than the 6F35 shaft as shown in figure 4. The 6T40 turbine shaft also seen in figure 4 is approximately 10 1/4 inches in total length.

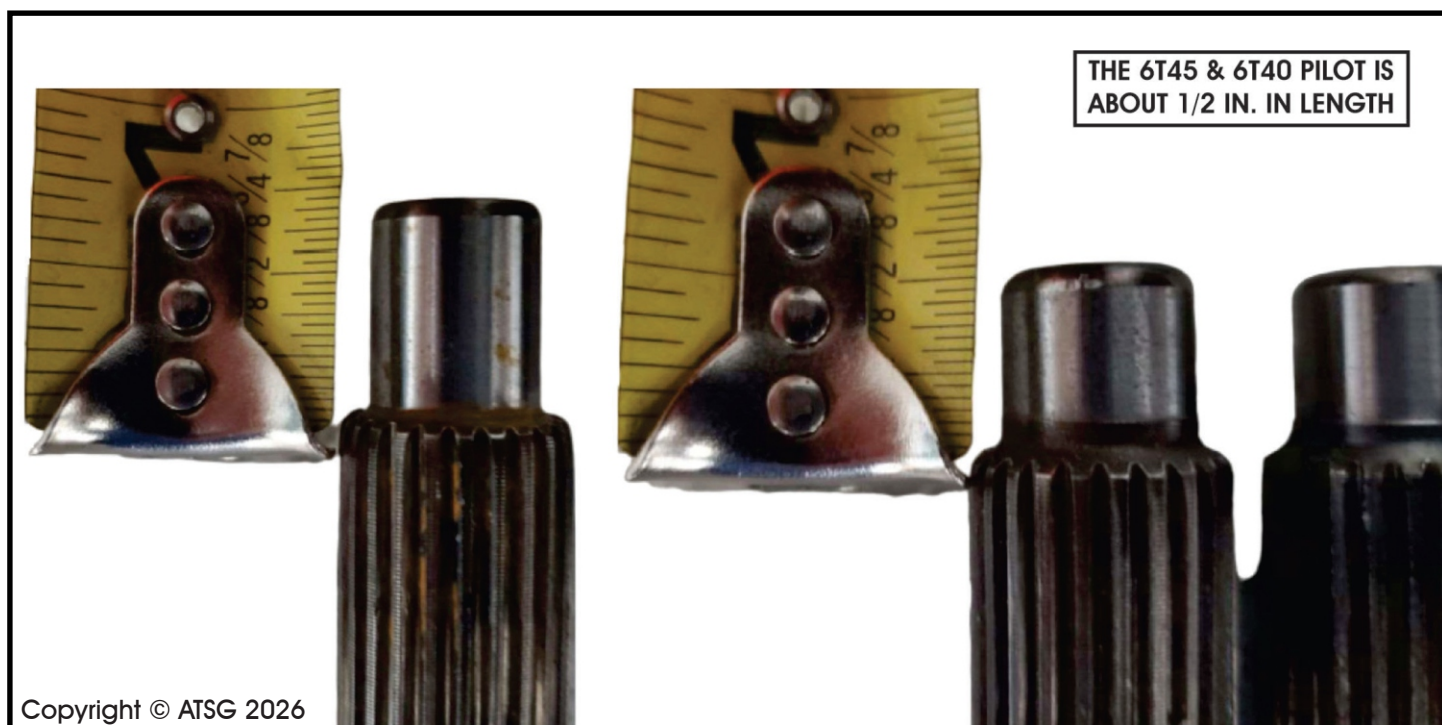
**Figure 5**

The 6F35 pilot is approximately 3/4 inch in length as seen in figure 5. The 6T40 and 6T45 pilot is approximately a 1/2 inch in length also seen in figure 5.
