**FORD 6F35****TRANSMISSION OVERTEMP CONDITION**

**COMPLAINT:** A Ford vehicle equipped with the 6F35 transmission comes back with a complaint of the transmission operating in an over temperature condition. This is verified by the repair shop by reading the transmission temperature on the scan tool and verifying that reading by the use of an infra red temperature sensing tool. At the time of transmission repairs, the cooler was flushed and seemed to have adequate flow, however a current check of cooler flow indicates it is not adequate.

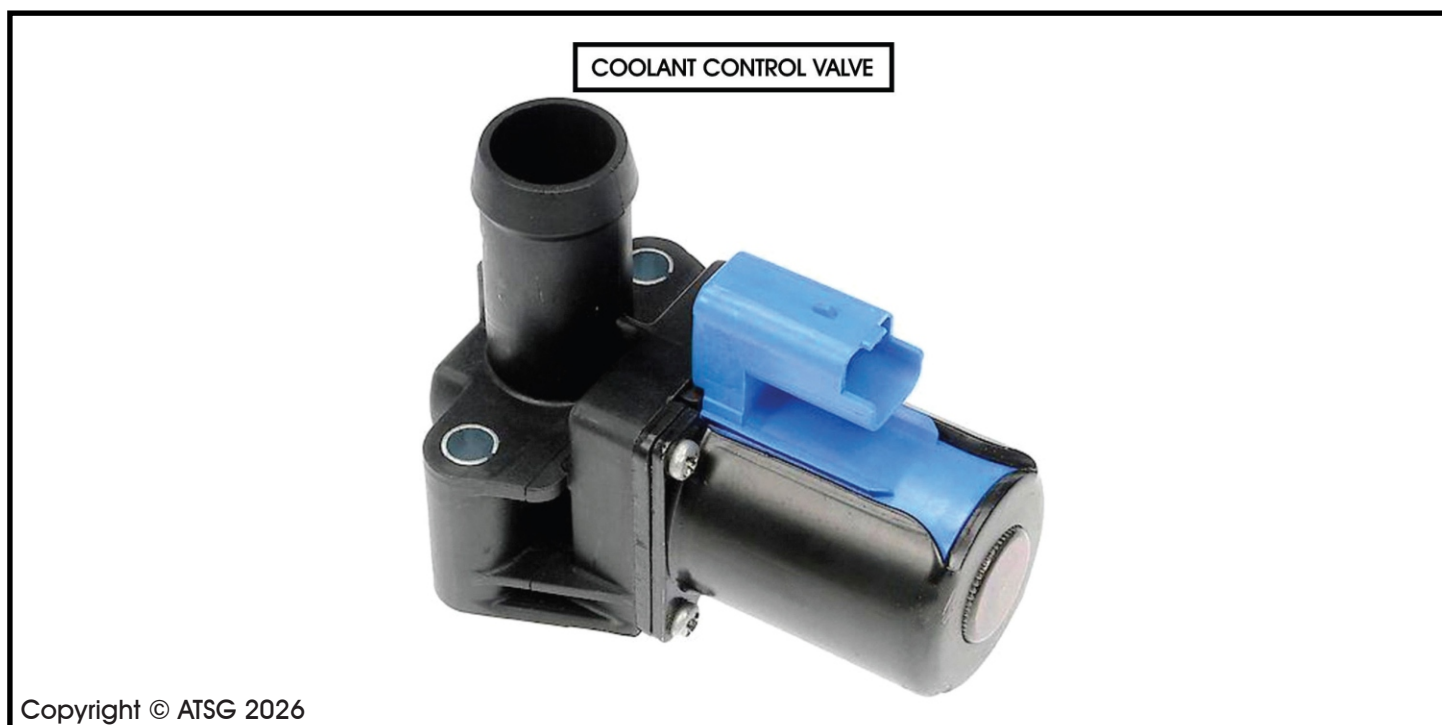
**Figure 6**

**CAUSE**  
**CONTINUED:** Some applications use a transmission fluid cooler “coolant” control valve and a fluid heater “coolant” control valve as seen in figure 6. Notice that the word “coolant” is in quotation marks. That is to catch your attention purposely. These control valves regulate the flow of engine coolant to the heat exchanger. If these valves malfunction, they will compromise the cooling of the transmission fluid by not allowing proper flow of coolant to pass through the heat exchanger.

**CORRECTION:** It is of the utmost importance that cooler flow is checked when the transmission is at normal operating temperature and that transmission temperature remains normal. Utilize the necessary equipment to verify this such as flow meters, infra red temperature sensing devices and the scan tool. Some of these systems coolers and heat exchangers do not flush well especially when there was a great deal of contamination. The decision should be made at this time as to whether the cooler or heat exchanger should be replaced. Cooler bypass valves should be replaced with new thermal elements or employ the use of one of the aftermarket solutions that eliminate the original equipment valve. Ensure that the engine cooling system is functioning properly and that the coolant control valve is operating normally. The cooling system seen in figure 7 for the Transit Connect with 2.5 Liter engine has two coolant control valves and is designed with an active transmission warm up function. Transmission fluid continuously flows through the oil-to-water heat exchanger. Two engine coolant control valves direct engine coolant to the transmission fluid heat exchanger. When the transmission fluid is below operating temperature, the transmission fluid heater coolant control valve will direct coolant from the engine to the heat exchanger to warm the transmission fluid. When the transmission fluid is above operating temperature, the transmission fluid cooler coolant control valve will direct coolant from the radiator to the heat exchanger to cool the transmission fluid. These two operating states maintain the transmission fluid at operating temperature.
