### Power, Water & Infrastructure contract specialists

### Concrete Repairs and Protective Coatings

CSC Services (UK) Limited were appointed by MB Developments (Scotland) Limited to carry out Concrete Repairs and Protective Coatings to a Wet Well, on the East Coast Scotland.

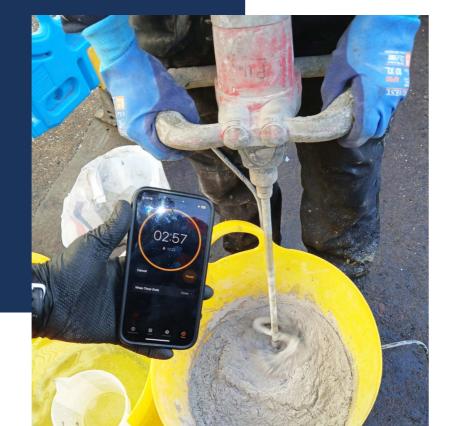
Concrete Repairs to various areas of the Wet Well followed by Flexcrete Monolevel 844 SP Waterproof levelling/fairing coat. All internal surfaces to be finished with Flexcrete Cemprotec E942 protective coating.

- Vac ex clean out
- Installation of scaffolding
- Confined space access/egress
- Substrate repairs
- Flexcrete monolevel 844 SP application
- Cemprotec E942
  application

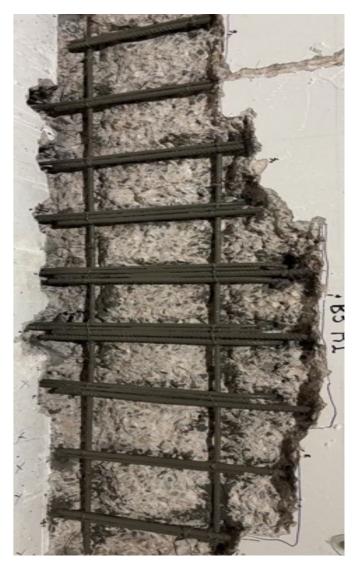
Progress photos

- Defective Concrete Removal: Removal of any delaminated and defective concrete identified in the soffit, ensuring that any compromised sections were systematically addressed.

- Rebar Assessment and Replacement: A detailed examination of the embedded rebar was carried out, resulting in the replacement of rebar that exhibited significant corrosion or loss of integrity.

- Installation of Patch Guard 350 Anodes: To mitigate the incipient anode effect, PatchGuard 350 Anodes were installed at 400mm centres around the perimeter of the repairs. This solution was facilitated with support from Sam Wheelhouse and Ryan Williams from CPT.

- Concrete Repair System Implementation: The repairs were reinstated using Flexcrete concrete repair material – Monomix HD followed by the Monolevel SP levelling/fairing coat.

- All materials were installed in accordance with BS EN 1504 and to the manufacturer's specifications.
- Corrosion Inhibitor Application: Upon complete curing of the repairs, a corrosion inhibitor (Sika Margel VPI 580) was applied across the soffit to address the elevated chloride levels identified during the survey. This application significantly enhances the longevity and durability of the concrete structures.

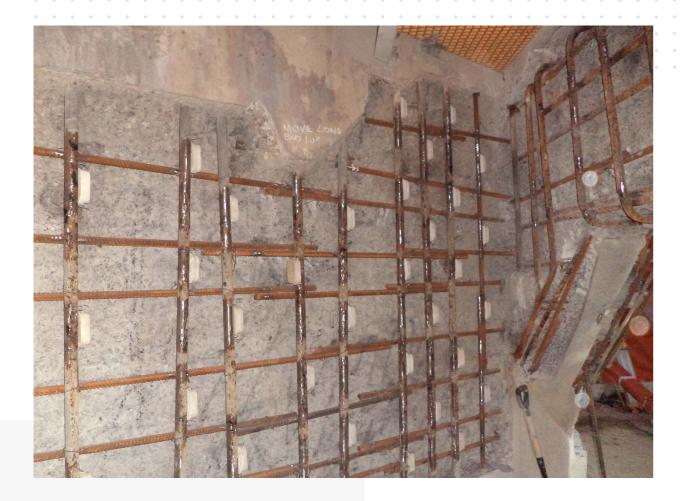
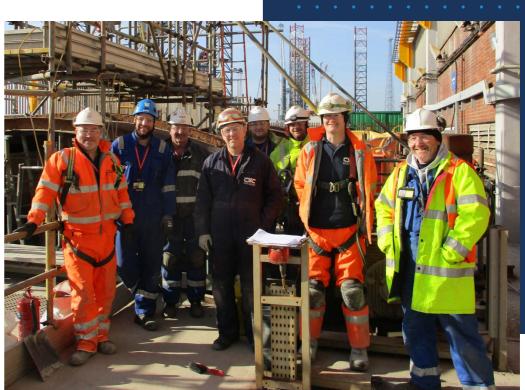
Carbonation and chloride ingress of the reinforced concrete structure had been caused by sea salt passing through the Drumscreen as part of the Power Station's cooling process.

A cathodic protection system was specified to address corrosion across the entire area treated. This could not be achieved with conventional repair methods without removing all the concrete where salt or carbon dioxide had penetrated.

Hammer testing of concrete surfaces was undertaken prior to hydro demolition to give an estimated square meterage of repair site. Following the hydro-demolition of spalled concrete, a site inspection quantified the structural reinforcement replacement bar and anode requirements.

580 sacrificial anodes were installed and several hundred metres of structural reinforcement replacement bar in a range of dimensions fitted. Over 22,000kg of concrete was then spray applied to return the structure's surface to profile. Access ladders, platforms and framework were then replaced.

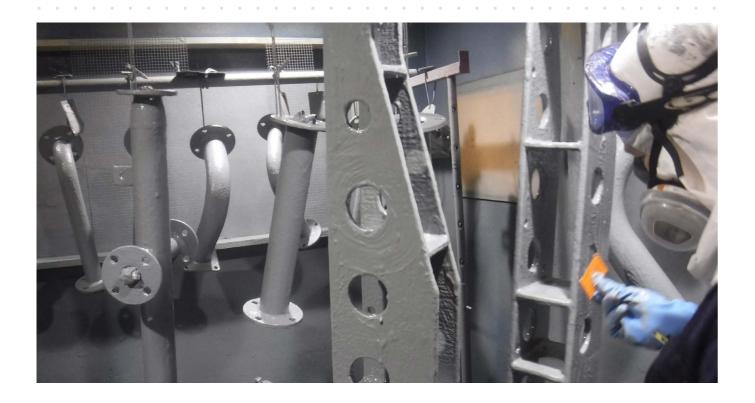
Work to replace the rubber lining of the Mixed Bed Regenerator Vessel was completed. The vessel forms part of the Power Station's water treatment plant, backwashing, rinsing and injecting resins with sulphuric acid and caustic soda. Inspection revealed the internal rubber lining to be significantly blistered with some patches degraded through to substrate.

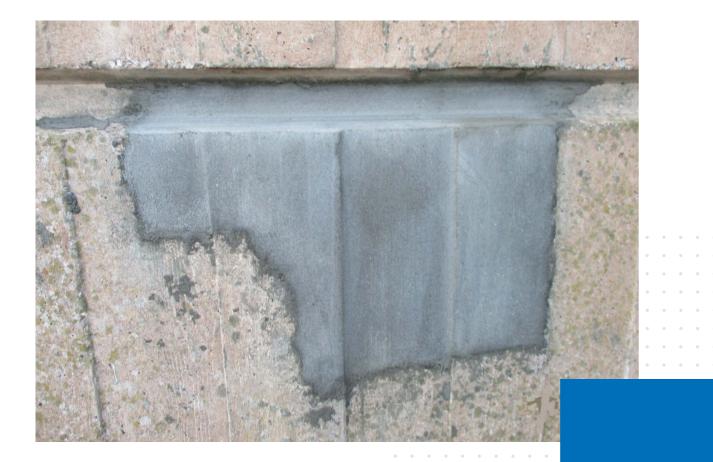
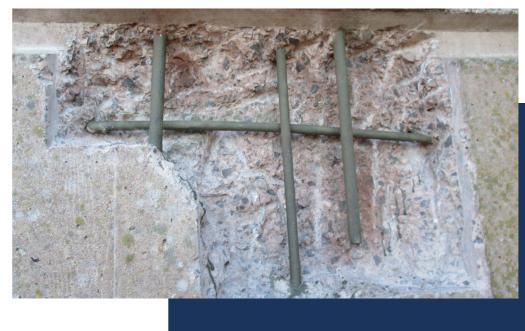
A combination of environmental exposure, water ingress and the age of the station building, had caused spalling in areas, including the flask bay and turbine hall.

Over ten tonne of specialist repair mortars and structural strengthening products were used to rectify the degradation of reinforced concrete at various areas across the station.

A range of protective coatings were used to protect the structures from moisture intrusion and further corrosion, reducing the need for ongoing maintenance work for the life of the station.

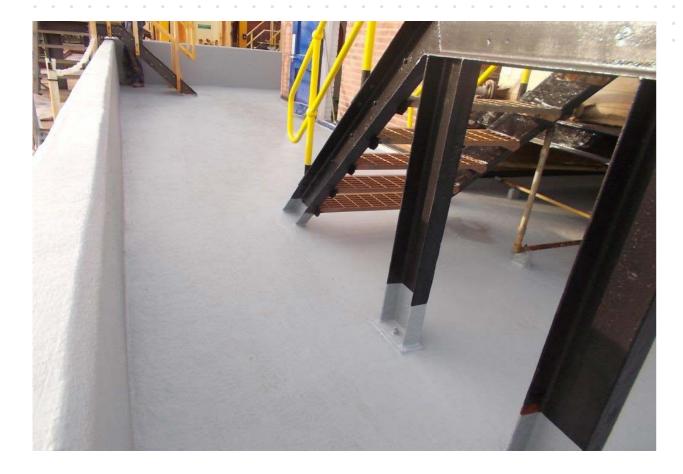
CSC Services installed a Sika Liquid Plastic Roof to a Pumphouse Flat roof at Hartlepool Power Station for EDF Energy. Sika Decothane Ultra was specified for this system, which was inclusive of Reemat and Decotrim Type F. The roof was approximately 205 square metres.

The full contract took 28 days. This also included the application of a new coating system and non-slip floor to the bund area, within the ferrous sulphate plant. (This was also to a Sika specification comprising of Sika Monotop 620 repair mortar, Sikalastic 625 coating including concrete primer, reemat and termination bars, Sika Floor 415 none slip system and Sika 625 steelwork.)

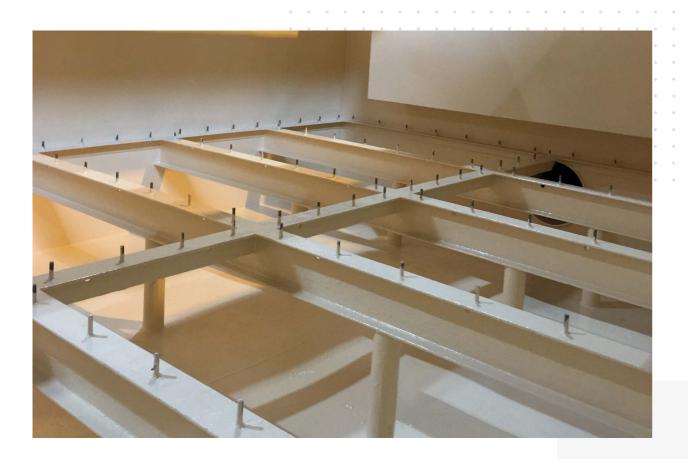
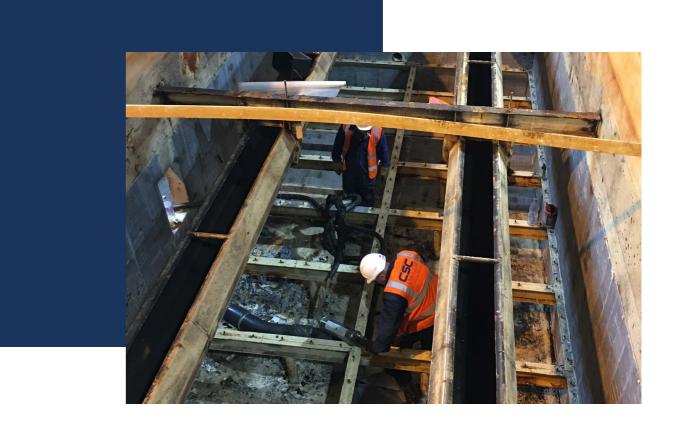
Corrosion to the tank walls, accelerated by the abrasive action of the filter material had caused rust to develop. CSC Services removed all of the failed coating and rust. This created the required surface profile for the installation of a new protective coating.

Acothane, a solvent free polyurethane protective coating was installed to provide effective corrosion and erosion resistance. Approved by the Drinking Water Inspectorate, this coating provides a completely waterproof membrane, preventing any potential ingress of water, which can cause osmotic blistering, air filled cavities and cracks. Acothane is proven to resist the growth of bacteria, such as micro aquatic organisms and black spore fungi. It has a long life performance and requires minimal maintenance.

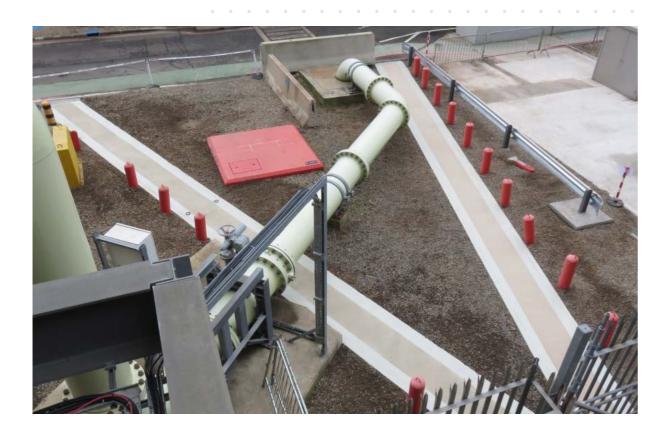
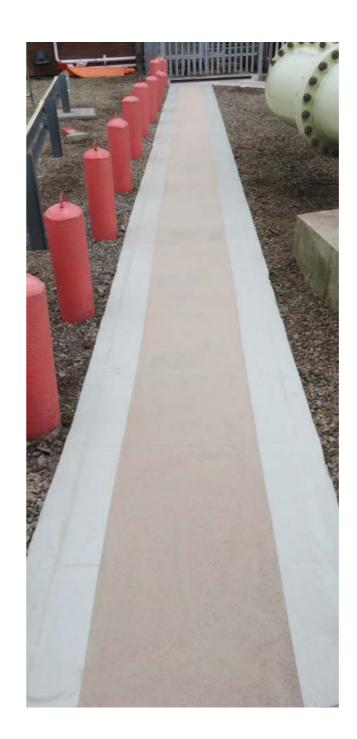
CSC Services completed work to waterproof cable trench covers at Hartlepool Power Station for EDF Energy. Deterioration of the previous concrete cable covers had resulted in water ingress. This was having ramifications with the Station's fire protection system in the Turbine Hall Cable Tunnels.

To rectify the problem localised joints were filled with a fast setting mortar and the area was cleaned and prepared using a water jetting unit before a concrete was primer was applied. Sikalastic 625 was then applied.

Sikalastic 625 is a single component, cold-applied, moisture-triggered liquid waterproofing membrane that cures to form a seamless, durable and weather resistant waterproofing solution for exposed areas. This coating was selected for the work as it is completely cold applied so there is no requirement for any heat or naked flame. This meant the risk of fire was completely eliminated and work could be safely carried out whilst operations continued.

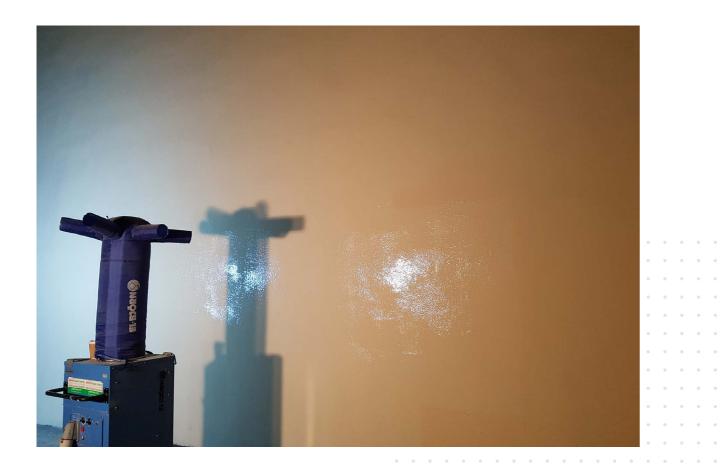
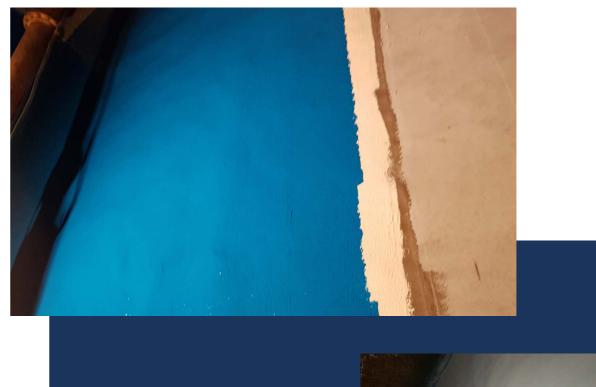
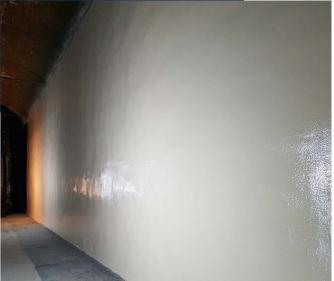
The first image shows a tank heating system was used to dry the tanks after cleaning and repair, prior to coating application. This ensures the correct environmental conditions are achieved.

The fourth image shows the second coat applied.

On this occasion CSC Services installed an Acothane DW system. This is a polyurethane coating approved by the Drinking Water Inspectorate. It is a complete solvent free technology that has a tough impact resistant finish, that will resist the growth of microaquatic organisms and protect against periodic cleaning regimes.

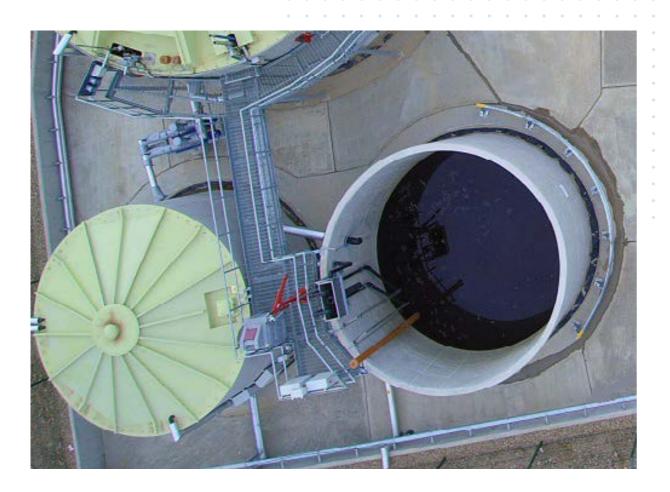
The process of Resin Injection was used to repair cracks in the bunded area of the treatment plant, where water was percolating through construction joints as shown in this image.

On this occasion a hydrophobic polyurethane foam was used, which is very fast acting on contact with water and can halt the flow of water quickly and prevent future leaks.

With any refurbishment programme, surface preparation was key. The concrete must be cleaned to remove contaminants. The crack itself was blown off with clean dry air so that resin could flow freely into and along the cracks. Resin is then injected under pressure either into inlet ports that have been stuck to the concrete surface over the crack or through holes drilled to intersect the crack.

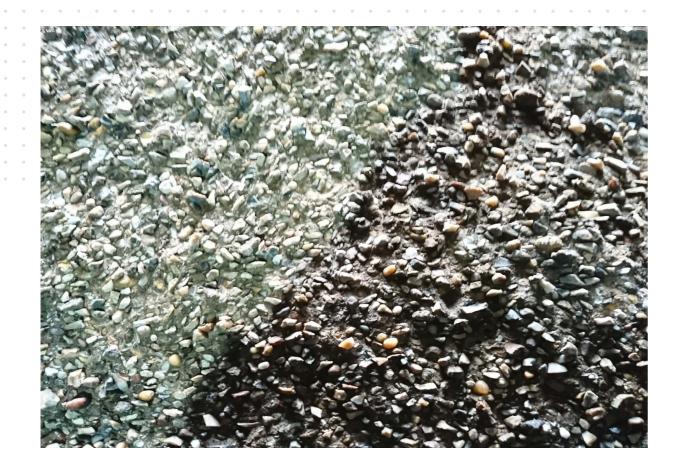
CSC Services refurbished a sewer pumping station wet well for Anglian Water. The structure had suffered from significant hydrogen sulphide corrosion to the internal concrete surfaces, and had been taken out of service.

The first image shows the profile of the corroded concrete surface prior to refurbishment work.

Following high pressure water jetting off internal surfaces and removal of debris, a high strength structural repair mortar was applied to the concrete surfaces. A water based cementitious coating system was installed over the repair mortar to provide a hard, durable coating with excellent resistance to water and hydrogen sulphide. With greatly enhanced chemical resistance this system was specified for the protection of concrete offered in sulphate contaminated conditions. This will significantly extend the life-span of the structure.

The third image shows a CSC Services Operative installing repair mortar to the wet well. The bottom section of the wet well is complete.

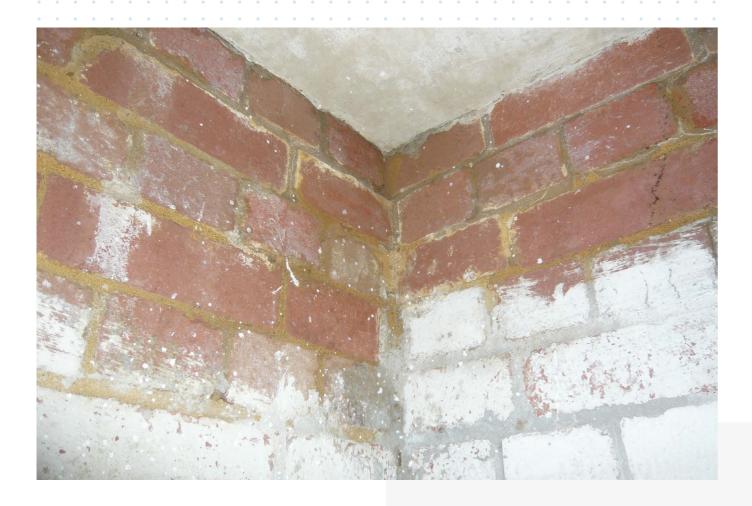
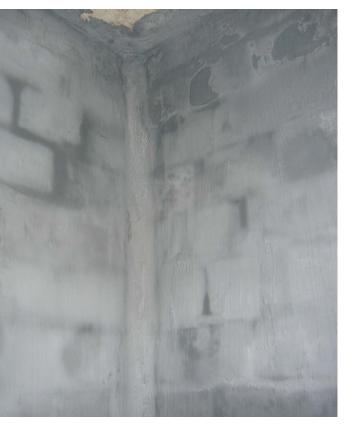
The chamber forms part of the surface water drainage system and is also the authorised minor discharge route for waste condensate water being discharged from the power station. Although the chamber was intact, there were voids in the mortar and cracking around pipe penetrations. The defects needed to be repaired to ensure environmental compliance is maintained. A protective lining was required that would tolerate the heat from the water being discharged.

CSC Services repaired the chamber and lined it with Cemprotec E942 from Flexcrete. This water based cementitious system gives a hard, durable coating with excellent resistance to water, chloride ions, oxygen and aggressive chemicals. Images of the chamber before and after the cementitious system was installed are shown.

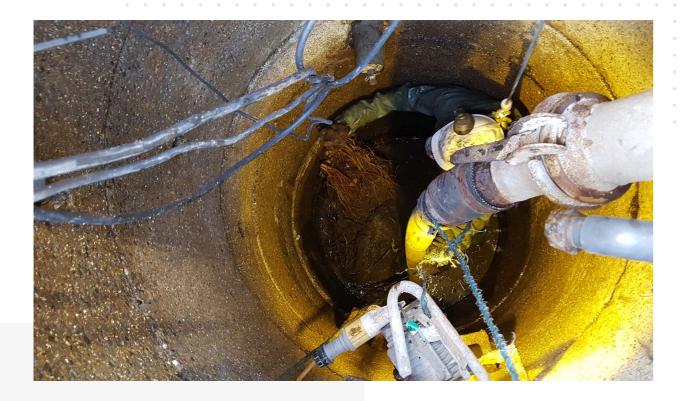
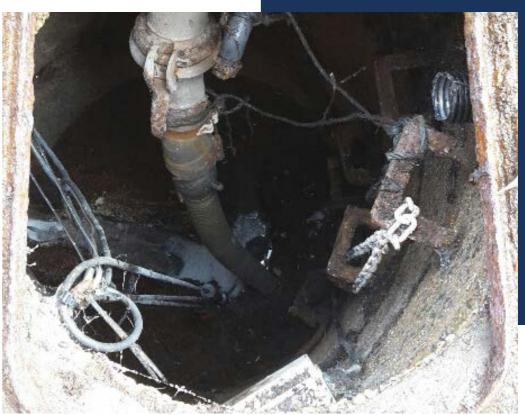
With visible signs of cracking to a wet well, CSC Services were contacted to remove all vegetation and reline the wet well to prevent future problems and to ensure its structural integrity remained. Upon initial inspection of the wet well, tree roots were found to be entering the well through joints and pipe entry. Ring joints and grout holes were leaking. There were holes to the base, and cracks to the wall. 5-10mm of concrete had been lost from the walls and soffit.

CSC Services began the project by inserting pipe access bungs and setting up over-pumping to an intermediate bulk container. Confined space entry was then established. Once the atmosphere was tested and forced ventilation was set up the tree roots were cut out and removed. High pressure water jetting was undertaken to all surfaces.

All joints, grout holes, cracks and voids were sealed using Flexcrete repair mortars. A first coat of Monolevel 844 SP was applied to all surfaces which is a chemical resistant fairing coat to bring concrete back to profile. Protective coating Cemprotec E942 was applied in two 1mm coats to all surfaces to provide protection from future Hydrogen Sulphide Attack. A physical check was made to ensure coating was fully cured. Bungs were then removed and the wet well returned to normal service.

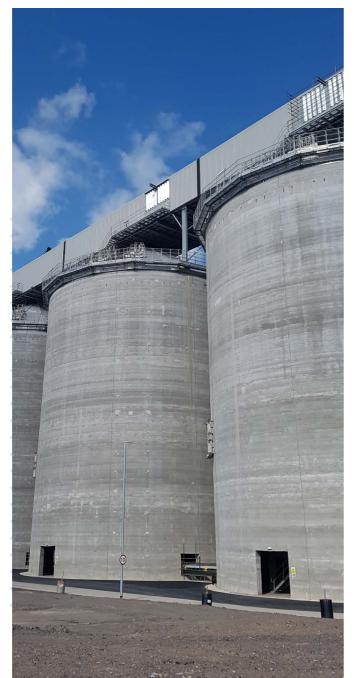
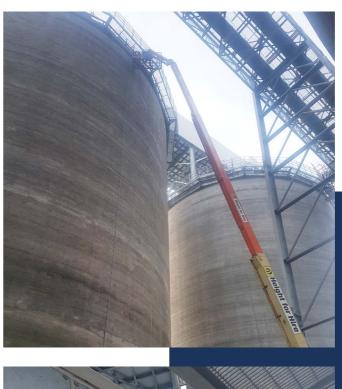
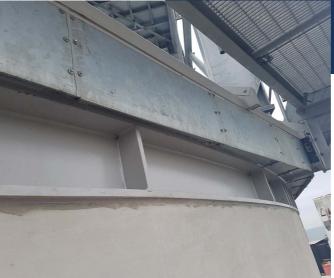
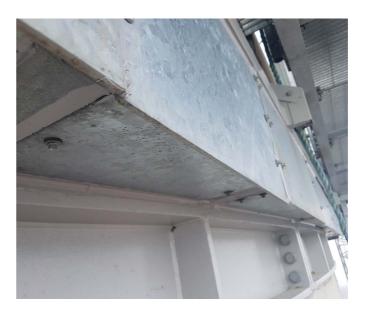
CSC Services eliminated ingress of water around the floor joints in the rail offloader area caused by the coastal location and high-water table. The TamPur 100 Resin Injection system by Normet was used to halt water flow. This hydrophobic polyurethane reacts when it comes into contact with water, producing a rigid polyurethane foam. The system is solvent free, environmentally safe and chemically resistant.

Sikaflex PRO 3 was used to leak seal areas around the metal rings and roof panels of six of the Power Station's silos used to contain the wooden pellets that fuel the station. This moisture-curing elastic joint sealant has both high mechanical and chemical resistance and is solvent free.

Images of the Silos and some of the leak sealing work are shown.

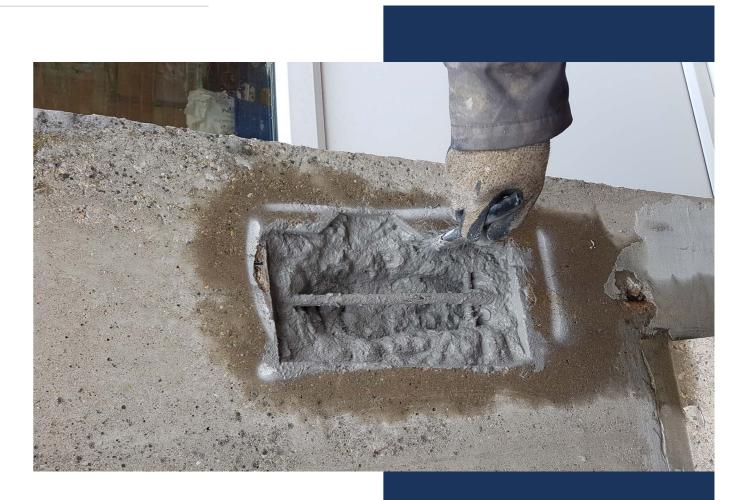
The age of the buildings combined with environmental factors has resulted in spalling of concrete at various areas across the hospital. Defective concrete was removed and concrete repairs undertaken using cementitious repair materials.

To prolong future use of the building, a cementitious coating was used to protect steel rebar from further corrosion. The highly alkaline coating passivates the steel surface chemically to prevent further rust formation. It protects the steel from moisture, gasses and chlorides.

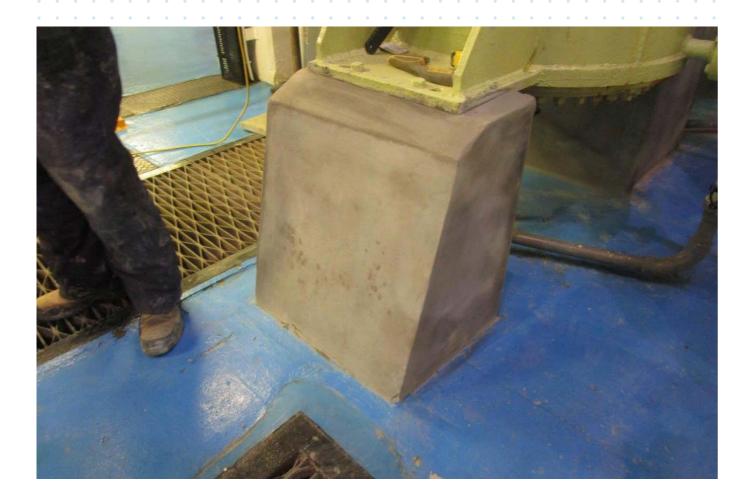
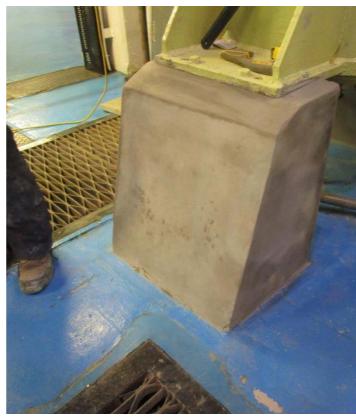
As part of the Spalling Concrete Remediation Programme, Carbon Fibre Wrapping was used to add structural strength to the DW Plinths in the Turbine Hall at Hinkley B Power Station.

Carbon fibre has very high tensile strength and is also very lightweight. When bonded to the exterior of a concrete column, beam, or slab, it can add significant strength without adding weight that would increase the load on foundations and other structural members. A mix of usually carbon or glass fibre fabrics, and an epoxy resin, wrapping systems are custom designed for each project.

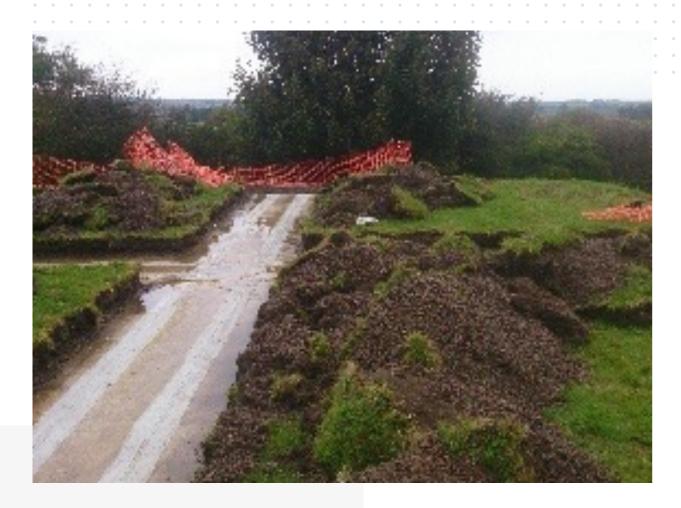
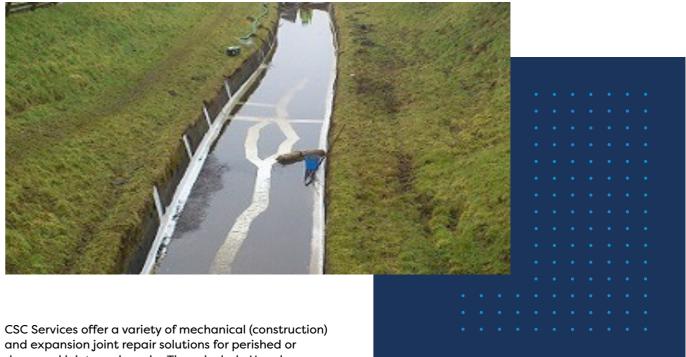
CSC Services completed a programme of works including internal and external joint repairs for a regional Water company. This was to a range of assets including, several Service Reservoirs, Aqueducts and storage facilities.

CSC Services offer a variety of mechanical (construction) and expansion joint repair solutions for perished or damaged joints and cracks. These include Hypalon bandage systems which are secured and sealed to each side of the expansion joint or crack using epoxy resin adhesives. DWI approved products are available. These systems are chemical resistant and will alleviate water egress and ingress whilst allowing the expansion joint to accommodate movement.

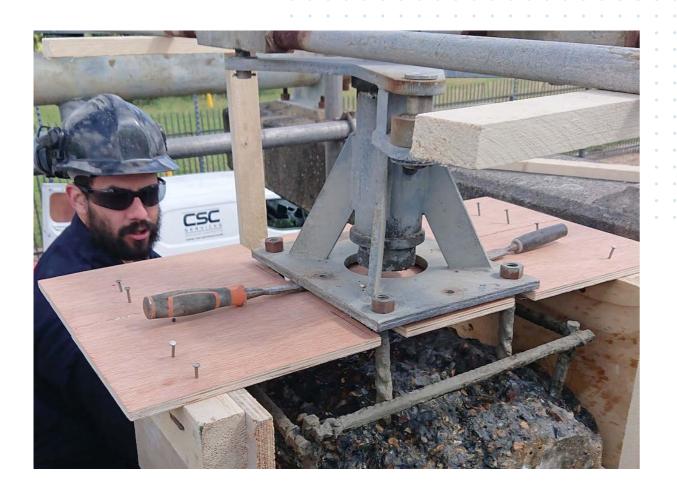
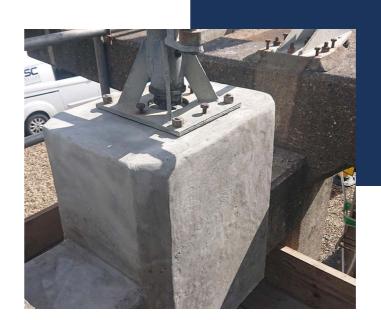
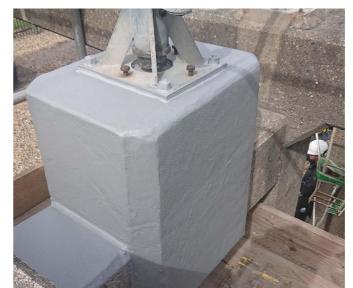
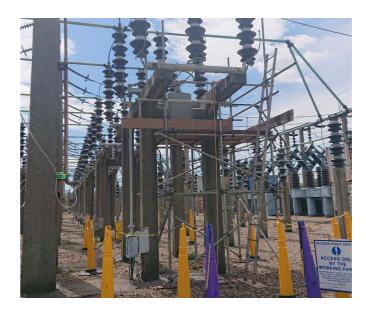
Concrete repair work to columns carrying switchgear within a high voltage substation. The works were carried out under outage conditions over several days, due to the dangers associated with operating in this high risk environment.

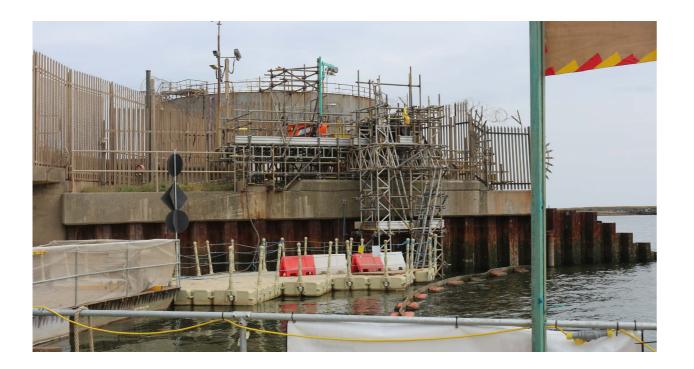
· · · · · · · · · · · · · · · · · · ·	•••	•••	•	•	•
We were asked by the Investment Delivery Team of a	••••	•••	•	•	•
existing power station client to carry out concrete rep	• •	•••	•	•	•
work to a 40-metre-long section of sea wall which inc			•	•	•
crane support and cantilever beams. The steel rebar l rusted, and concrete spalling was found to most of th			•	•	•
beams and wall.		•••	•	•	•
	• •	•••	٠	•	•

The challenge was access to the area to be repaired, which was in direct contact with the sea and no access possible from the station itself. 6-metre-high rising tides were another challenge to overcome.

The first stage was to think innovatively about how to access the repair area. We worked with North East Safety Boats, who built a bespoke barge for the project using NATO pontoons. The barge was delivered to the site location via the Tees estuary in 3 sections, which were then rigged together and supervised by qualified personnel throughout the entire project, raising and lowering the barge as required in response to sea levels through means of a winch. The barge was fully calculated for stability and mooring analysis carried out to ensure safety and confidence of those working on the project.
