DESIGN AND CONSTRUCTION ASPECTS OF A RIVERWALL SYSTEM CONSIDERING STAGE-CONSTRUCTION TO MINIMISE EFFECTS OF DETRIMENTAL RIVERBANK SOIL MOVEMENTS

D. E. L. ONG

This paper highlights the design and construction challenges of a riverwall constructed in soft riverbank deposits. Finite element modelling was carried out to develop the necessary construction stages so that the riverwall project can be safely executed. In the design of the riverwall system, amongst the important considerations include (i) low bearing capacity of the soft riverbank deposits, (ii) requirement of overall riverwall stability, (iii) effect of tidal variations, (iv) proposed dredged levels and (v) relatively shallow pile penetration depths. By adhering strictly to the construction stages, the riverwall project was successfully executed. Besides, some local case studies show that over-filling at such soft riverbank slope crest can induce instability and may eventually lead to failure. This observation reinforces the importance of performing stage-construction during the implementation of riverine infrastructure projects in soft riverbank deposits.

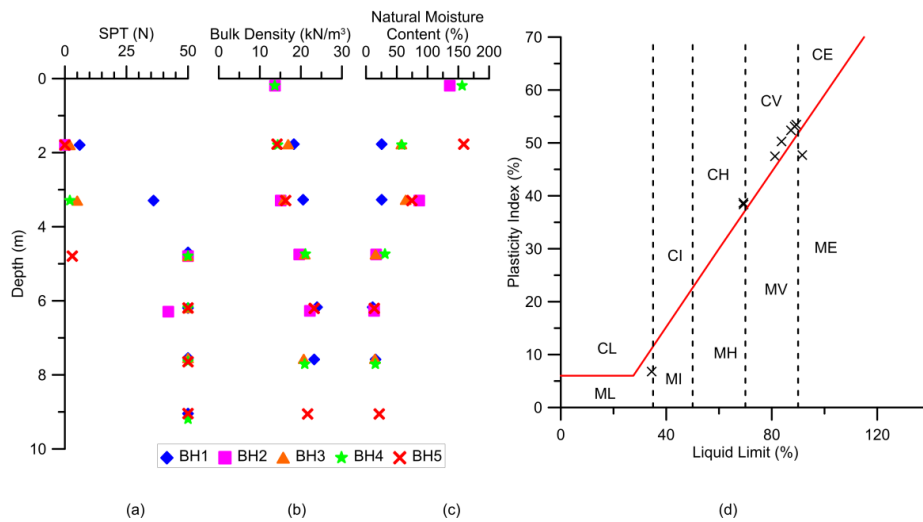
Figure 2. Variation of (a) SPT N values, (b) bulk density, (c) natural moisture content with depth and (d) plasticity A-Line chart.

Standard penetration test (SPT) was carried out in the boreholes to assess the stiffness of the ground. Figure 2(a) shows the distribution of the SPT blow count recorded. In general, the borelogs show the presence of 2.5m of very soft silty clay layer with SPT N-value of less than 3. Underlying the soft silty clay is a layer of very dense sand or hard clayey silt of approximately 3.5m thick with SPT N-value between 30 and 50. Dense sand with SPT N-value greater than 50 is suitable for pile bearing and socketing to prevent uplift.

Typical plots of bulk density and natural moisture content are shown Figure 2(b) and (c). The average bulk density for the first 3.5m of soil from the two boreholes is about 16.5kN/m³, after which the bulk density would increase to a range of between 18kN/m³ and 20kN/m³ indicating closely packed soil particles leading to stiffer soils. Soil natural moisture, however, decreases with increasing depth as shown in Figure 2(c), because most voids would have been filled with the closely packed soil particles.

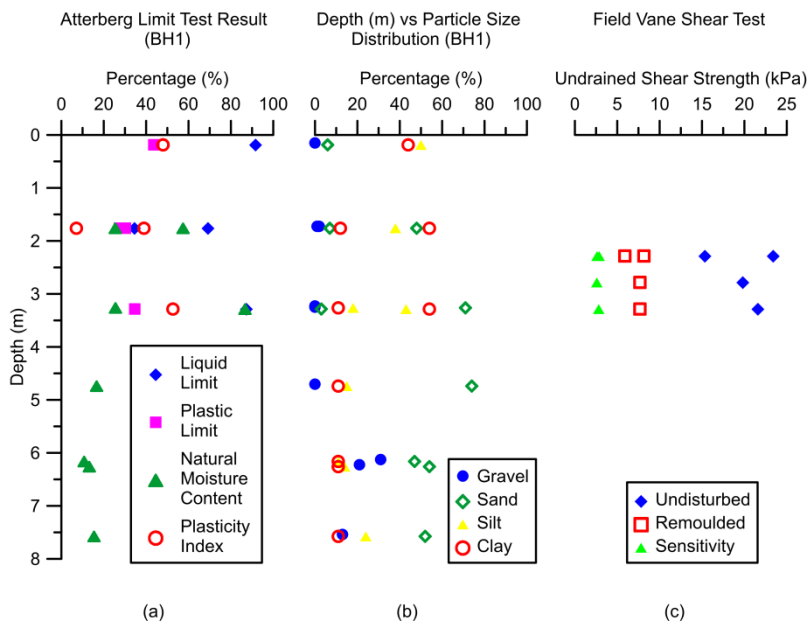
Figure 3. (a) Atterberg Limits, (b) particle size distribution and (c) vane shear strength vs. depth.

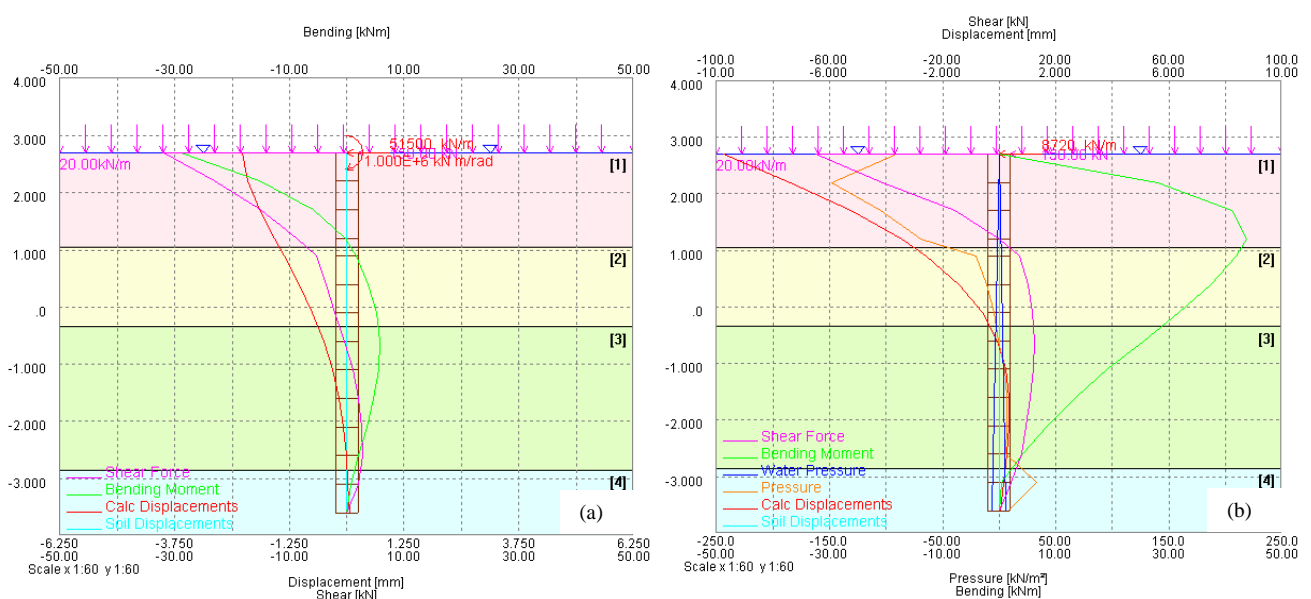
Figure 5. Typical ALP analyses for 400mm diameter spun pile (a) CH0+175 (fixed head) and (b) CH0+175 (pinned head).

Table 7, respectively. It is observed that the induced forces are all within the allowable capacity of the pile. Typical ALP analysis can be found in Figures 5(a) and (b).

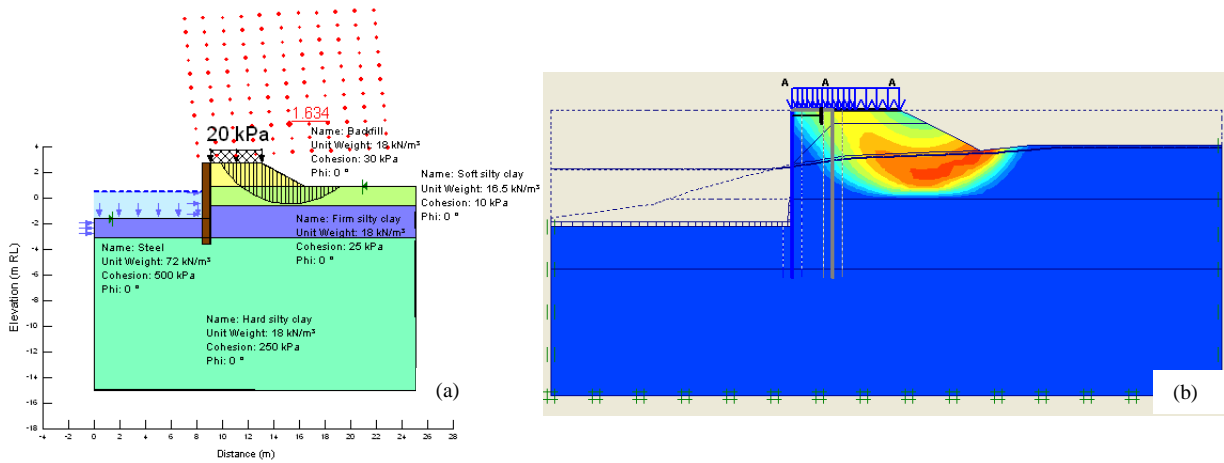
Figure 6. Benchmarking of slope stability analyses using (a) GEOSTUDIO SLOPE/W and (b) PLAXIS 2D.

Slope stability analyses are performed to assess the stability of the earth fill slopes behind the riverwall as well as the riverbank slopes after installation of the riverwall. Table 10 shows that earth fill slopes at CH0+175 and CH0+275 graded at 1V:2H to a maximum height of about 2m yield a factor of safety (FOS) of greater than the minimum of 1.5 in undrained condition, thus acceptable. The very high FOS generated for Case 2 is due to the presence of the riverwall which intercepts potential slips from occurring, thus providing a stabilizing effect to the riverbanks. The benchmarking of slope stability analyses using GEOSTUDIO SLOPE/W and PLAXIS 2D ($c'-\phi'$ reduction method) can be found in Figure 6.

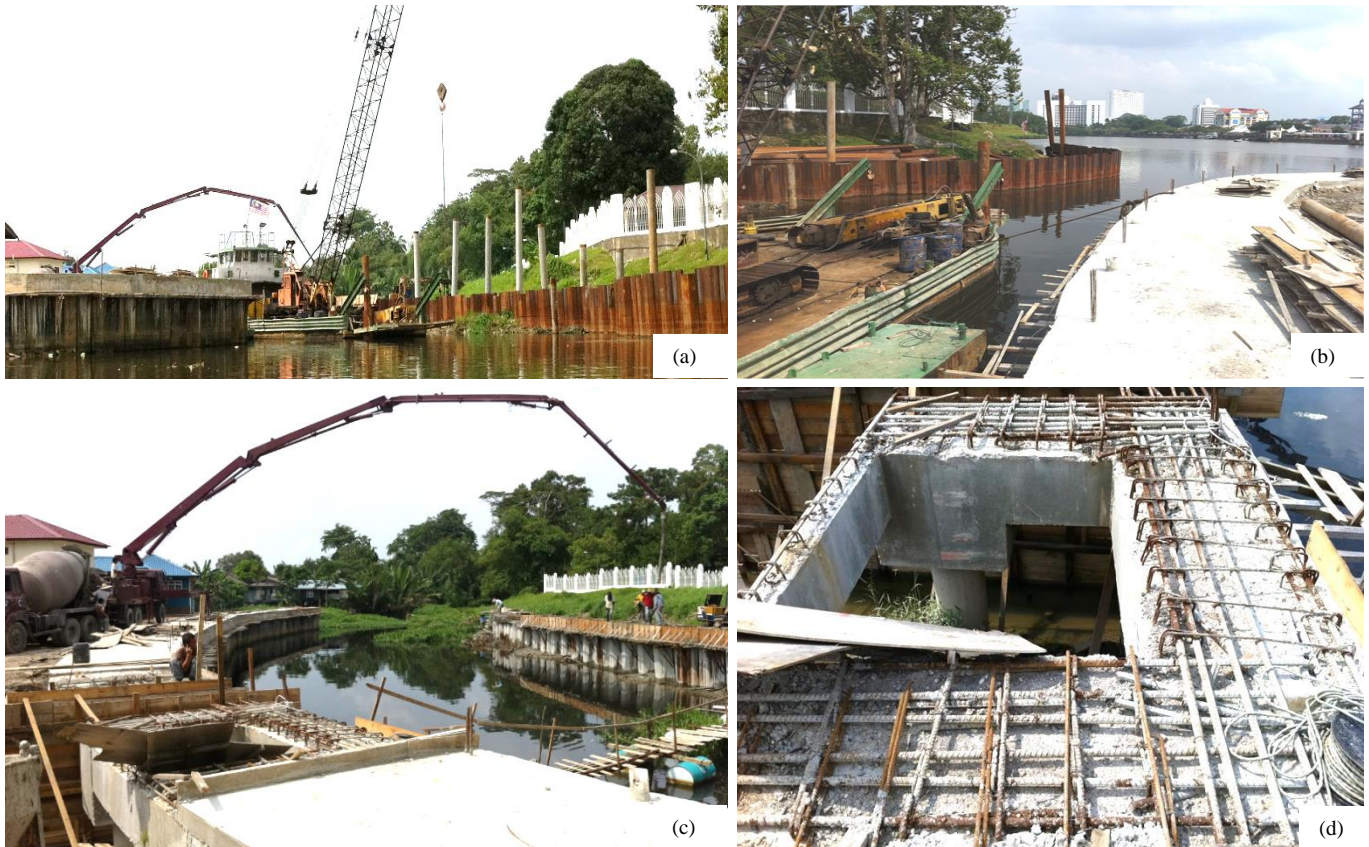
Figure 8. Good construction practices: (a) Use of overhead crane and piling equipment on barge, (b) stable berthing of barge for piling works, (c) use of long-reach concrete pump to relieve unnecessary surcharge load on the soft riverbank and (d) stage-construction of riverwall in progress (Stage 3, note that filling works was intentionally delayed from being placed under the platform until after successful completion of the tie team, which acts as a load transfer mechanism).

- (d) Figure 8(d): A good example where stage-construction was emphasised i.e. filling works was intentionally delayed from being placed under the platform until all the foundation piles were tied together via the tie beam to ensure efficient resistance against any unwanted potential slope movements / circular slips that might be triggered.

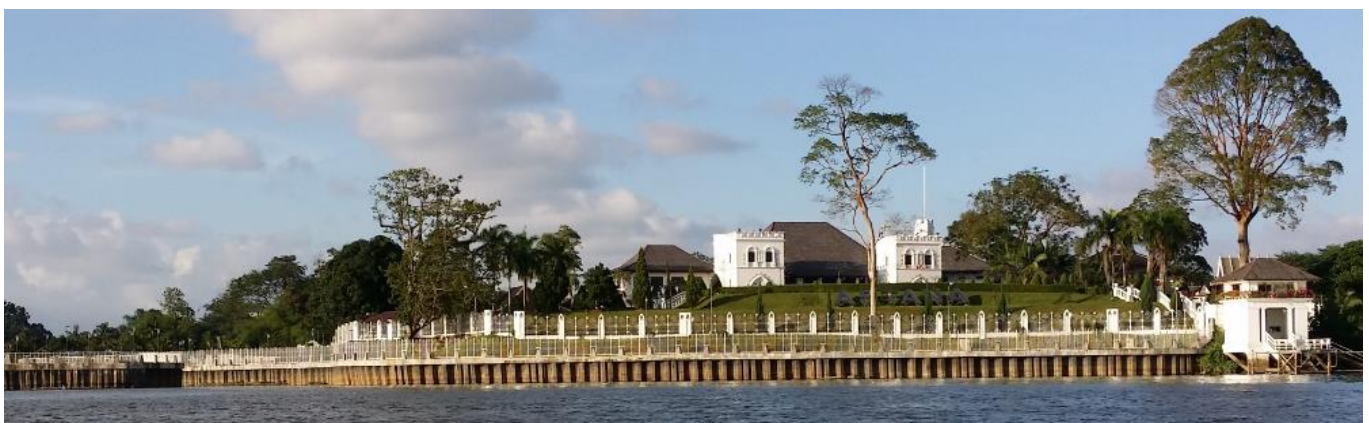
Figure 9. The completed riverwall in front of the Astana (official residence of the Governor of Sarawak).

- Figure 9 shows the successfully completed riverwall standing majestically, lining the riverfront of the Astana (official residence of the Governor of Sarawak).

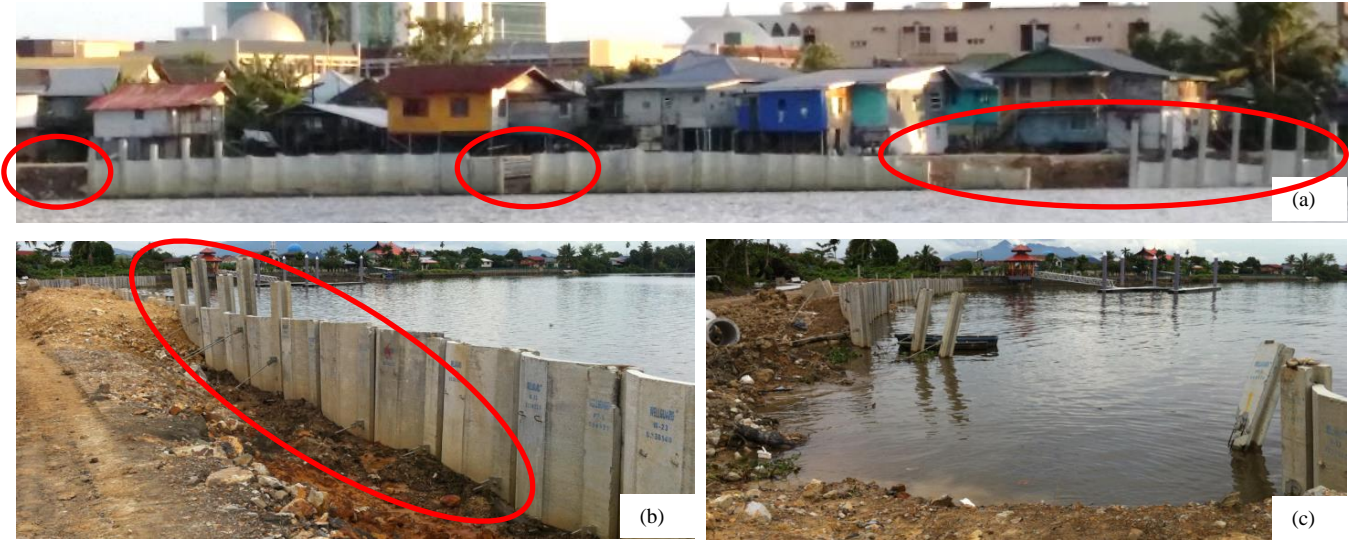
Figure 10. (a) Longitudinal view of 3 locations where circular slips most likely occurred that dragged parts of the concrete sheet pile riverwall system into the river, (b) close-up view showing the haphazard installation of the RC guide piles and anchorage system at grossly different lengths and angles, respectively and (c) close-up view of a major circular slip that might have taken place due to over-loading of the soft riverbank slopes by unplanned filling.

Figures 10 and 11 show two local case studies where the proposed riverwall systems had been suspected to be undermined by riverbank slope failures. The aftermaths of such events are usually unforgiving as rectification works usually involve a lot of money and time. Even though forensic engineering on the actual causes of the failures has not been officially carried out, technical observation seems to suggest that the recommended stage-construction might not have been carefully planned and thus could have led to the formation of circular slips on the soft riverbank slopes, most likely due to rapid over-filling carried out on the soft riverbank slopes.

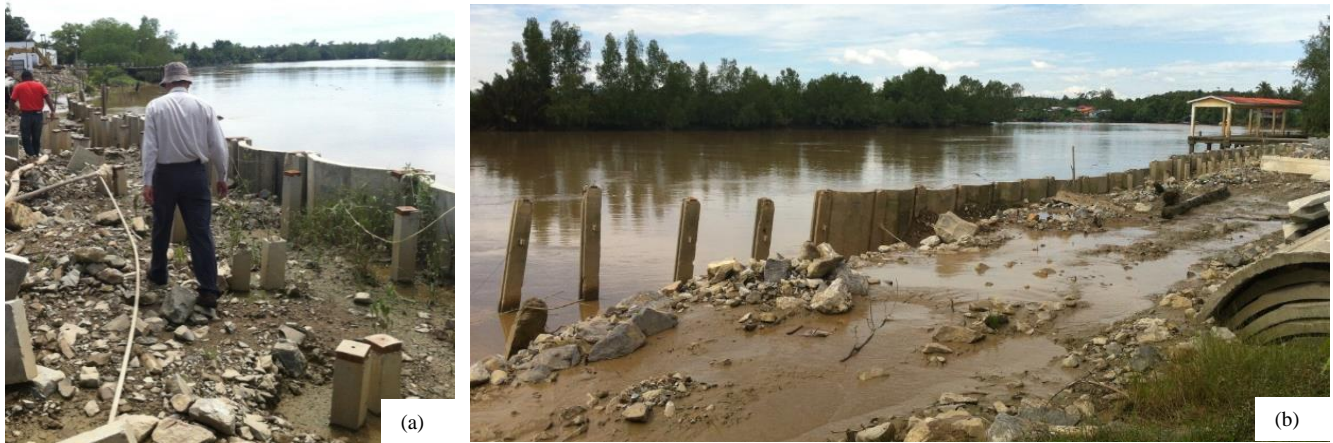
Figure 11. (a) Misaligned concrete sheet pile riverwall system and RC piles and (b) longitudinal view of a major circular slip that might have taken place due to over-loading of the soft riverbank slopes by unplanned filling.

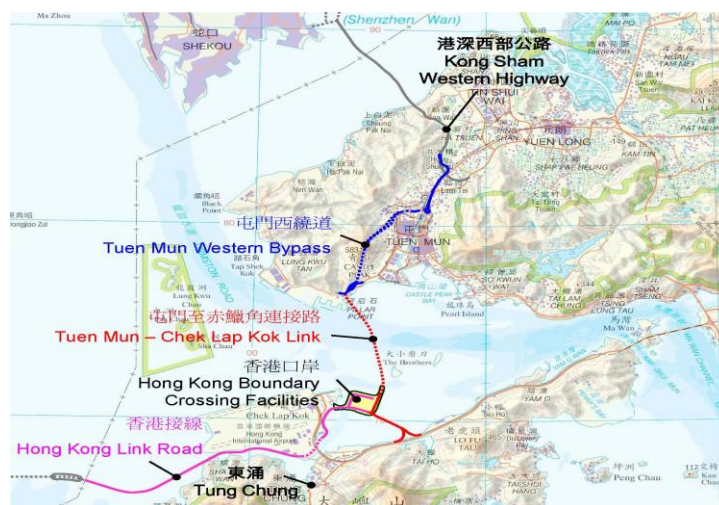
The Hong Kong–Zhuhai–Macao Bridge (HZMB) is an ongoing construction project package commenced in 2012 and consists of a series of bridges and tunnels that will connect Hong Kong, Macao and Zhuhai, three major cities on the Pearl River Delta in China. The whole project package comprises main bridge, Hong Kong Link Road (HKCLR), Cross Boundary Facilities (HKBCF), Tuen Mun-Chek Lap Kok Link (TM-CHKL), Tuen Mun Western Bypass (TMWB) and the Connectivity.

Figure 1. Hong Kong–Zhuhai–Macao Bridge, Hong Kong Boundary Crossing Facilities

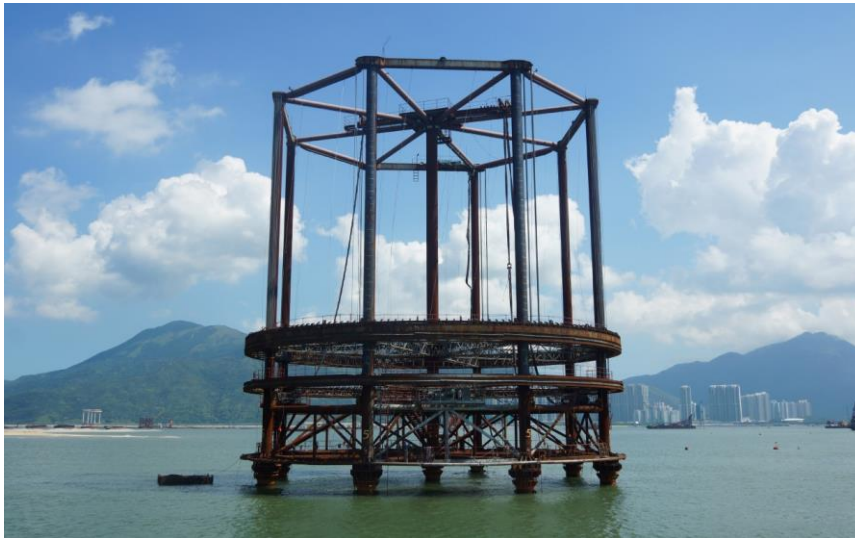
To facilitate fabricating cell in places, a temporary working platform is utilized to properly align sheet piles during the pitching process and maintain alignment during sheet pile driving. The temporary working platform consists of circular guide frames connected by temporary piles driving to stiff stratum by vibratory method. Each guide frame is fabricated in modular sections for ease of lifting and transport from cell to cell.

Figure 3. Temporary working platform for sheet piles installation

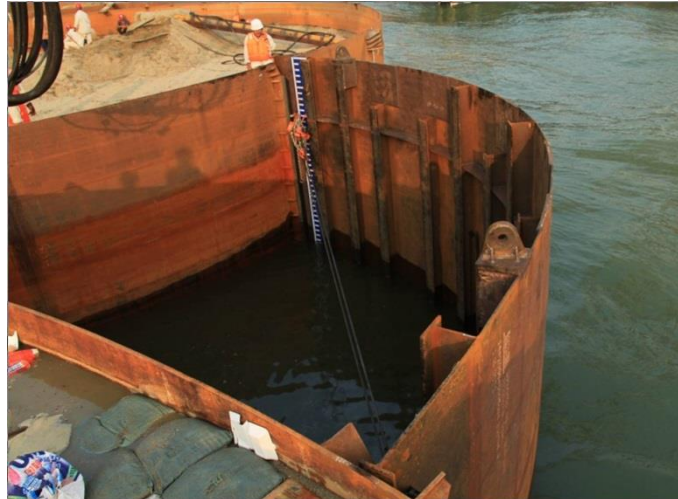
Figure 4. Installation of Arc Cell

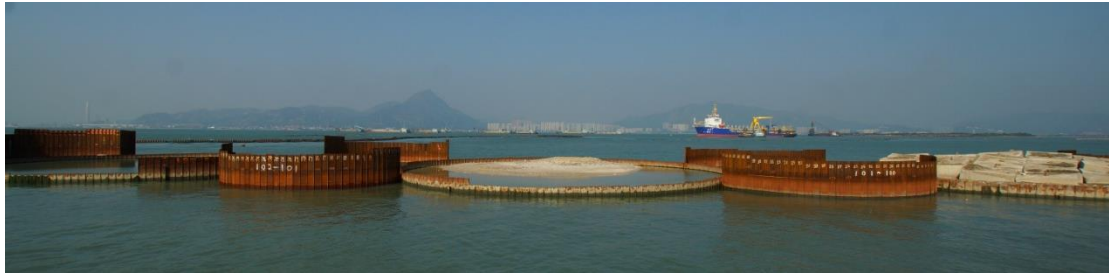
Figure 8. The cellular structure and arc units are completed and filled up with fill materials and the reclamation fill behind in progress

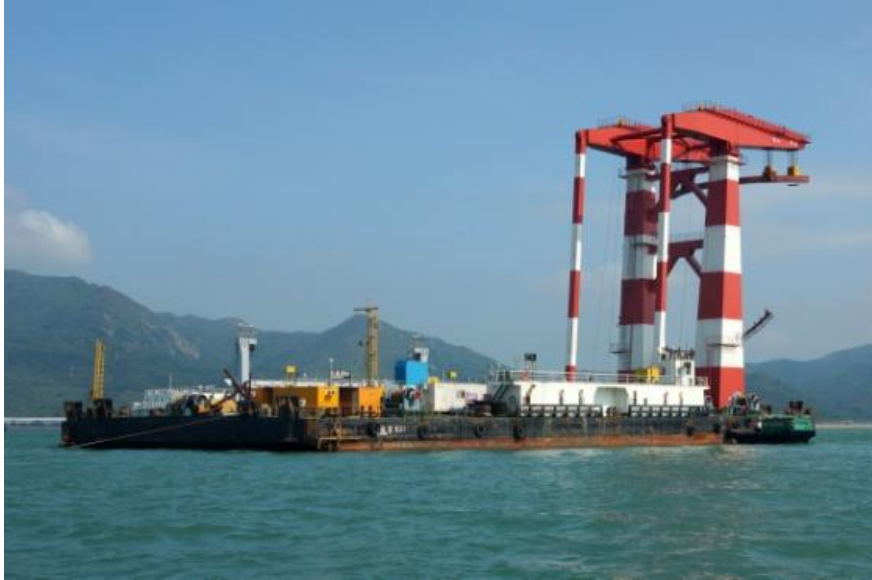
Two special barges for main cells and arc units' installation are specially designed and modified by three self-owned flat-topped barges to suit the official AHR requirement. The maximum height of barges together with the cell attached will keep at least one meter clearance below the official AHR level.

The adjustable truss tower on stone column barge is erected to suit for the official AHR levels in different working zones. The special vibrolance adopted in this Contract is also extensible to suit both AHR requirement and the total depth of installation.

Figure 11. Special barge

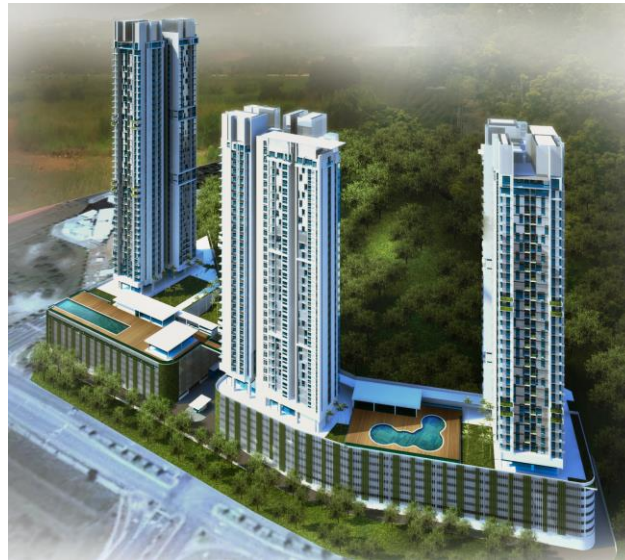
Figure 1 - Architectural Layout for the Proposed Development

The proposed structure will be located on a cut platform at 100m PD. The structure itself will be independent of the retaining wall. The existing hillslope comprises of a man made cut slope to the south of the site with the rest being natural hillslope with dense vegetation.

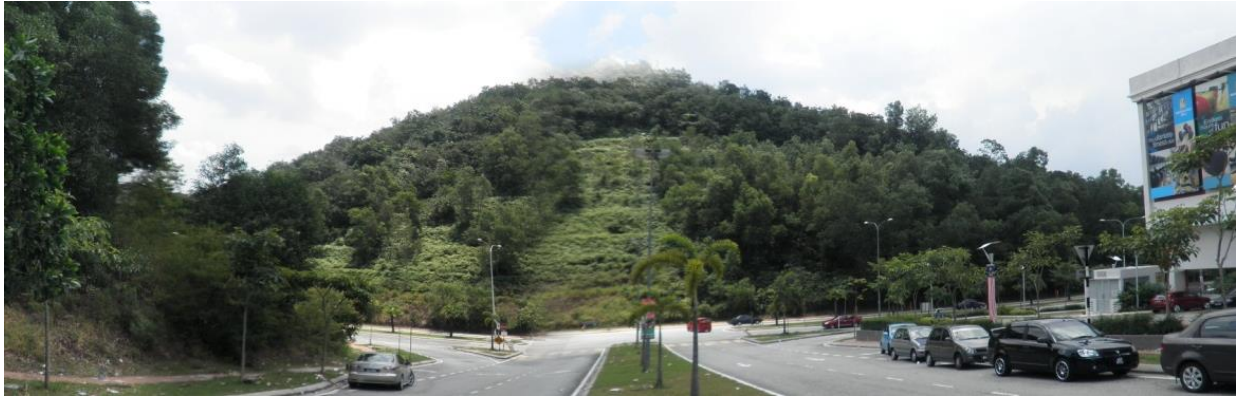
Figure 3 - Front View of the Development

The site is situated along the southern portion of an existing natural hillslope. The hillslope is over 80m high with a base height of RL+96m and a peak height of over RL+176m. The peak is located outside the project site. The slope is quite shallow, around 25° to 40° and completely obscured by vegetation. The western side of this hill has been cut to locate the existing Telekom Exchange building. Between the natural hillslope, almost centred on the site is a man-made cut slope. This cut slope faces Jalan 58/26, approximately 200m in length and 80m in height. Intermediate berms were formed such that the slope condition can be inspected.

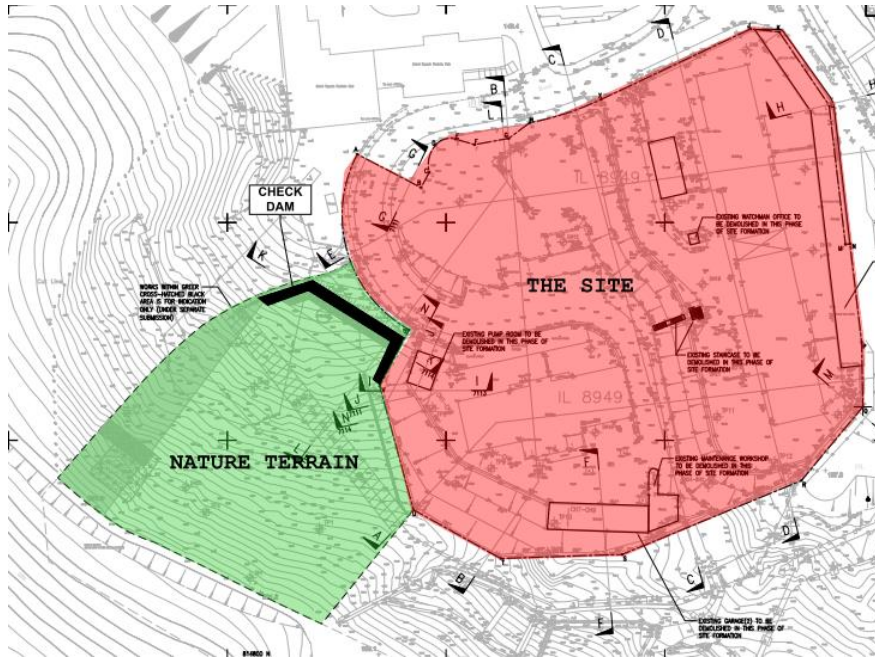
Figure 4 - Site Layout Plan at Borrett Road

Similar to the project in Wangsamaju, there is a natural slope laid behind the proposed development site at Borrett Road. Natural terrain was assessed and site formation design was carried out to cut into the originally natural hill. The natural terrain hazard assessment identified several potential hazards such as debris flow and boulders fall that would likely occur; hence, a check dam with temporary soil nail is designed for the potential debris flow and in-situ boulder stabilization was carried out after detailed boulder survey. Site formation design, including socketted H-pile, reinforced concrete wall and rock cut slope were proposed to form platform for superstructure development after cutting.

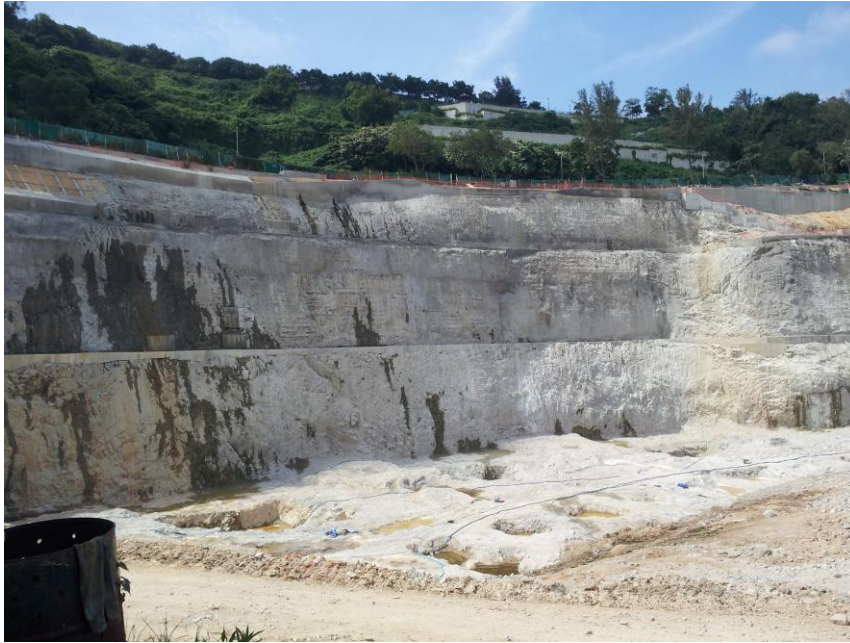
Figure 6 - As-built Condition at Wai Lung Site

The proposed development at Macau was originally a hilly slope with elevation difference of more than 50m. The purpose of the site formation works is to cut into the existing slope to cater for the future residential building blocks. Since the rockhead was generally located 6m below the existing ground, reinforcement concrete wall was proposed to retain the soil on top of the rockhead with 70 degree to 85 degree rock cut slope underneath. Rock joint mapping assessment with necessary remedial works, including rock dowel and buttress, were proposed for the rock cut slope.

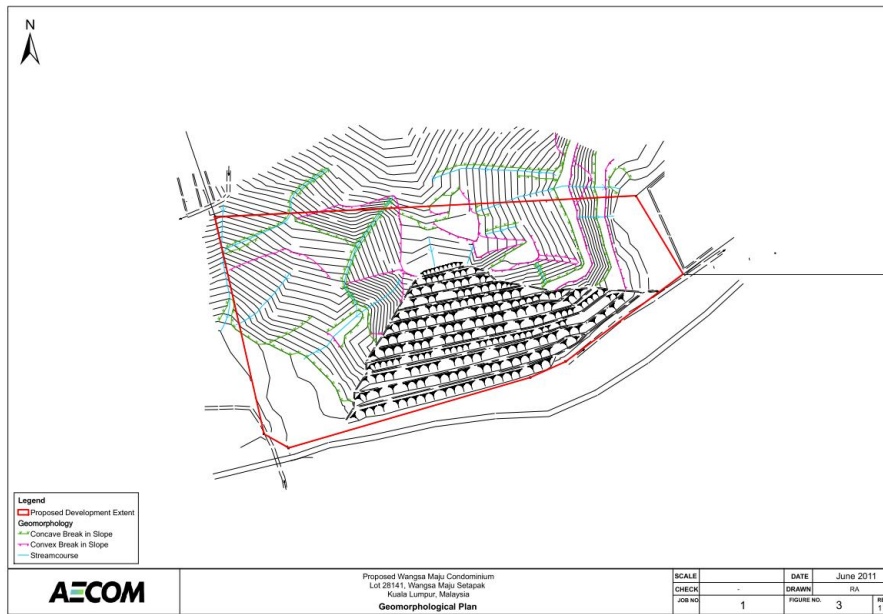
Figure 8 - Geomorphological Plan

A slope angle plan is presented in Figure 7 and a geomorphological plan in Figure 8. Both plans are based on limited contour data and therefore may not be accurate. A number of potential landslide initiation locations are considered to exist based on slope angle and geomorphology. Through lower hillslope within the east of the study area the steeper topographic areas could be the result of anthropogenic activity.

In general, streamcourse channels are poorly defined and will tend not to confine a landslide to generate high mobility or channelised debris flows, with the exception of the incised streamcourse channel within the western portion of the study area.

The distance between the upslope and toe of the study area is also short and steep, and although some possible depositional/colluvial areas are defined by concave breaks in slope, the potential for entrainment is considered low. Therefore, landslides which occur within the study area are likely to reach the toe of the study area.

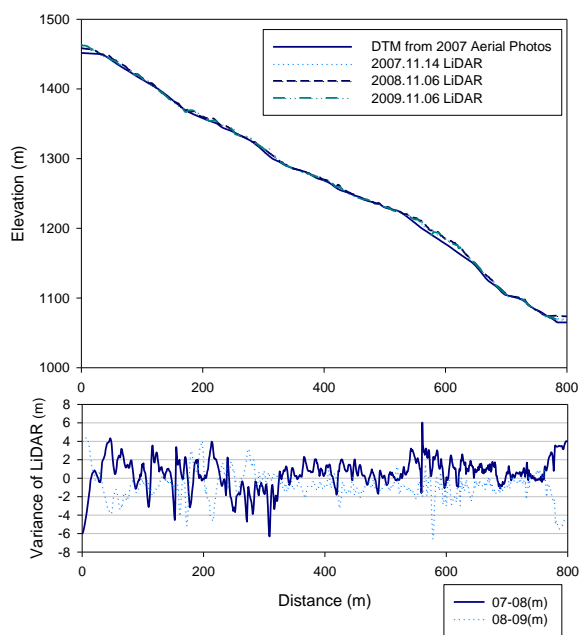
Figure 9. The variations of profile elevation acquired from LiDAR data
