# New Priority Ranking Systems (NPRS) for Selection of Man-made Slopes

Anthony Lam  
(Senior Geotechnical Engineer)

Standards and Testing Division,  
Geotechnical Engineering Office,  
Civil Engineering and Development Department

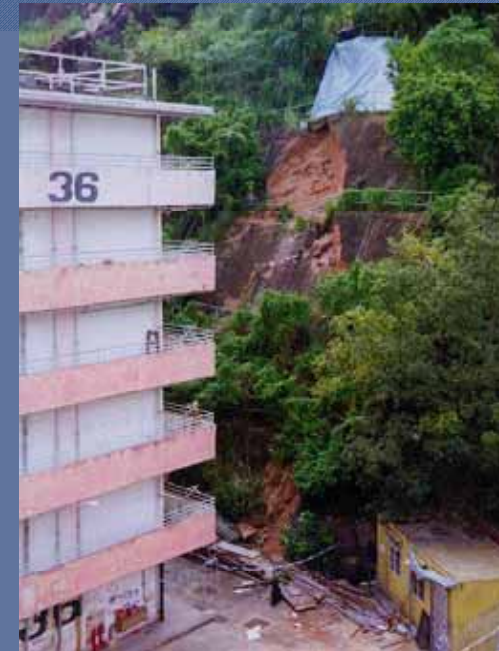
**1999 Shek Kip Mei landslide –  
emergency evacuation of 700+ people**

- slope formed /treated based on knowledge and technology from 1977 to late 1980s
- slope trimmed to less steep gradient without reinforcement or structural support
- prone to deterioration based on performance history

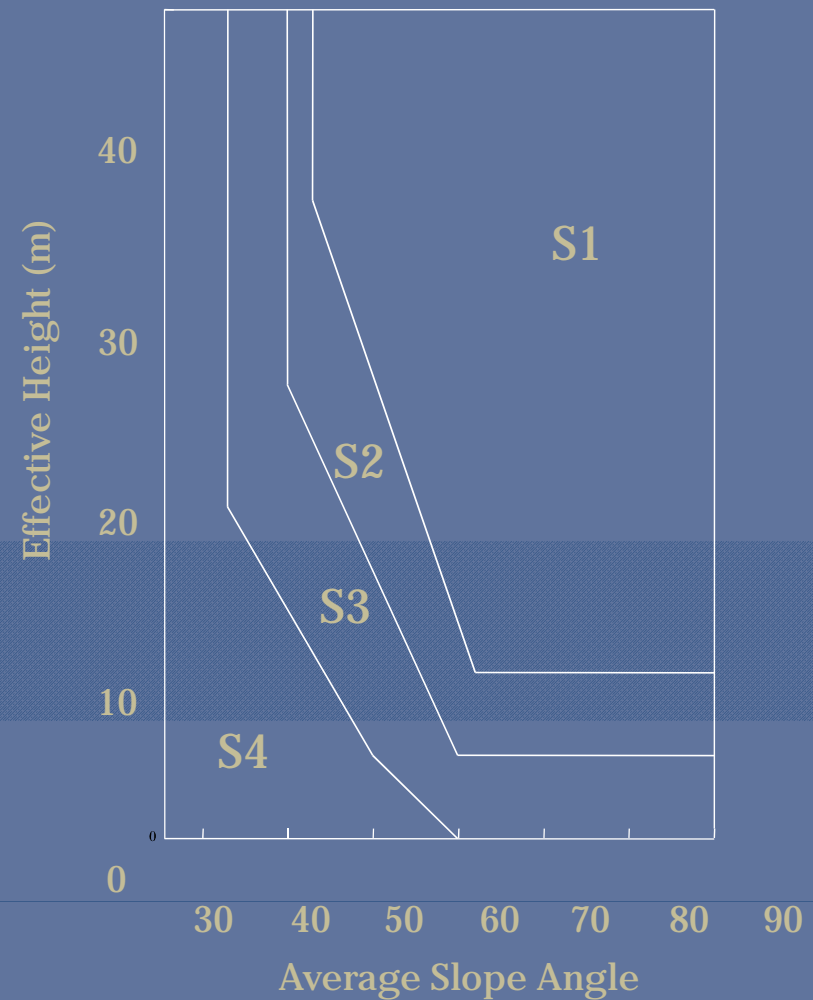
Slope Geometry	A3
S1	8
S2	4
S3	2
S4	1

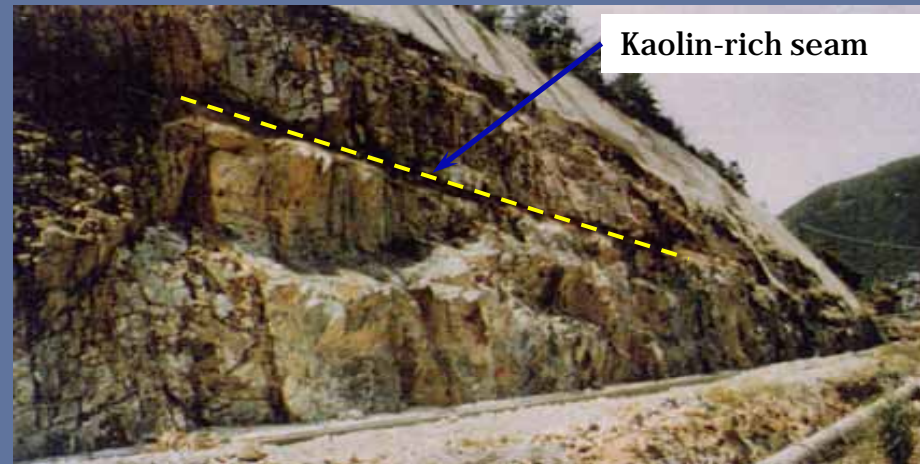
## Significant

sites with relict massive failure, observable or recorded adverse discontinuities (e.g. adversely oriented, persistent, pre-existing shear surfaces or zones)

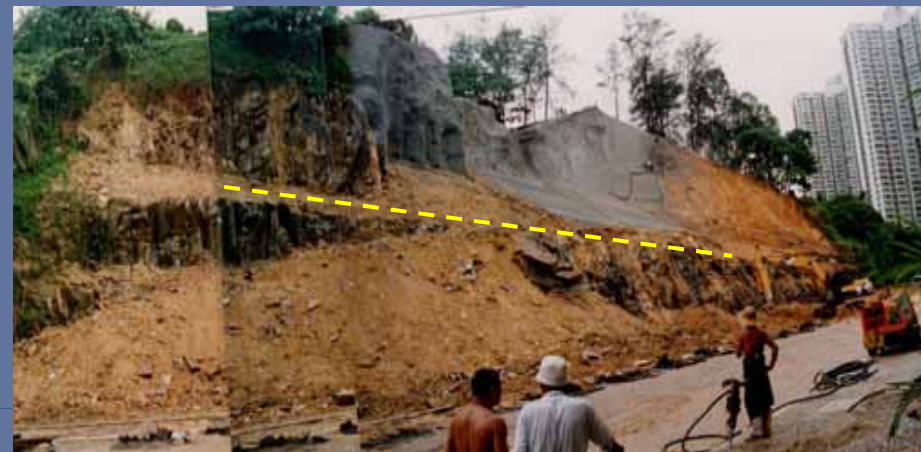
Fei Tsui Road Landslide in 1995

## Moderate

observable or recorded adverse geological materials (e.g. weathered dykes)

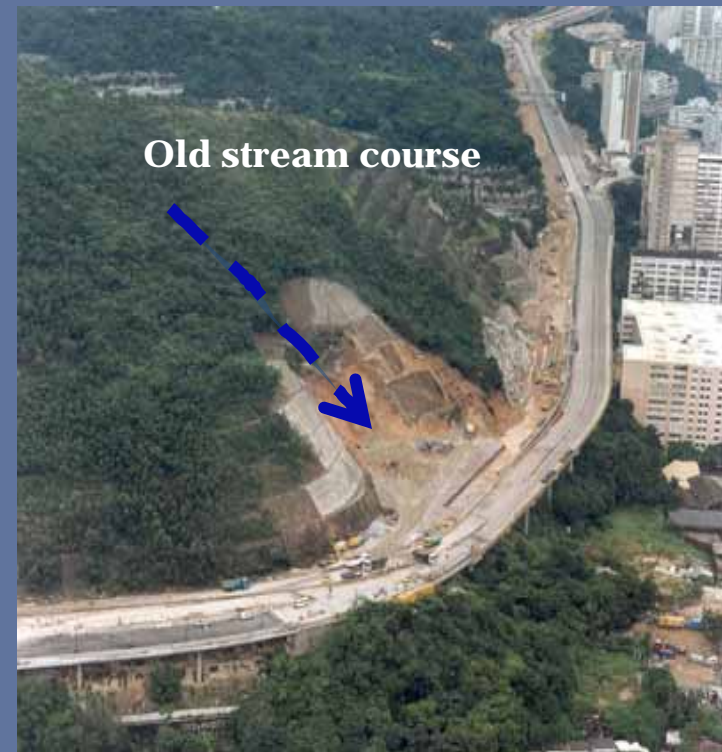
Ching Cheung Road Landslide in 1997

observable or recorded adverse groundwater conditions (e.g. high groundwater over most area of the slope or complex groundwater conditions with significant storm response)

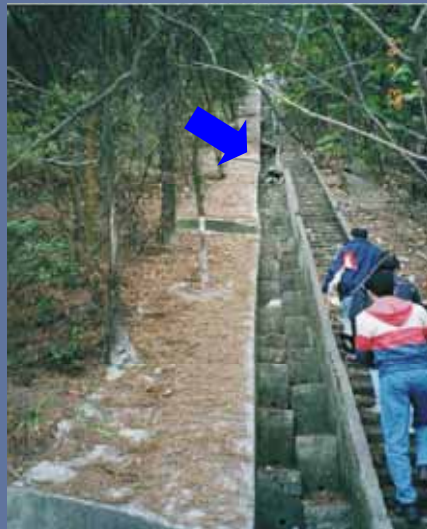
Collapse of  
side wall of  
surface  
channel

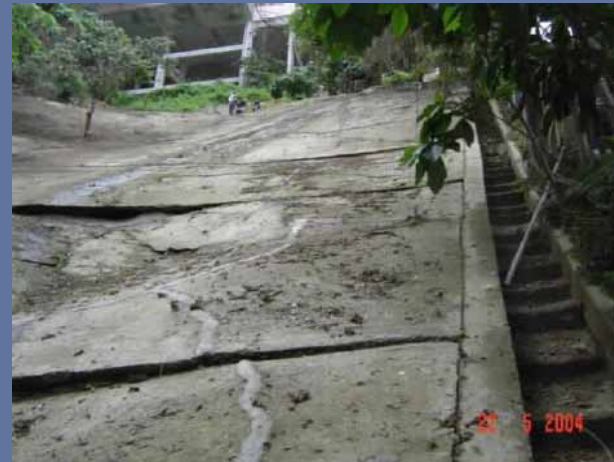
Subsidence  
of slope  
cover

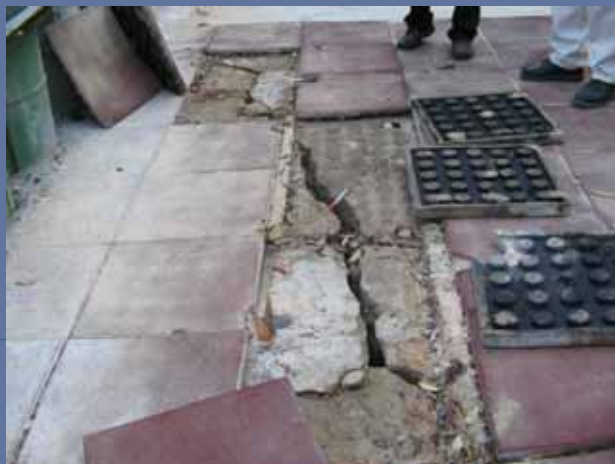
Tension  
crack at  
crest

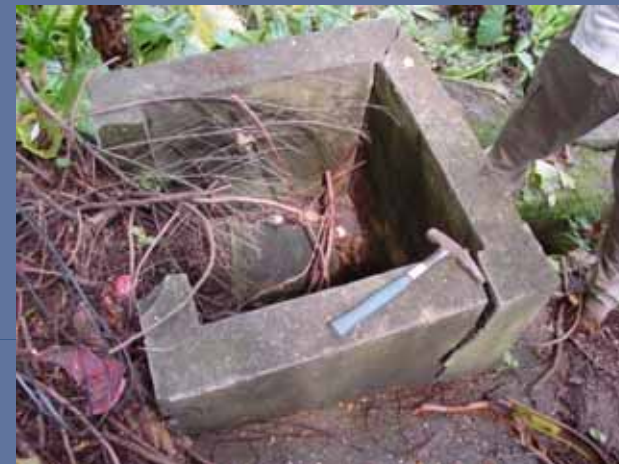
Cracking of  
catchpit

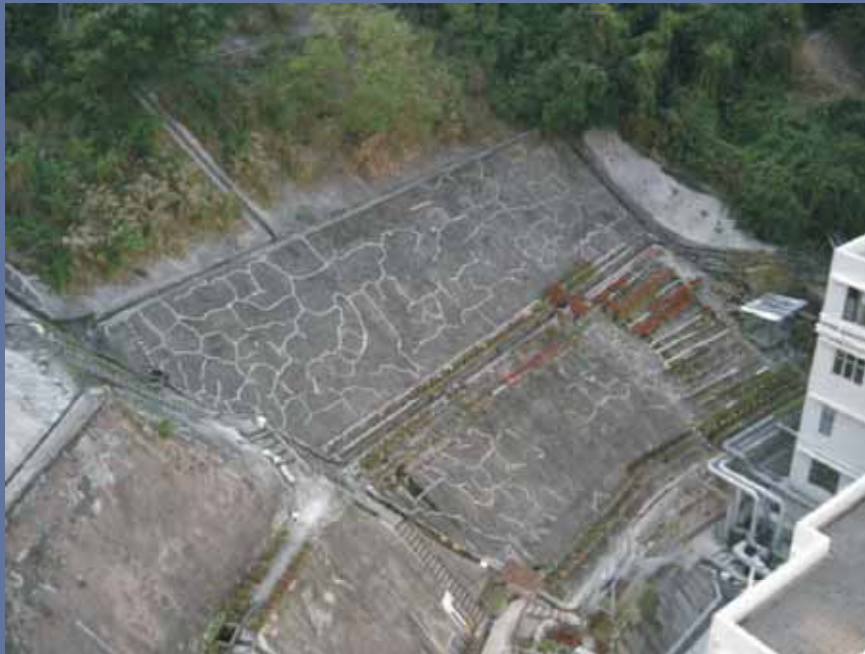
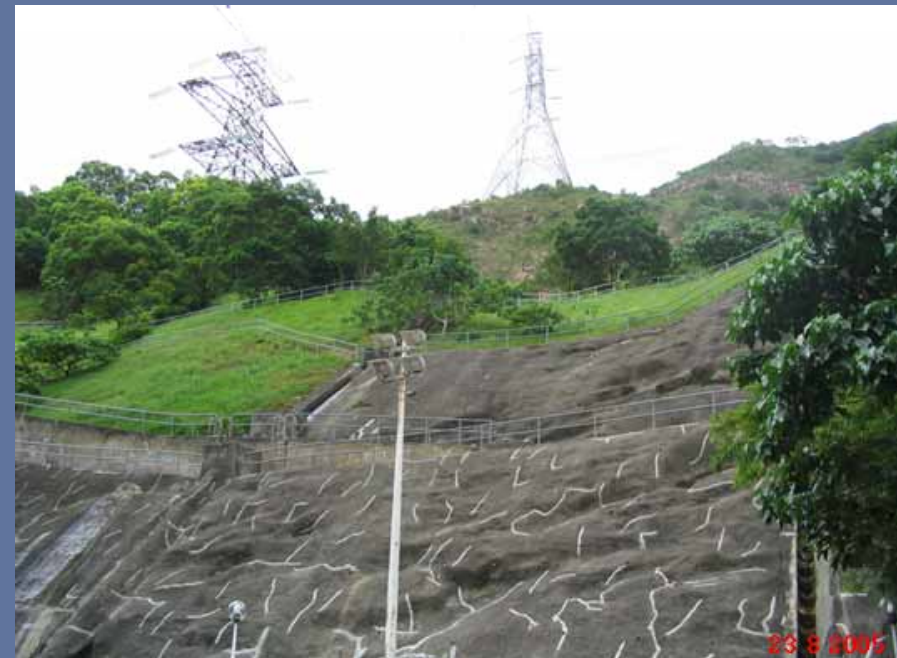
## Severe Cracking of Surface Cover

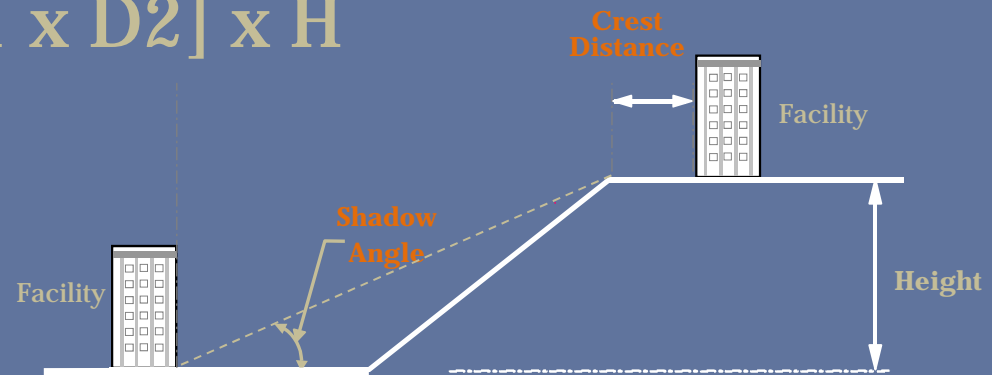
$$CS = [C1 \times C2 + D1 \times D2] \times H$$

- Type of Crest Facility (C1)
- Vulnerability of Crest Facility (C2)
- Type of Toe Facility (D1)
- Vulnerability of Toe Facility (D2)
- Slope Height (H)

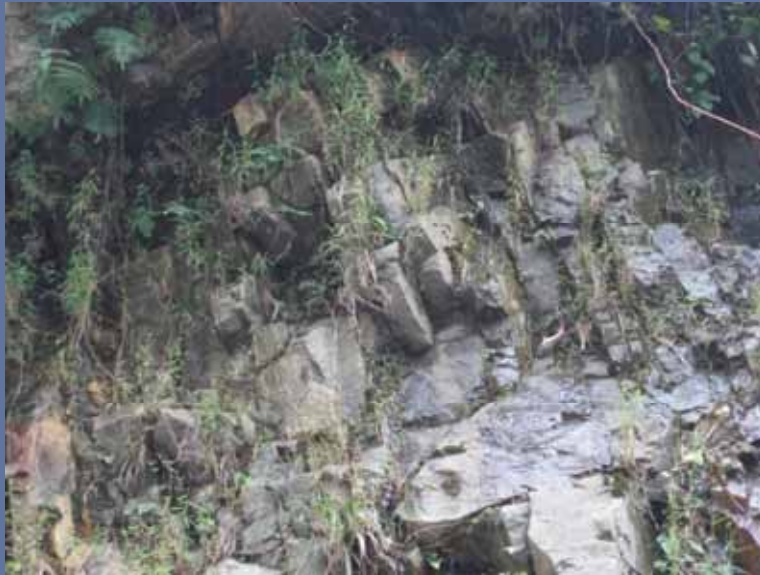
Ravelling Failure – Kennedy Road

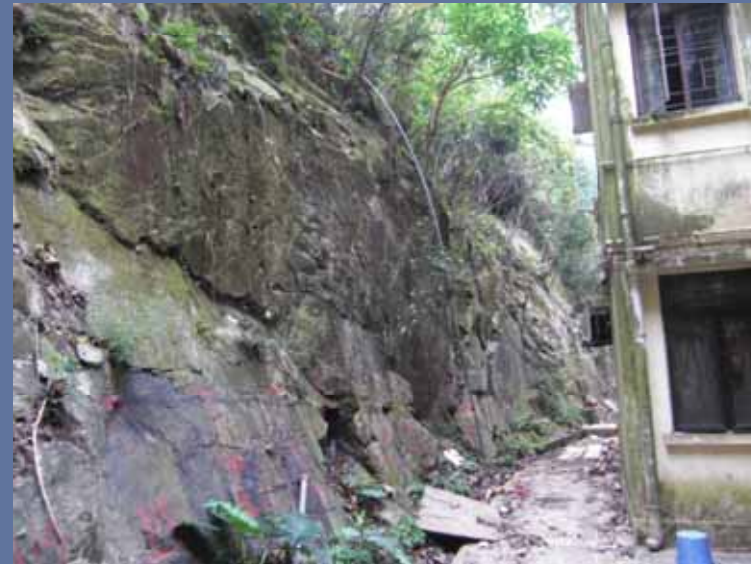
Wedge Failure – Pokfulam Road

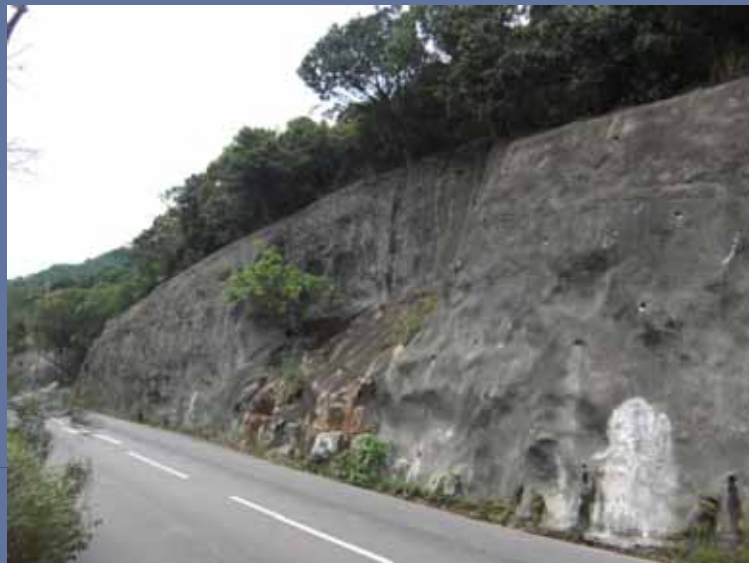
Planar Failure – Tai Tam Road

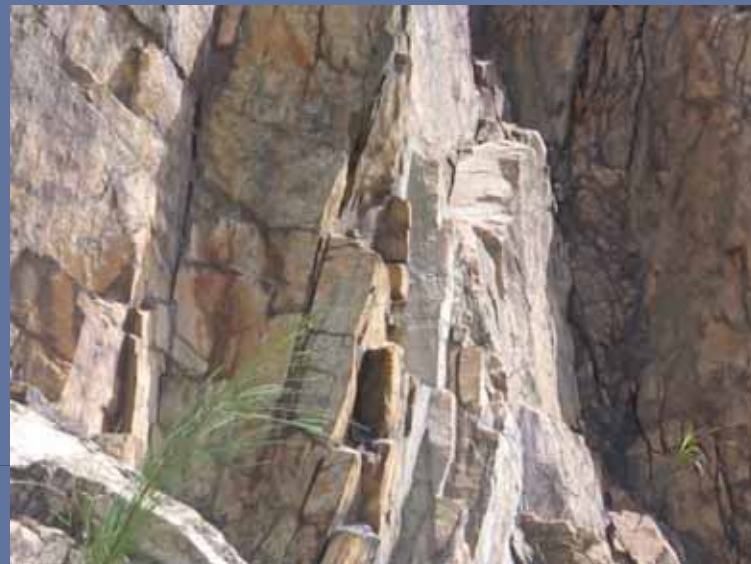
Toppling Failure – Mt Butler

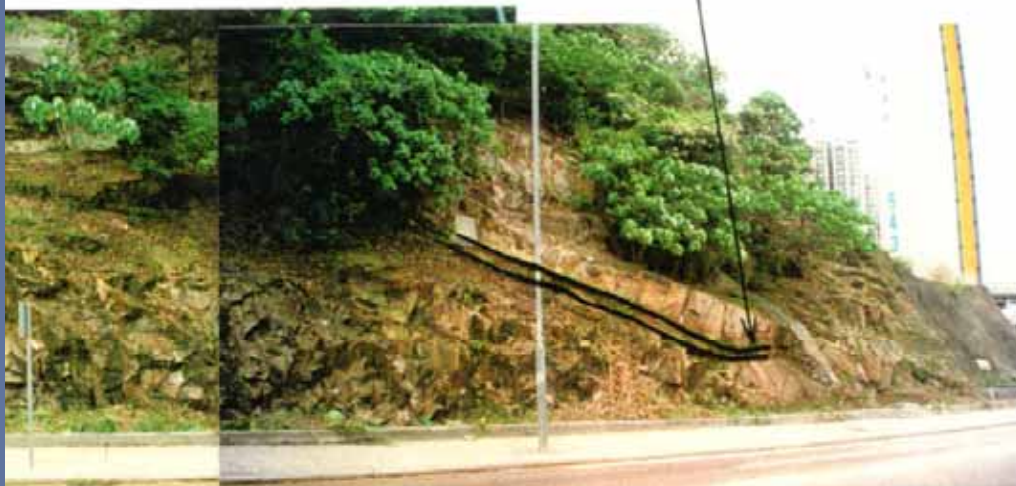
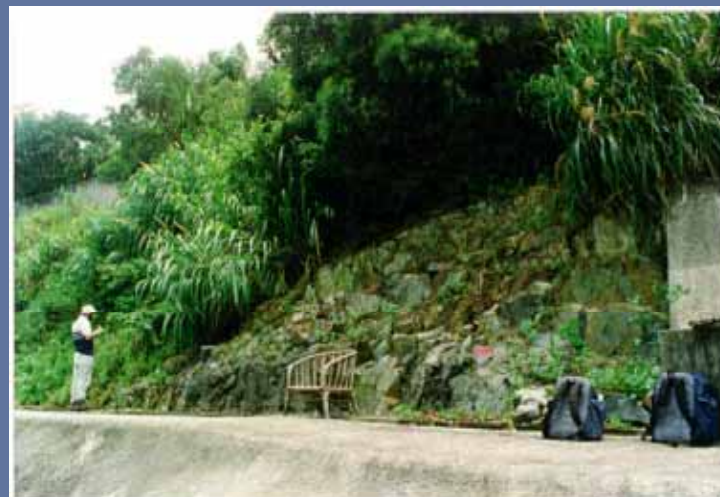
Seam with Loose Sand-sized Material and Lenses of Kaolinitic Clay

Plate 3 - General View of Planar, Obliquely Outward-dipping PW0/30 and PW90/100 Rock Mass Weathering Zone Interface (84356 81362), Associated with Kaolinitic Clay Development, in Slope 11SE-D/C188, West of Siu Sai Wan Estate (Taken 17/7/96)

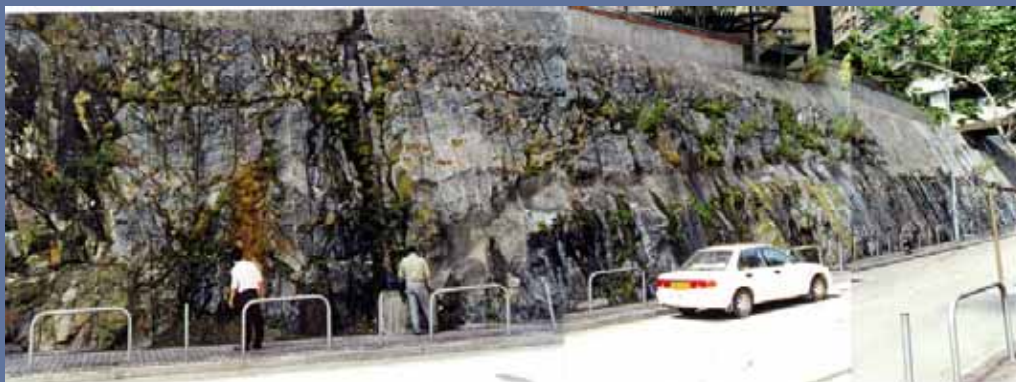
Plate 6 - Unregistered Slope 15NW-3B/S10 (834250E 811530N), in Lei Tung Estate Showing a Relatively Planar Weathered Seam (Largely Covered by Chunnam) of Kaolinitic Clay, c.150 mm Thick, Dipping c.30-35° out of the Slope at about Mid-height within Grade II Tuff. Extensive Groundwater Seepage was Noted from the Seam during Site Inspection. (Taken 12/11/96)

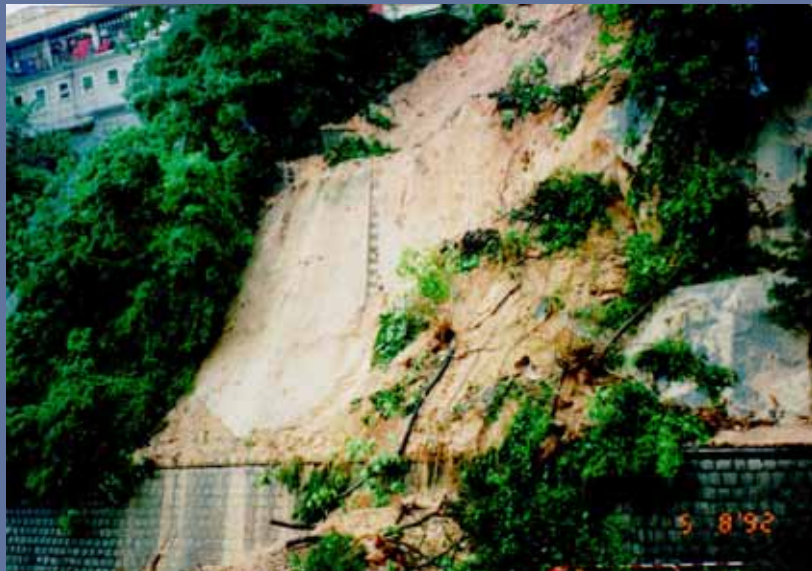
**Kennedy Road (1992)**

## Liquefaction

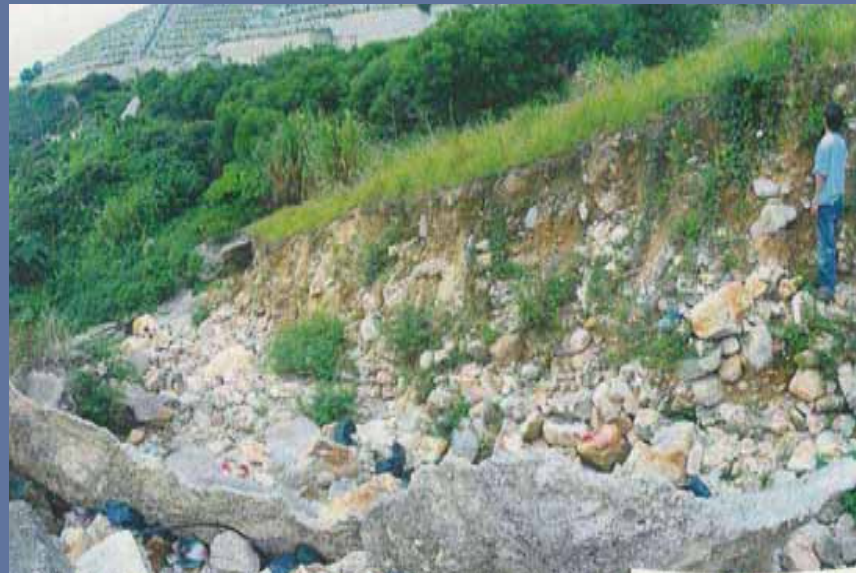
**Tseung Kwan O Chinese  
Permanent Cememntray (2004)**

## Major Washout

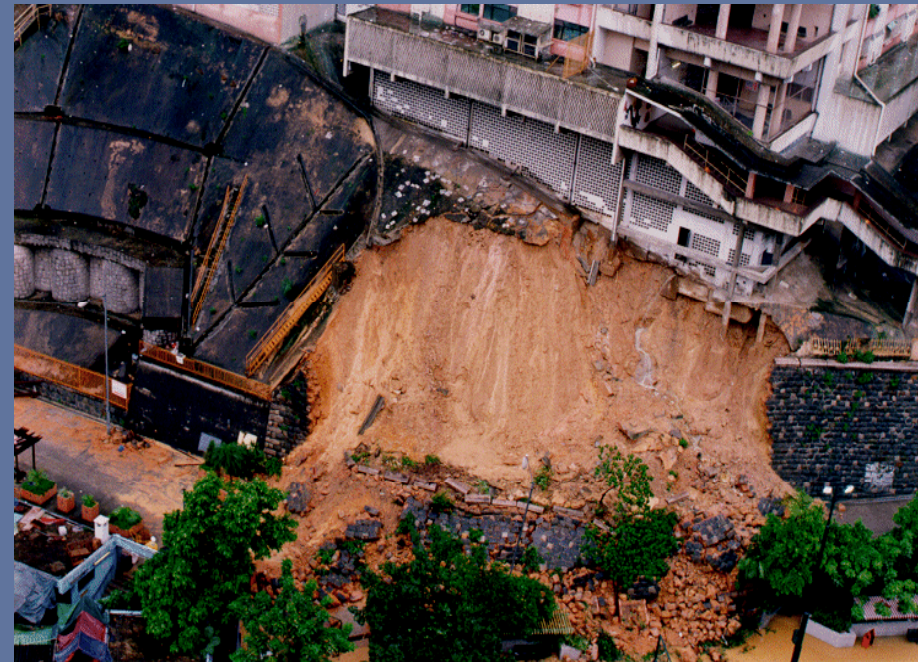
Kwun Lung Lau Failure in 1994

- Documentary Records
- Weephole Probing
- If unable to determine, accord  $H_e/B_w > 5$

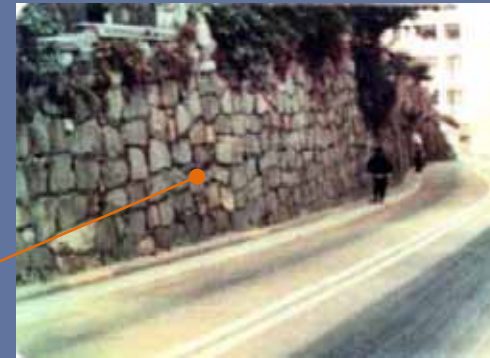
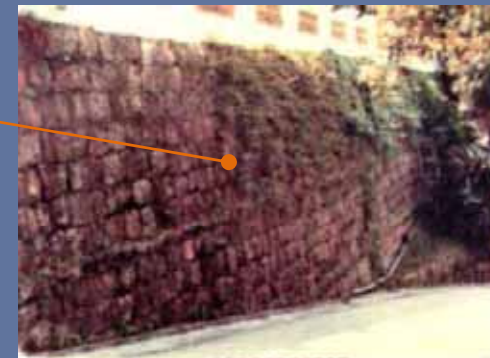
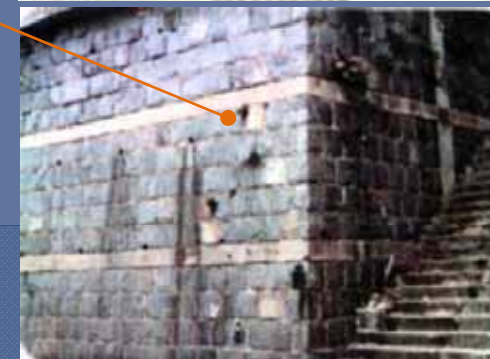
Type of Wall	A3
Random rubble masonry wall	8
Dry packed dressed block/squared rubble wall without ties, or Masonry wall with horizontal beams made of lime-stabilised soil or brick	5
Dressed block/squared rubble wall with ties, or Masonry wall with concrete horizontal beams	3
Concrete wall	1

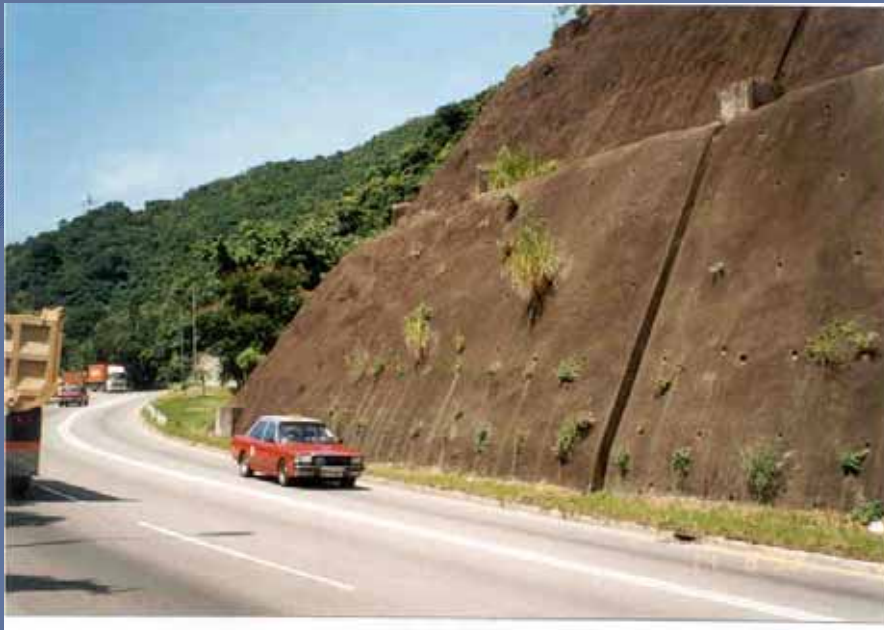
## Soil Cut Slope

Height of the slope = 40 m,  $\theta = 50^\circ$

Formed pre-1977 and modified in association with the road widening works before 1990's

Road with heavy traffic at toe

Previous inspection records indicated an inferred failure scar at southern end

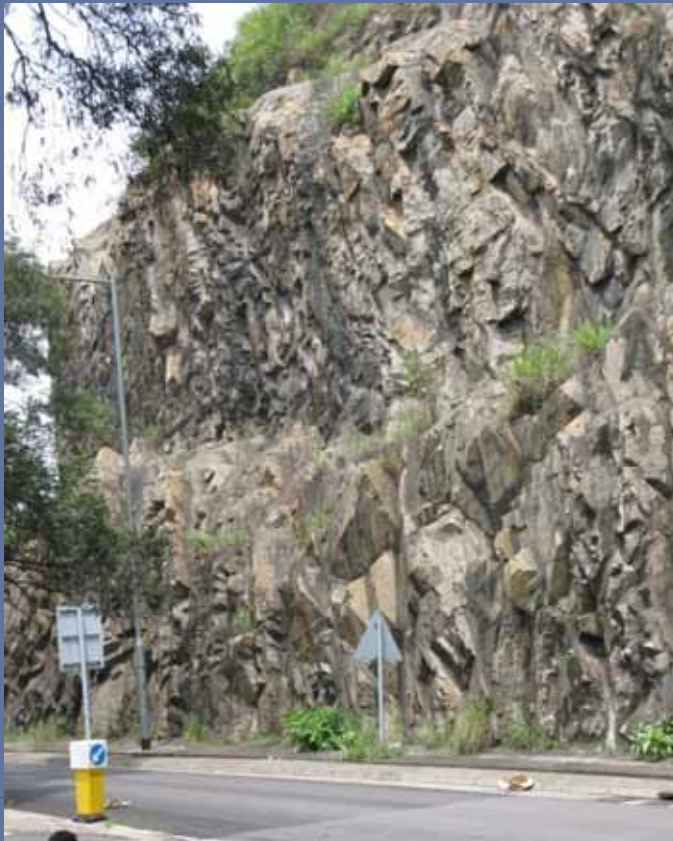
## Rock Cut Slope

Height of the slope = 45 m,  $\theta = 70^\circ$

Formed pre-1977

Road with heavy traffic at slope toe

Previous inspection records indicated signs of distress

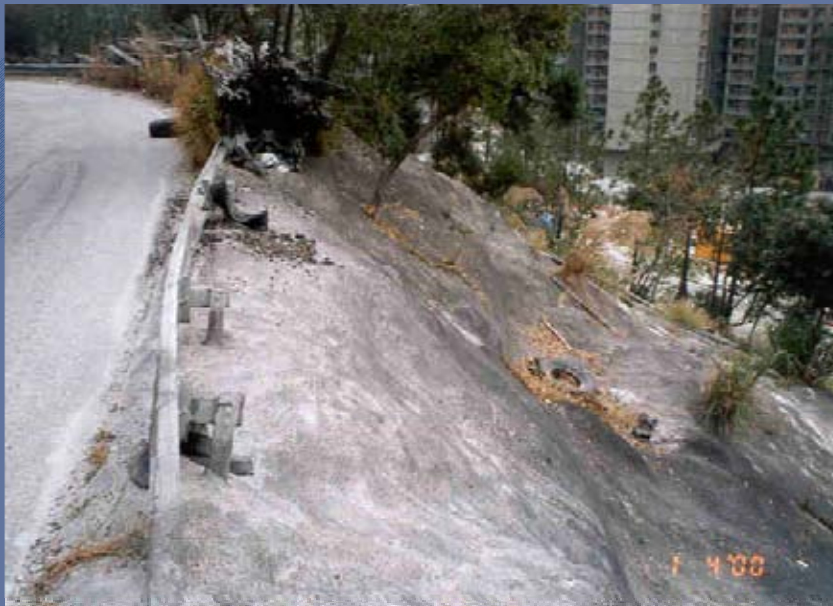
## Fill Slope

Height of the slope = 16 m,  
 $\theta = 35^\circ$

No record of formation

Road with heavy traffic at toe

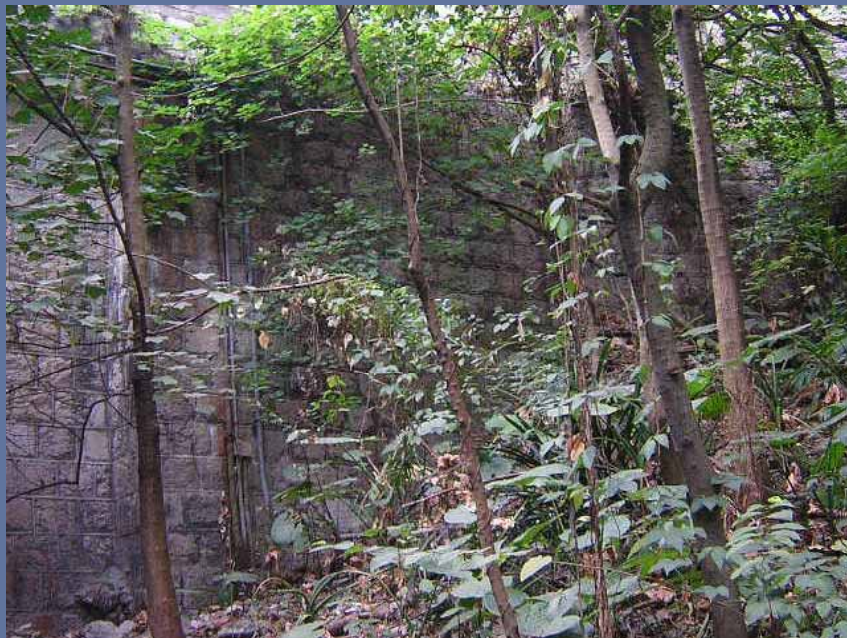
## Retaining Wall

Dressed block masonry wall  
without ties

Height of the wall = 8 m

Formed pre-1977

Road with heavy traffic at crest
