A case study on an open hillside landslide impacting on a flexible rockfall barrier at Jordan Valley, Hong Kong

Kwan, J.S.H., Chan, S.L., Cheuk, J.C.Y. and Koo, R.C.H.

Abstract: A case study on an open hillside landslide impacting on a flexible rockfall barrier at Jordan Valley, Hong Kong is presented in this paper. The landslide occurred sometime in June 2008. This is so far the only case history of landslide debris having been intercepted by a flexible rockfall barrier in Hong Kong. The landslide scar is 10 m wide and 7 m long, and the landslide volume is about 110 m³. The landslide debris was largely retained by the barrier but two of the barrier posts were severely damaged and failed. Debris mobility analysis and structural analysis of this case history have been undertaken with a view to obtaining a better understanding of the possible landslide dynamics and behaviour of flexible barrier upon debris impact. The analyses appear to have reproduced some of the salient field observations. The probable key contributory factors to the failure are highlighted and discussed. Through the study, the possible range of equivalent pseudo-static impact pressure exerted on the flexible bar

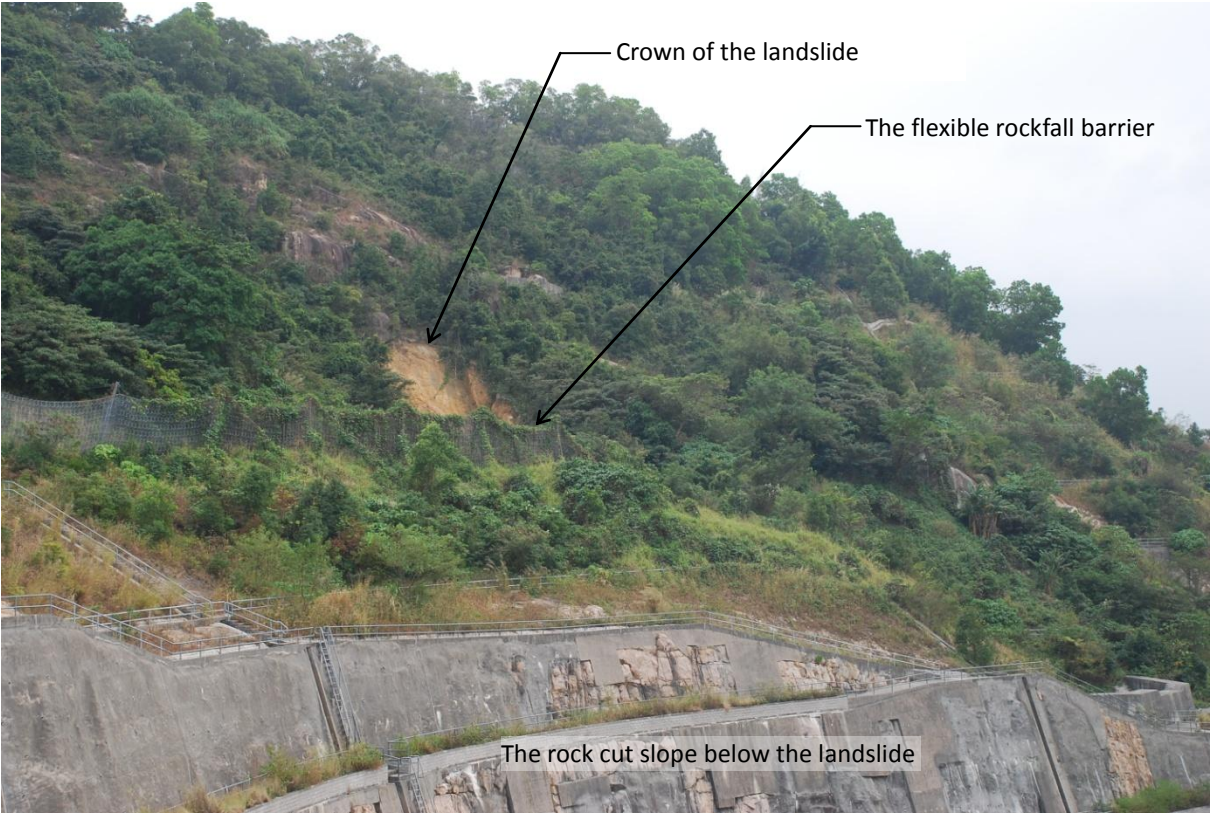
Figure 1 An overall view of the landslide site

The open hillside landslide occurred on a west-facing terrain above a cut rock slope which was formed as part of a site formation project at the Jordan Valley in Hong Kong (Figure 1). Both the failed hillside and the man-made slope below are within the construction site. The flexible barrier has a total length of 128 m and was constructed as part of the site formation project. The height of the steel posts is 5 m. The role of the posts is to hold the netting in place for catching rockfalls. The netting was composed of ring nets. The opening of each ring is 350 mm. In order to capture small rock pieces or rock fragments, a secondary mesh with openings of about 60 mm was attached to the ring nets. The steel posts, each made of 140 mm × 140 mm steel hollow section with a steel thickness of 4 mm, are at 10 m spacing and supported on concrete pad footings of 400 mm × 400 mm in dimensions. The embedment depth of the footings is about 500 mm. The barrier has a design capacity of 1,000 kJ for retaining boulders with volume up to 1 m³. Energy dissipation is designed to be achieved through the energy dissipation elements and deformable netting. A sketch showing a schematic design of the barrier system is shown in Figure 2.

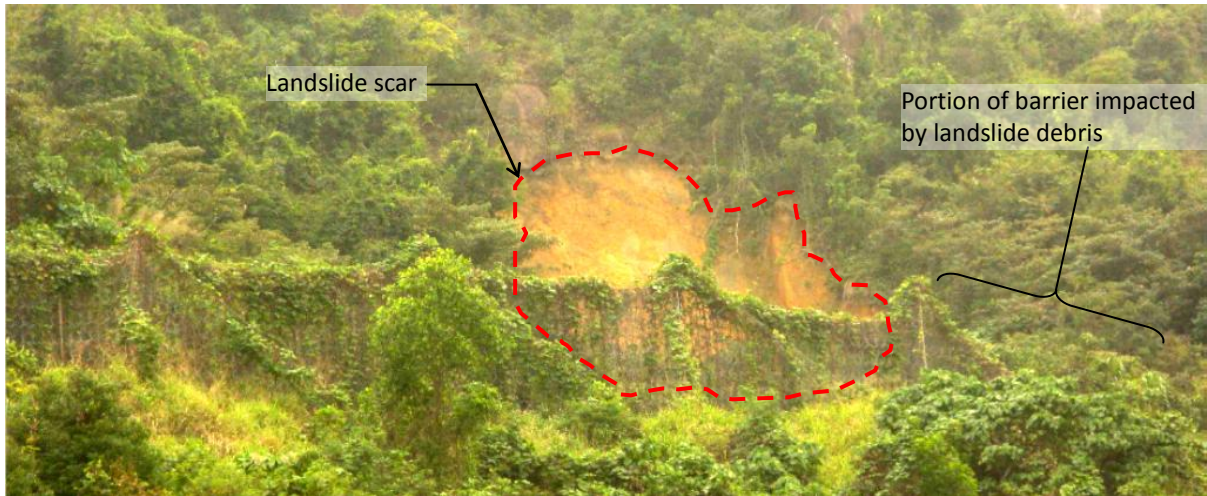
Figure 3 The landslide scar and the flexible rockfall barrier

The landslide was reported in December 2009. Interpretation of aerial photographs taken in November 2007 and July 2008 suggested that the failure should have occurred within this period. It was suspected that the landslide occurred during the heavy rainfall in June 2008. Prior to the site formation project, there is no past recorded landslide in the vicinity according to landslide database established by the GEO. Post-failure inspections revealed that the total volume of the landslide is approximately 110 m³. The landslide source covers a plan area of 7 m (long) and 10 m (wide). The maximum depth of the landslide source was 3 m. Figure 3 shows a general view of the landslide site. The upper portion of the source area comprises predominately saprolitic terrain and is steeply inclined (>50°) with adversely oriented joints, whilst the lower portion comprises predominately matrix-supported debris overlying saprolite. The debris was dry at the time of inspection, and measured approximately 11 m long and 10 m wide. After the debris was removed, it could be seen that the lower portion of the landslide source area was sloping at 30° to 40°. Deposition of

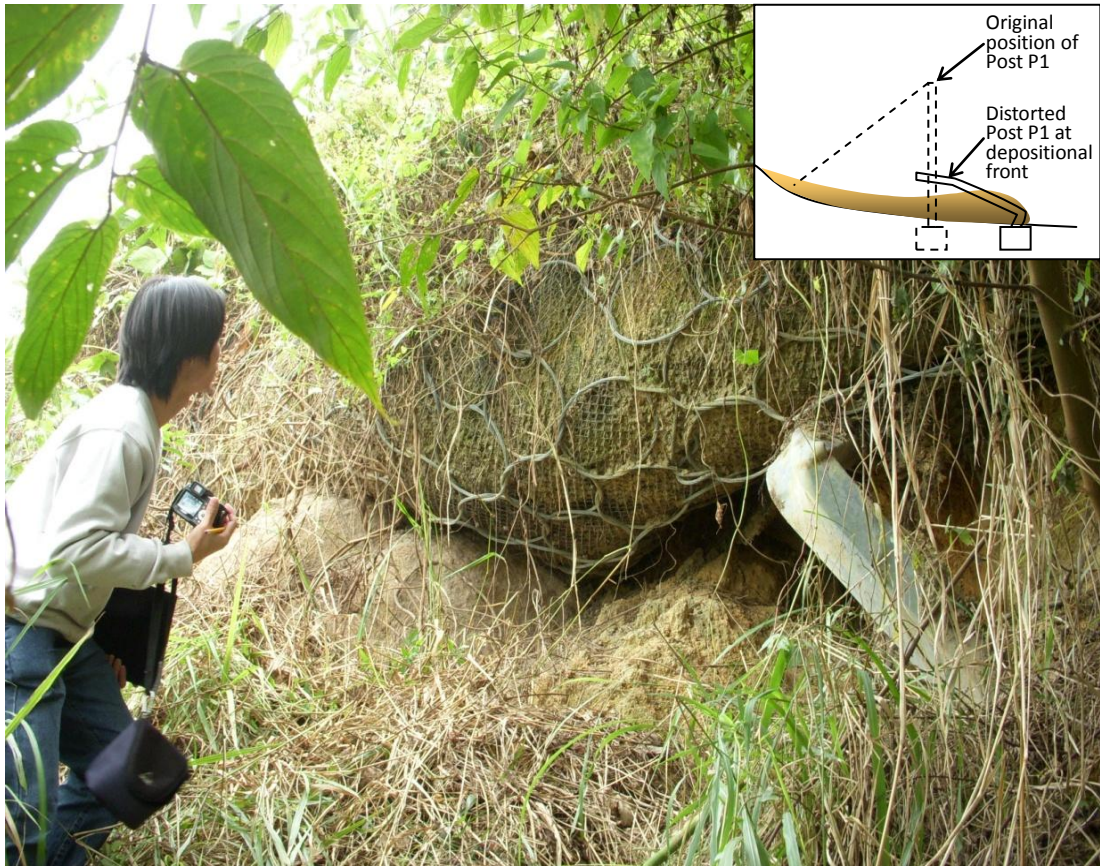
Figure 5 Post P1 damaged; landslide debris was largely contained by the barrier

The landslide debris struck one of the supporting posts, Post P1, near the southern end of the barrier and two netting panels adjacent to the post (i.e. netting panels spanning across Posts P2-P1 and Posts P1-P15). A plan showing the locations of the posts and the landslide affected area is presented in Figure 4. The debris was largely retained by the barrier and there were no signs of overflow or marks left behind by a large amount of debris passing through the netting. However, Post P1 was severely damaged by debris impact (Figure 5). Post P15, located at the southern end of the barrier, had also been bent, although it was not subject to any direct impact by the landslide debris (Figure 6). Both Posts P1 and P15, together with their concrete footings, were found to have displaced forward by about 1 to 2 m. No signs of damage to Post P2 were evident (Figure 7). It is noteworthy that the construction details of Post P15 are different from the intermediate Posts P1 and P2. The netting was attached to Post P15 by about nine layers of stainless steel bands (Figure 8), whereas Posts P1 and P2 were not tied to any net. These details might have contributed to the failure of Post P15 despite that it was not impacted by landslide debris directly. The failure of the post may also be linked to rigid connection between the post and the foundation, which is the weakest point of the barrier. If the connection between the post-plate and the foundation was able to dissipate some of the impact energy, failure of the post may not have occurred. It was also observed during the inspections that the energy dissipation devices attached to the uphill cable ropes of the barrier had not been mobilised, and no tensile failure of any cable ropes was apparent. Energy dissipating elements which are able to dissipate the energy by the deformation of their elements are preferred to the one that works with friction (i.e. friction of the cables).

Based on the site inspections, Posts P1 and P15 failed but not P2. Different magnitudes of UDP are used in the analysis with a view to replicating the observations numerically. Results show that both Posts P1 and P15 could fail by buckling when the applied UDP was increased to 50 kPa. The large bending moment in P1 is induced by the UDP directly acting on the post, whereas the bending moment in P15 is induced by the lateral deformation of the netting attached to it. Failure of both P1 and P15 is due to the combined actions of bending moment and axial compression load. The combined actions could have resulted in buckling failure of the posts. For P15, analysis shows that the post could have been subjected to bending moments and shear forces induced by load transferred from the netting attached to the post. In addition, P15 could have experienced an axial compression load larger than that in P1. This larger compression load could be due to the downward forces brought about by both the uphill and the lateral anchor cables attached to the top of the post, as well as the

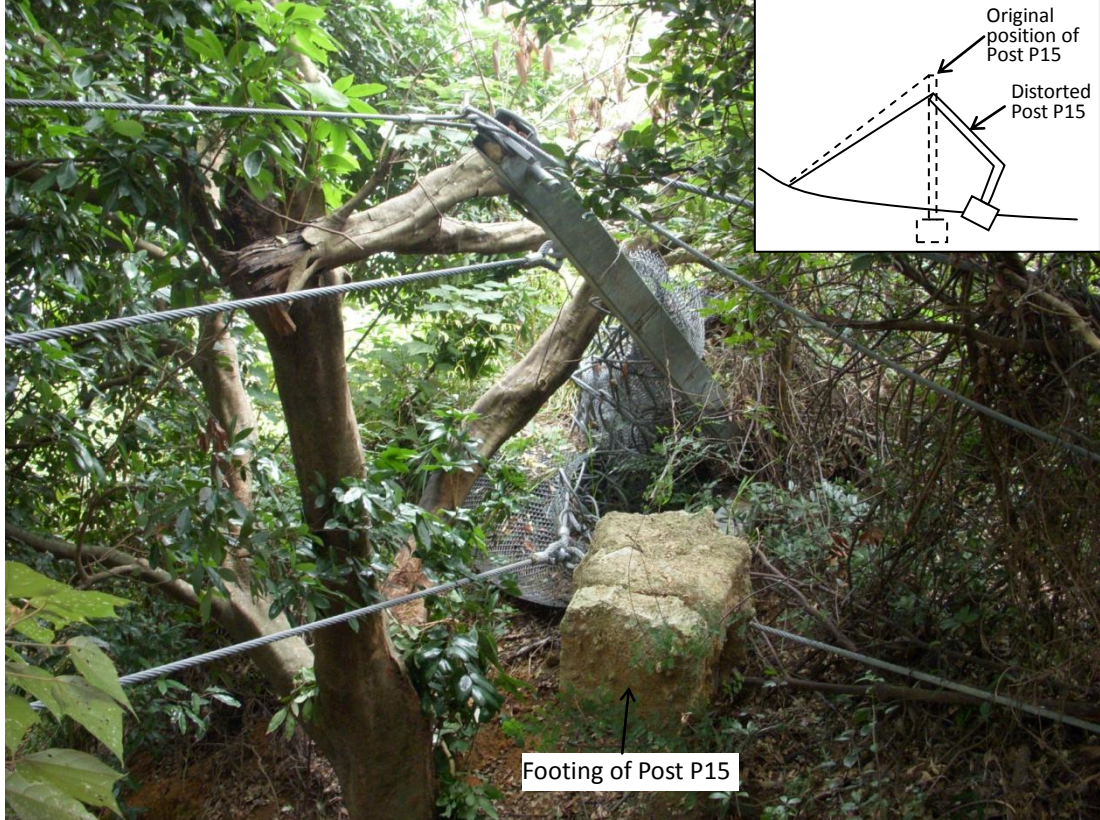
Figure 6 Post P15 severely bent and foundation failed

deformed netting that was connected to the post. This may explain the reason for the failure of P15, which was not subject to a direct hit by the landslide debris. The shear forces induced in the posts were found to be not critical in terms of the structural capacity. The analysis also shows that the calculated maximum deformation of the netting is about 2.5 m. The order of magnitude of the calculated deformation generally agrees with the site measurement. The calculation results for P1, P2 and P15 are summarised in Table 1.

In the present case study, the foundations of two of the barrier posts failed upon the impact of landslide debris. The rigid connection at the post and the base plate could have played a role in this respect. Numerical analyses indicate that the loading on the post foundations in the Jordan Valley barrier could have been up to about 350 kN to 450 kN which was liable to cause sliding failure. Attention to the loading on post foundation of barriers subjected to landslide debris impact is warranted in future research.

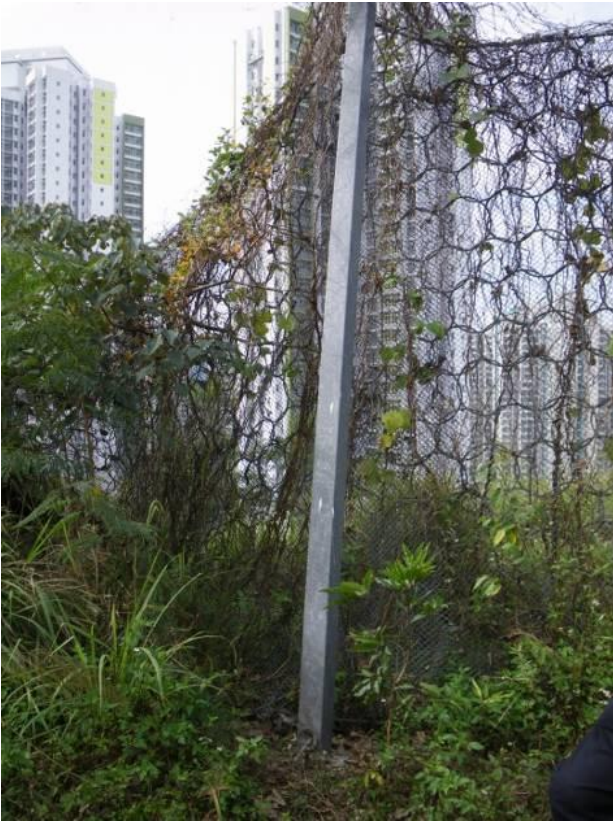
Figure 7 Post 2 undamaged

An attempt to estimate the upper limit of the applied UDP to cause an overall failure of the barrier has been made. It is noted that when the applied UDP is increased to 66 kPa, the calculated tension developed in the lower cable ropes reaches the ultimate tensile strength of 270 kN. Therefore, analysis based on UDP of magnitude exceeding 66 kPa has not been undertaken. The computed deformations of the flexible barrier panels and the calculated bending moment and shear force diagrams on the posts for an UDP of 66 kPa respectively are shown in Figures 14 to 15. In all the analyses, the calculated forces in Post P2 remained low. Structural assessments indicate that these calculated forces do not exceed the structural capacity of Post P2, which is consistent with the site observation that Post P2 was undamaged.

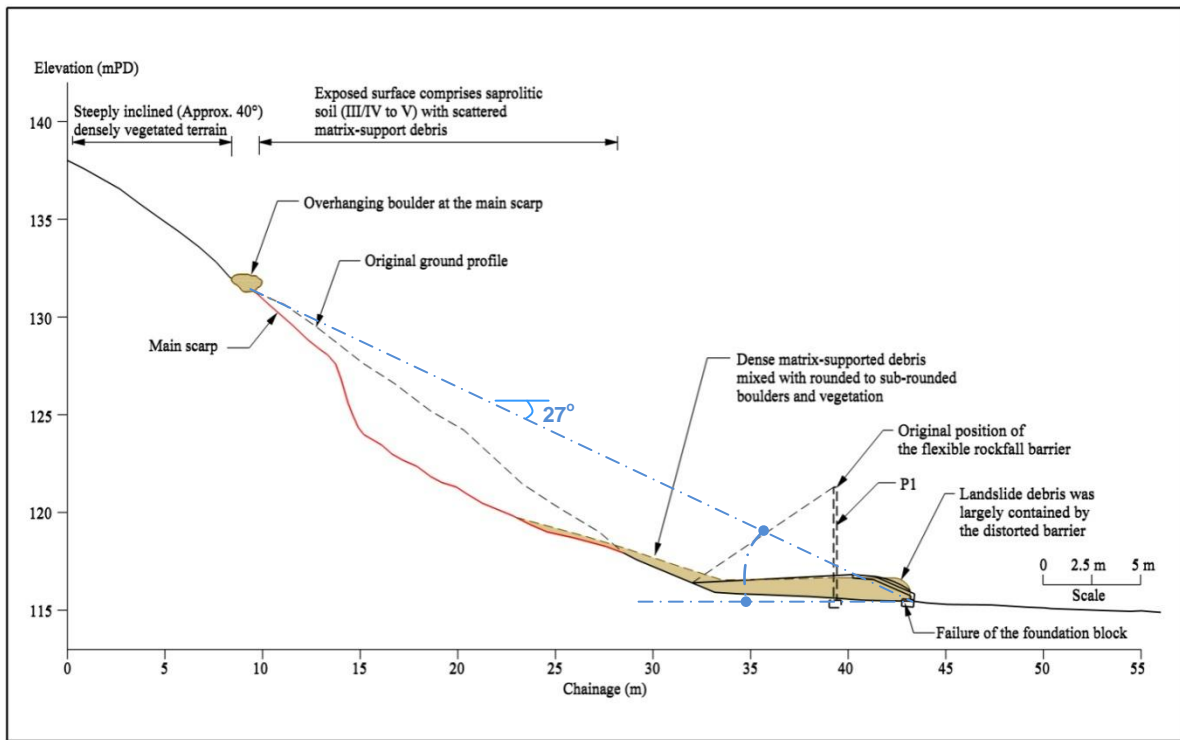
Figure 9 Cross-section along the centreline of the landslide

A mobility assessment of landslide debris is carried out using computer program 2d-DMM developed by Kwan & Sun (2006). Figure 9 shows a cross-section along the centerline of the landslide debris trail. The travel angle of the landslide debris, given the

The geometry of the runout path and the initial debris profile at the landslide source determined based on the field mapping and the cross-section shown in Figure 9 have been adopted for the debris mobility analysis. The debris velocity and debris thickness hydrographs at the location of the barriers have been obtained from the analysis. Figures 10 and 11 present the hydrographs. The analysis shows that debris could have reached the barrier at about 4 seconds after the landslide. The maximum frontal debris velocity at the location of the flexible barrier could be around 4 m/s. After the peak value, the velocity drops to zero within 2 seconds. The calculated debris thickness is within the range of 0.8 m to 1.2 m, which is generally consistent with the site observations that the debris deposit was about 1 m thick. Since the debris velocity could have dropped rapidly and the debris could be as thick as about 1 m, it is considered unlikely that the rear portion of debris mass over-rode on the frontal portion to result in multiple impacts to the barrier.
