Natural Hillside: Study and Risk Mitigation Measures

**Proceedings of the 29th Annual Seminar
Geotechnical Division, The Hong Kong Institution of Engineers**

**17 April 2009
Hong Kong**

**Jointly organised by :
*Geotechnical Division, The Hong Kong Institution of Engineers
Hong Kong Geotechnical Society***

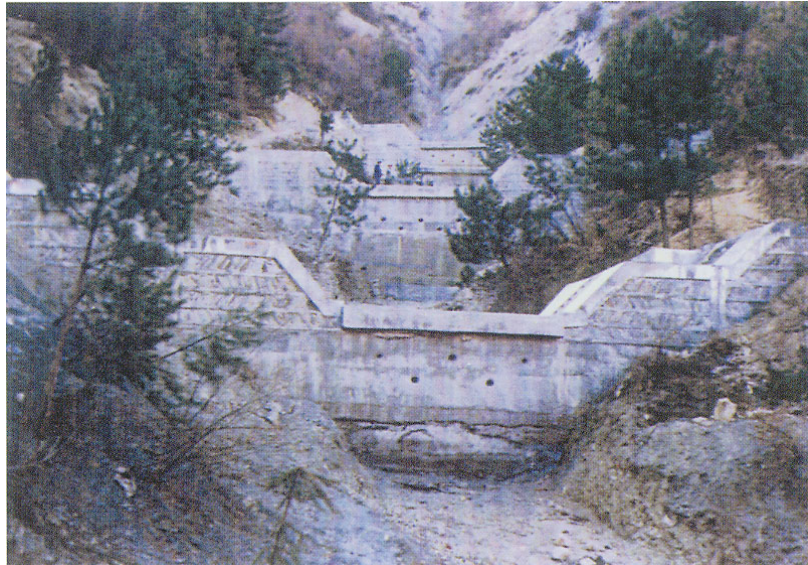
Figure 1: Houshan mountain step-dam is located Heishui county, Sichuan province. These dams with 3-5 m of average high of every step could come into effects in common and protect each other when debris flow hazards occur

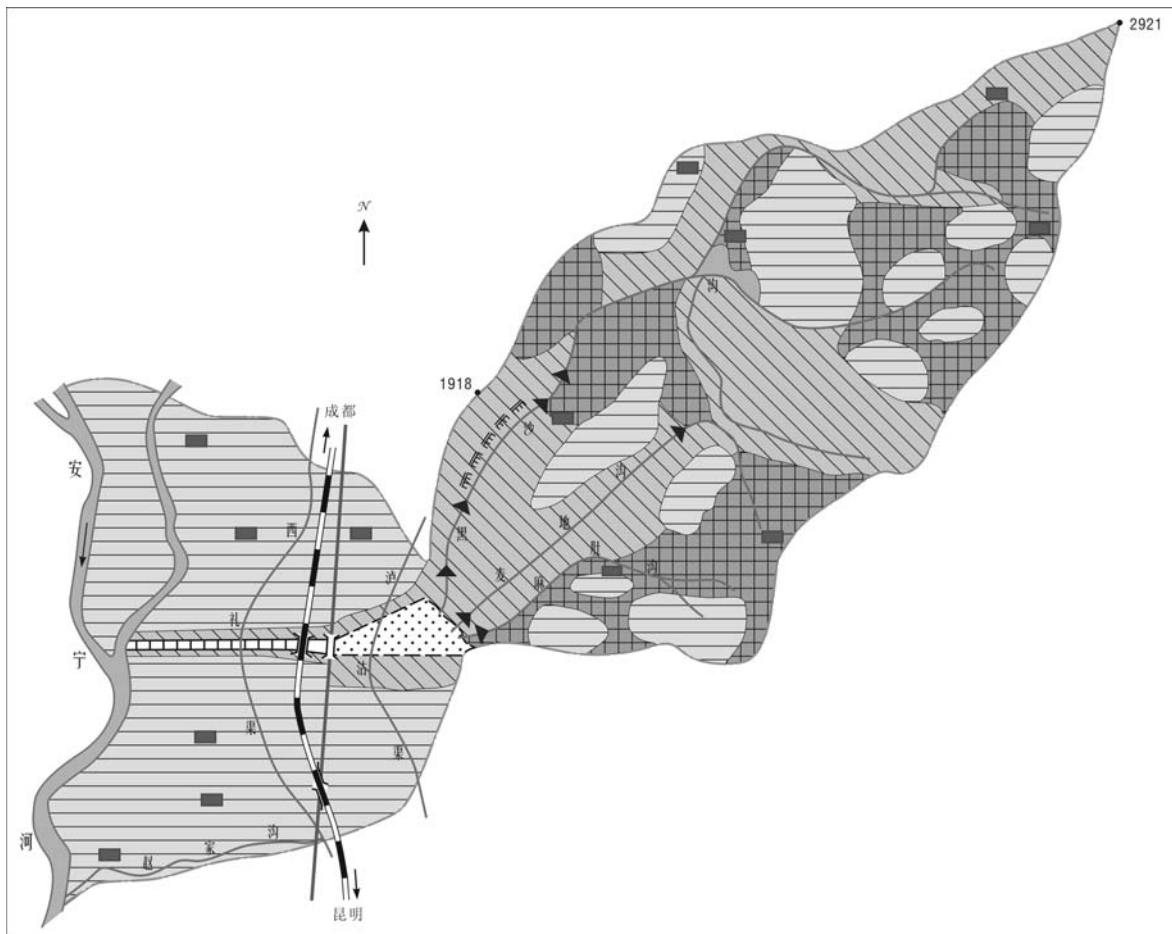
Figure 4: Integrated management of debris flow in Heshaha valley

Heishahe river watershed is a located in Xichang city, Sichuan province and a active debris flow valley, and began to be integrated managed since 1970. Before the control, there were 180 sites of landslide and landslip and 135 sub-valleys of debris flow in 22.7 km². In the past nearly 100 years, 5 villages became into wasteland and 200 ha farmland changed into sand land because of severe geological hazards. Debris flow hazard also endangered the security of Xichang section of Chengdu-Kunming railroad. After over 10 years control, in the upper of the valley, over 1670 ha had been rebuilt to plant trees, 7 shelter-belts for debris flow had been built, 210 ha terrace has been constructed, and a flood control reservoir with 22 meters dam height and 0.55 million m³ reservoir content has been built. In the upper and middle of this valley, 7 storage sediment dams, 5 steps check dam and 7 downstream dams had founded in order to store sediment and reduce solid source of debris

flow. In the lower of the valley, 3 km drainage slot and an overflow weir had been built and made flow channel stable. The integrated management not only kept road, railroad, factory and village in safe, but also improve agricultural yield and local ecological environment. Figure 4 is the design of integrated management of Heishahe valley.

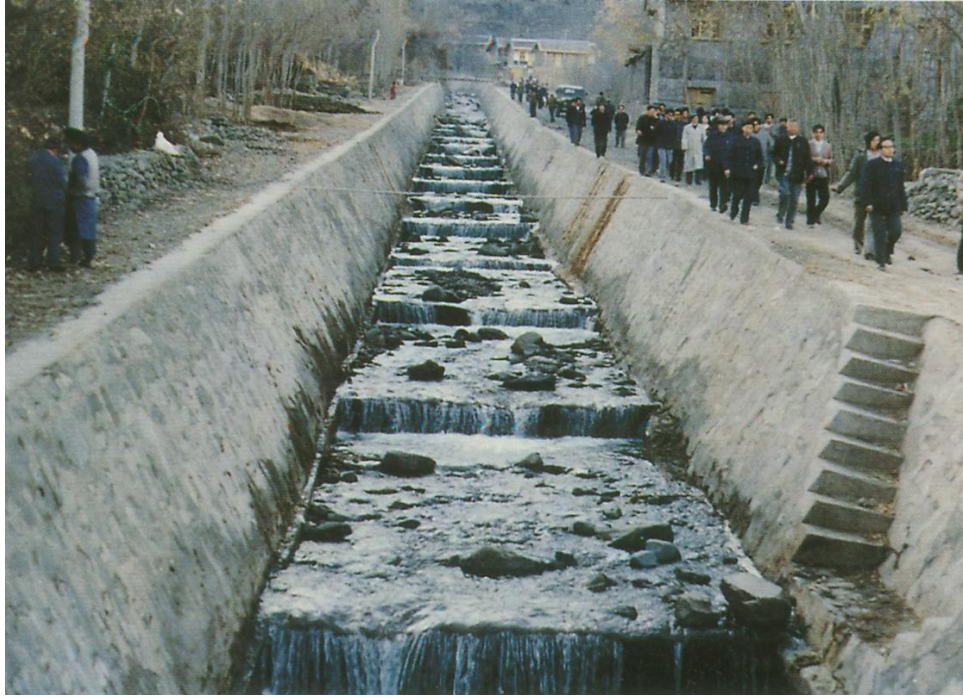
Figure 5: Babuligou valley drainage slot (to protect the city of Jinchuan county, Sichuan province)

Both controlling debris flow gully and protecting cities and towns which are threatened by debris flow are to avoid or lighten the harm caused by debris flow. However, the former is the fundamental and long-term measure and the latter is the temporary and short-term measure. However, the former costs lots of fund and its effects appear in the longer time; while the latter is contrary. The main projects include the protection bank, the flood path, the drainage slot, silt storehouse and so on. Babuligou valley drainage slot operates well to protect the city of Jinchuan county, Sichuan province (Figure 5).

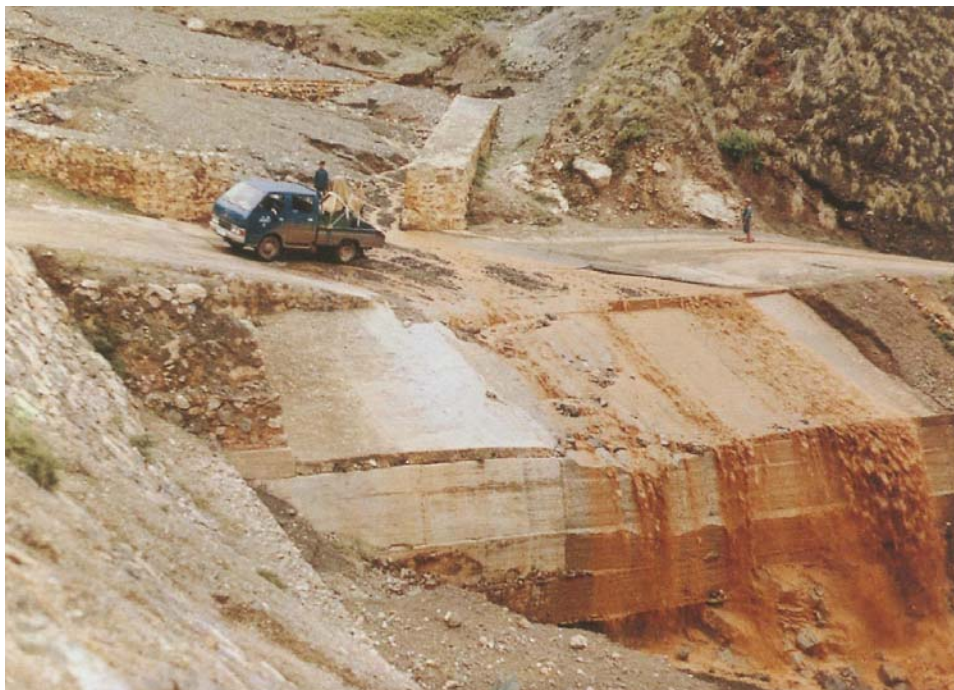
Figure 9: Overflow pavement is a feasible scheme when a road must pass through debris flow field where the bridge and tunnel not be constructed for economic or technical reason. Although the overflow pavement is economical and easy to build, it should be located in stable section eroded and deposited by debris flow. The concrete overflow pavement in Wangjiaqing valley, Dongchuan, Yunnan Province, is located in the key area where the erosion and deposition of debris flow reached equilibrium and has resisted debris flow hazards for over 20 years

Besides the above three principal protection system, there are also debris-flow protection projects which are built to protect irrigation engineering and important constructions. For instance, overflow pavement can be built in stable section with less erosion and deposition of debris flow (Figure 9).

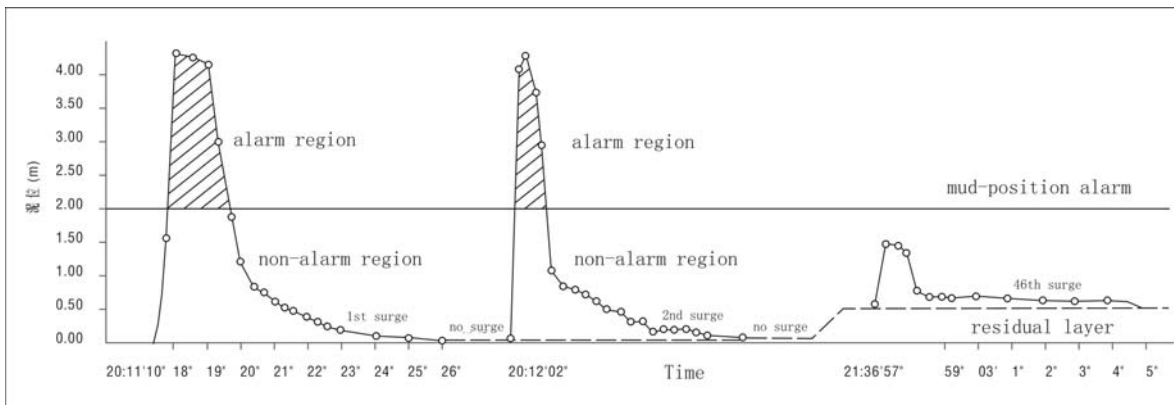
Figure 10: Comparison of measured value of debris flow's mud position between alarm region and non-alarm region in Jiangjiagou gully

The observation results of mud position alarm showed as follow (Figure 1): A debris flow with total 75 surges was observed from 20:16:38 to 22:47:31. It could be divided into three parts: early stage, mid-stage and late stage. Alarms at early stage account for 53% of the total surges, mid-stage account for 20% and late stage account for null due to mud position below 2m (mini-observation mud position). In figure 1, the relation between alarm process and alarm duration showed that alarm of 1st surge lasted for about 2 seconds, 2nd surge for about 1 second and 46th surge for null. As a result, alarm duration can reflect the process of over-mud position and debris flow of magnitude (Figure 10).

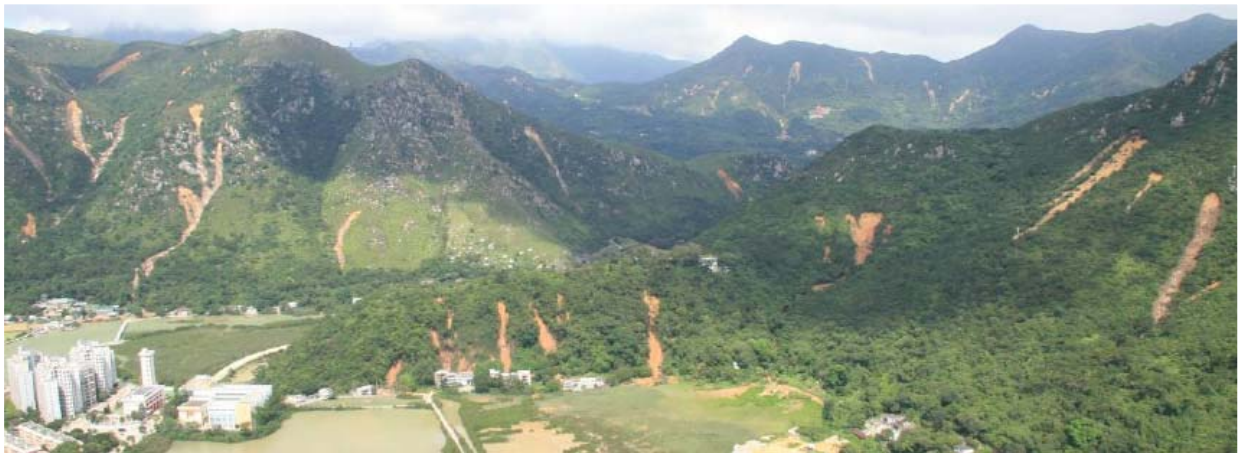
Figure 10: Landslides in Tai O, Lantau in the June 2008 rainstorm

- (q) **Studies of June 2008 landslides:** A severe rainstorm hit Lantau Island in June 2008 and caused about 1,600 natural terrain landslides (Figure 10). Many of the landslides were sizeable and resulted in a much greater runout distance than those that have previously occurred in Hong Kong. Detailed mapping of the landslides and the related technical development studies are being carried out. The landslides serve as a vivid reminder of the risk associated with natural terrain landslides in the densely developed setting of Hong Kong.

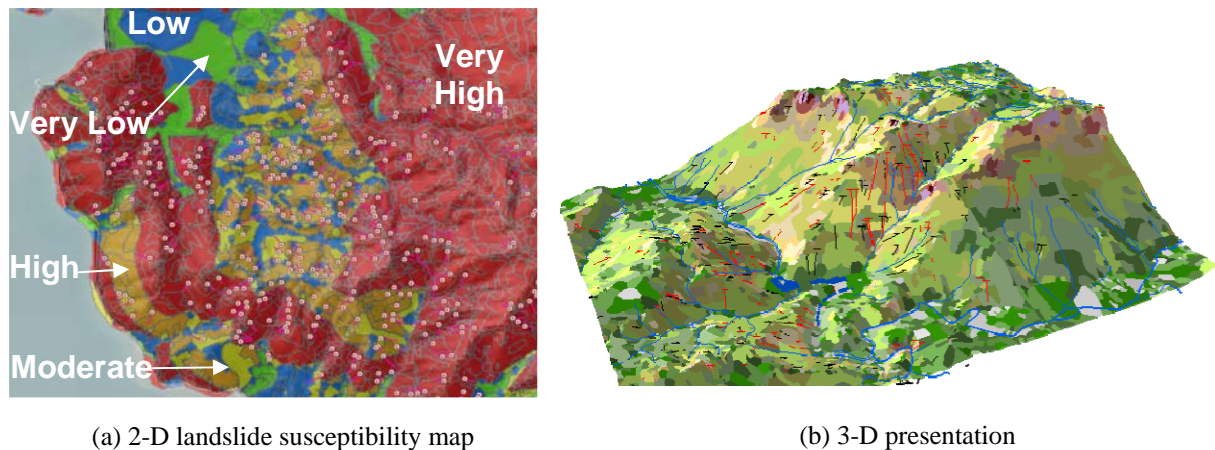
Figure 16: Terrain landslide susceptibility classification.

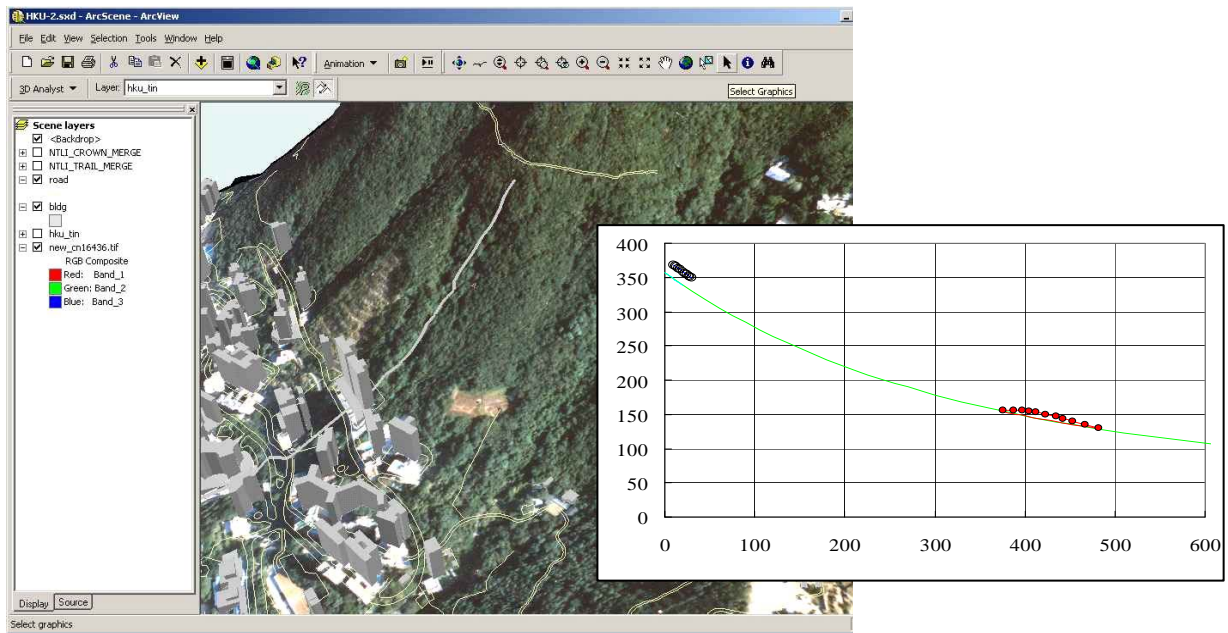
Figure 21: 2D-DMM debris runout modelling

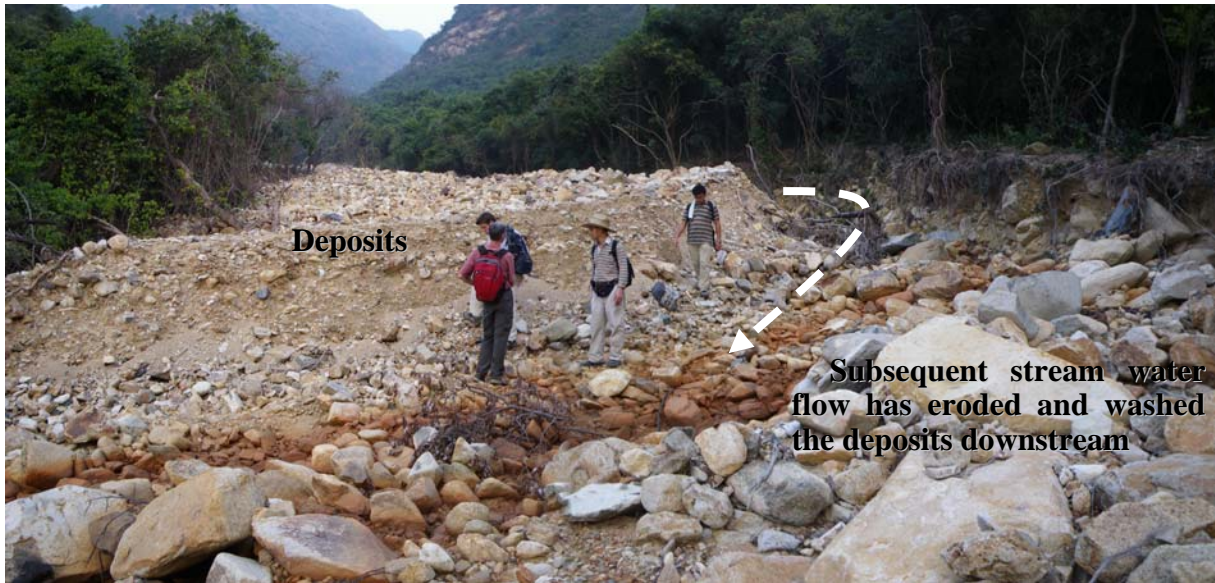
Figure 28: Deposits of a watery debris flow at the deposition zone
 (Note: The June 2008 Shek Pik No. 4 debris flow is shown; the deposits have been subject to considerable sorting)

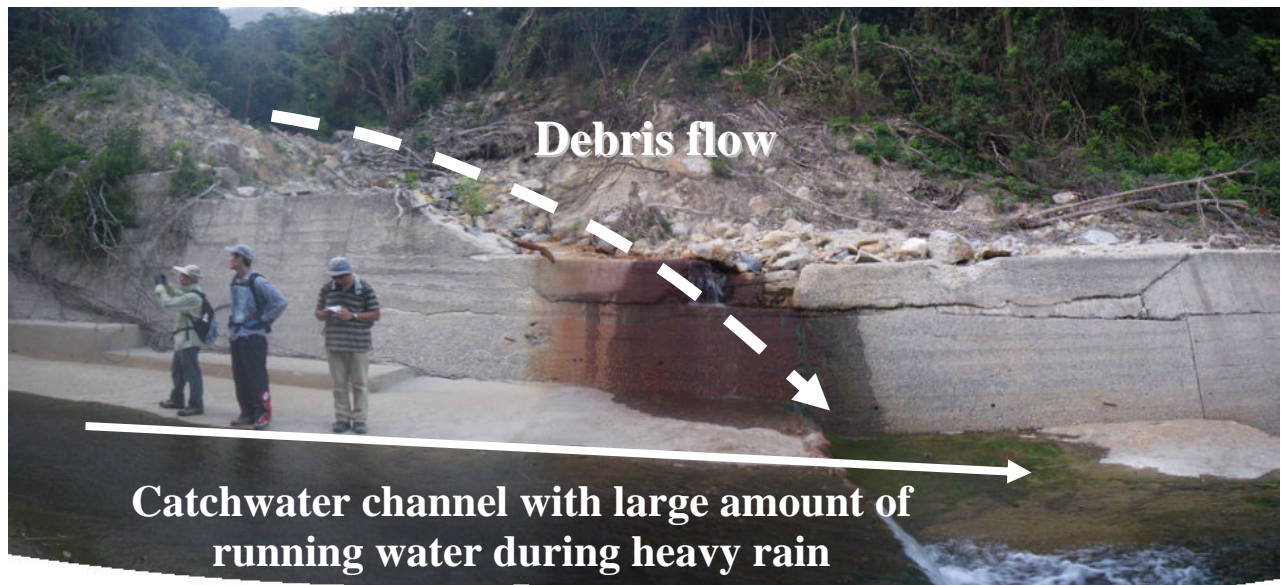
Figure 37: Debris flow entering catchwater channel
 (Note: The June 2008 Shek Pik No. 1 debris flow is shown; the debris flow turned into a debris flood after entering the catchwater channel)

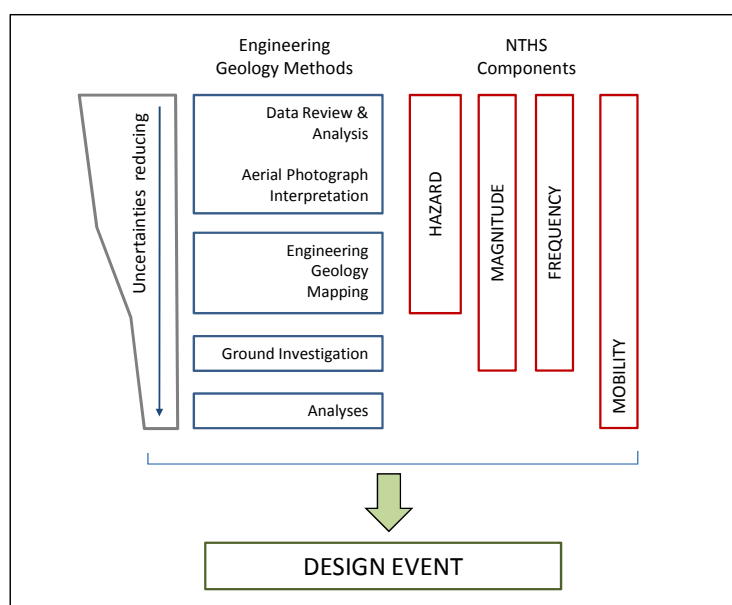
Figure 1: Engineering geological input within an NTHS

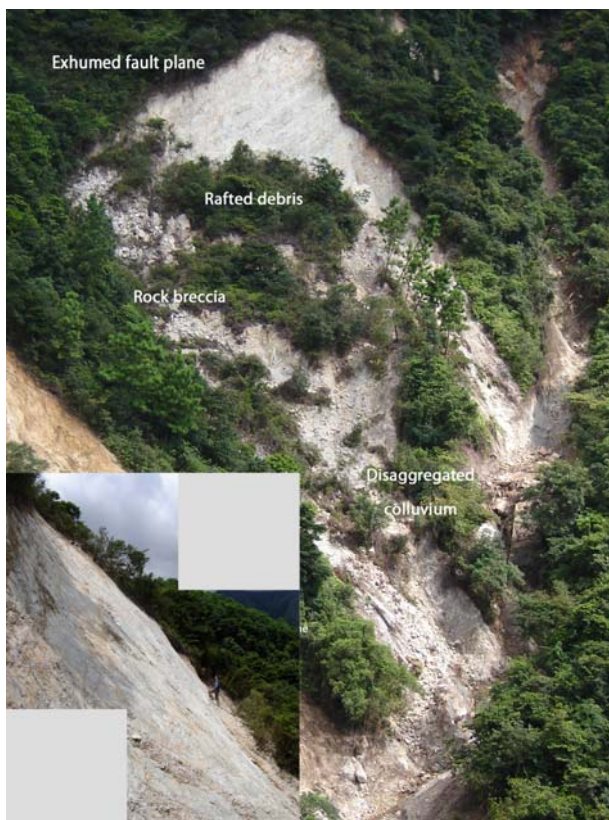
Plate 1: Oblique aerial view to the north of the deep-seated debris slide showing the exhumed fault plane, and the distribution of the debris. Lineations are visible on the fault plane dipping to the west. The inset photograph is a ground level view showing the exhumed fault plane

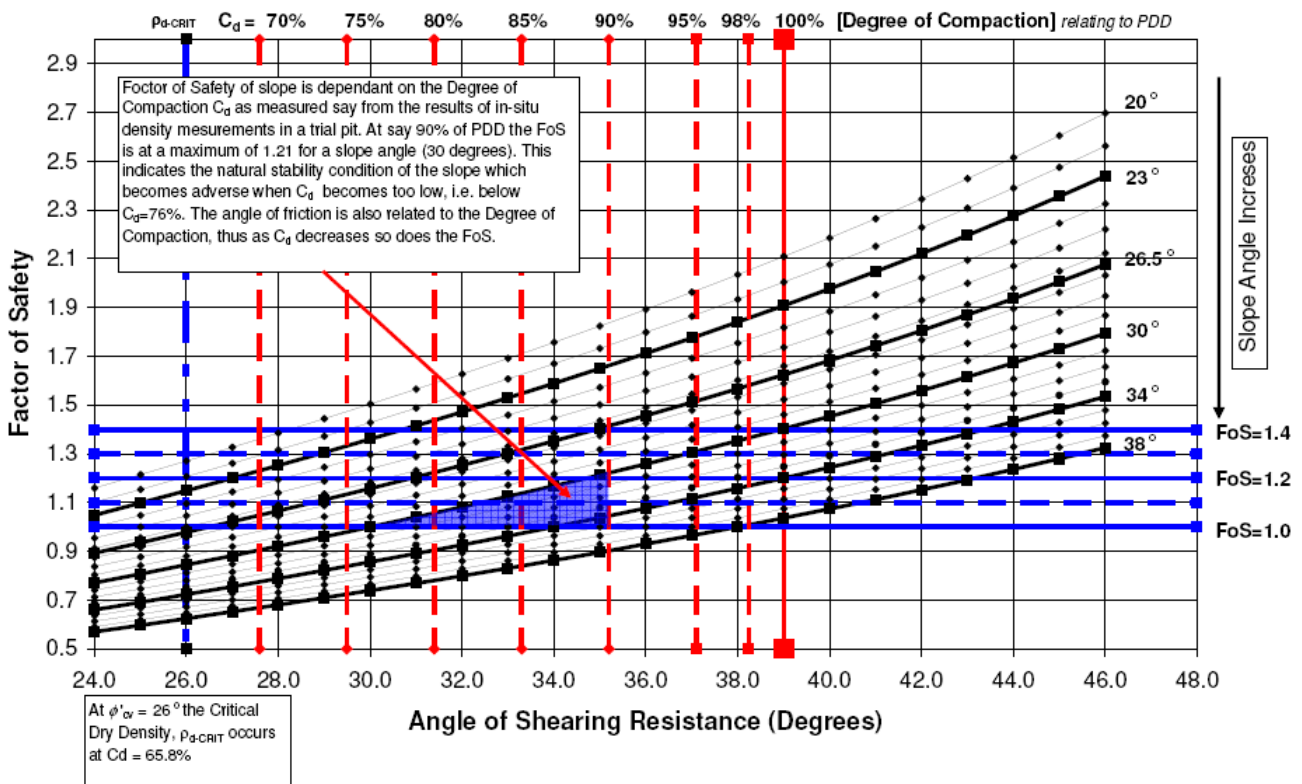
Figure 5: Graph showing the relationship between Factor of Safety, angle of slope, angle of shearing resistance and the degree of compaction of the soil. 100% C_d indicates a highly compacted soil whereas ρ_{d-crit} is the degree of compaction of a soil at the critical state below which the soil becomes subject to a collapse mechanism leading to potential liquefaction

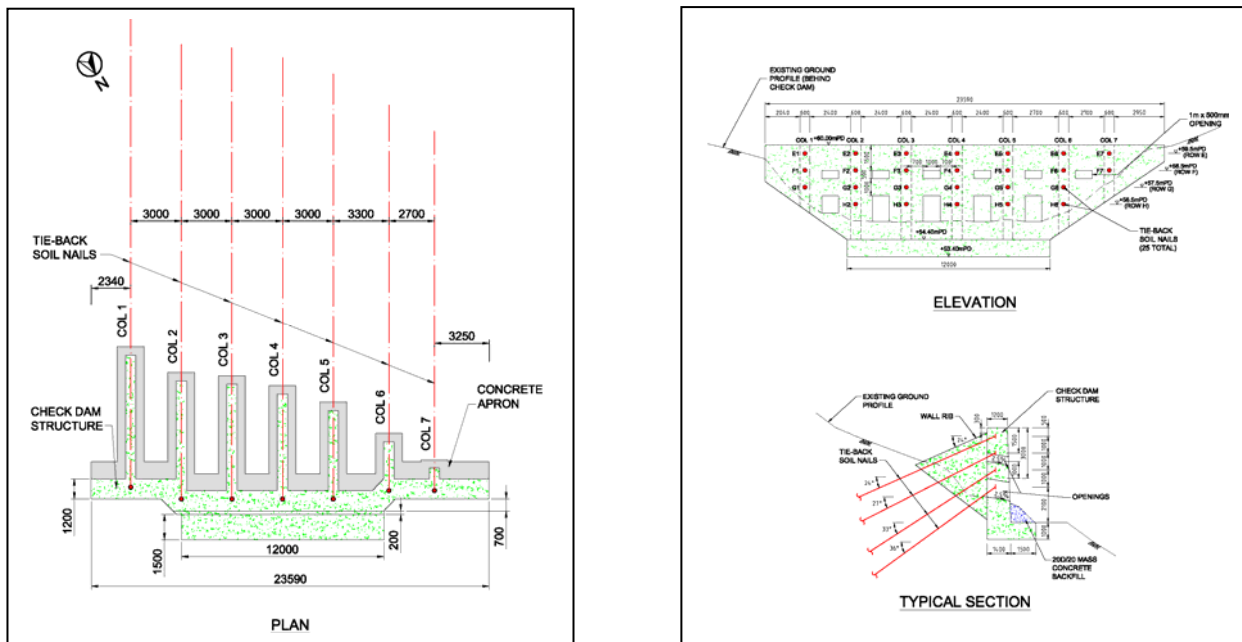
Figure 2: Protective mitigation measures (concrete check dam tied back with 23 – 25m long nails within a stream course)
