# 東京市區地帶的沉積軟岩的強度及變形特性

## STRENGTH AND DEFORMATION CHARACTERISTICS OF SEDIMENTARY SOFT ROCK IN THE TOKYO METROPOLITAN AREA

# STRENGTH AND DEFORMATION CHARACTERISTICS OF SEDIMENTARY SOFT ROCK IN THE TOKYO METROPOLITAN AREA

**Abstract :** The strength and deformation characteristics of sedimentary soft rock that were evaluated in relation to several large-scale research and construction projects in the Tokyo metropolitan area are described. A large amount of data showing the elastic stiffness at small strains, non-linearity due to strain and pressure level, anisotropy of the stress-strain properties, viscous properties and deformation properties of shear bands is presented. The elastic stiffness of sedimentary soft rock obtained from triaxial tests using high-quality core samples, while measuring stresses and strains accurately, is generally similar to the corresponding value from field shear wave velocity. Deformations of sedimentary soft rock deposits and displacements of structures constructed on and in them at working loads could be reliably predicted based on the elastic stiffness evaluated by field seismic surveys. It was necessary to take into account the dependency of stiff

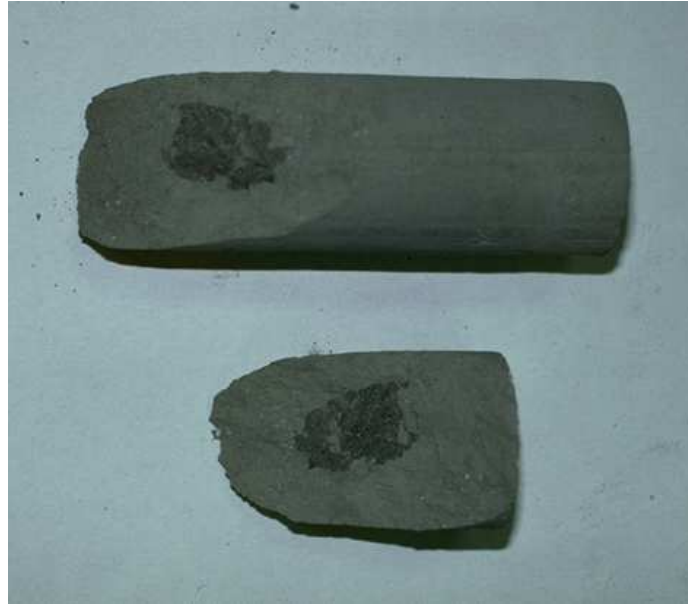
Figure 3.5. A RCTS sample with a shear plane after a TC test, Sagamihara test site.

obtained from samples retrieved from a depth of around 50 m, which is typical of the mudstone at the site. This grading curve and other similar ones presented in this paper were obtained by first breaking each oven-dried sample with a hand-held hammer followed by crushing and grinding the broken pieces in a mould until all the material passed through a sieve with an opening of 0.42 mm. **Table 3.1** shows the material properties of the samples retrieved from depths down to about 50 m that were used for triaxial compression tests performed by Kim et al. (1994). **Fig. 3.5** shows one of the core specimens used in the TC tests, which exhibited a clear shear plane along which a fossil of leaf happened to have been embedded.

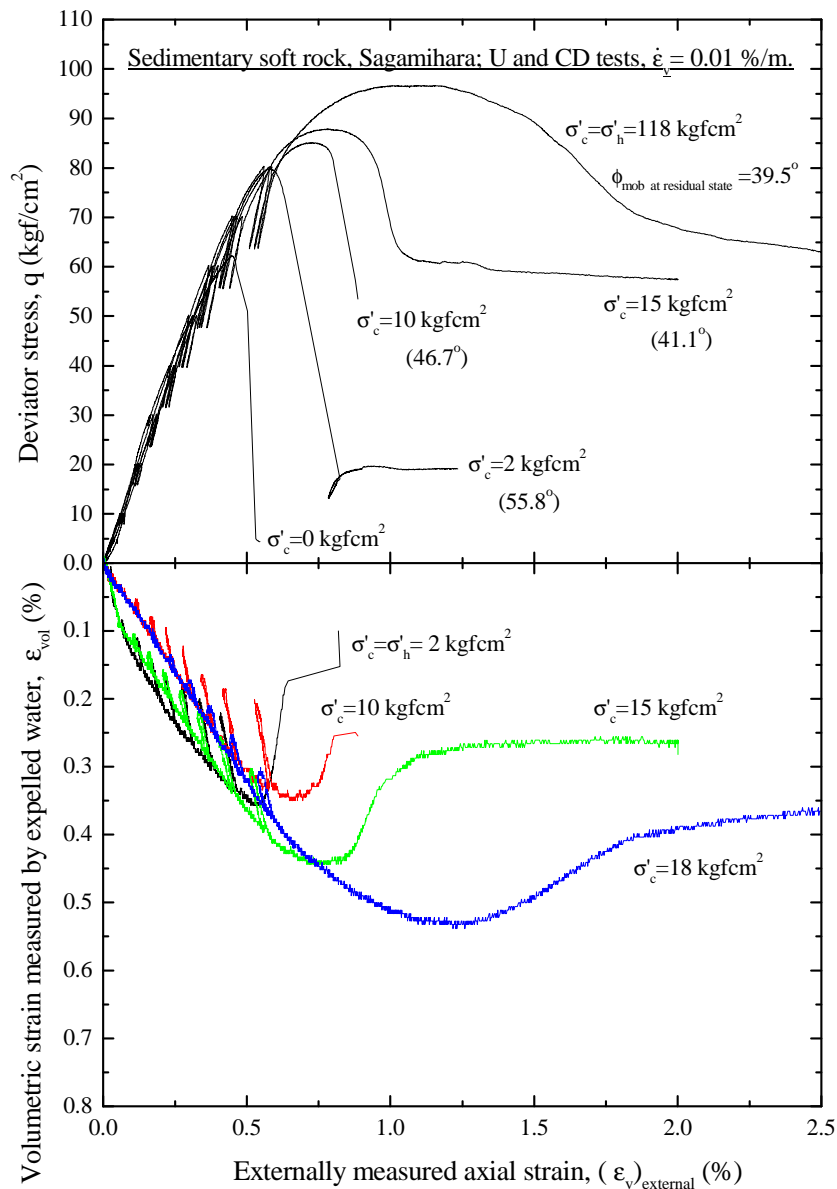
Figure 3.7 Results from U test and a series of CD TC tests at different consolidation pressures using core samples from single block retrieved in the tunnel at a depth of 50 m, Sagami-hara site (Wang 1996; Hayano et al. 1999b).

the  $q_{max}$  values from TC tests presented in Fig. 3.6 is much larger than the one that could be deduced from the results presented in Figs. 3.7 and 3.8a. This fact indicates that the  $q_u$  strengths of RCTS core samples are generally smaller than those of core samples obtained by BS. This is due to the effects of sample disturbance in RCT sampling (Tatsuoka et al. 1995a).

- iv) *Strain level:* The locally measured strain level at which  $E_{50}$  is defined at a strain that is much larger than the elastic limit strain, which is about 0.2 % in the data presented in Fig. 3.7. The axial stress becomes much larger than the initial value by that strain level. As the pressure level-dependency becomes larger, the  $E_{50}$  value could be still similar to the initial value  $E_0$  under otherwise the same conditions if the effects of strain

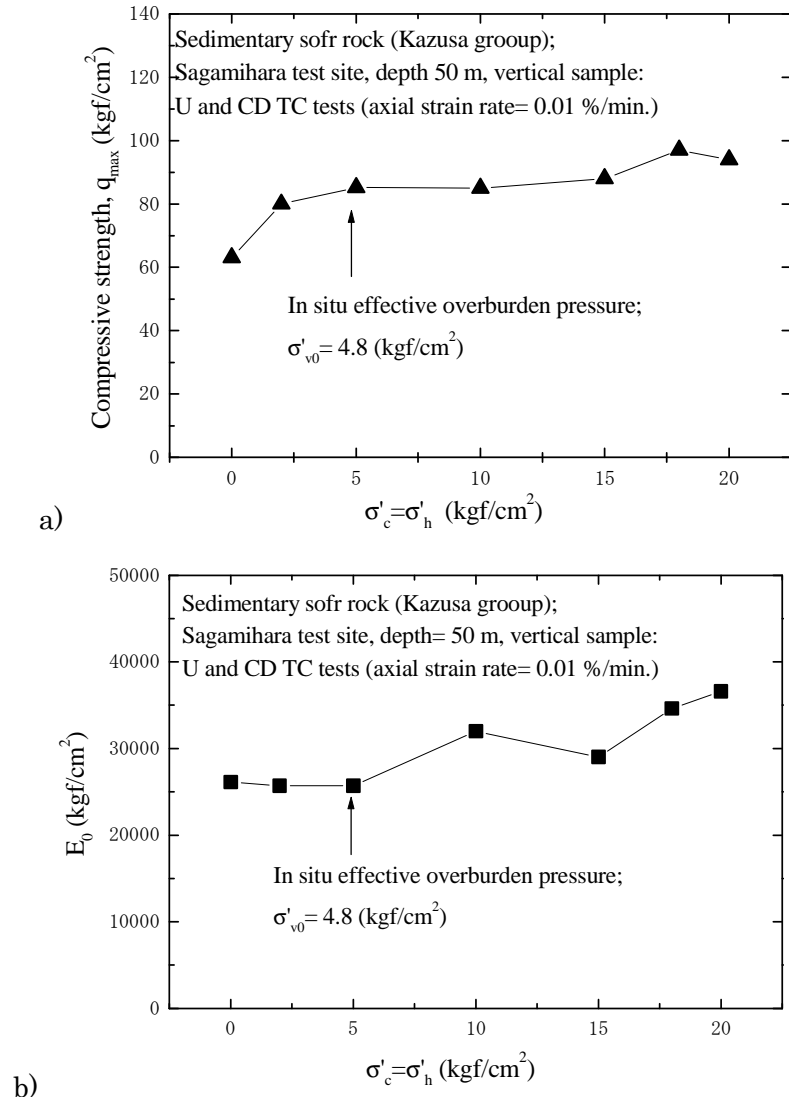
Figure 3.8. Dependency on the isotropic pressure of; a) peak strengths; and b) initial Young's modulus (based on locally measured strains less than about 0.001 %) from the compression tests presented in Fig. 3.7 (Wang 1996).

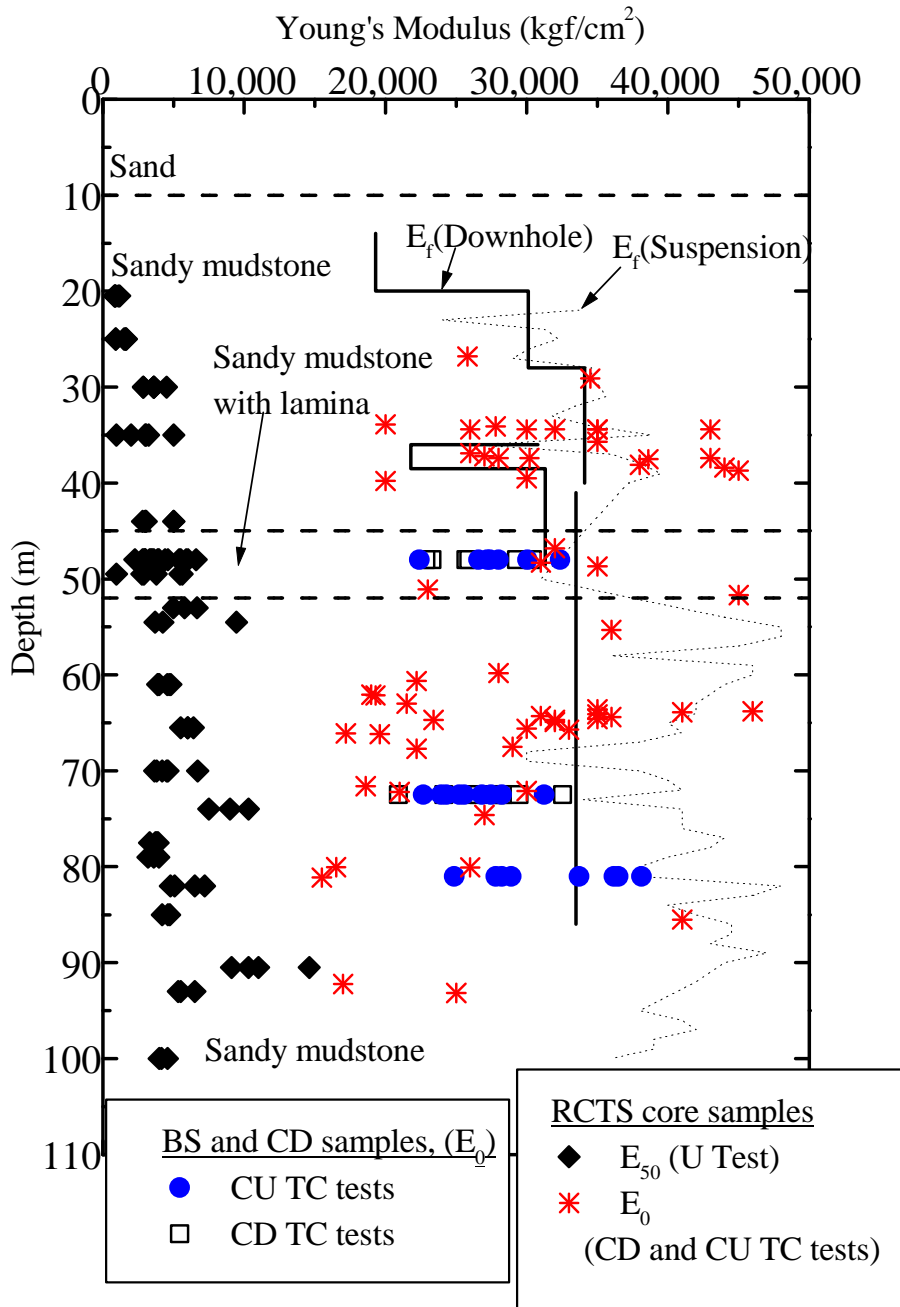
Figure 3.9. Distribution of Young's modulus from unconfined compression tests and triaxial compression tests and field seismic surveys (Wang 1996; Hayano et al. 2000).

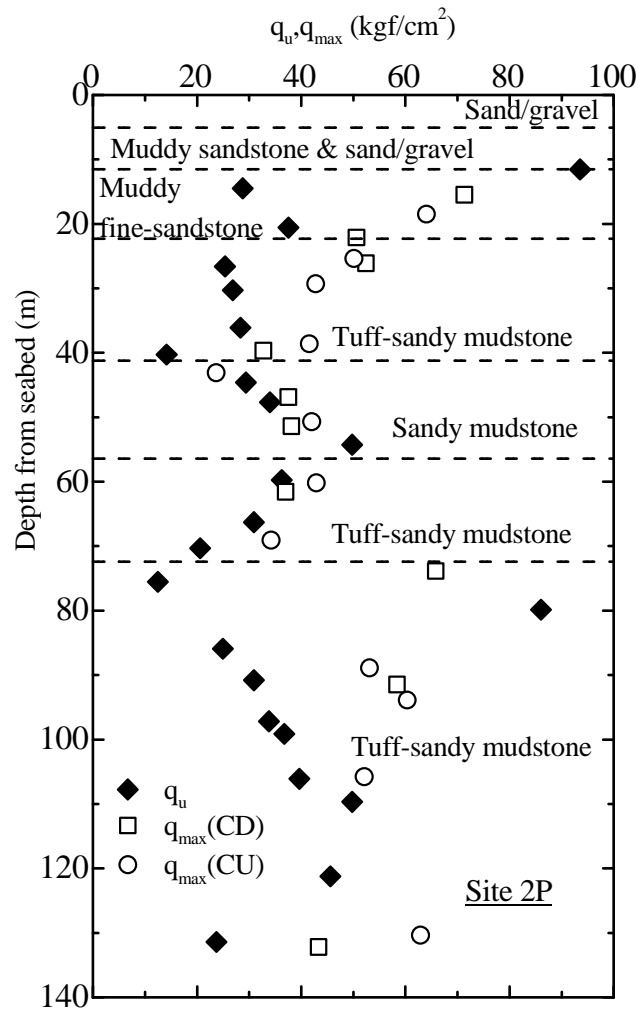
Figure 3.15b. Distribution with depth of compressive strength from U and TC tests, sedimentary soft rock Tokyo Bay mouth, site 2P (Kodaka et al. 2000; Hayano 2001).

*Compressive strength:* **Figs. 3.15a** through **3.15d** show the distribution with depth of compression strength from U tests (except for site 1A) and CU and CD TC tests, all using RCTS core samples. In the TC tests, the specimens were reconsolidated isotropically to the respective field effective vertical stress. The axial strain rate was 0.01 %/min. It is seen that the difference in the  $q_{max}$  value between the CU and CD tests is not as obvious as at the Sagami-hara test site. It may also be observed that the difference between the  $q_u$  and  $q_{max}$  values is generally larger in the layers where sandstone is dominant, typically at site 3P. At the early stage of investigation performed in the 70's, only unconfined compression tests were

performed on RCTS core samples as laboratory stress-strain tests. It can be readily seen again from the results presented in Fig. 3.15 that the unconfined compression strength is not at all representative of the compressive strength under field stress conditions, especially with the sandstone of sedimentary soft rock.

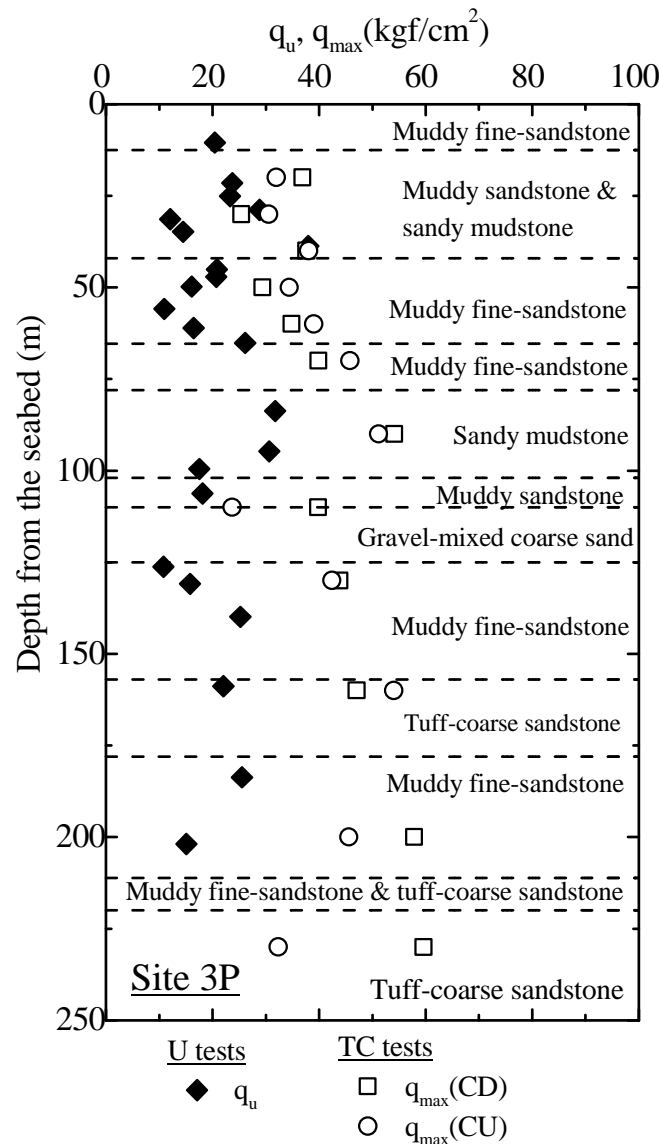
Figure 3.15c. Distribution with depth of compressive strength from U and TC tests, sedimentary soft rock Tokyo Bay mouth, site, site 3P (Kodaka et al. 2000; Hayano 2001).

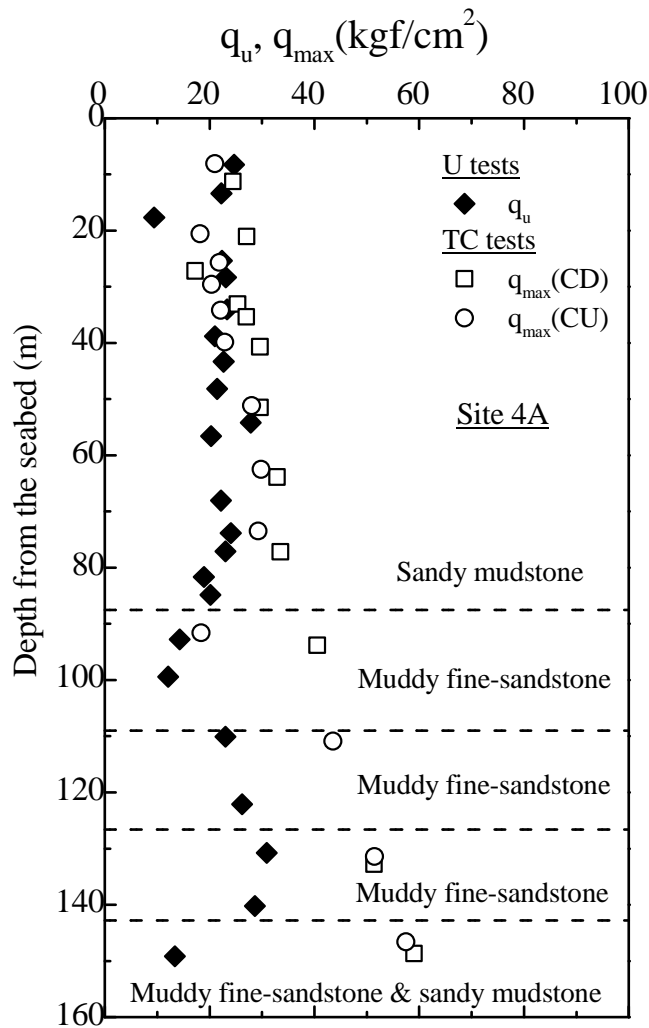
Figure 3.15d. Distribution with depth of compressive strength from U and TC tests, sedimentary soft rock Tokyo Bay mouth, site 4A (Kodaka et al. 2000; Hayano 2001).

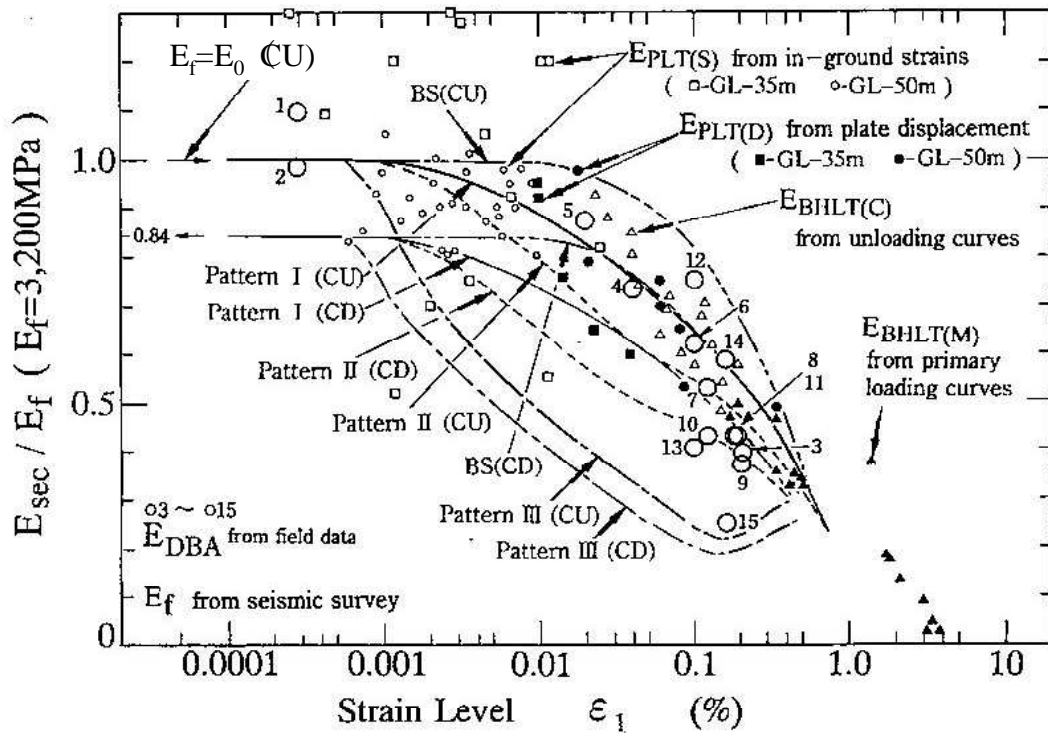
Figure 4.1. Comparison of Young's modulus from laboratory and field tests and full-scale field behaviour, sedimentary soft rock (Kazusa group), Sagami-hara test site (Tatsuoka et al. 1997a).

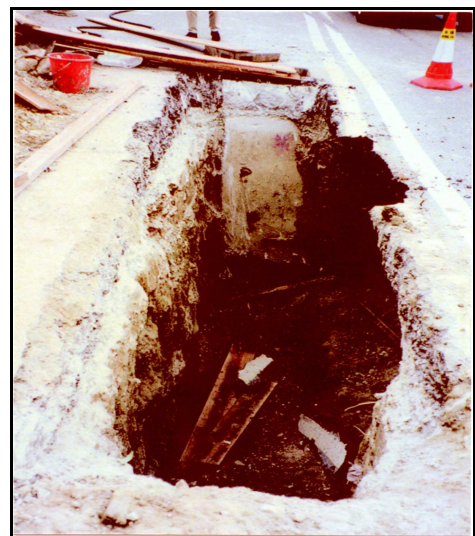
Workers were laying pipes inside a 3 m deep unsupported trench when a cave-in occurred. One of the workers was killed and another one was injured by the collapsed soil. The collapse was likely to have been caused by the absence of shoring support and the external loading induced by a heavy vehicle parked at the trench side.

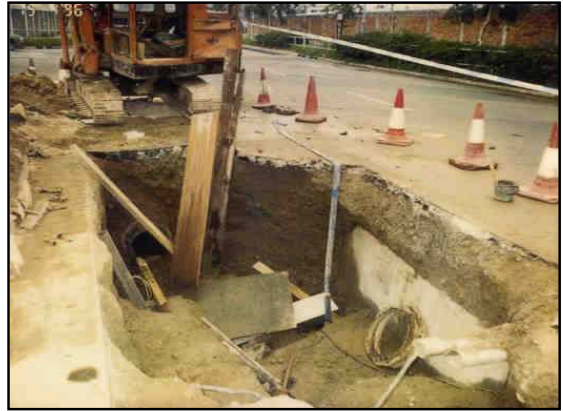
An excavated trench caved in and a worker was killed by collapsed soils. The open trench was about 2.2 m deep. The probable cause of the failure was reported to be insufficient shoring.

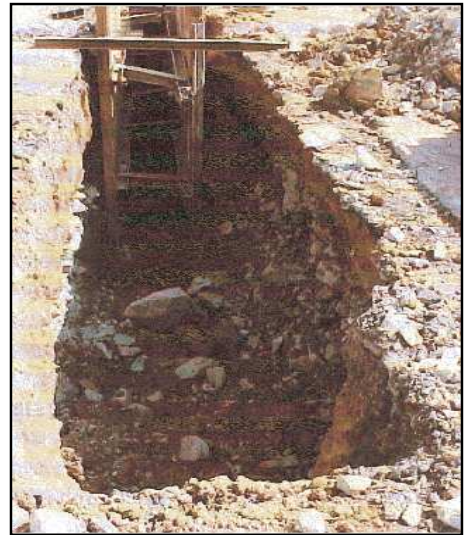
Workers were preparing for the installation of support when the trench side collapsed. The unsupported trench was 2.8 m deep. The failure caused one death and one injury.

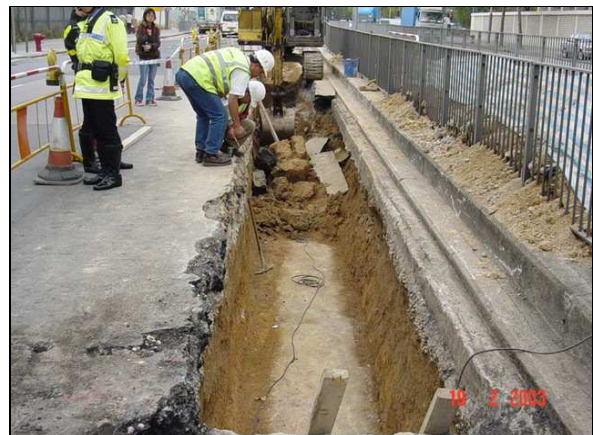
Two workers were injured, one seriously and one critically, by the collapsed trench. They were working inside the unsupported 1.5 m deep trench at the time of the failure.

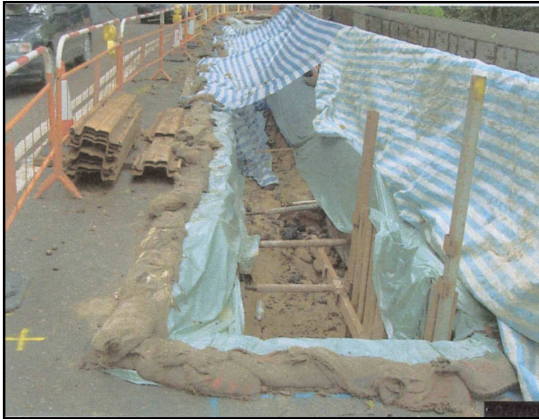
The trench was located at the crest of a slope and excavation work was in progress. The open trench was left uncovered during a heavy rainstorm. It was likely that because of inadequate drainage provision on site, water was allowed to enter the trench and infiltrated into the slope below. A landslide occurred as a result of rise in groundwater level.

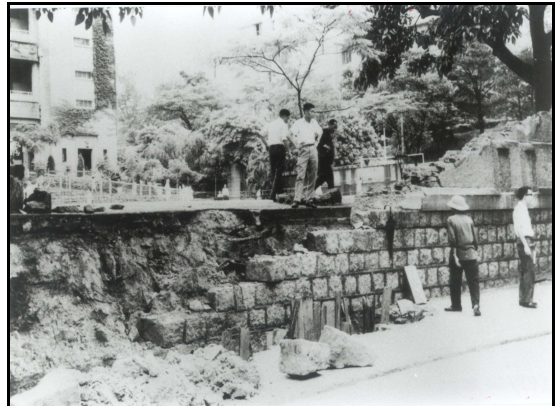
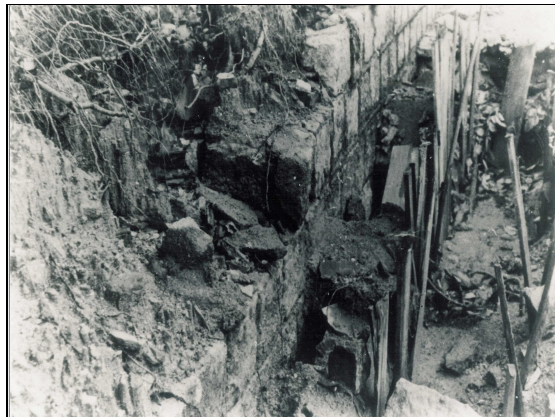
A trench was excavated to facilitate the laying of cable in the pavement in front of a section of a masonry wall. The 2 m high, 15 m section of the 76 m long masonry wall forming the boundary of La Salle Primary School collapsed outwards onto Boundary Street during heavy rainfall. The wall collapsed on a bus queue full of school children at 12:30pm, killing six and injuring 16 others.

Professor Lumb in his investigation report concluded that “the collapse of the wall at La Salle Primary School was due to a combination of (a) water pressure behind the wall, (b) poor quality of the mortar in the wall, and (c) the excavation at the foot of the wall”. He went on to say that “Failure might not have occurred if there had been no trench excavated, but the prime cause of the collapse was water pressure...”.

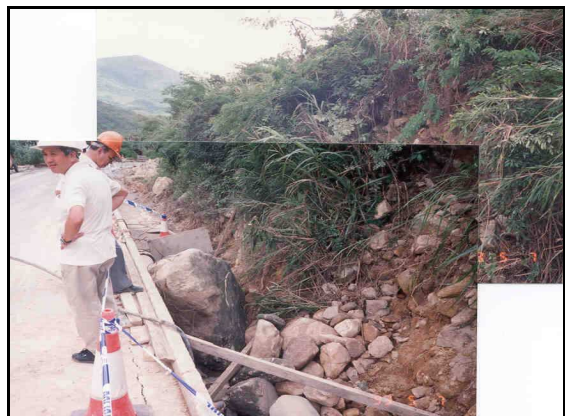
A pipe was being laid when a worker inside the trench was struck by a rock falling from an adjacent upslope. The trench was 1.5 m deep and support was not installed throughout. It was likely that the slope was disturbed and its stability undermined by the excavation of the trench, resulting in the rock fall and one fatality.

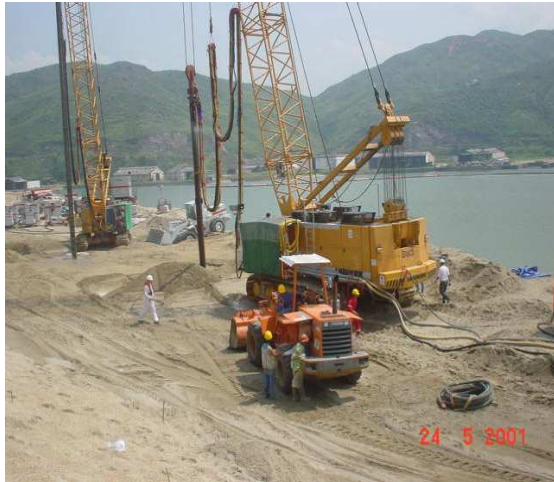
Figure 3 Vibrocompaction in Progress

As previously mentioned, ground treatment in dredged areas comprised vibrocompaction and nominal surcharging. Figure 3 shows the vibrocompaction in progress. The design intent was generally to densify the top 15m of the sand fill to provide a ‘stiff’ upper layer in the sand fill profile. In more sensitive areas of the site or where greater loadings were anticipated, vibrocompaction was specified to full depth.

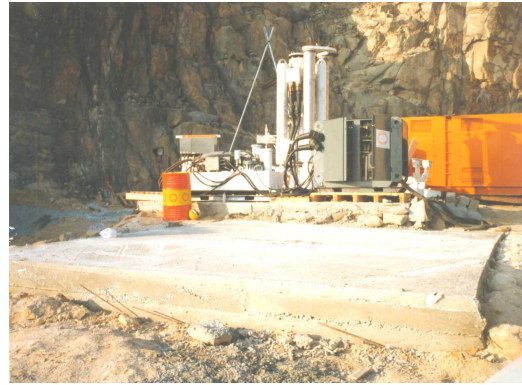
Plate 1: Robbins Raise Borer

Mechanical Tunnel Boring Machine (TBM) method was used in the vertical shafts construction for this project. A raise borer from Robbins (Plate 1) was used to carry out the work. A pilot hole was initially drilled down from the peak platform. As the pilot hole intersected with the horizontal tunnel, the raise borer head was installed. The vertical shaft was then bored from bottom up. The process is known as raise boring.

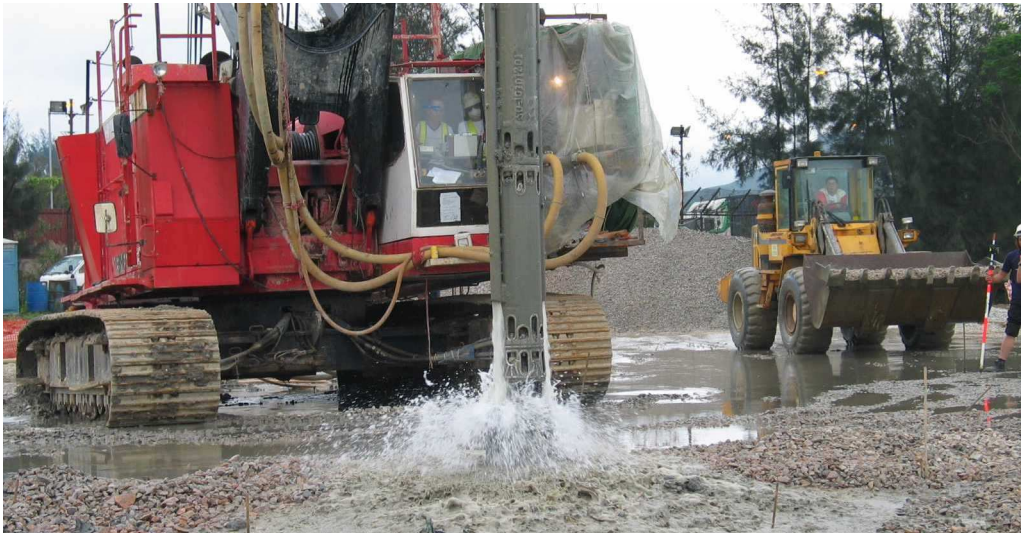
*Figure 6 – Installation of Stone Columns by Wet Top-Feeding Process*

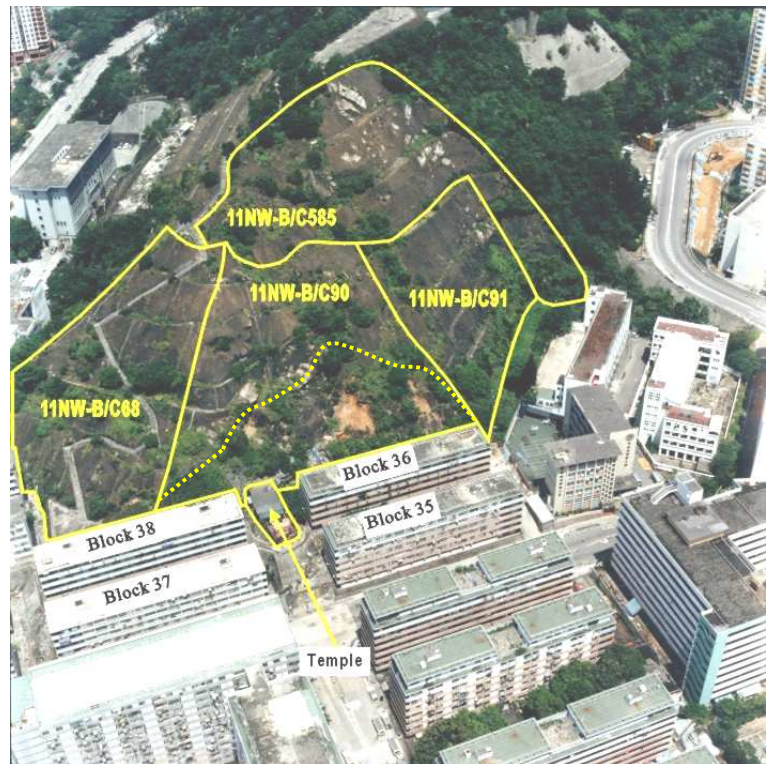
Figure 1 – View of the Slopes (Dotted line shows extent of distressed zone)

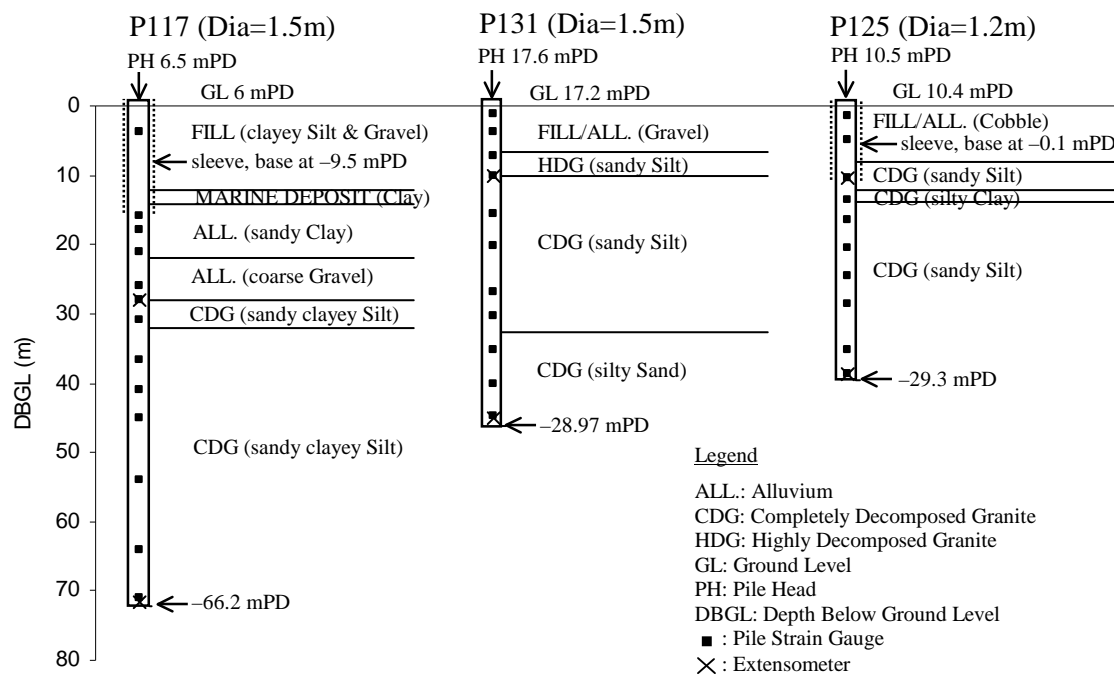
Figure 1: Ground conditions and details of the three test piles.

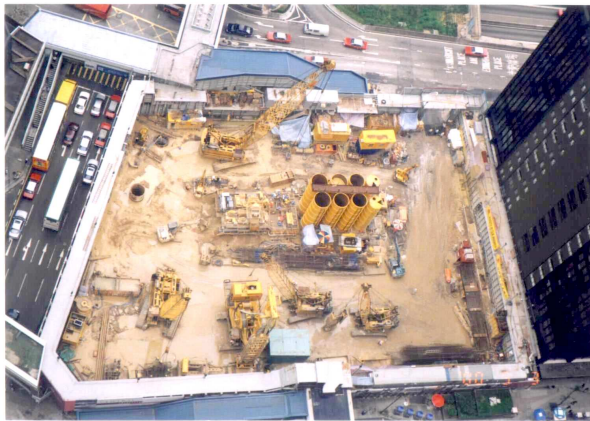
Plate 2 : Aerial View of Foundation Construction

Diaphragm wall and toe grouting works commenced in March 2000 and were completed in September 2000 (Plate 2). In general, diaphragm wall was constructed by the hammer grabbing method. Along Chater Road, a mill type reverse circulation trench cutter “hydromill” was used to excavate the diaphragm wall panels in order to reduce the induced vibration to the existing MTR Central Station.

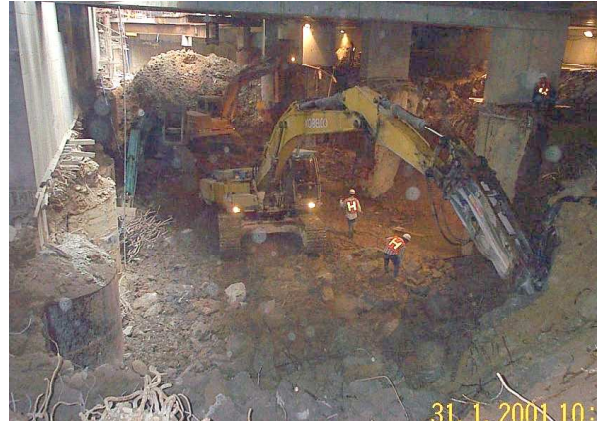
Plate 3 : Basement Excavation

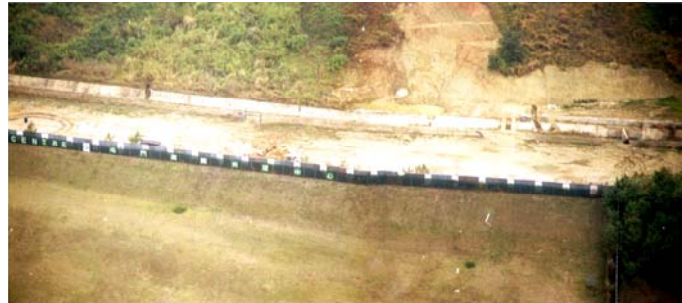
(a) Earthfill Berm in Tuen Mun

Debris-resisting barriers have been employed in Hong Kong as protective measures against natural terrain landslide hazards. These include rock fences, gabions, reinforced concrete retaining walls, earthfill berms and check dams (Figure 4). They are generally less than 10 m high. These barriers have been designed to contain debris of up to about 2000 m<sup>3</sup>

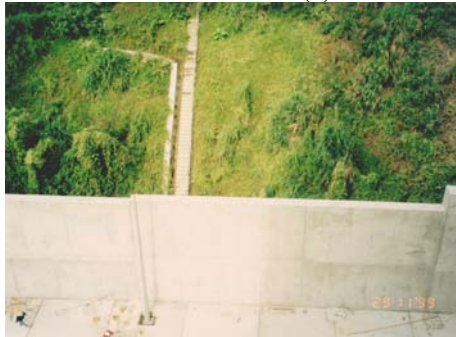
(b) Reinforced Concrete Retaining Wall in Fanling

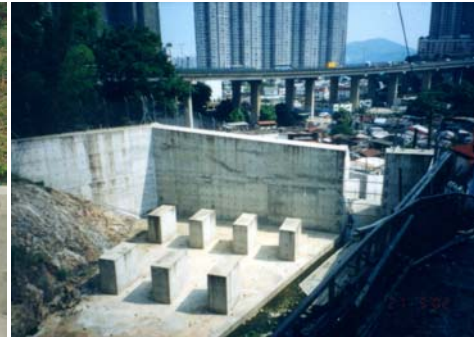
(c) Check Dam in Sham Tseng

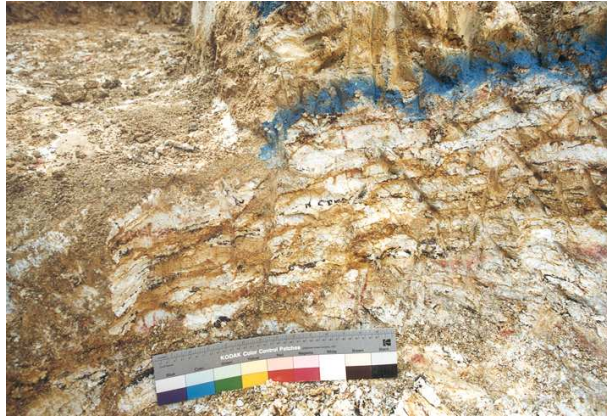
**Plate 1 - Kaolinite-rich Altered Tuff at the base of the Fei Tsui Road Landslide**

The post-failure investigation established that the basal slip surface of the landslide developed along a laterally extensive (>50 m) layer of kaolinite-rich altered tuff, which was about 15 m below the crest of the cut slope and dipping out of the slope at about 10° to 25° to the horizontal, whilst the backscarp of the landslide was defined by two sets of steep joints. Plate 1 shows that the layer (about 0.5 m thick) that controlled the basal failure plane is highly kaolinised and completely decomposed, with abundant kaolinite veins ranging from 2 mm to 20 mm in thickness.

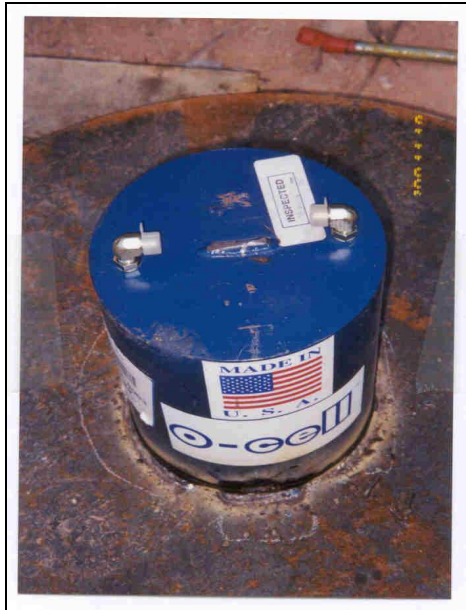
Figure 5A – 230 mm-dia. Osterberg Load Cell

The set up of the loading device was formed by assembling two 75 mm-thick and 900 mm-diameter circular steel plates to the top and bottom of a 230 mm-diameter O-cell. The O-cell and the assembled loading device are shown in Figures 5A and 5B respectively. Steel rod extensometers, strain gauges, transducer extensometer and displacement transducers were installed for monitoring the displacement and deformation of the test piles. Instrumentation set up of the test pile is shown in Figures 6A and 6B.

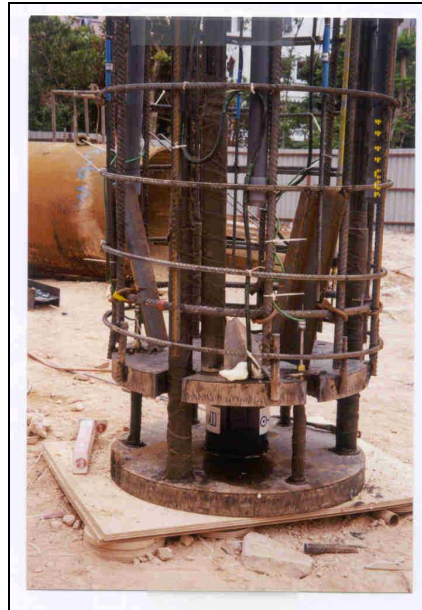
Figure 5B – Assembled jacking device attached to the bottom of reinforcing steel cage

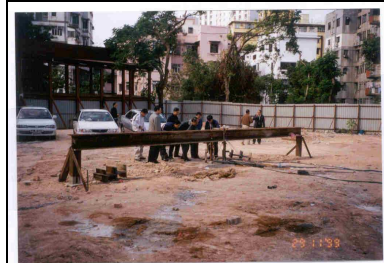
Figure 8 – Reference Beam

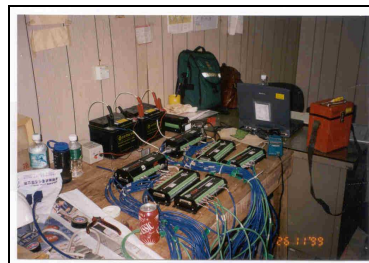
Figure 9 – Central Automatic Data Logging System

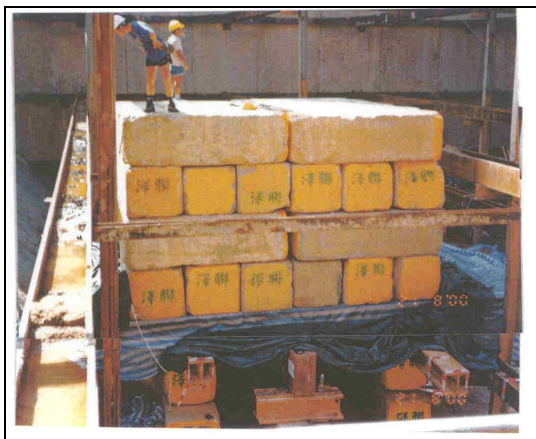
Figure 11A – General View of Plate Load Test Using Conventional Method

Upon completion of the plate load tests using the O-cell method, the results of which indicating that the bearing capacity of the soil stratum at the intended founding level is adequate, the basement excavation works were then proceeded. In order to compare the results of the plate load tests between using O-cell and the conventional method, two additional plate load tests using conventional kentledge method were carried out at the intended founding level upon completion of the excavation works. The general view and set up of the additional plate load tests are shown on Figures 11A and 11B respectively. The results of the additional plate load tests were in general agreement with that by the O-cell.

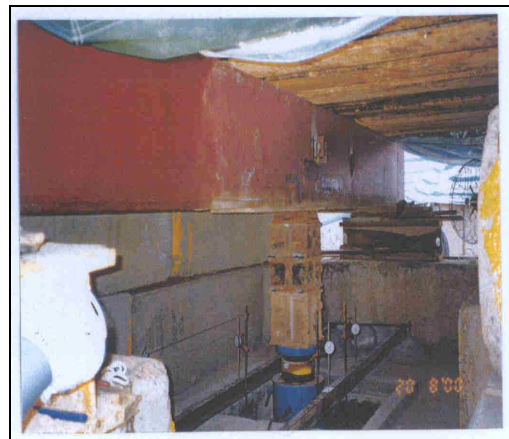
Figure 11B – Testing Set up of Plate Load Test

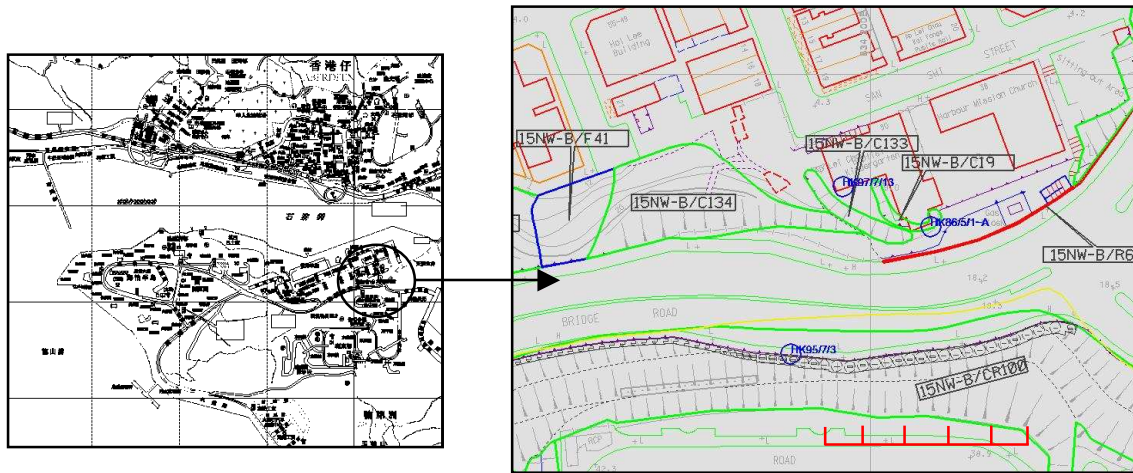
Figure 1 : Site Plan

The site, on a sloping ground with a cantilevered caisson wall (feature no. 15NW-B/CR100), was built in 1994 as part of the Ap Lei Chau Bridge Road Improvement (Figure 1).

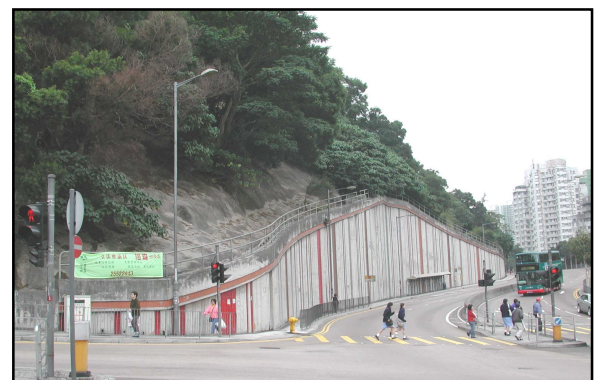
Figure 2 General Appearance of the Wall 15NW-B/CR100

The caisson wall 15NW-B/CR100 (Figure 2) comprises 2.6m diameter cantilevered caissons socketed into bedrock with a maximum retained height of about 12m above the road level. It supports a 40° slope, up to the platform of Yue On Court, which is at about 24 m above the Ap Lei Chau Bridge Road. Figure 3 shows the typical interpreted geological section based on the information collected from the ground investigation.

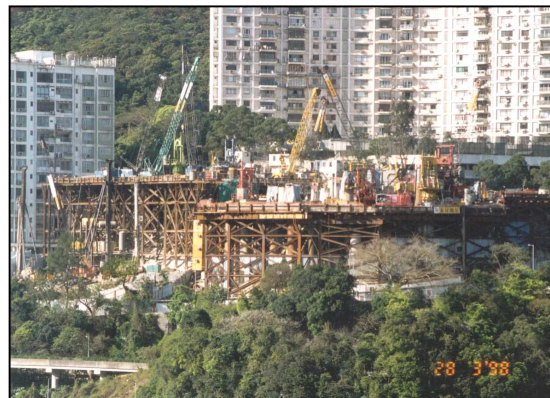
**Figure 14 : Similar Gigantic Temporary Working Platform at Stubb's Road**

It was anticipated that there could also be a substantial risk and danger of accident to the public passing under the temporary working platform at some 20m below, as well as nuisance from noise, spoil, etc. Unless partial closure of Ap Lei Chau Bridge Road be implemented, the risk to the public during construction was considered unacceptable. A similar substantial temporary working platform is shown in Figure 14. It was envisaged that construction of the bored pile would involve excavation of 600m length of 2.5m diameter bored pile in soil, together with another 400m length of pile in rock. The works may take longer than 15 months to complete.

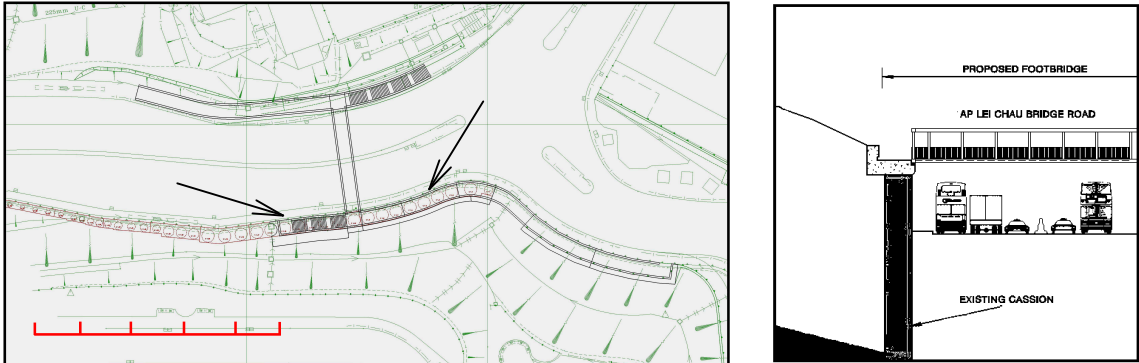
**Figure 15 : Retaining wall layout and section under revised scheme**

In view of potential huge gain, a Value Engineering review was eventually applied to the original design, involving the project team, the client and the major stakeholders, trying to re-examine the basic functional requirements and reassess the design and construction options to pursue additional optimisation based on experience of the project team members. It was found and agreed that there was no strict requirement to separate the new footbridge from the existing retaining structure, and that the standard pedestrian access ramp and staircase structure was not a prerequisite requirement. These findings allowed greater flexibility in designing the layout and positioning the associated structures of the footbridge. Finally, it came up with a revised scheme basically fulfilling the redefined functional requirements of the client by providing a footbridge over Ap Lei Chau Bridge Road with a ramp and a staircase connecting to the footbridge as shown in Figures 15 and 16.

- (a) Five existing caissons, namely C1.11 to C1.15 of the wall 15NW-B/CR100 would be trimmed down by 5m to 11m to accommodate the staircase connecting to the proposed footbridge. The wall section would be replaced with a new 2m thick cantilevered L-shaped retaining wall connected to the trimmed caissons by a 2m deep base slab at their cut-off level, with staircase to be formed on top of the base slab with handrail and roof;

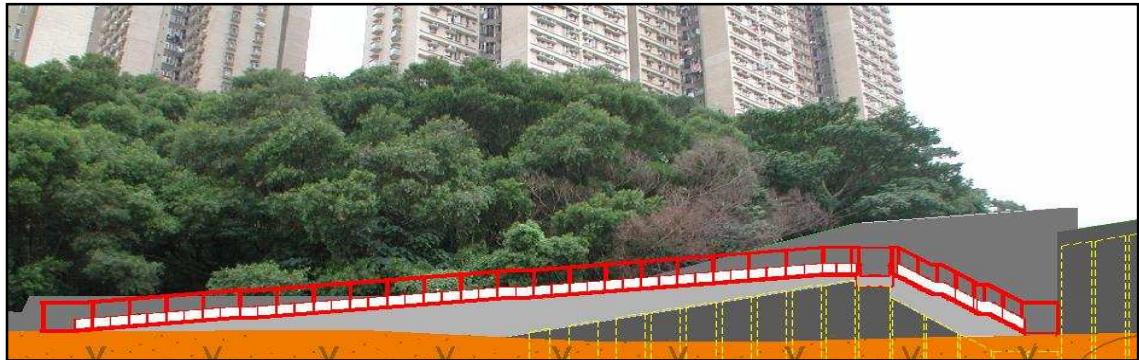
Existing Caissons C1.10 C1.12 C1.14  
C1.11 C1.13

**Figure 16 : Elevation of Retaining Wall Under the Revised Scheme**

- (b) Existing caisson C1.10 would be trimmed down to support the proposed footbridge at +25.7mPD. The caisson head would be modified to provide a suitable support for the footbridge and a retaining wall connected to the caisson head would be built to support the upslope. The caisson C1.10 would be checked against the loadings derived from the footbridge;

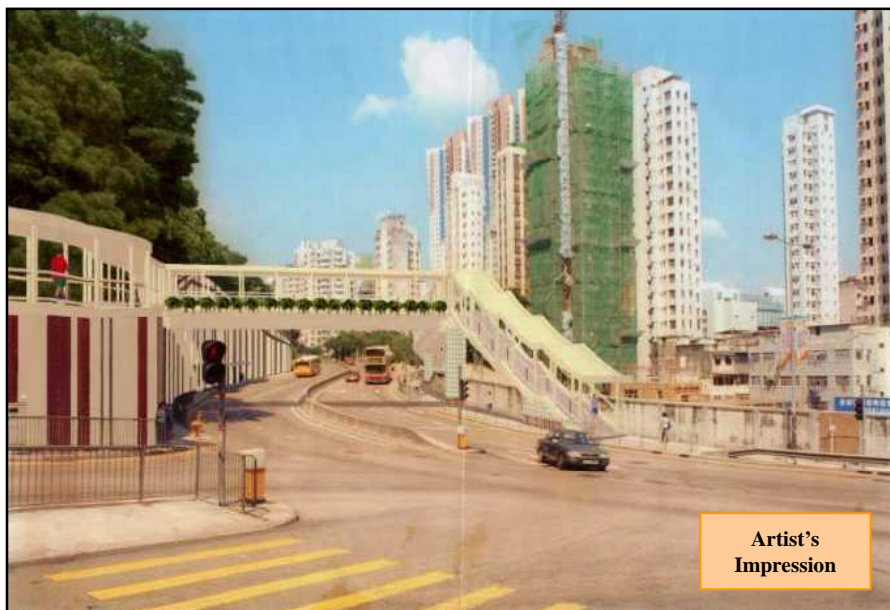
**Figure 17 : Artist's Impression after completion of Works**

- (c) For the provision of pedestrian ramp connecting to the proposed footbridge, the capping beam to the east of the proposed footbridge would be filled up with concrete to the required level for the pedestrian ramp running towards Ap Lei Chau Drive (Figure 17). A new cantilevered wall section would be built with thickened base slab to replace the capping beam and suit the required gradient of ramp.
