The HKIE Geotechnical Division 38th Annual Seminar 2018

Geotechnical Engineering for **INFRASTRUCTURE DEVELOPMENT**

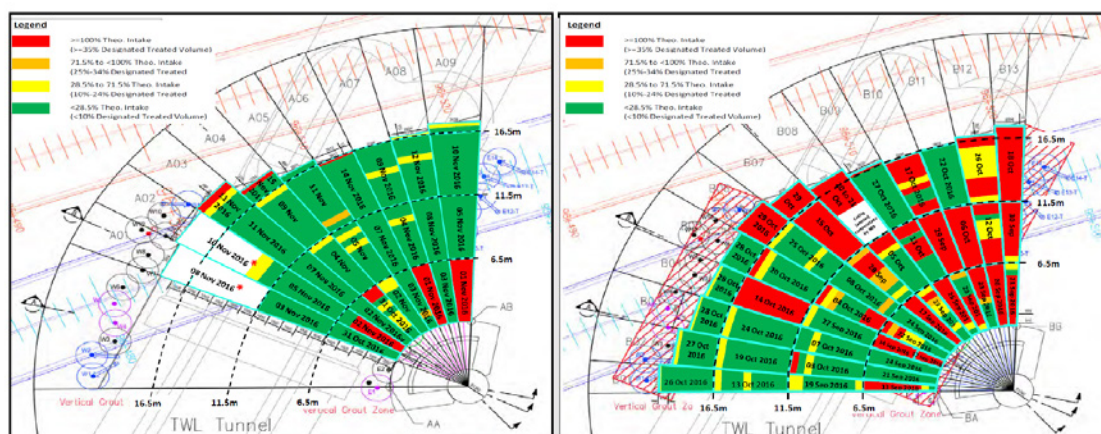
During horizontal grouting, the total actual grout intake for row B is larger than that of row A. It was considered that the earlier grouted row B had successfully formed a confinement curtain fan at the bottom for effective row A grouting. And row B treated a larger area than expected so part of row A treatment area was injected during row B grouting works. It was observed that the injected volume for hole B13 was relatively larger. This could be due to the possibility of grout outflow from the inclined vertical grouted holes (E10 to E14) and part of the hole (from 0m to 5m) was out of the footprint of the vertical TAM curtain. The relatively larger volume along the far end perimeter of curtain (B6, B7, B8, B12) was due to the lack of vertical grout to work as grout flow barrier. This also proved the confinement formed by vertical grouting was effective, when compared with B1 to B5. Furthermore, the result shows that desirable grout volume and pressure were achieved for hole B1 to B4, despite 3 planned holes in row A above them were cancelled due to their close proximity to the TWL structure. Furthermore, the actual grout volume placed for row A only accounted for 6.6% of the targeted ground volume. This figure was less than the value for row B as expected, in addition to the final pressure recorded at each injection step, indicates that the available void in the gravel layer have been properly filled. With the overall grout volume being 12.1% of the total ground treatment volume, it also suggested the original design assumption of 35% void ratio was on the conservative side.

Figure 16: Actual Injected Volume for row A and B

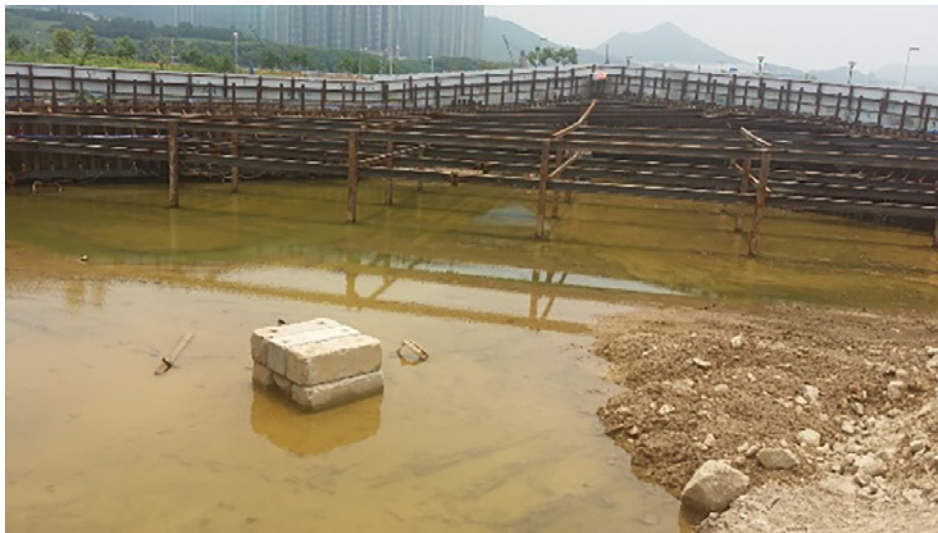
Plate 1: Photograph of a flooded cofferdam caused by leakage through pipe piles

The functions of the grout curtain are to provide water-tightness of the cofferdam and enhance the arching effect of soils to maintain temporary stability of the unsupported vertical cutting necessary for installation of the lagging wall. Tube-a-manchette (TAM) grouting is commonly used for the grout curtain. There are often situations where TAM grouting is not effective, such as when clay soil or rockfill is present or when there is a potential for high velocity flow of groundwater (e.g. close to seawall). When TAM grout curtain cannot achieve its intended functions, large inflow of water into the site or excessive oozing of soils through the pipe piles can occur before the lagging wall is installed. Plate 1 shows a photograph of pipe pile cofferdam located close to the seashore. Grouting was not effective at a particular spot between pipe piles with rockfill behind them, leading to uncontrollable inflow of water flooding the site.

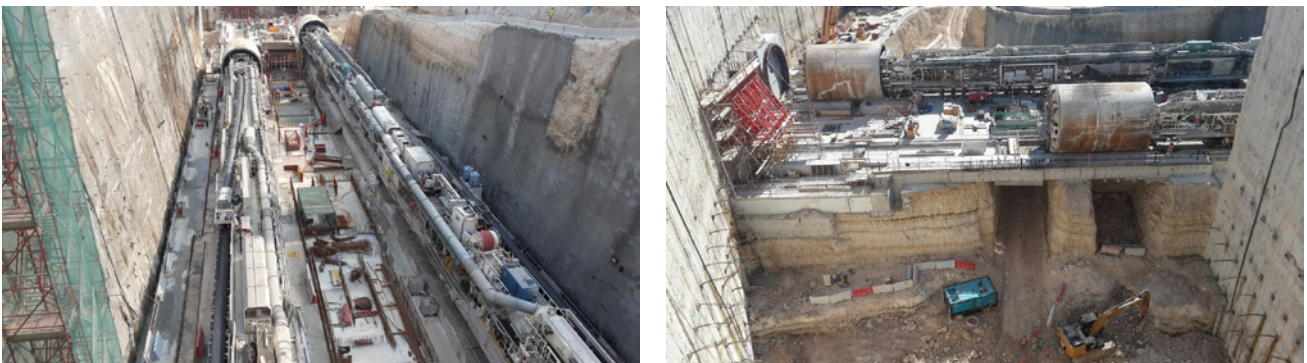
Figures 23 and 24: TBM transfer through Al Saad C-Ring

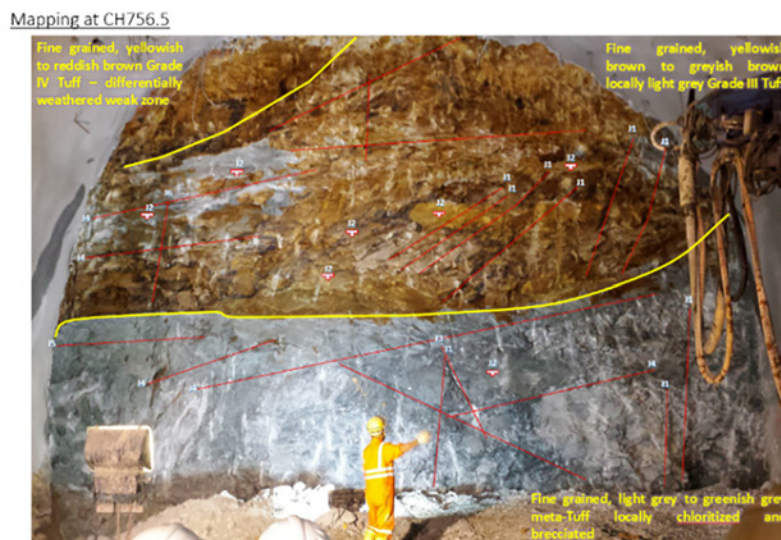
Figure 6 – Condition of tunnel face at CH756.5 showing a differentially weathered weak zone clearly defined and locally chloritized and brecciated tuff

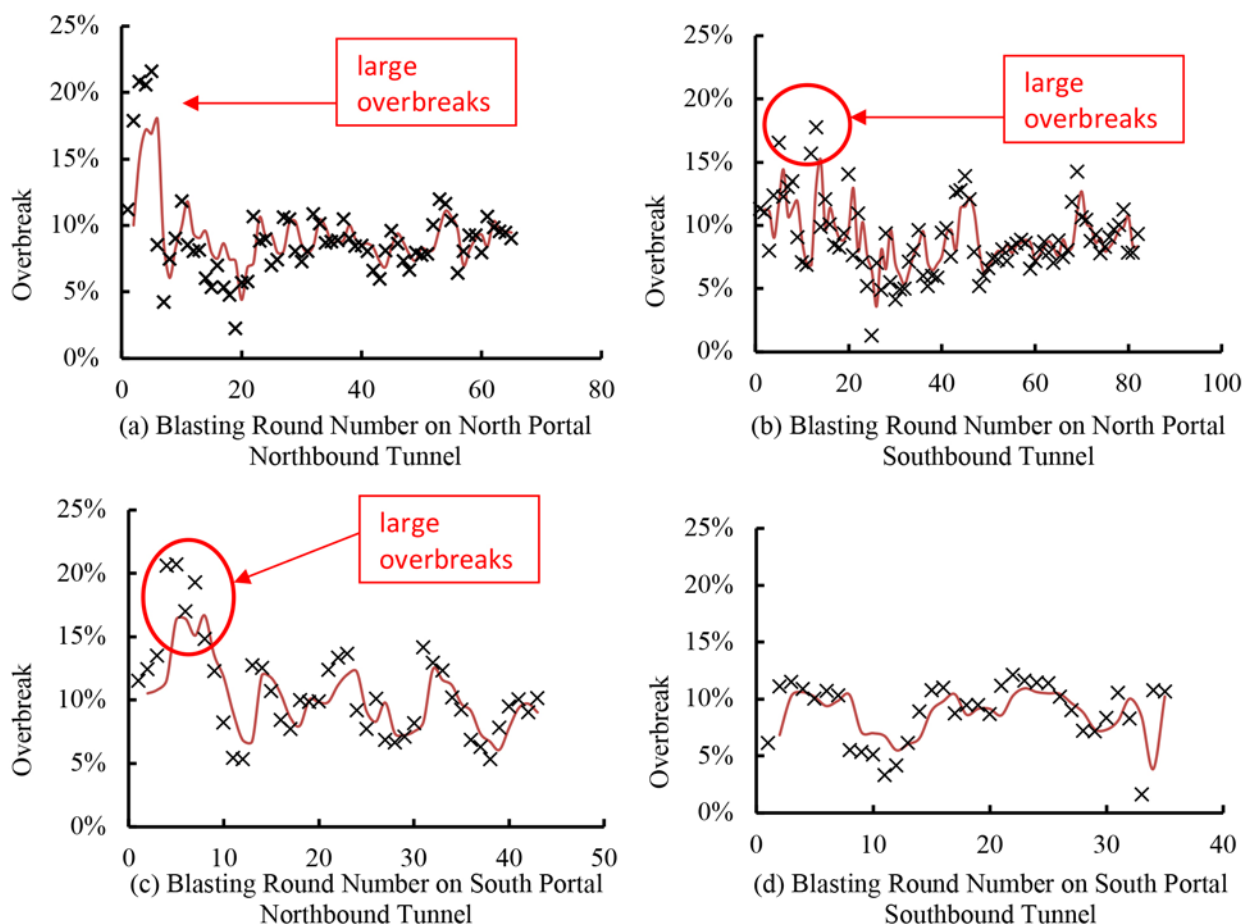
Figure 10 – Measured Overbreaks along the Tunnel with Prediction Curves

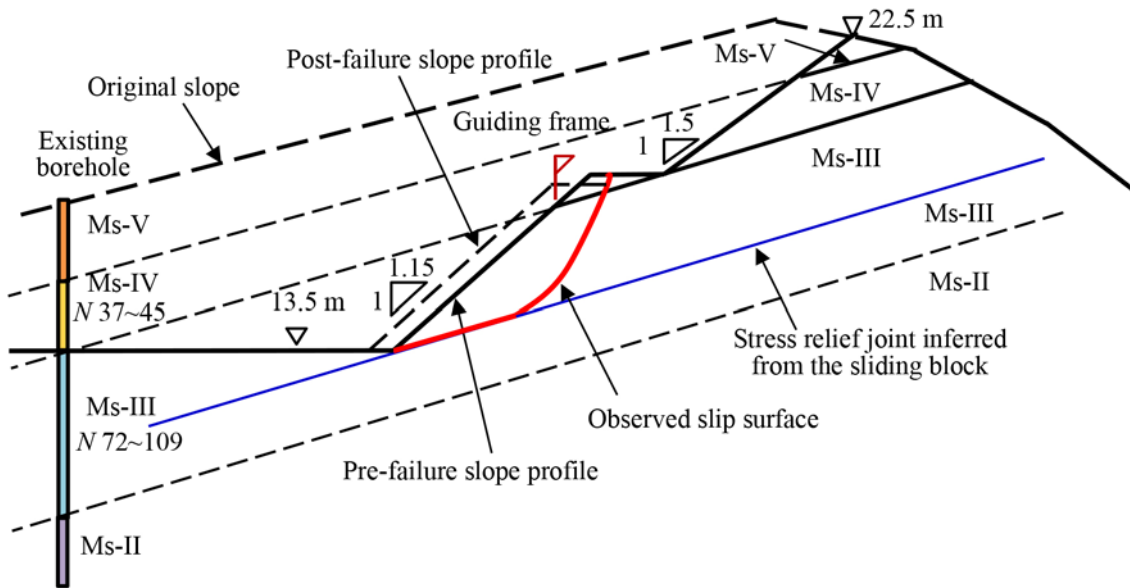
Figure 12: Cross-section along slope failure for Case 4

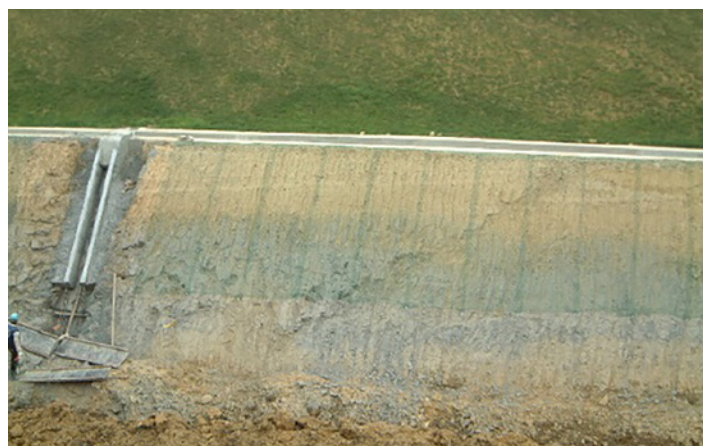
Figure 4: Pre-failure slope at Case 1 showing the joint plane intersecting the slope surface

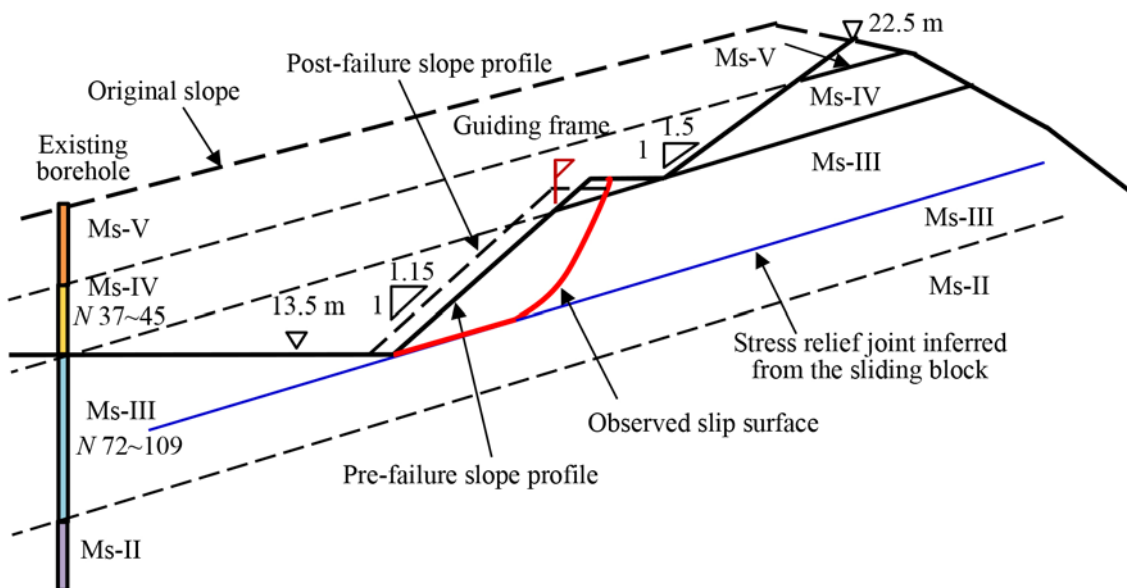
Figure 12: Cross-section along slope failure for Case 4
