THE 11TH LUMB LECTURE

Bridging the Gap between Theoretical and Actual Slope Performance

Ir Prof. WONG Hok-ning

Department of Civil Engineering
The University of Hong Kong

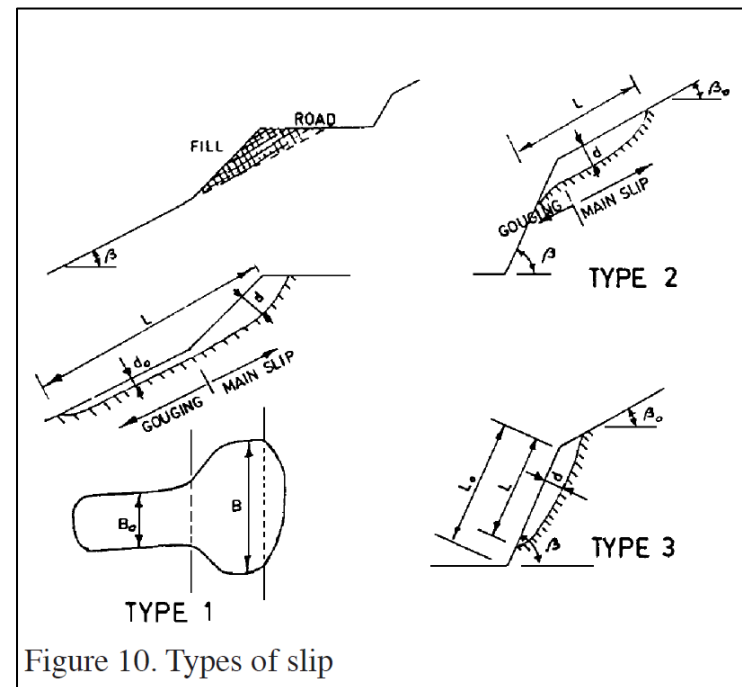
Figure 10. Types of slip

Summary: The recurrence of slope failures in residual soils of Hong Kong is analysed for the period 1950 to 1973, and various factors contributing to the instability are described. It is postulated that the prime cause of the failures is direct infiltration of rain water into the surficial zones of the slopes, producing a loss of effective cohesion following the saturation of the soil. Prevention of slips implies protection against excessive infiltration.

“the prime cause of the failures [1950 to 1973] is **direct infiltration** of rain water into the **surficial zones** of the slopes ...”

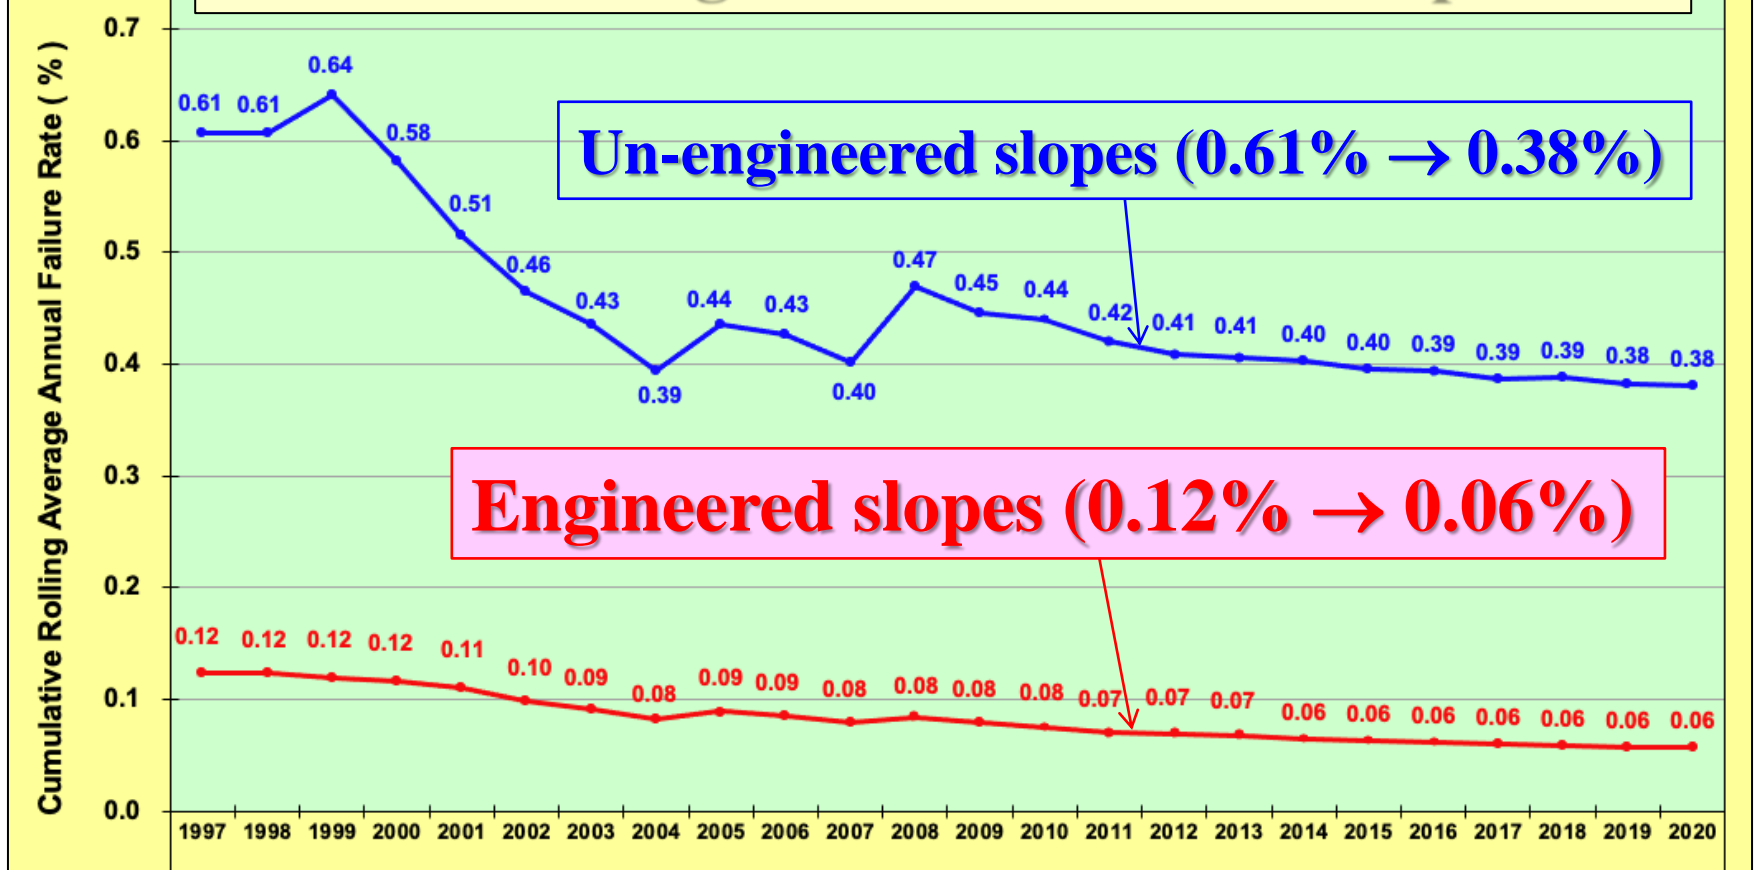
Cumulative Rolling Average Annual Failure Rate of Registered Man-made Slopes

1997 → 2020
 Annual Failure Rate = 0.06% (**326** landslides in **24** years)

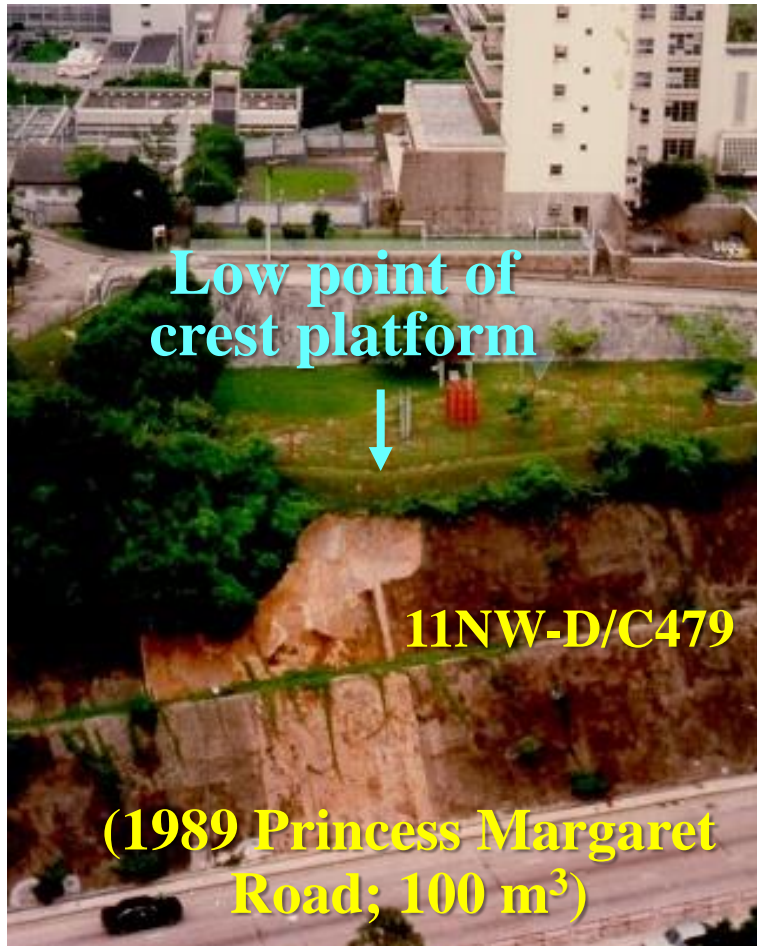
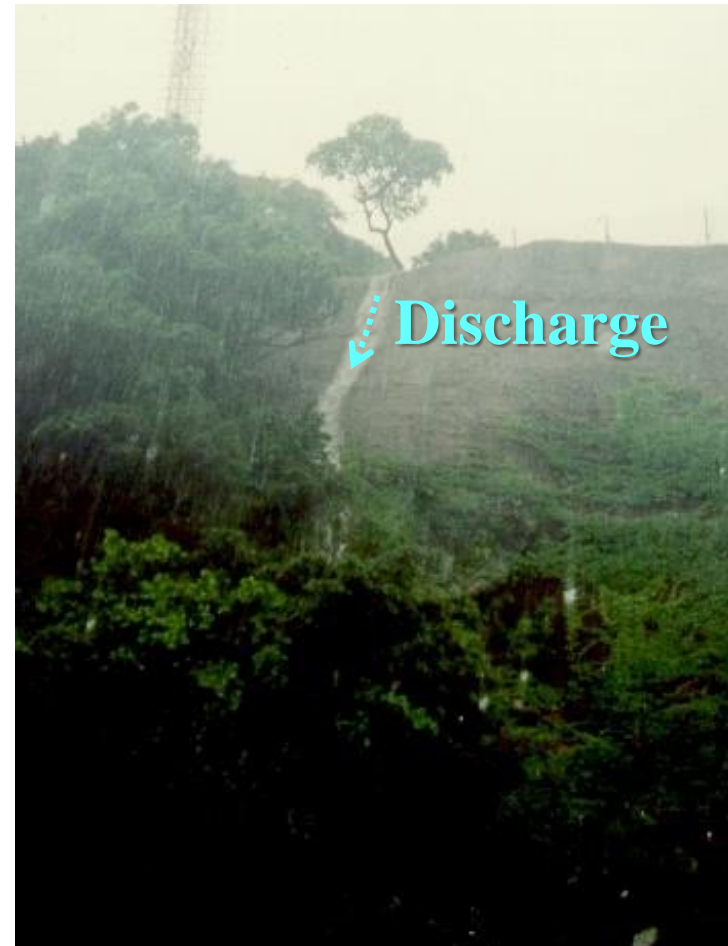
(i) Topographic

e.g. concentrated discharge at low point

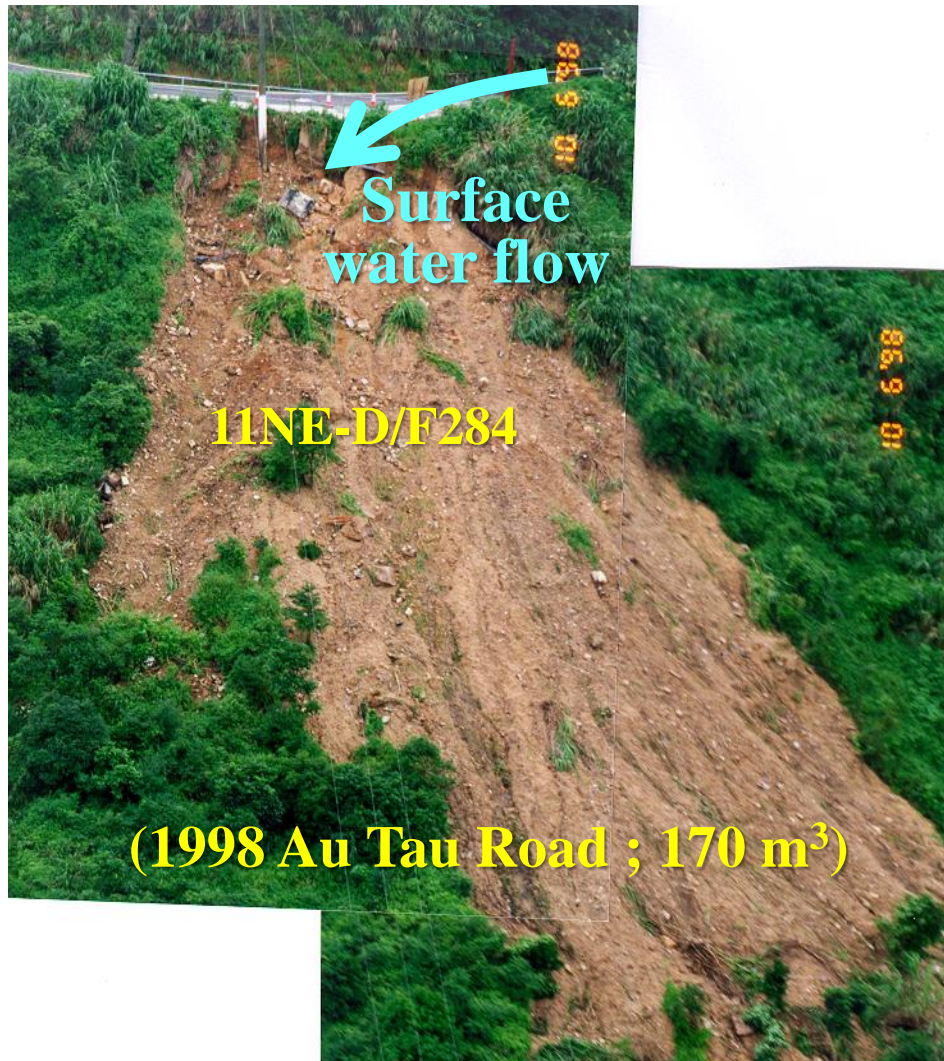
(i) Topographic e.g. road bend

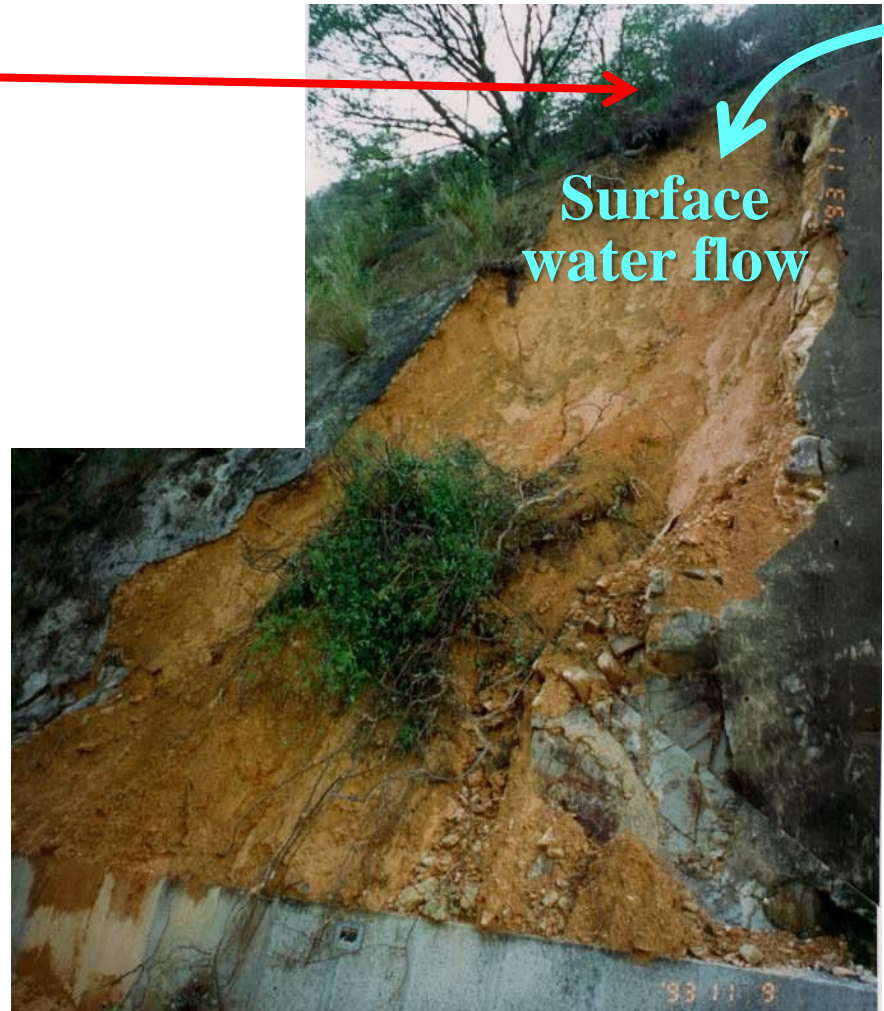
Blockage by debris and unplanned vegetation

Channel blocked

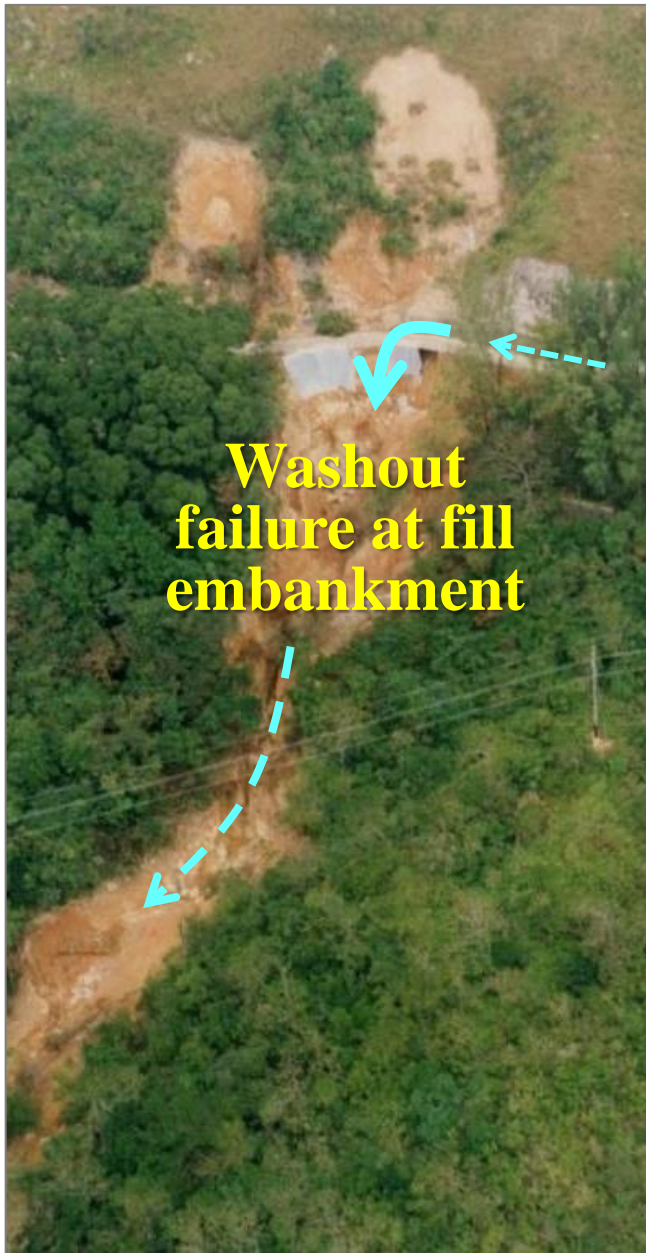
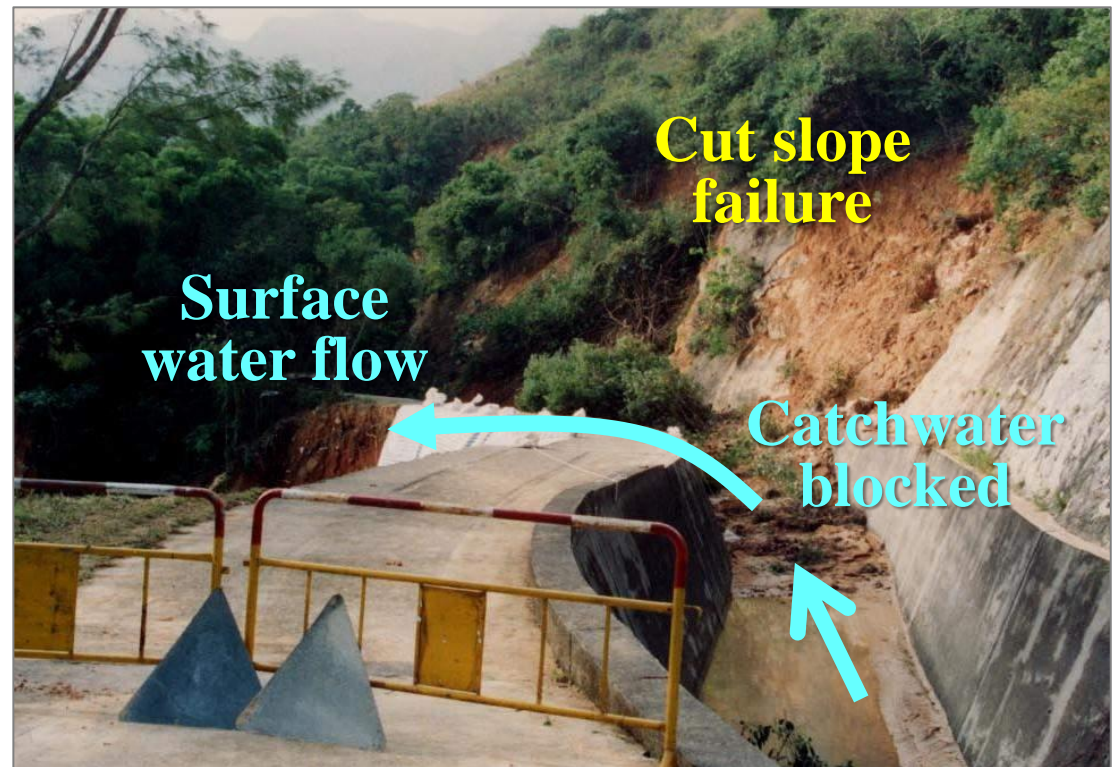
(ii) Blockage

e.g. catchwater blocked by landslide debris

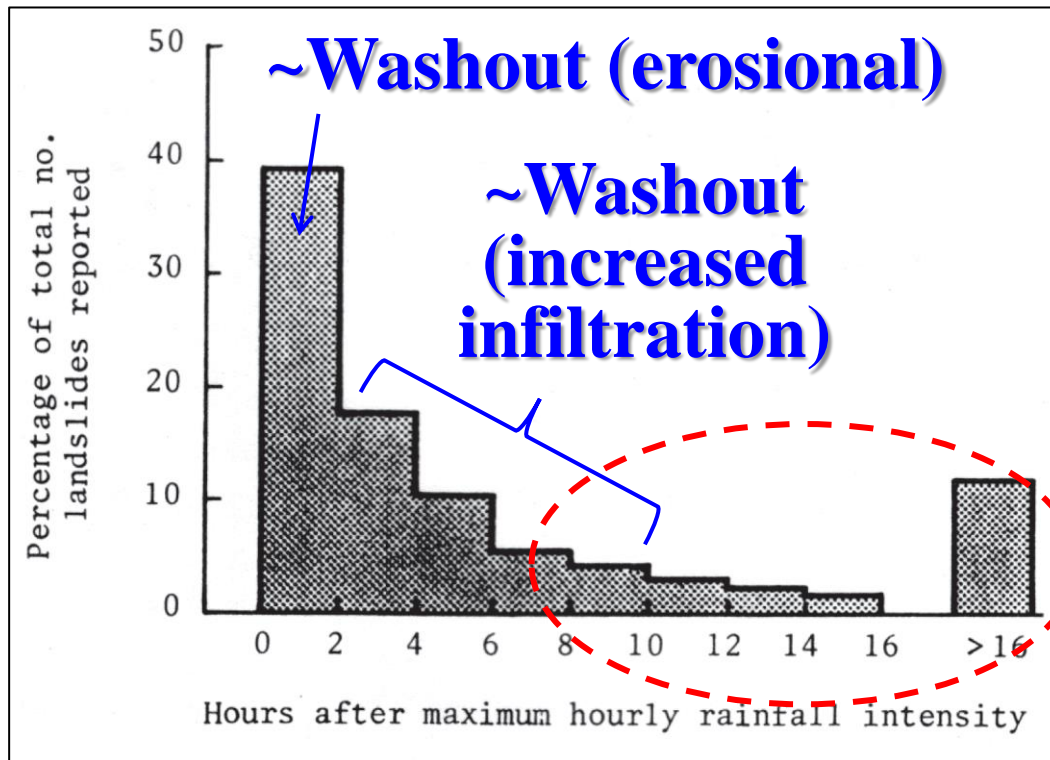
**Brand et al
(1984)**

“... landslides in Hong Kong are heavily dependent on the magnitude of the short duration rainfall intensity, with a threshold value of about 70 mm/hour”

Soil infiltration rate
 $< 5 \times 10^{-6}$ m/s
 $= 18$ mm/hr $\ll 70$ mm/hr

Thickness of wetted zone
 < 0.5 m in 2 hrs

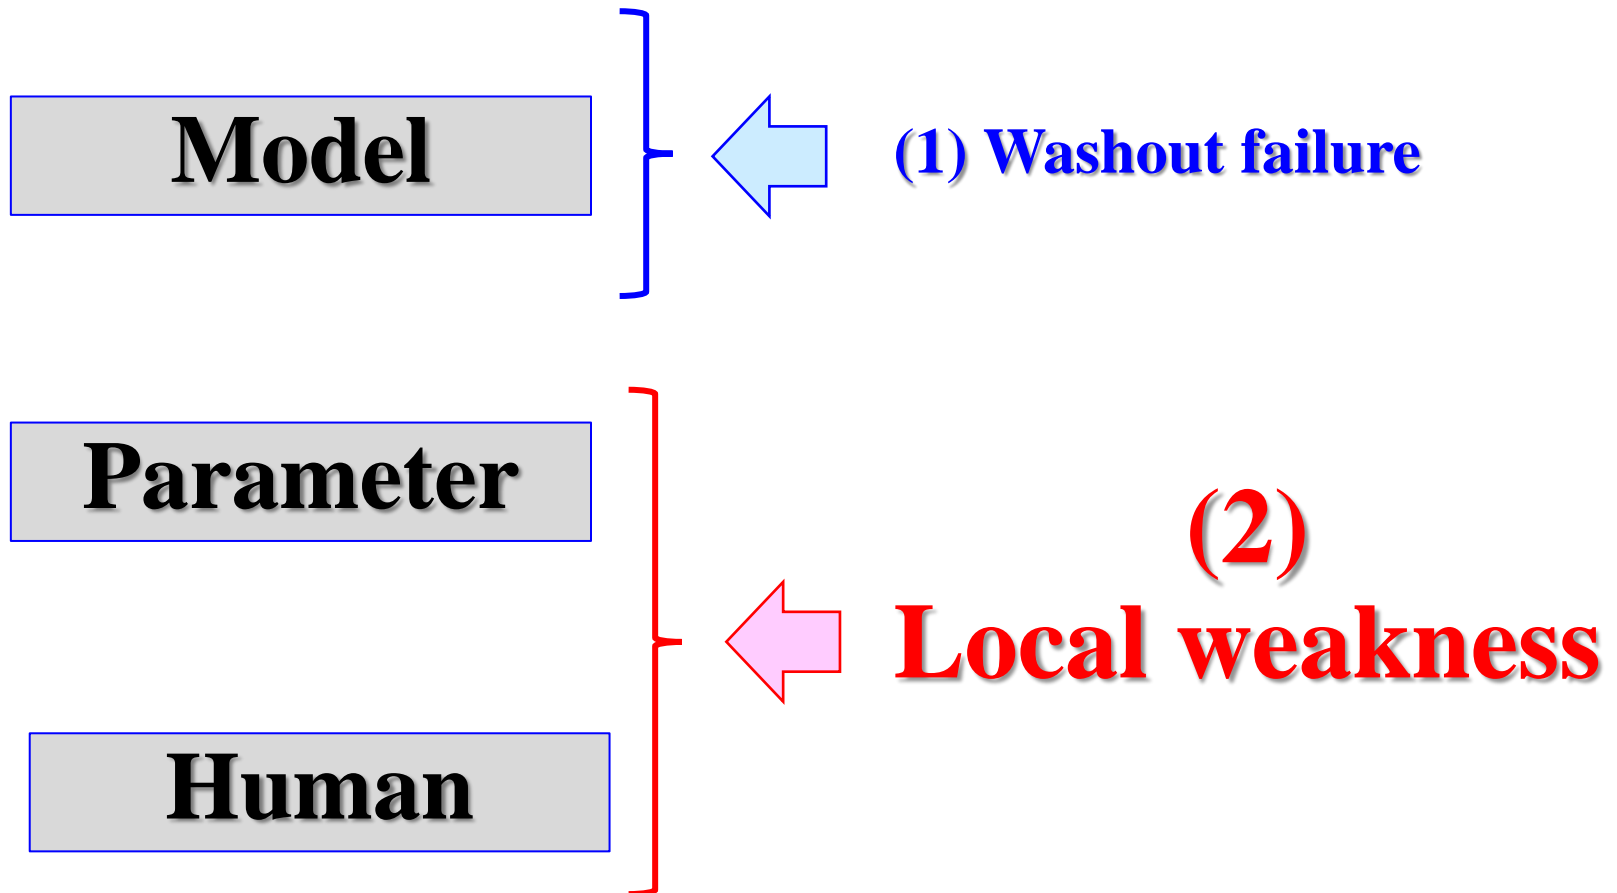
Schematic Cross-section

Local weakness: Relict Discontinuities

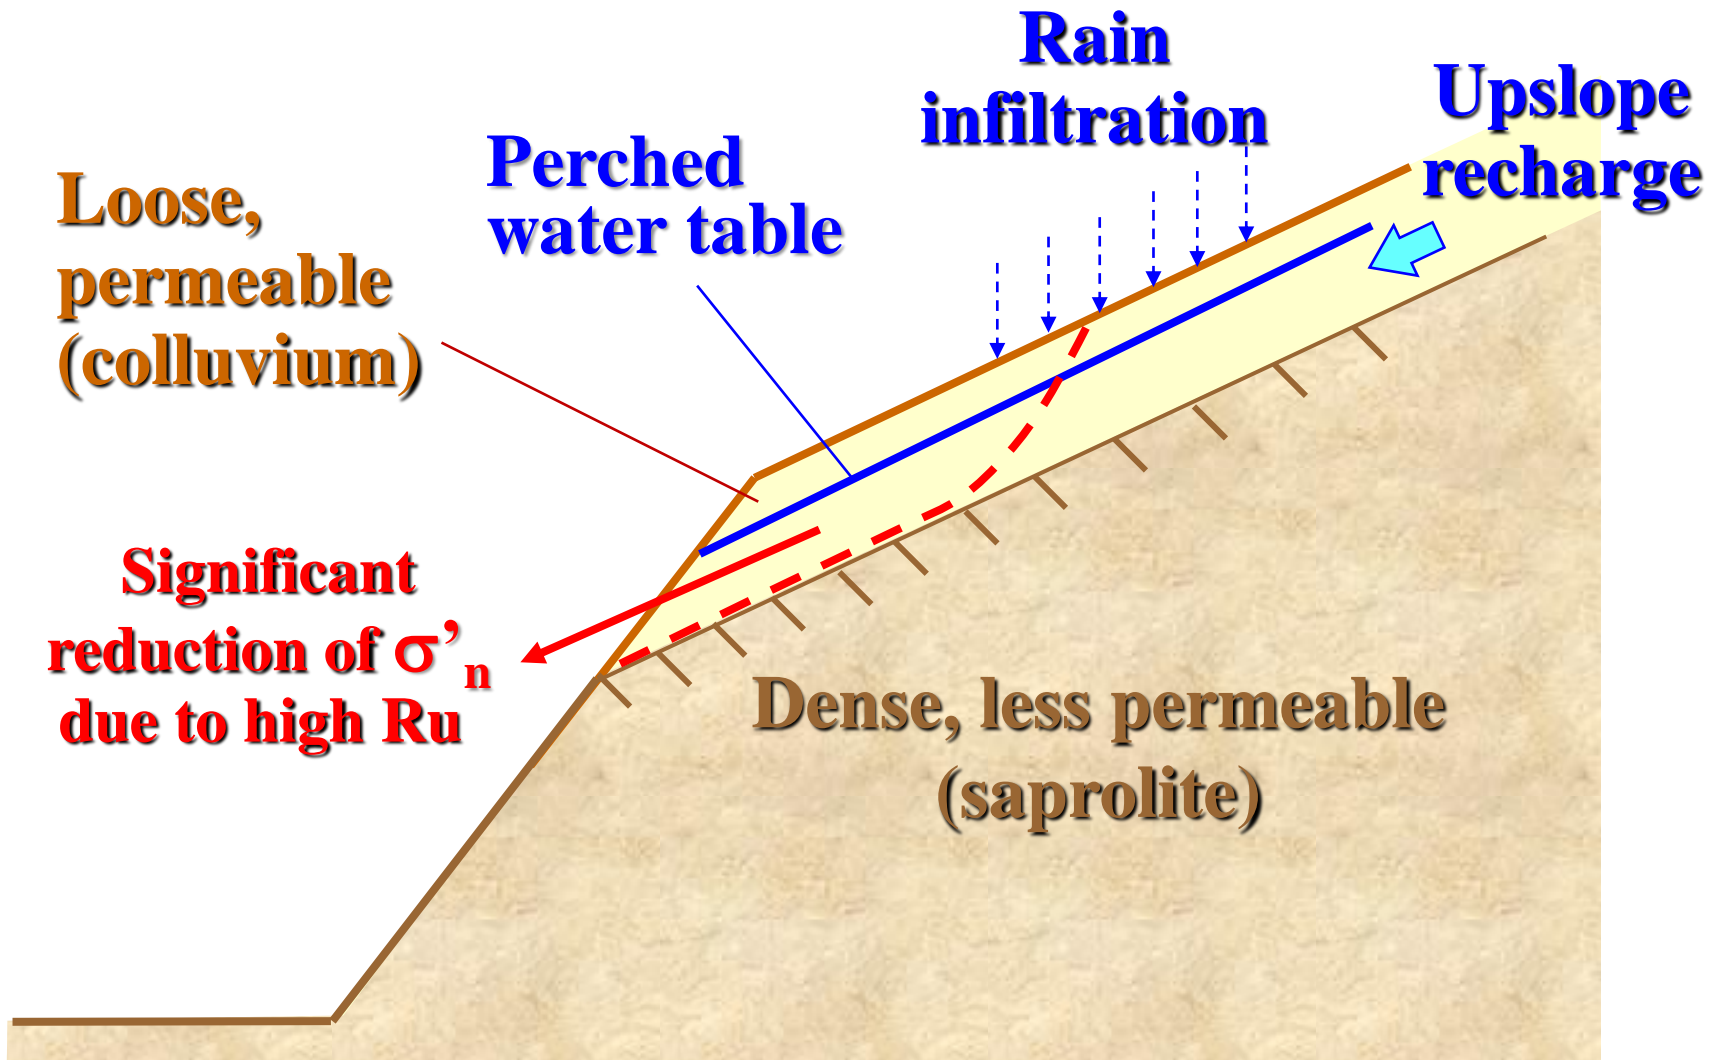
Perched Water Table (near slope crest)

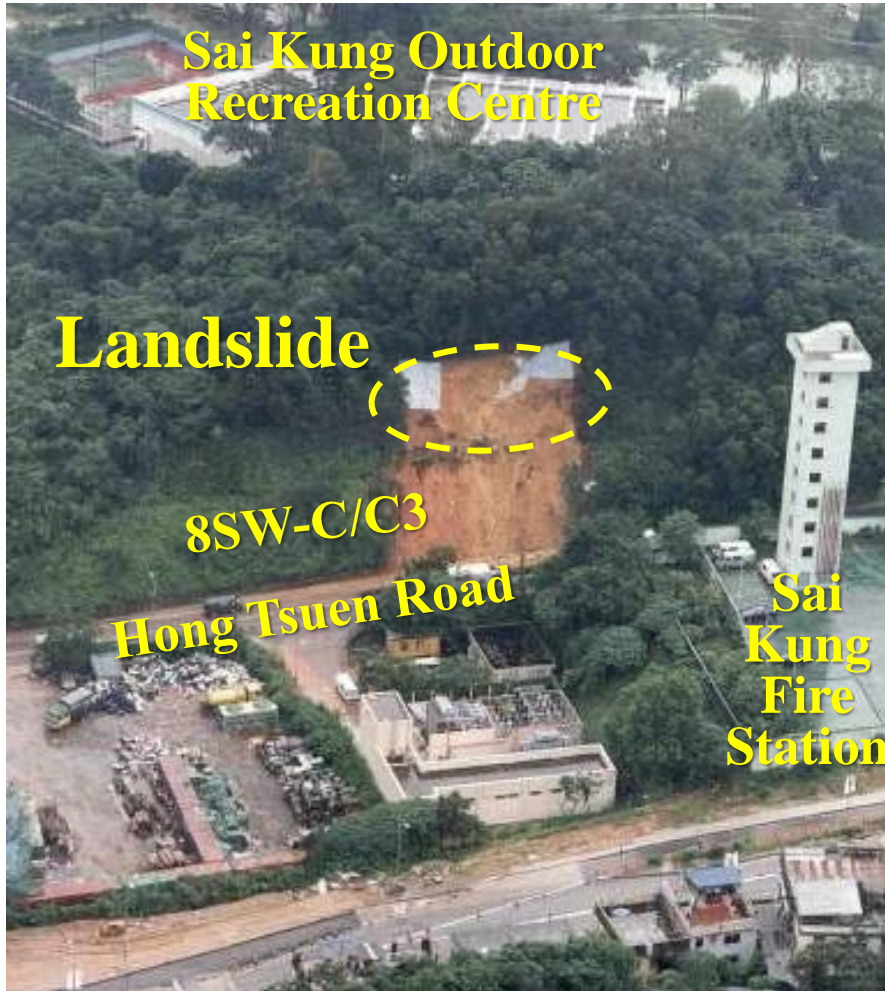
1997 Hong Tsuen Road (250 m³)

Government slope
formed in 1981
(16 yrs before 1997 landslide)

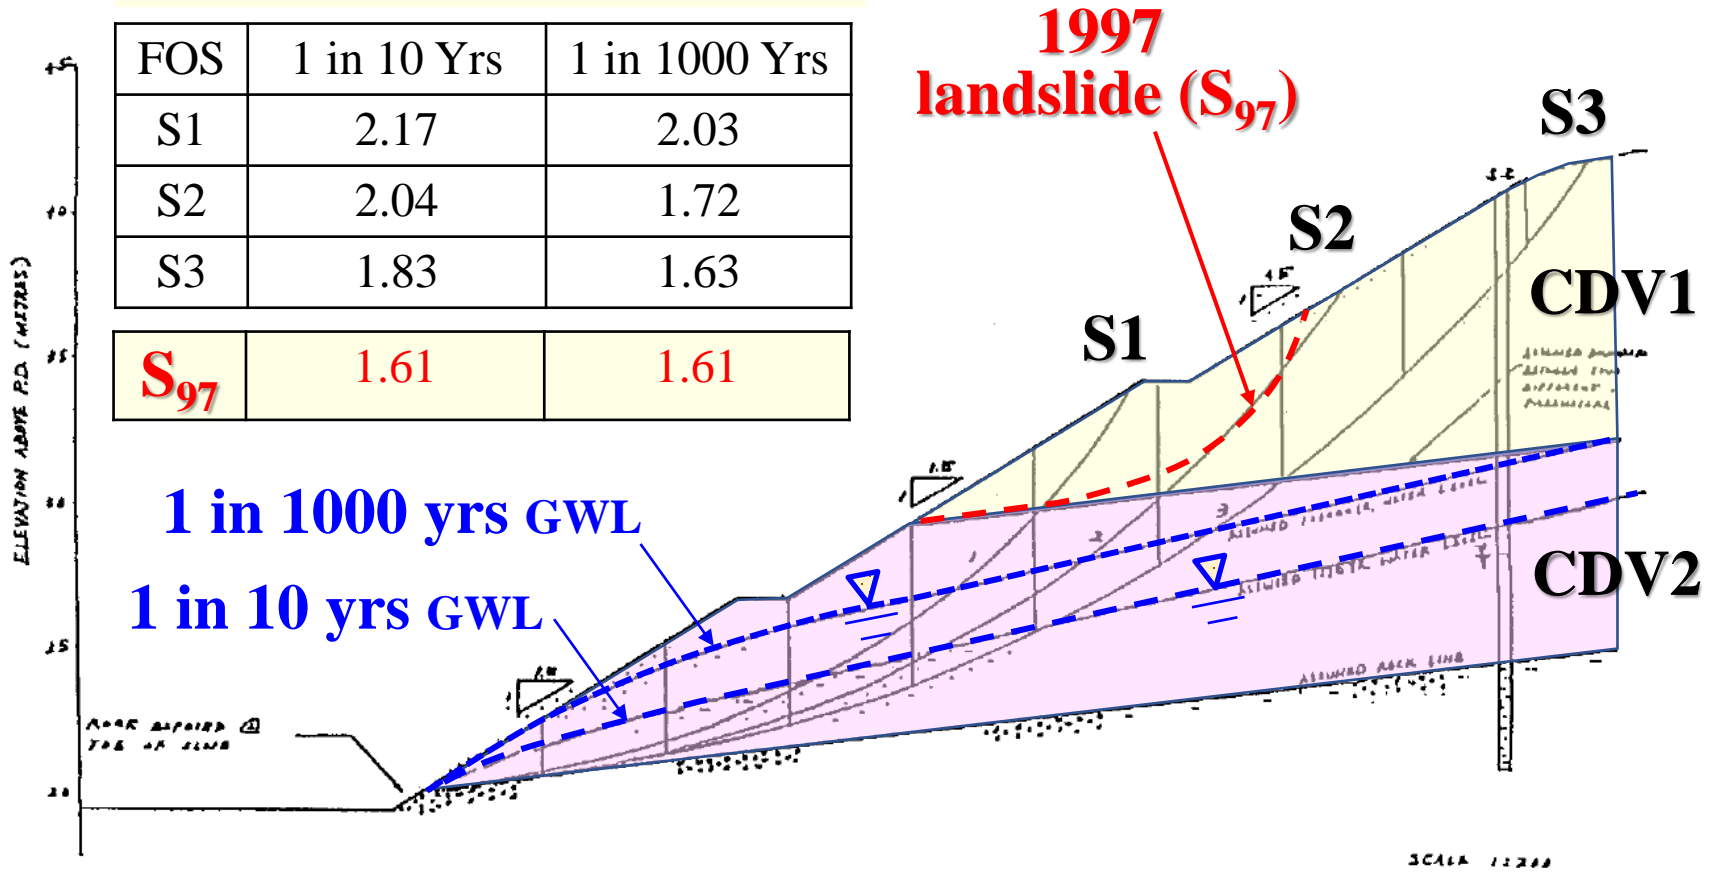
Design Cross-section

Design parameters for CDV1:
 $c' = 0$; $\phi' = 37^\circ$; $\gamma = 18 \text{ kN/m}^3$

FOS	1 in 10 Yrs	1 in 1000 Yrs
S1	2.17	2.03
S2	2.04	1.72
S3	1.83	1.63
S₉₇	1.61	1.61

Clay-rich CDV

(with low permeability bands)

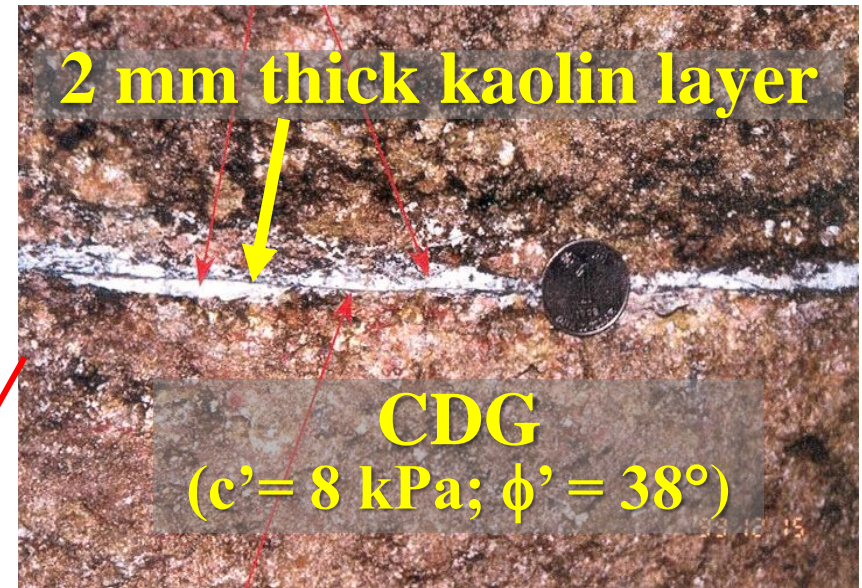
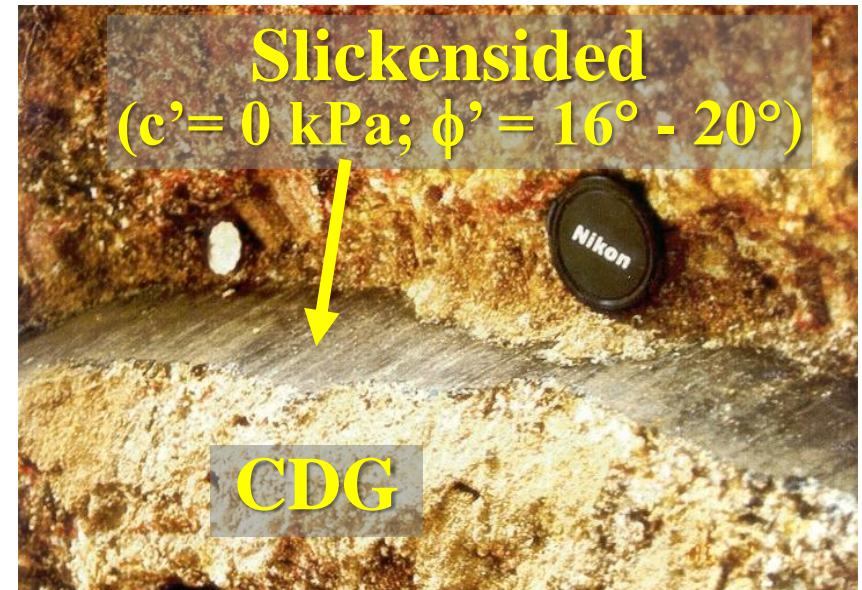
Failure controlled by Kaolin-rich discontinuities

Safety margin from original FOS = 1.4 1.6 2.0

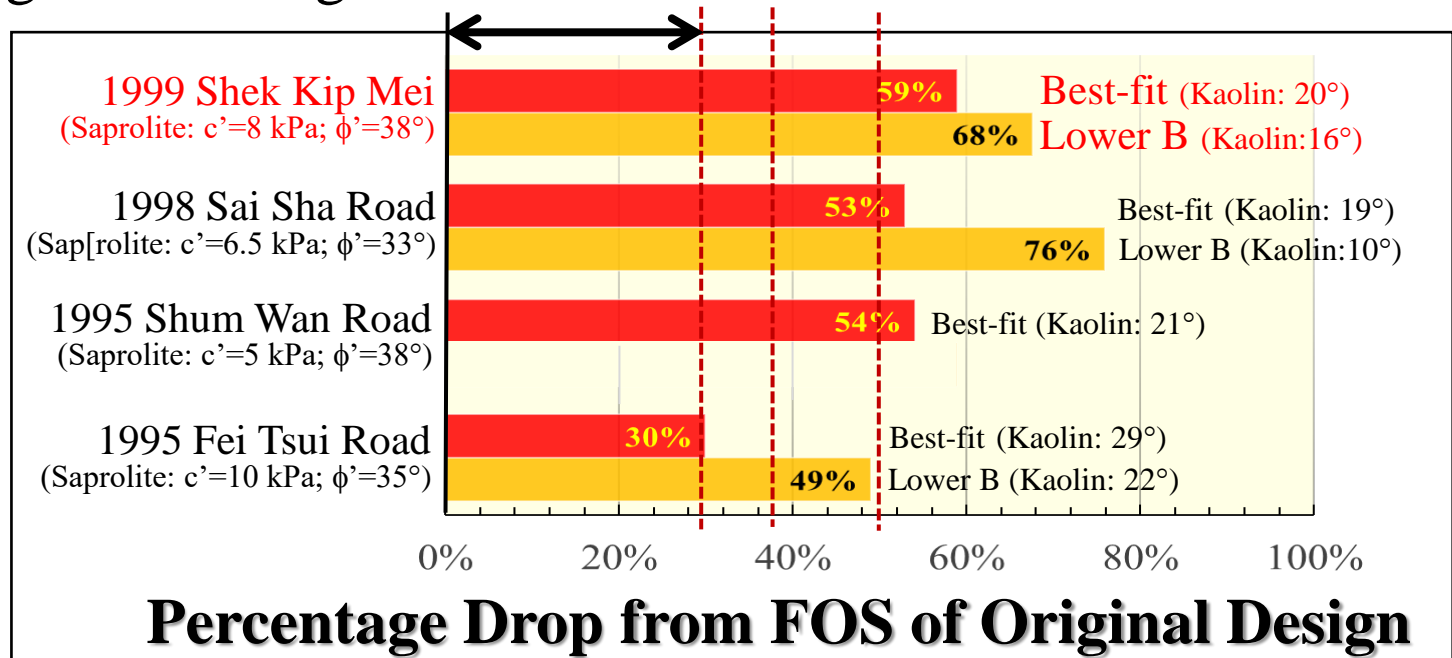
**Due to
kaolin-rich
structures**

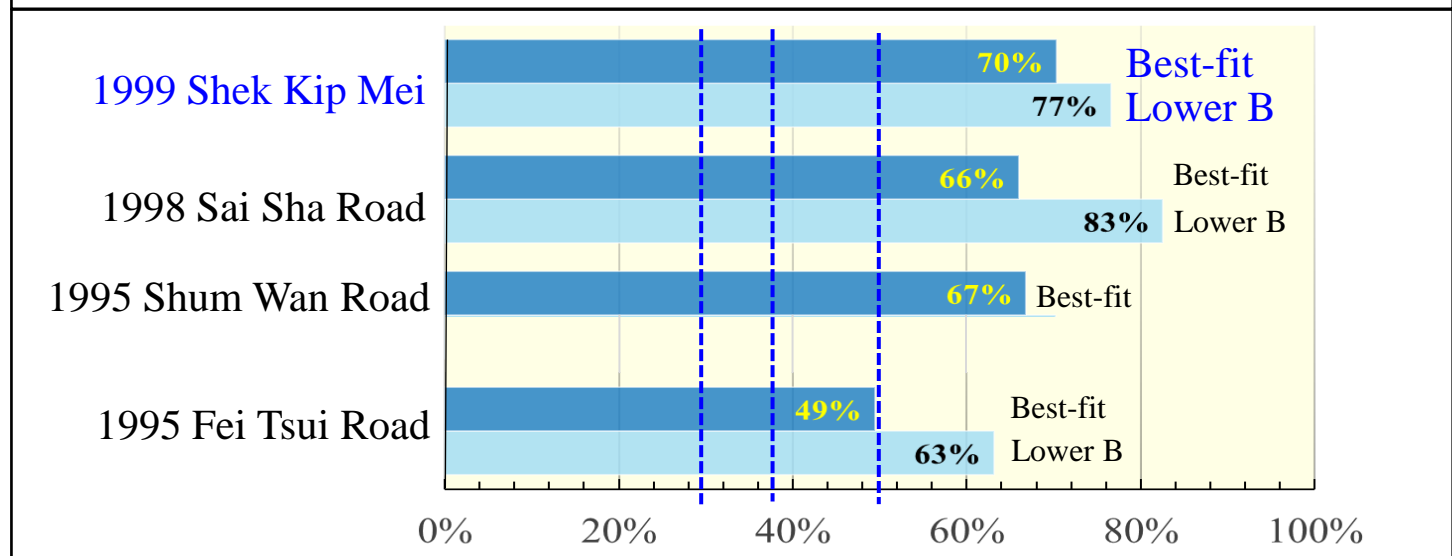
**Due to
kaolin-rich
structures
and
elevated
water level**

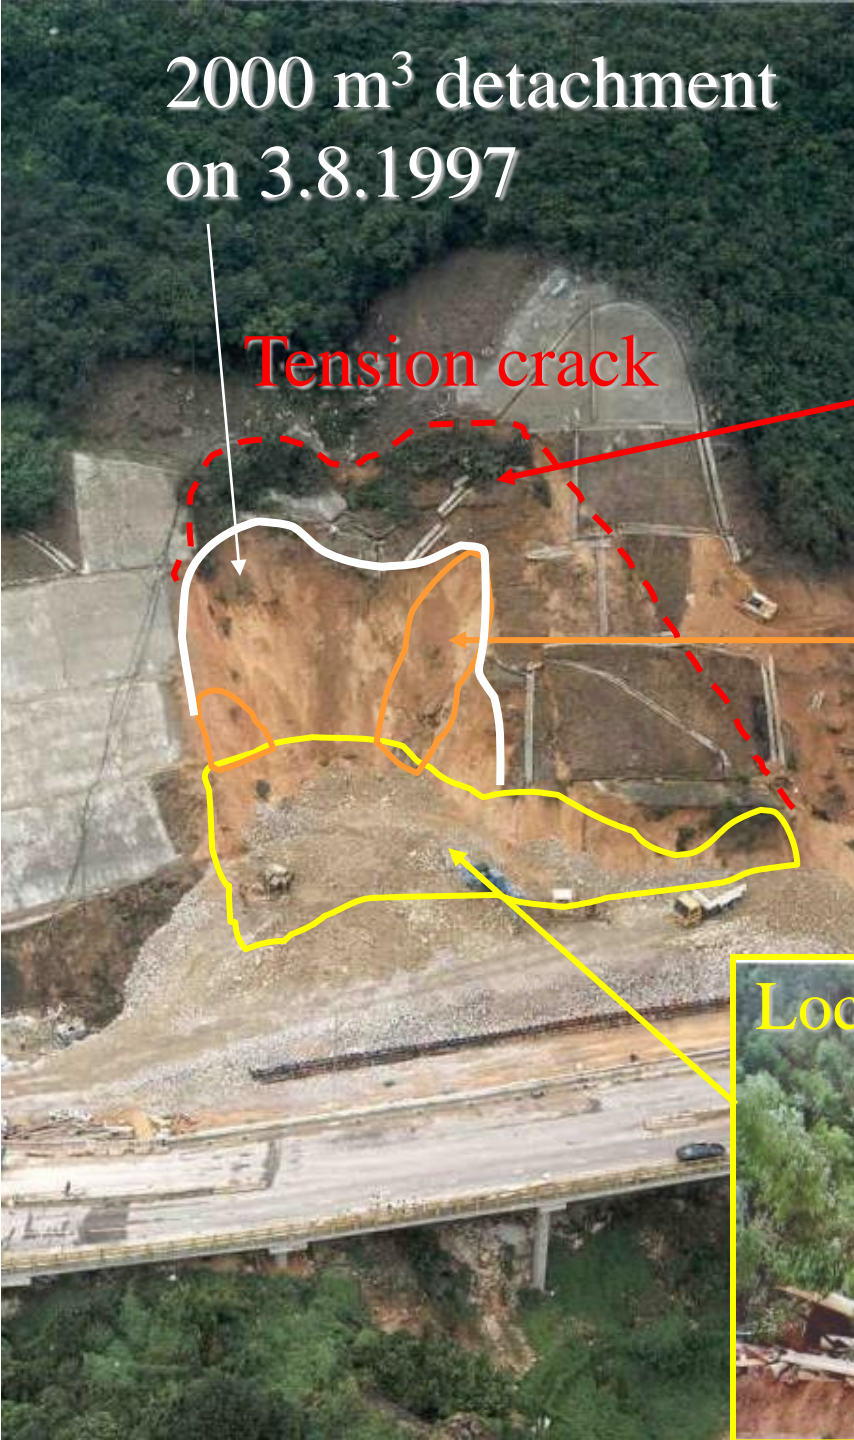
Tension crack

Tension crack (29.7.1997)

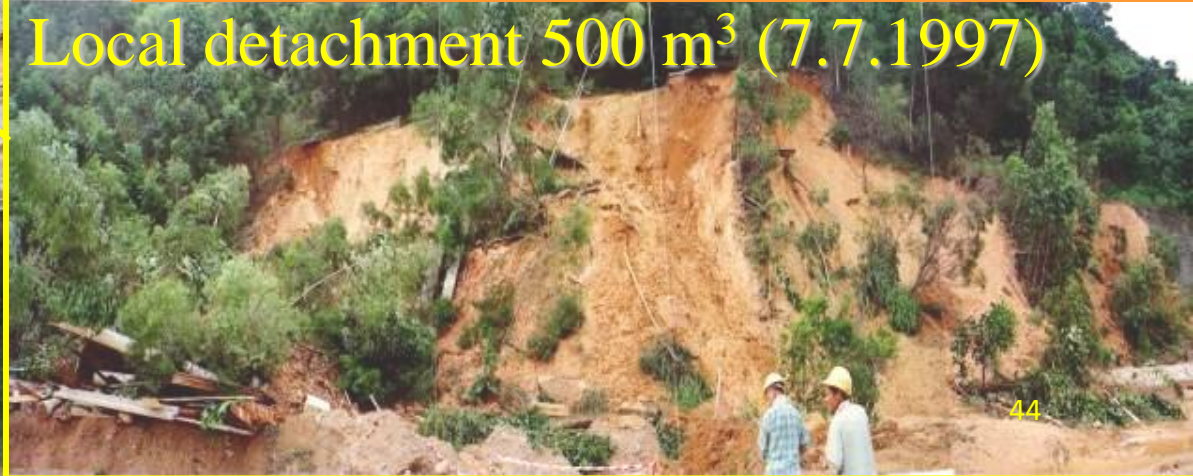
Further detachment 700 m³ (17.7.1997)

Local detachment 500 m³ (7.7.1997)

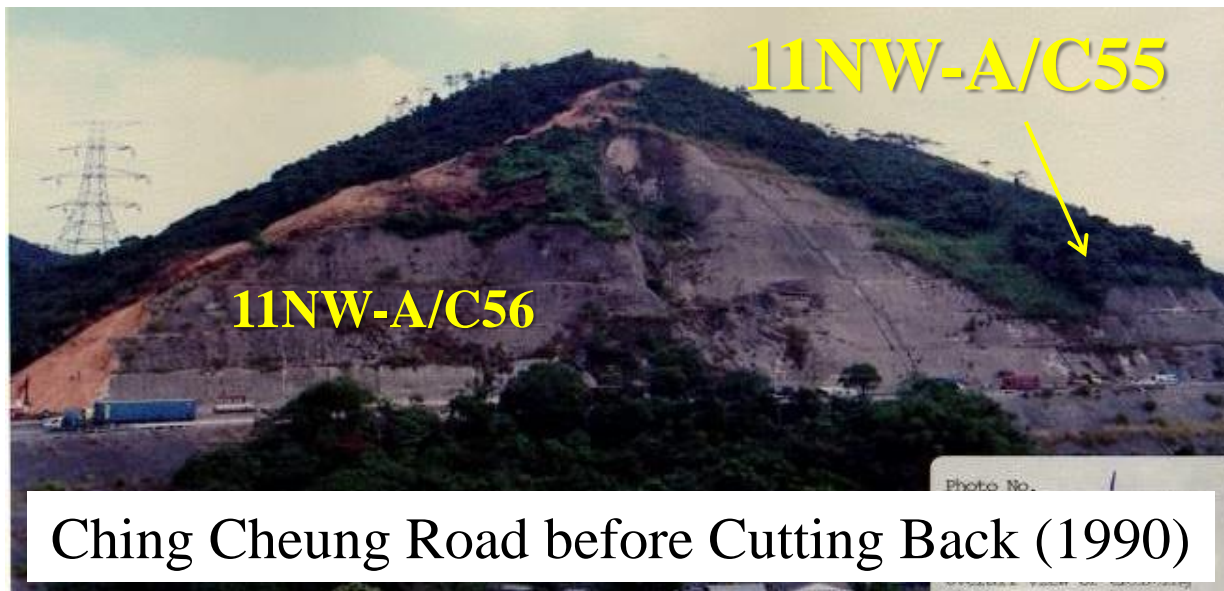
Landslip
preventive
works
(cutting back)
by GEO
in 1991-92

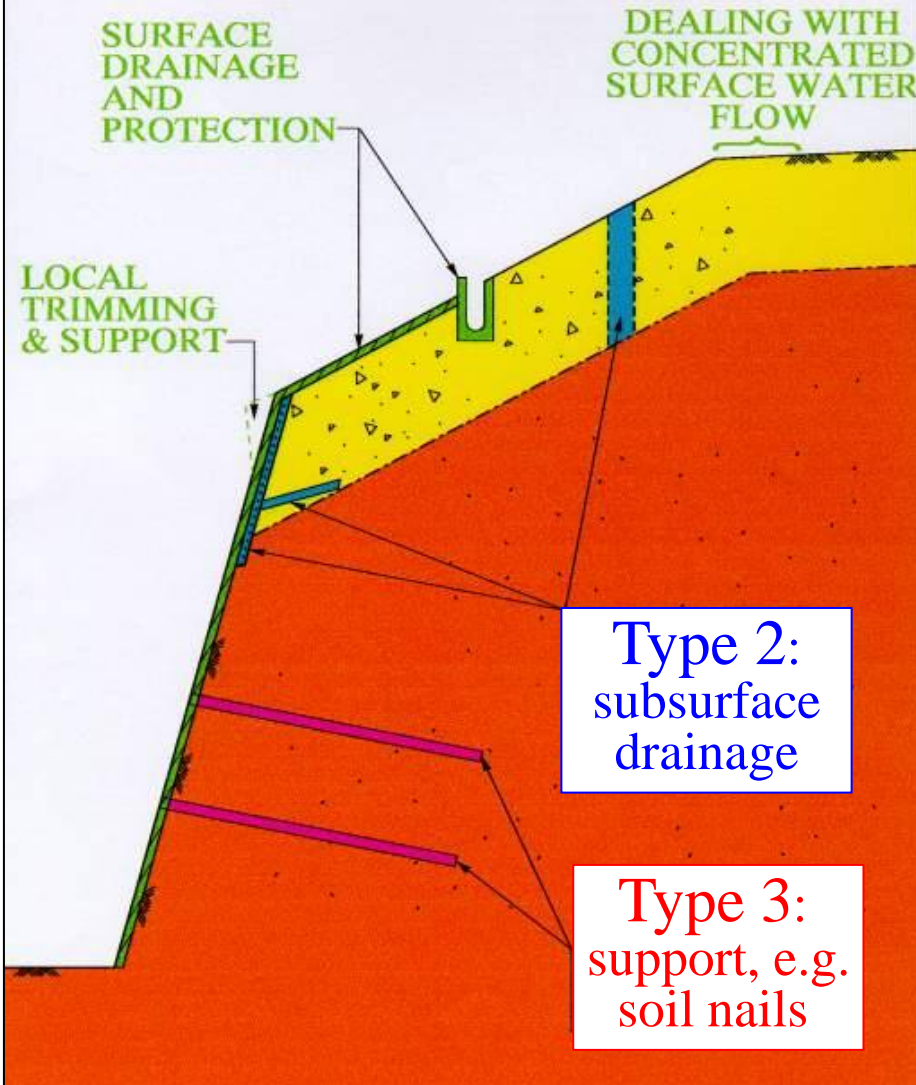
Type 1: surface drainage & protection

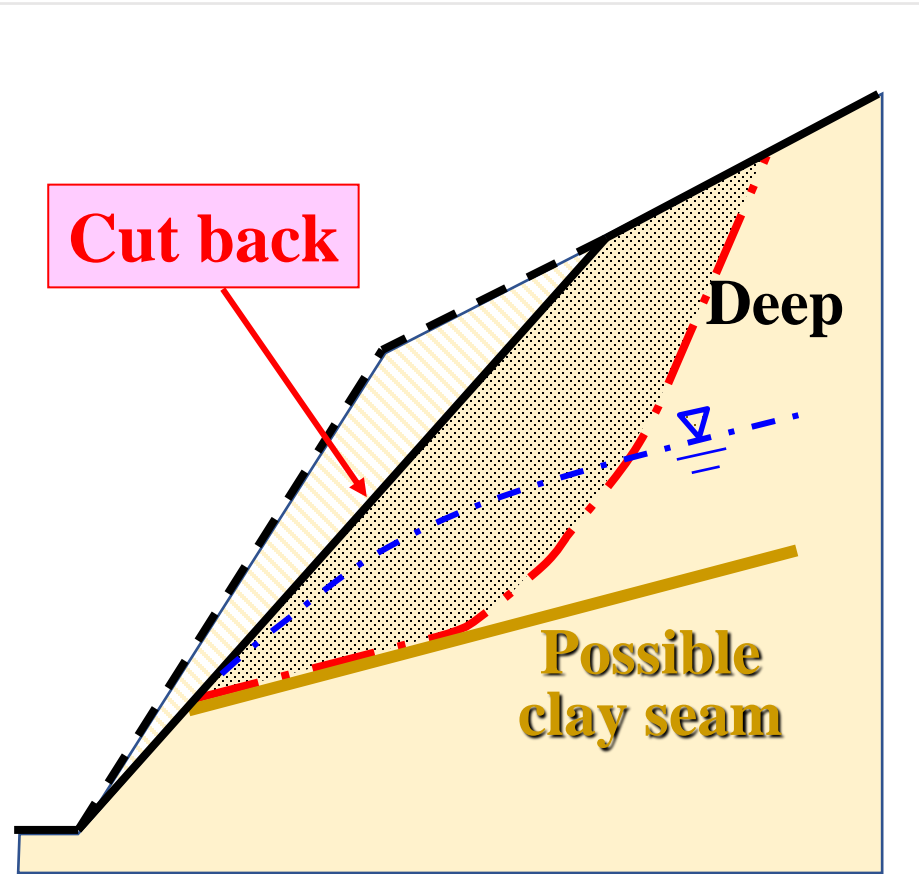
Robust Design Scheme (e.g. soil nailing)

Very sensitive to uncertainties

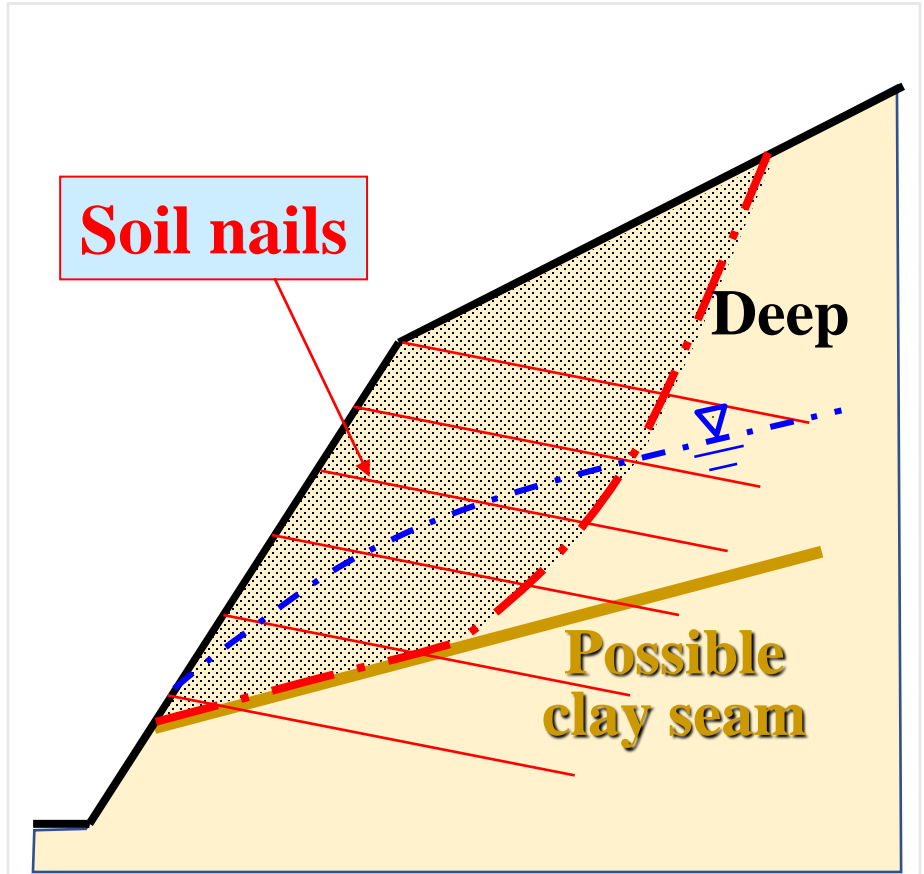
Less sensitive to uncertainties

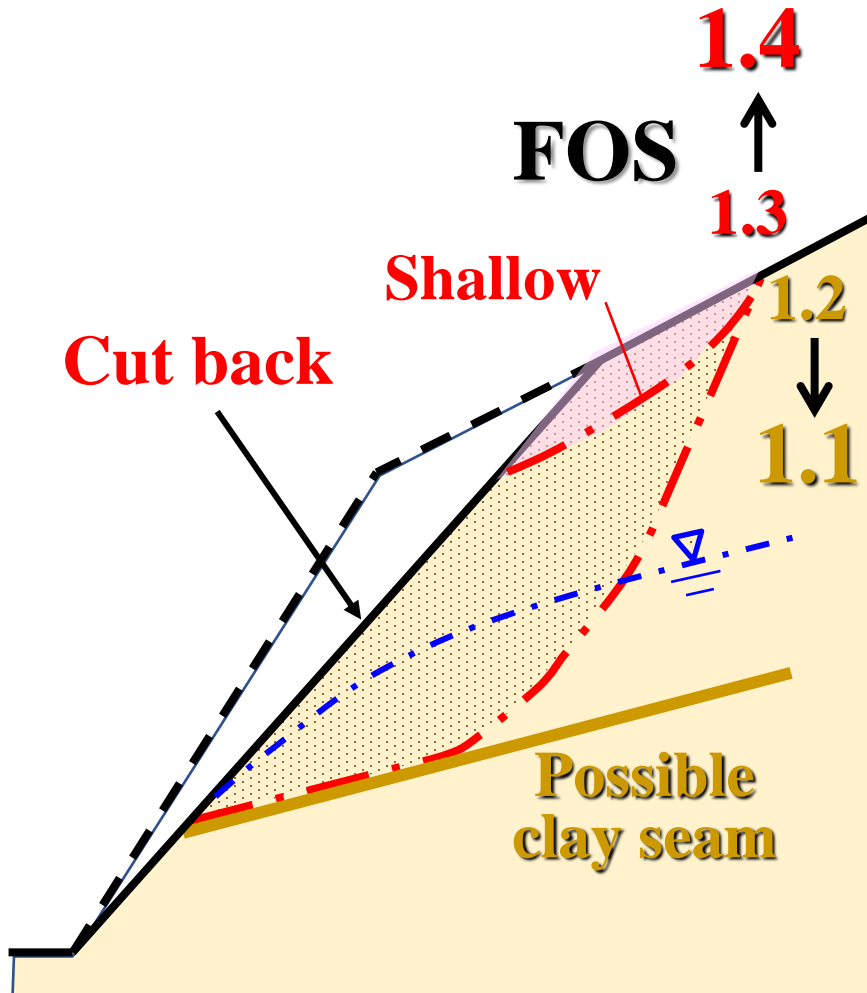
Effect of Cutting Back on FOS

**Design intent:
cut back to increase FOS**

**But:
may reduce FOS
of failure
controlled by
latent defect or
local weakness**
