THE 11TH LUMB LECTURE

Bridging the Gap between Theoretical and Actual Slope Performance

Ir Prof. WONG Hok-ning

Department of Civil Engineering
The University of Hong Kong

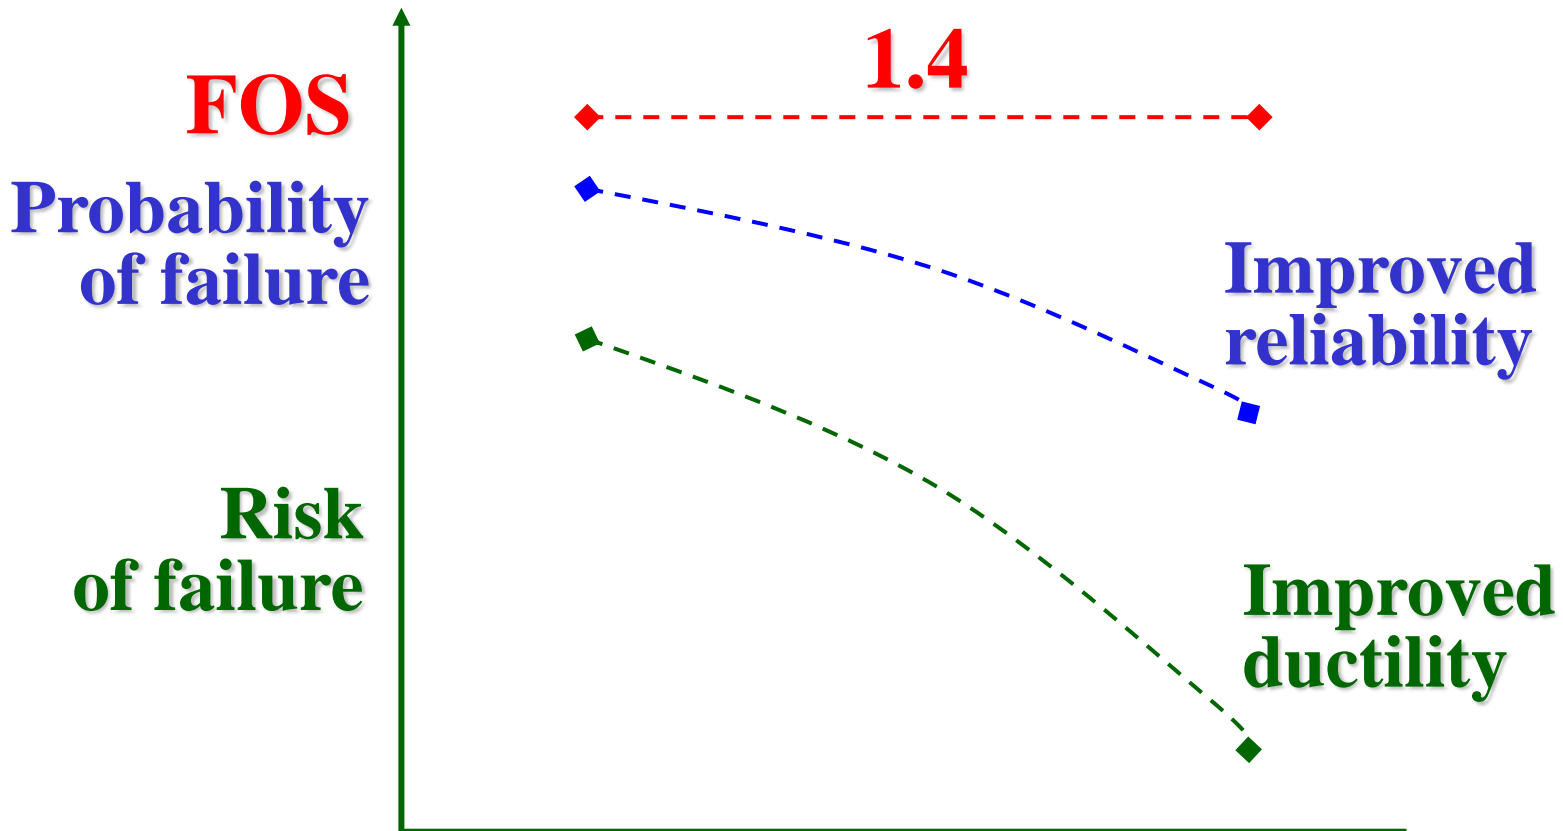
Robust scheme: soil nailing

Improved reliability:

- Less sensitive to adverse ground conditions
- Less vulnerable to local failure (large integral mass)

Improved ductility:

- Slope deformed for days/weeks before full detachment

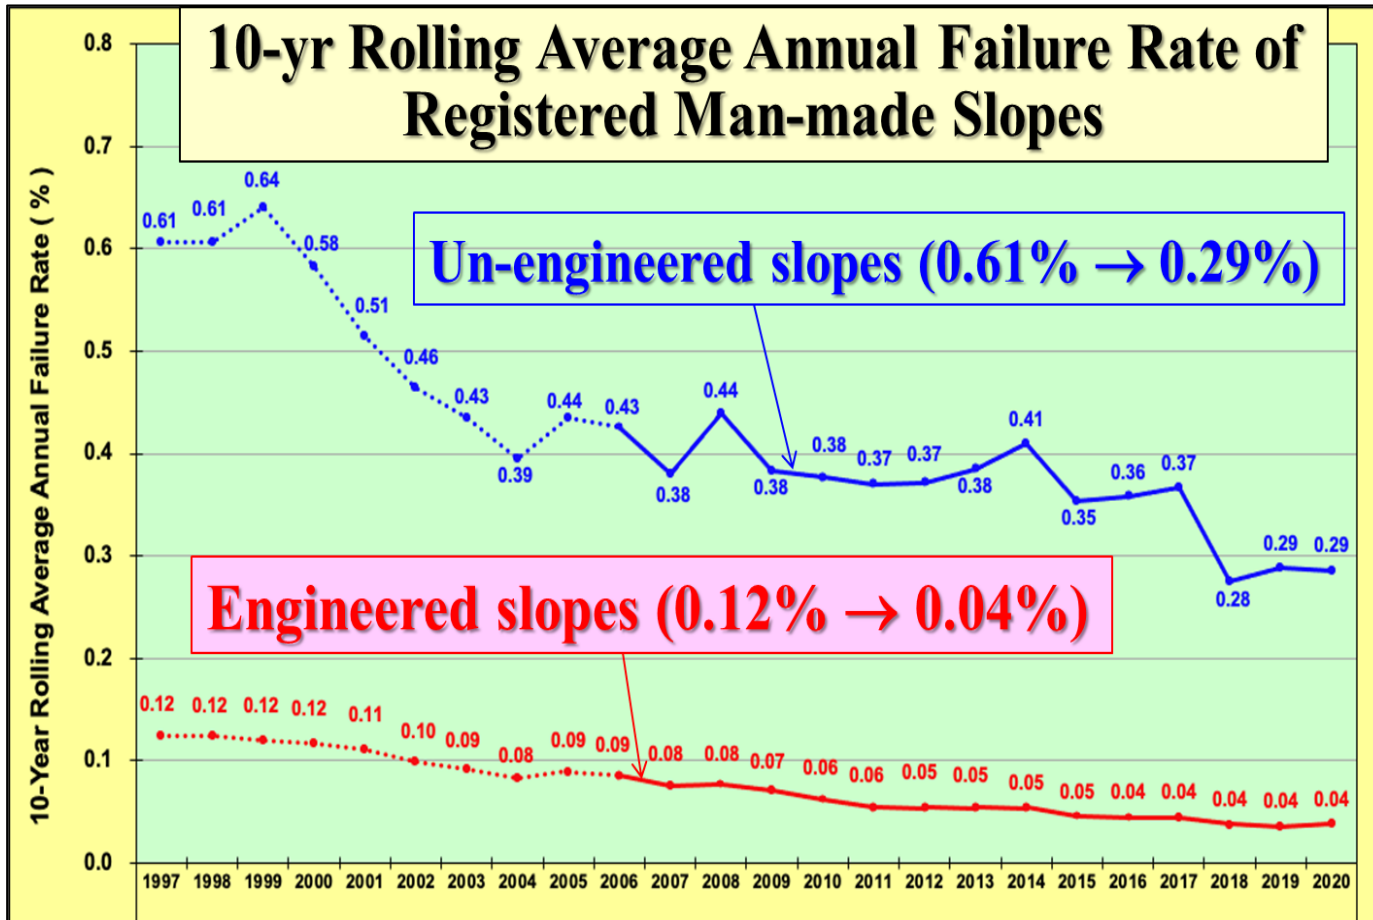
Improvement (1997 to 2020)

Note: 10-yr rolling average adopted to “even out” rainfall effects

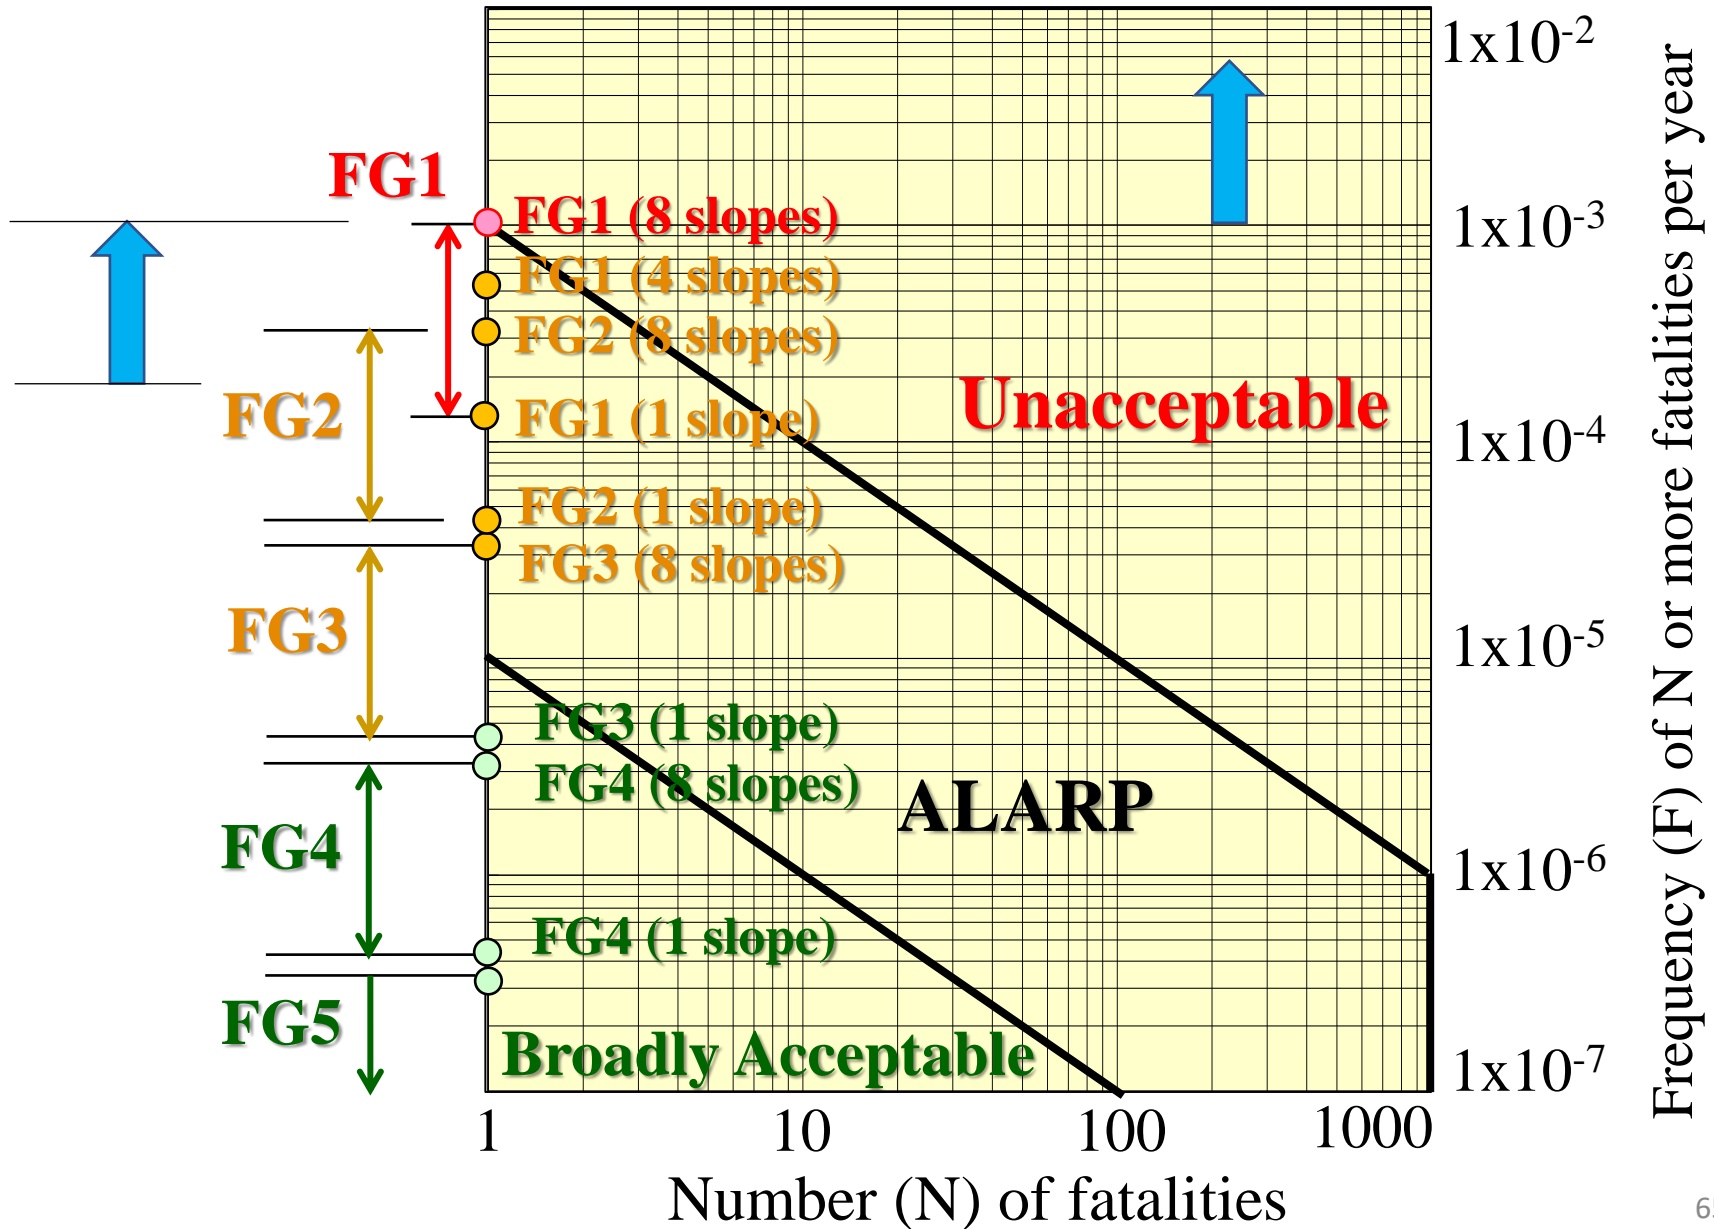
Risk of Engineered Slope Failure, PLL / yr (PLL = Potential Loss of Life)

As Low As Reasonably Practicable (ALARP)

Unacceptable

Broadly Acceptable

Note: For landslides in HK,
F at $N \geq 1$ is $\approx \frac{1}{2}$ PLL /yr

Note: Frequency in the late 1990s was ~5 times higher
