# Inspection Report

**Property Address:**  
4057 Jewel Lake Rd  
Sagle ID 83860

**Peak Inspections, Inc.**

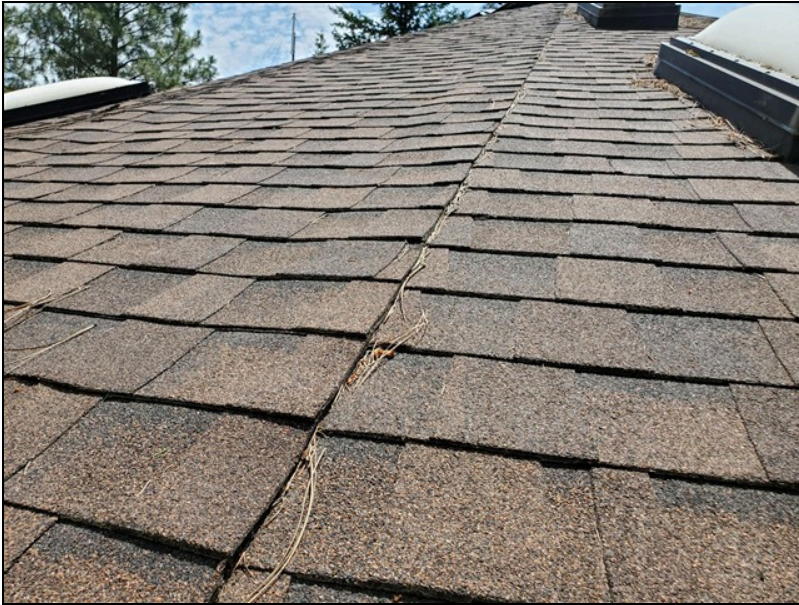
1.0 Item 1(Picture) Vertical seams

The roof appeared relatively recently installed. Due to the design of the roof there are vertical seams which can be susceptible to leakage. It may be advisable to apply sealant at these seams in the future to prevent leakage.

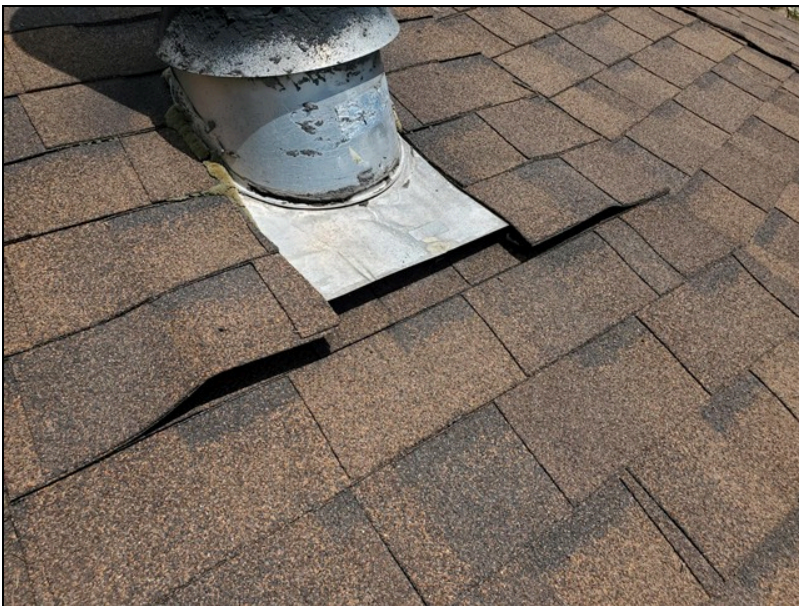
1.1 Item 1(Picture) loose flashing

Flashing has come loose below the chimney, which could lead to ice damming and leakage. The flashing and shingles should be sealed and secured to prevent leakage.

1. Flashing has come loose below the chimney, which could lead to ice damming and leakage. The flashing and shingles should be sealed and secured to prevent leakage.

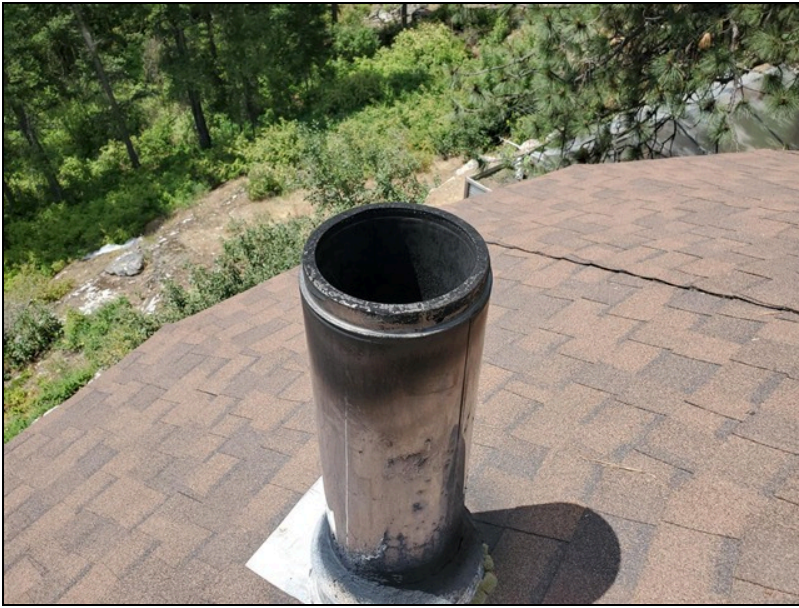
1.2 Item 1(Picture) No rain cap

(1) There was no rain cap on the wood stove chimney. I recommend a rain cap be installed.

2. (1) There was no rain cap on the wood stove chimney. I recommend a rain cap be installed.

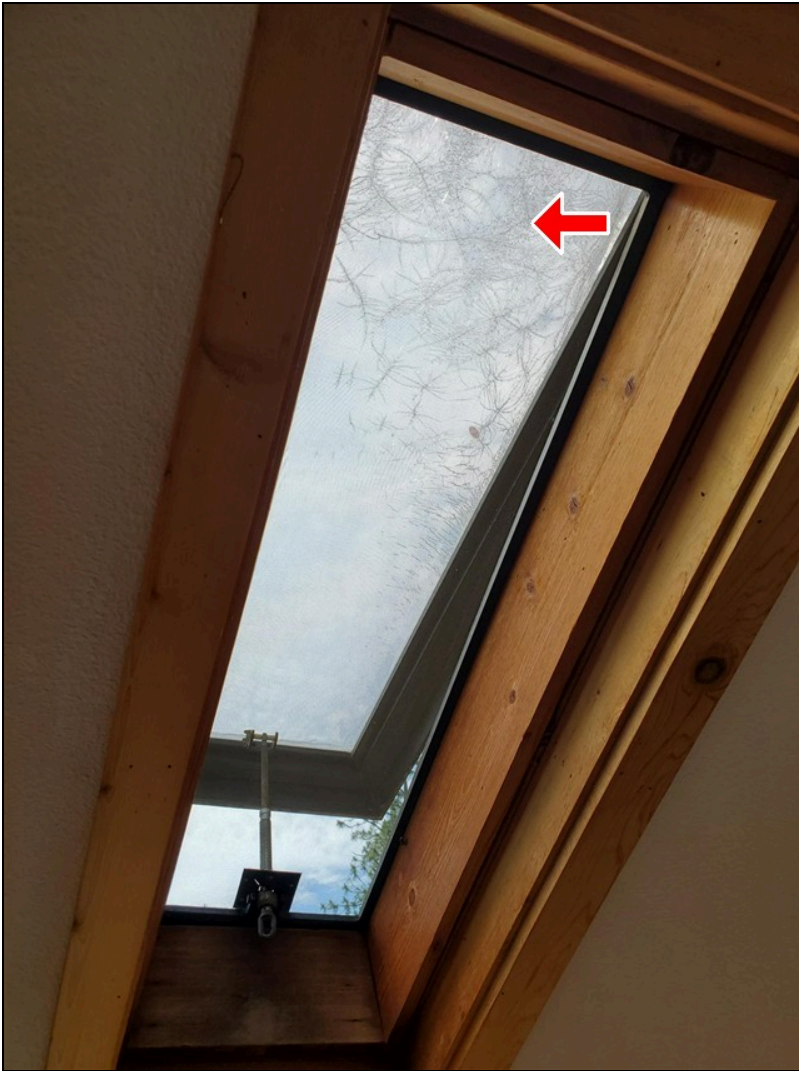
1.2 Item 2(Picture) plastic crazing

(2) Some of the skylights showed cracking or crazing of the acrylic surface. This appeared to be a cosmetic issue. There are also stains under some of the skylights indicating either prior leakage or

likely condensation.

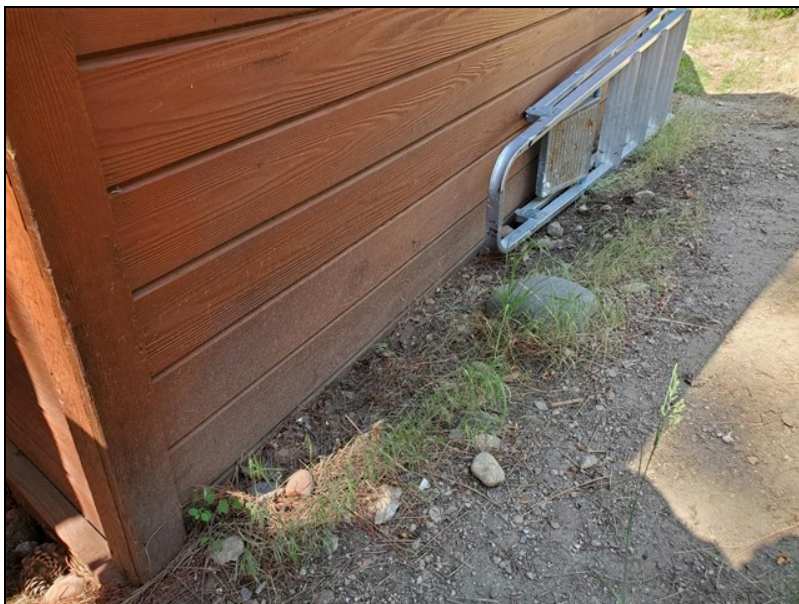
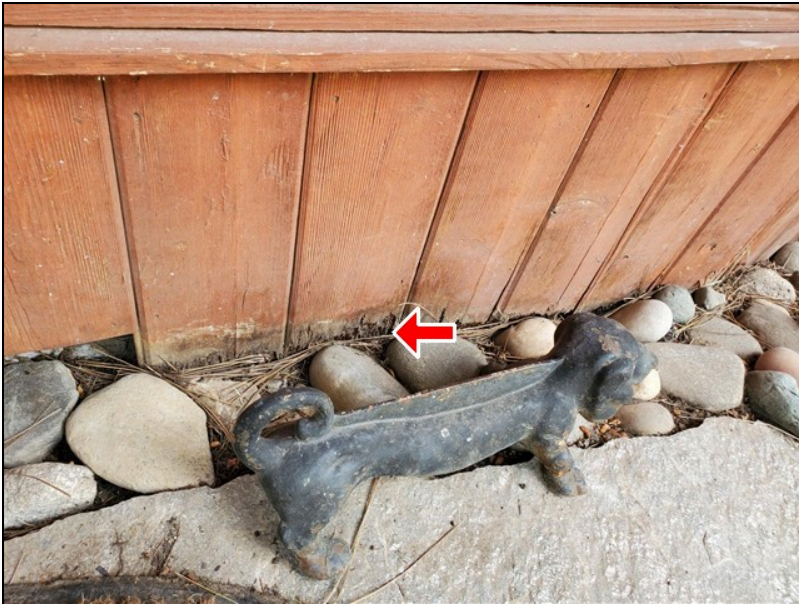
Siding is in contact with ground at front of home. Because the siding is in contact with ground it is possible for hidden damage to occur. There was damage observed to some of the vertical wood skirting that encloses the crawl space. Ideally, soil should be kept away from wood siding materials.

2.0 Item 1(Picture) Earth to wood contact

2.0 Item 2(Picture) Minor decay on skirt boards

4. Siding is in contact with ground at front of home. Because the siding is in contact with ground it is possible for hidden damage to occur. There was damage observed to some of the vertical wood skirting that encloses the crawl space. Ideally, soil should be kept away from wood siding materials.

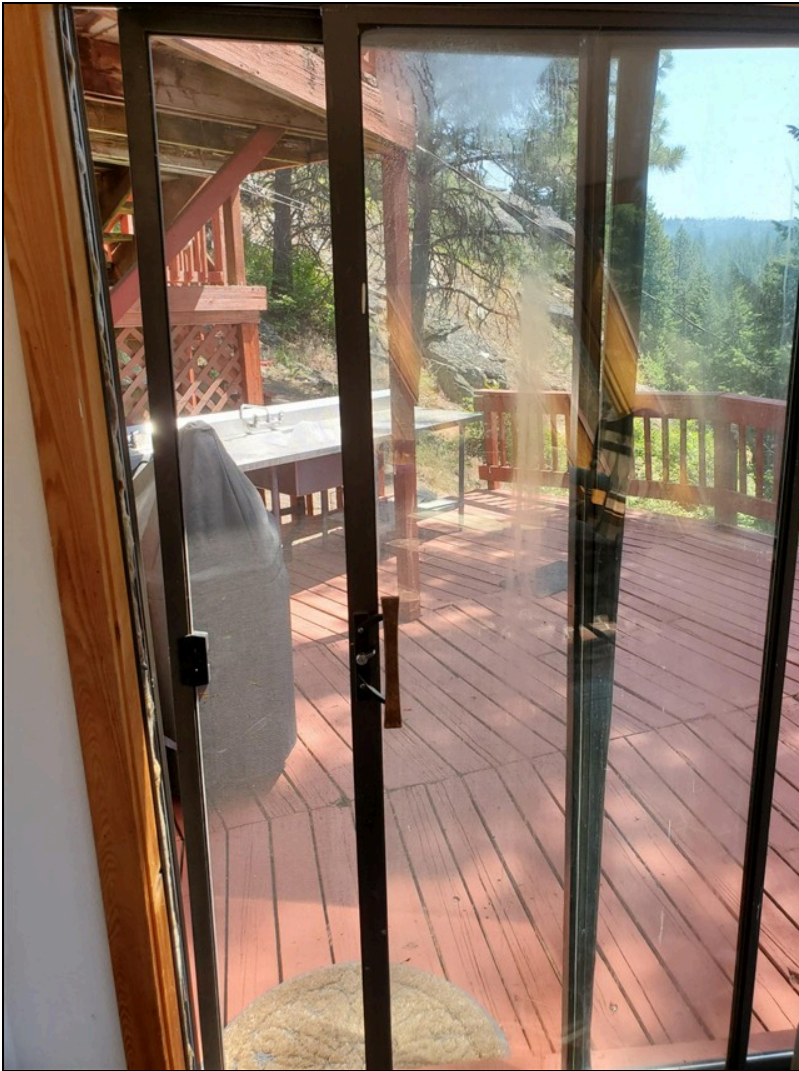
2.1 Item 1(Picture) Cloudy window in door

(1) The sliding glass door at the East End of the sunroom did not shut as the door frame was out of square. Also, one of the glass units was cloudy (lost seal). In order to correct the cloudy appearance of

glass, a replacement of glass pane or the unit will be necessary. Repairs are recommended.

5. (1) The sliding glass door at the East End of the sunroom did not shut as the door frame was out of square. Also, one of the glass units was cloudy (lost seal). In order to correct the cloudy appearance of glass, a replacement of glass pane or the unit will be necessary. Repairs are recommended.
6. (2) The Sliding glass doors at the upstairs bedroom was missing lock hardware. A qualified person should repair or replace as needed.

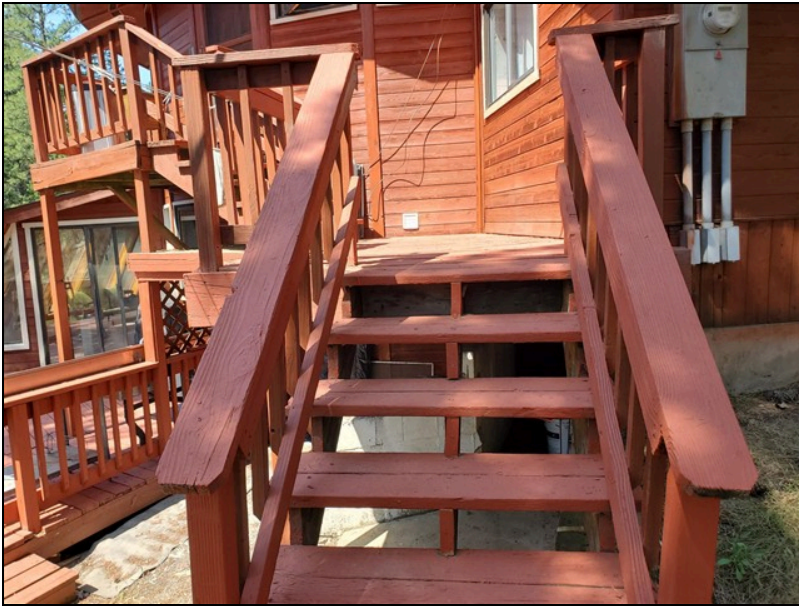
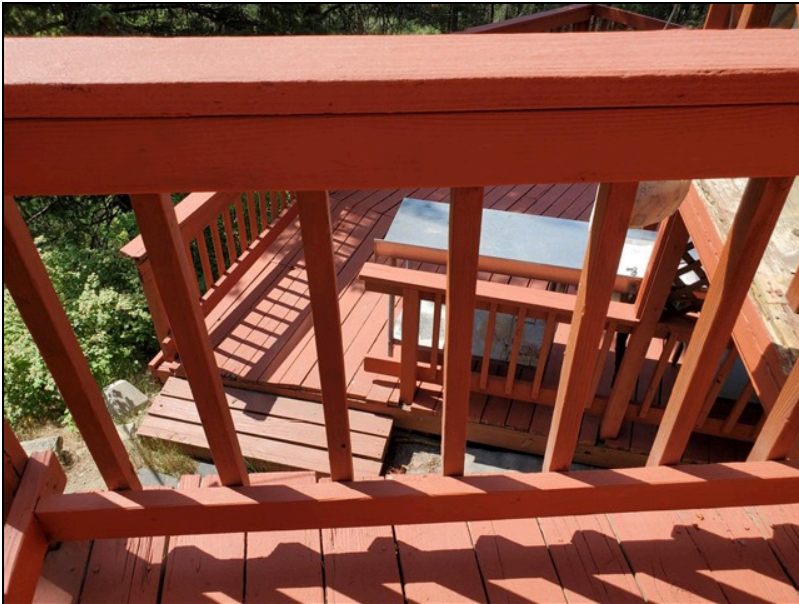
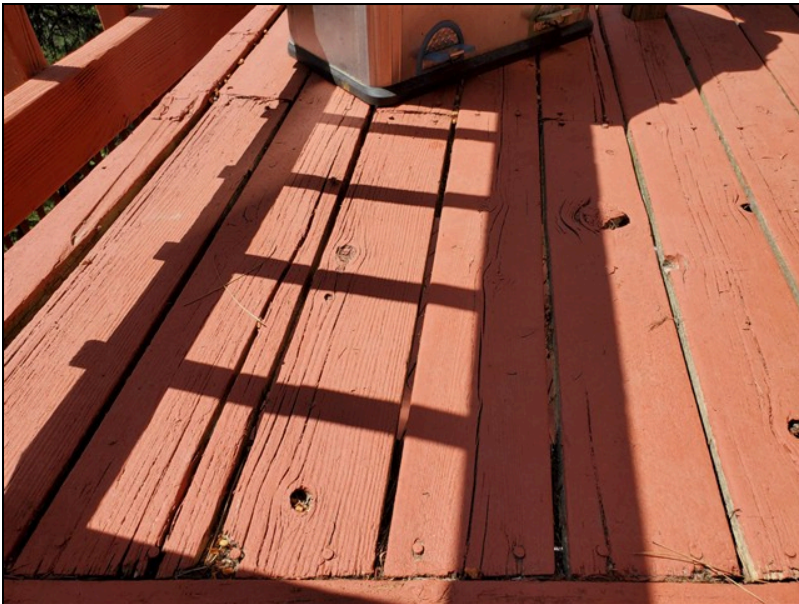
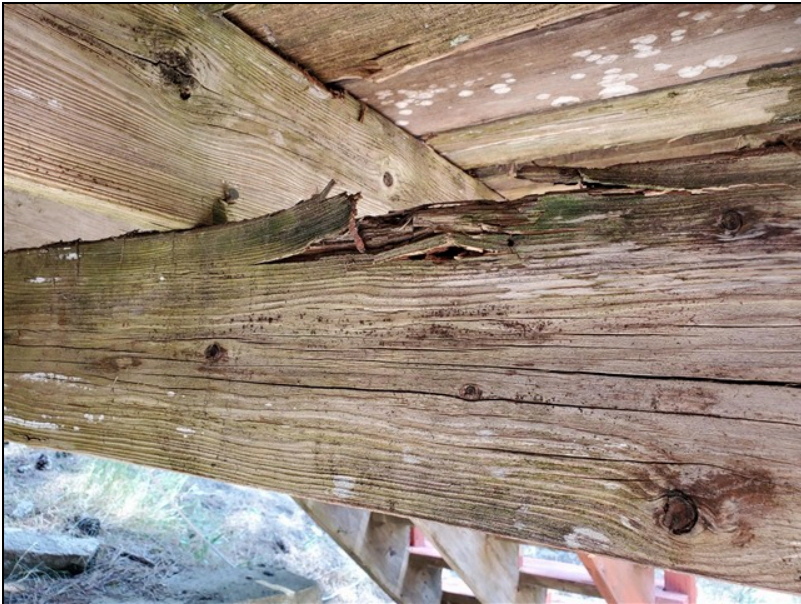
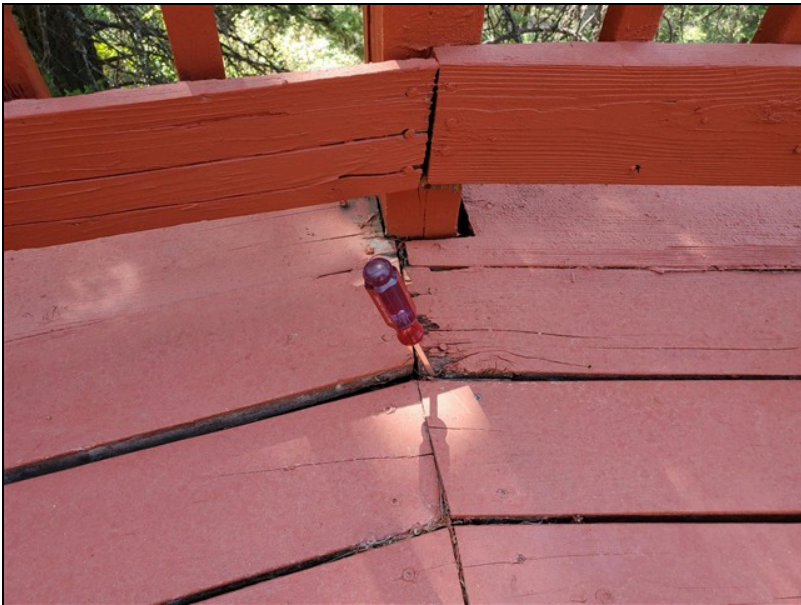
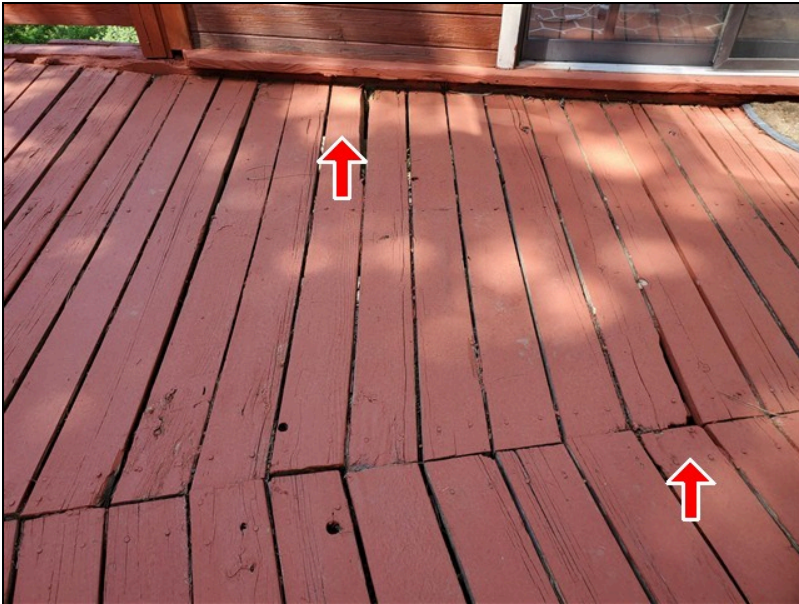
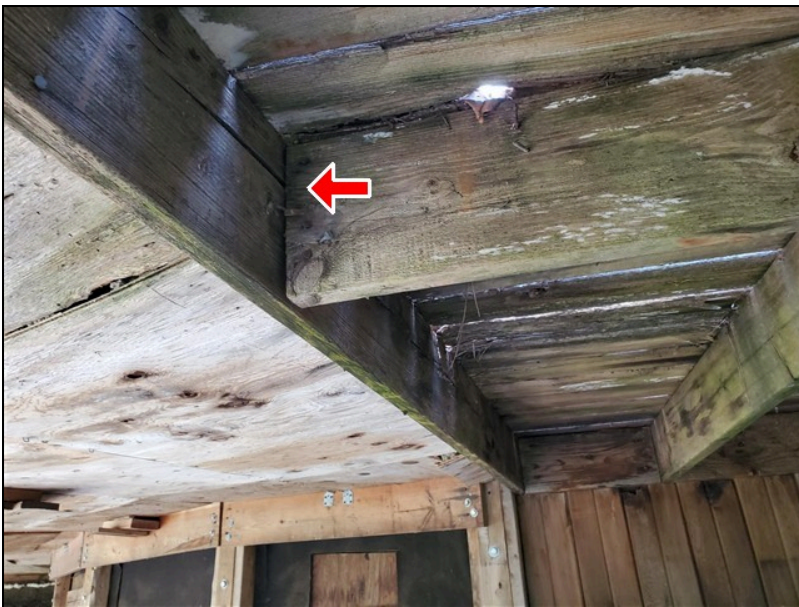
The two decks on the SE side of the home had loose railings and decking and structure were deteriorated in a number of areas. A general replacement is likely needed. Hidden damage at the

house wall may be revealed when removing the deck. Contact a qualified contractor for estimates.

2.3 Item 1(Picture) Loose railings

2.3 Item 2(Picture) Rail openings larger than 4" unsafe for children

2.3 Item 3(Picture) Decay

2.3 Item 4(Picture) decay

2.3 Item 5(Picture) decay

2.3 Item 6(Picture) deck decay

2.3 Item 7(Picture) connection loose

3. The two decks on the SE side of the home had loose railings and decking and structure were deteriorated in a number of areas. A general replacement is likely needed. Hidden damage at the house wall may be revealed when removing the deck. Contact a qualified contractor for estimates.

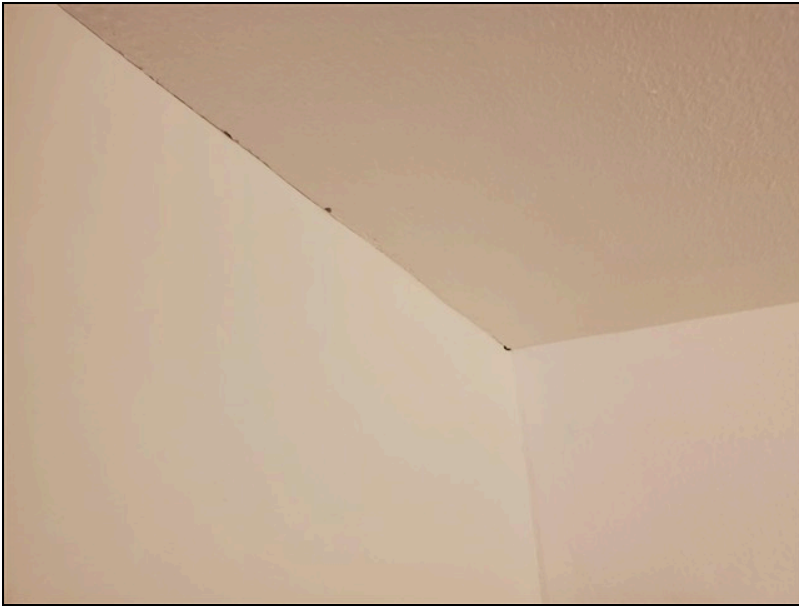
3.1 Item 1(Picture) crack

Minor drywall cracking and flaws were observed in several locations. Improvements can be undertaken

as needed prior to painting.

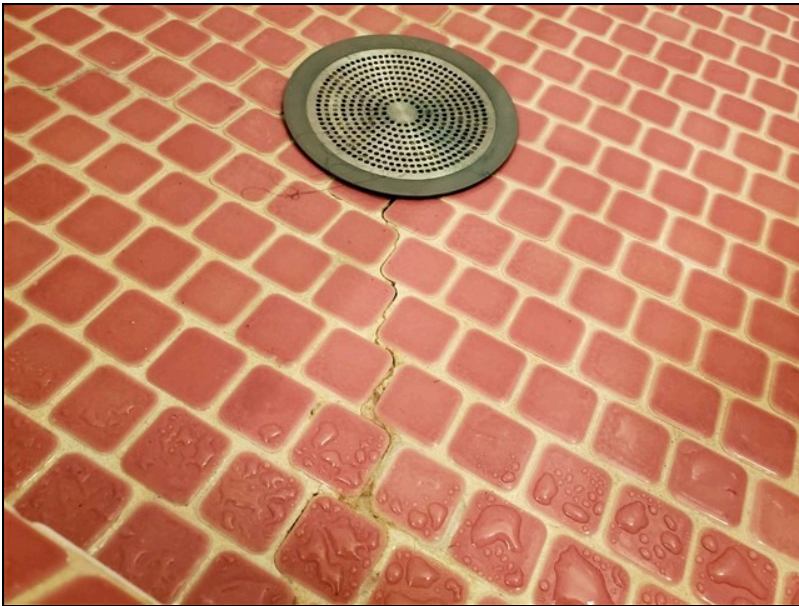
3.2 Item 1(Picture) Cracked grout

Tile at shower pan has cracked grout in the lower level bath. Repairs are needed to prevent water damage to shower/bath. A qualified person should repair or replace as needed.

7. Tile at shower pan has cracked grout in the lower level bath. Repairs are needed to prevent water damage to shower/bath. A qualified person should repair or replace as needed.

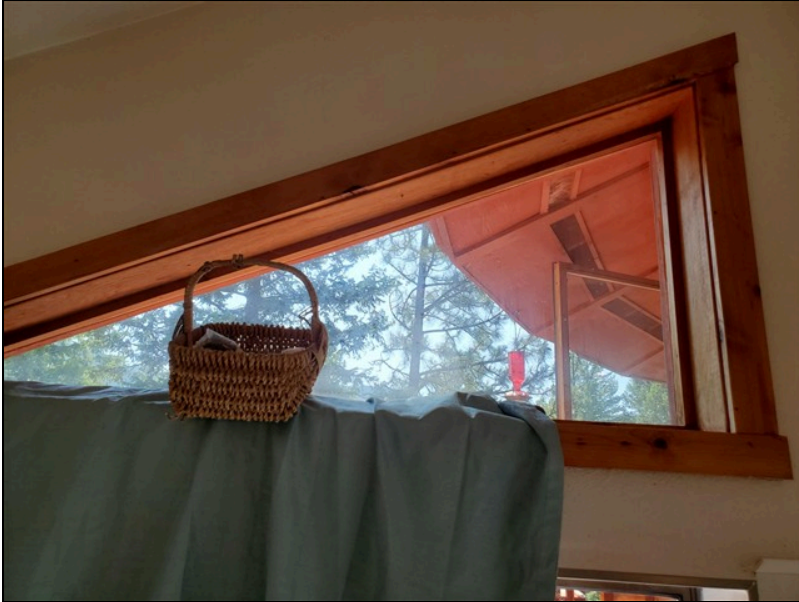
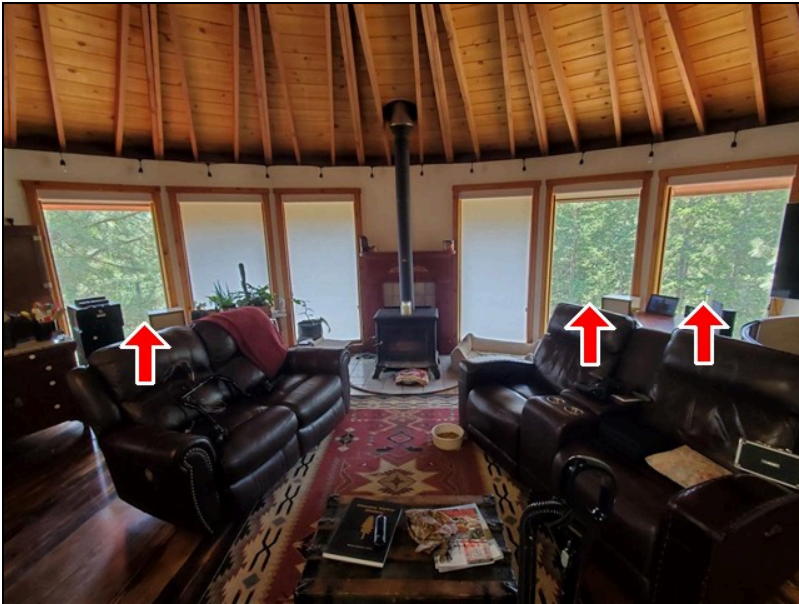
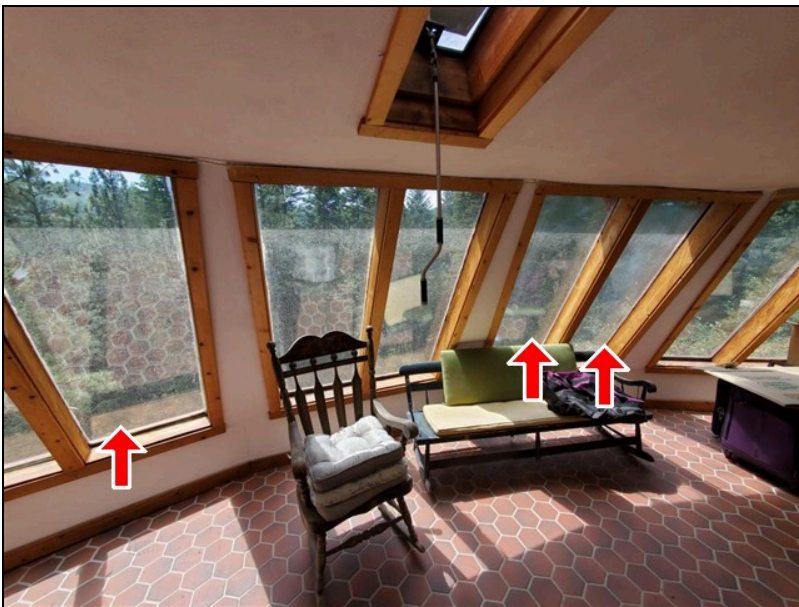
(1) A number of windows were cloudy (lost seal) in the living room, upper level bath, sunroom and downstairs bedroom. In order to correct the cloudy appearance of glass, a replacement of glass pane or the unit will be necessary. A qualified contractor should replace as needed. Upon cleaning, other cloudy windows may be revealed.

3.6 Item 1(Picture) Cloudy window in upstairs bathroom

3.6 Item 2(Picture) cloudy in living room

3.6 Item 3(Picture) Cloudy windows in sunroom

8. (1) A number of windows were cloudy (lost seal) in the living room, upper level bath, sunroom and downstairs bedroom. In order to correct the cloudy appearance of glass, a replacement of glass pane or the unit will be necessary. A qualified contractor should replace as needed. Upon cleaning, other cloudy windows may be revealed.
9. (2) Casement windows in the kitchen and lower level bedroom did not close fully when operated. Adjustments may help improve window operation.

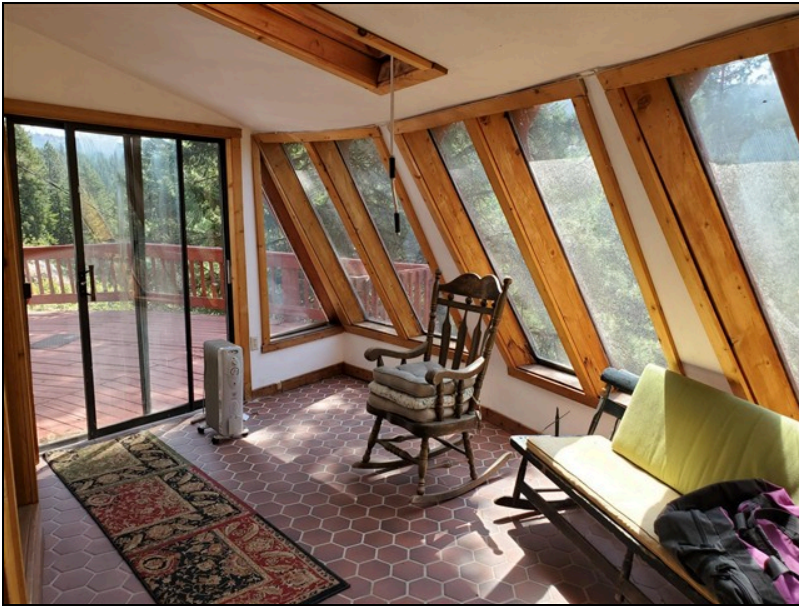
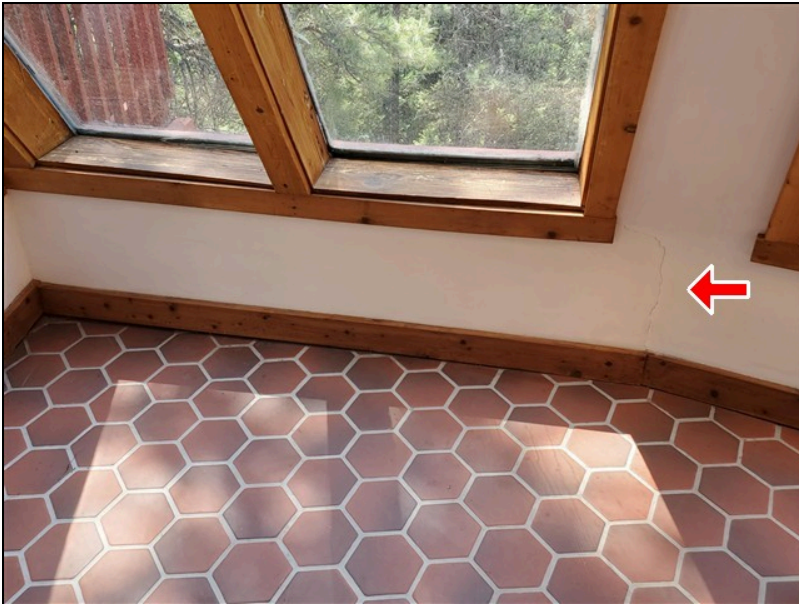
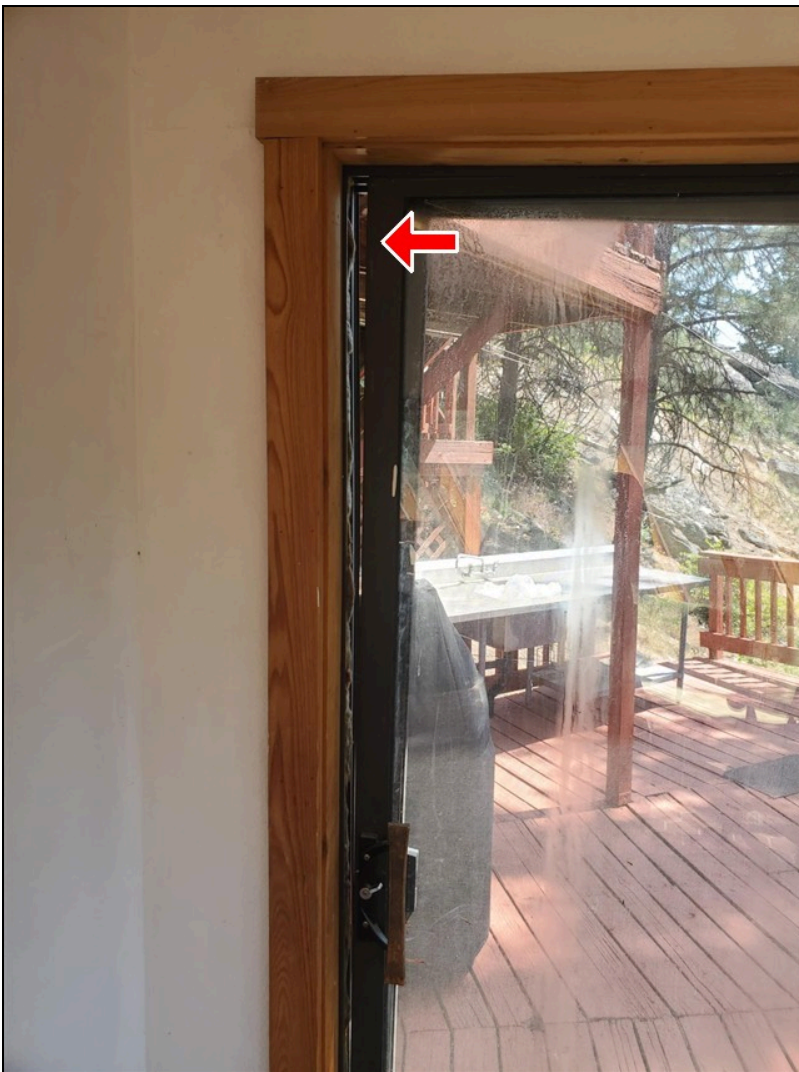
(1) The sunroom has settled noticeably. It is not known if this movement is ongoing or if it has been corrected as there were newer wood support posts under the room. A qualified contractor should

inspect and repair as needed.

4.2 Item 1(Picture) Signs of settlement- Floor slopes

4.2 Item 2(Picture) cracks

4.2 Item 3(Picture) doorway not square

10. (1) The sunroom has settled noticeably. It is not known if this movement is ongoing or if it has been corrected as there were newer wood support posts under the room. A qualified contractor should inspect and repair as needed.

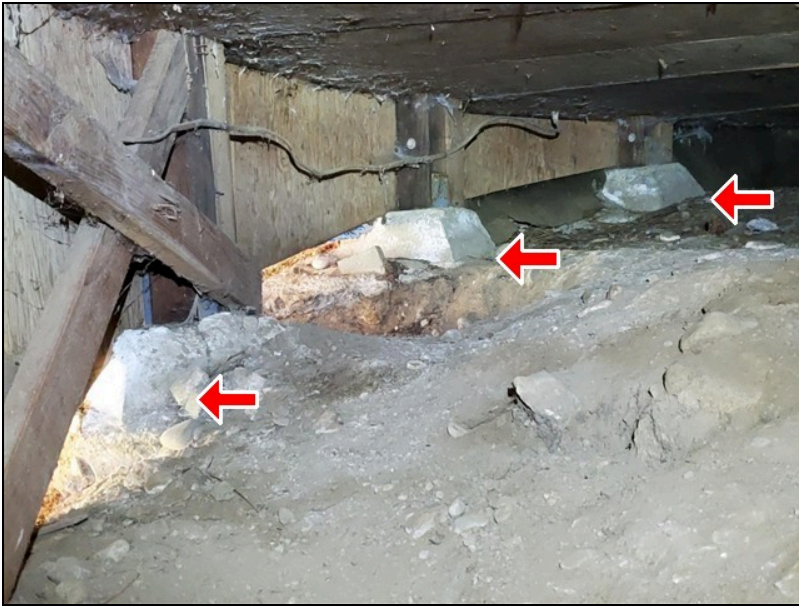
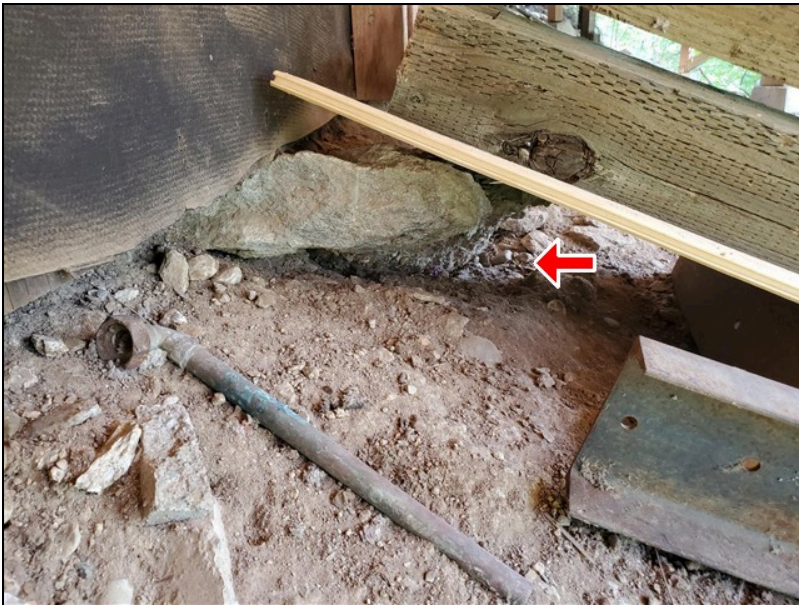
(2) The home is supported on wood post which rest on concrete pads. Because of the steep nature of the lot, some erosion has occurred under the concrete pads. No significant movement was observed in

the home however some backfilling around the foundation pads would be advisable.

4.2 Item 4(Picture) piers

4.2 Item 5(Picture) erosion below pier

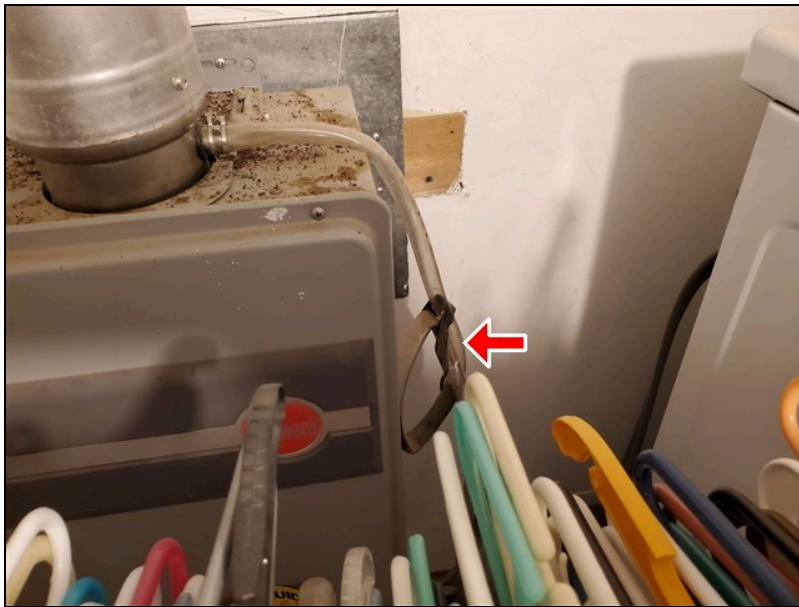
5.2 Item 1(Picture) condensate drain blocked

(1) The condensate drain for the vent on the water heater was kinked and not connected to a drain. The drain tube should be run into the adjacent waste pipe for the washing machine.

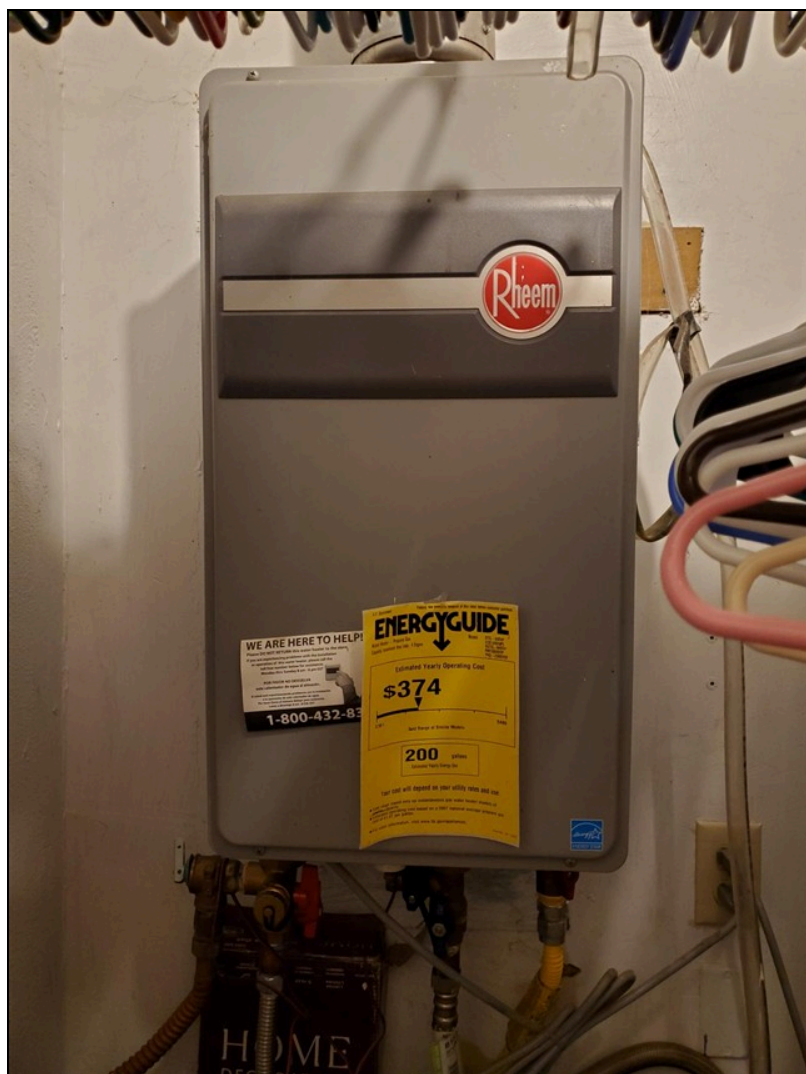
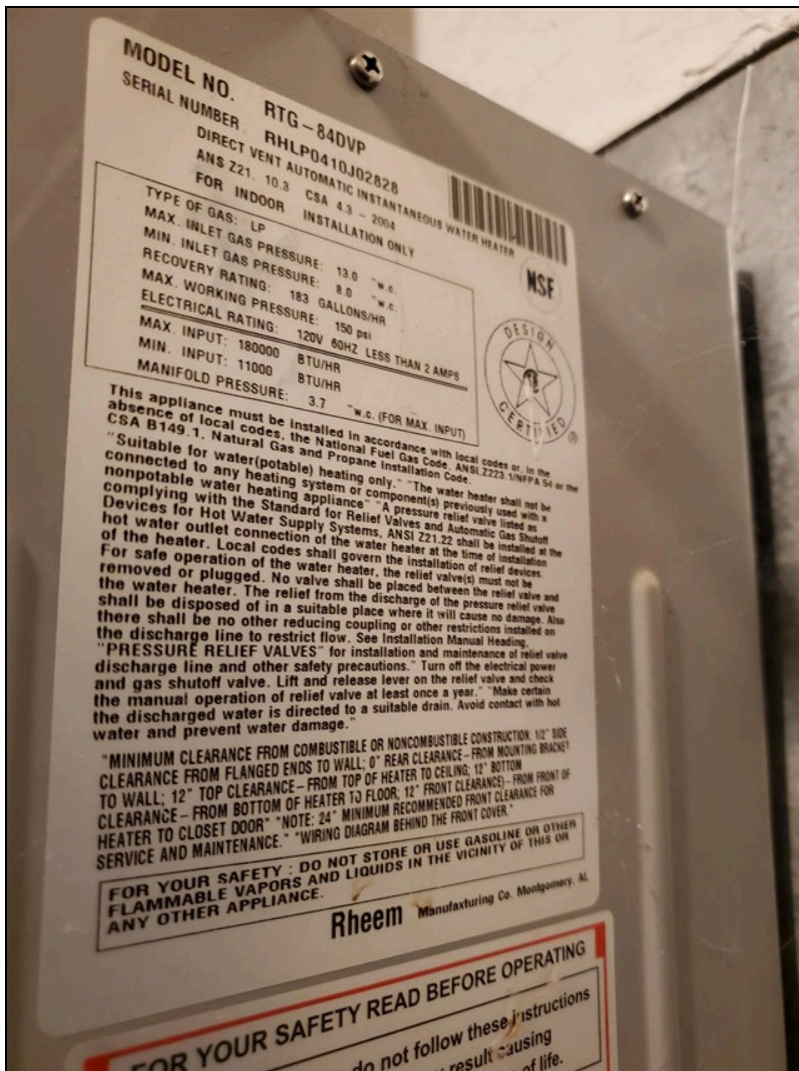
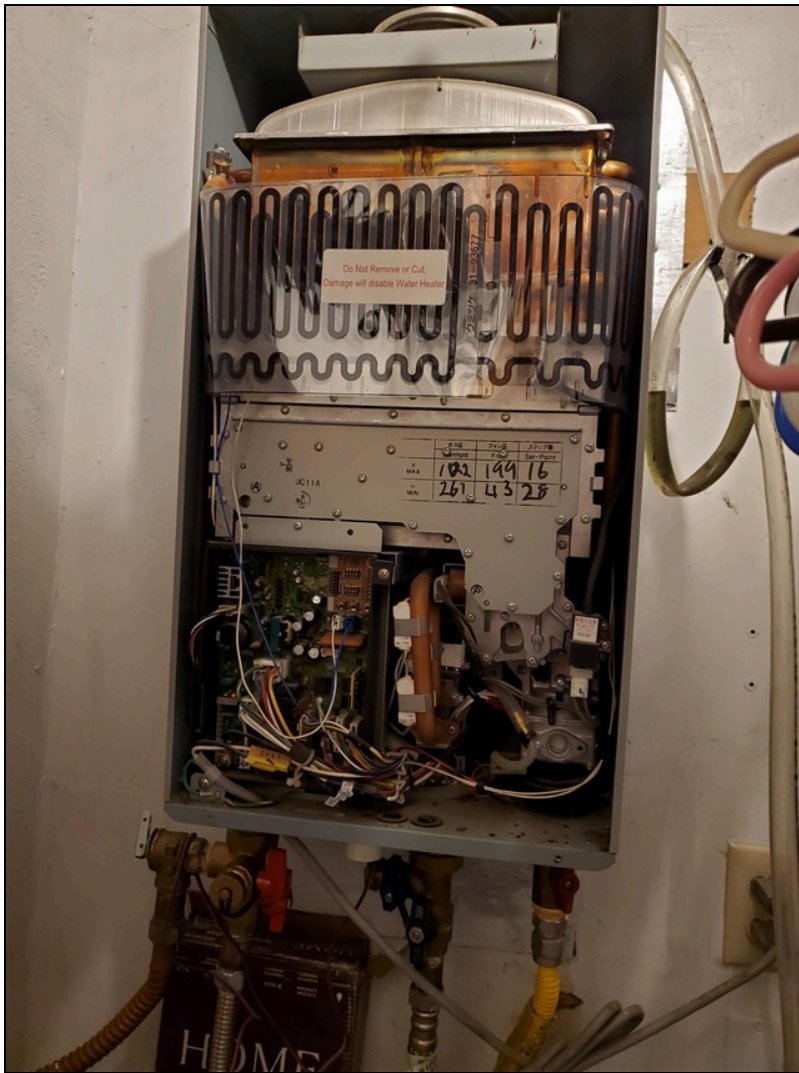
(2) The home has an "on-demand" tankless water heater. These systems are more efficient than a tank style heater but operate differently in that the unit comes on only when hot water is called for at a fixture. It can take a little longer for hot water to reach the fixture for this reason. The systems are

mechanically complex and it is recommended that they be cleaned and serviced annually for trouble free use.

5.2 Item 2(Picture) Water heater

5.2 Item 3(Picture) Mfg Data

5.2 Item 4(Picture) Interior view

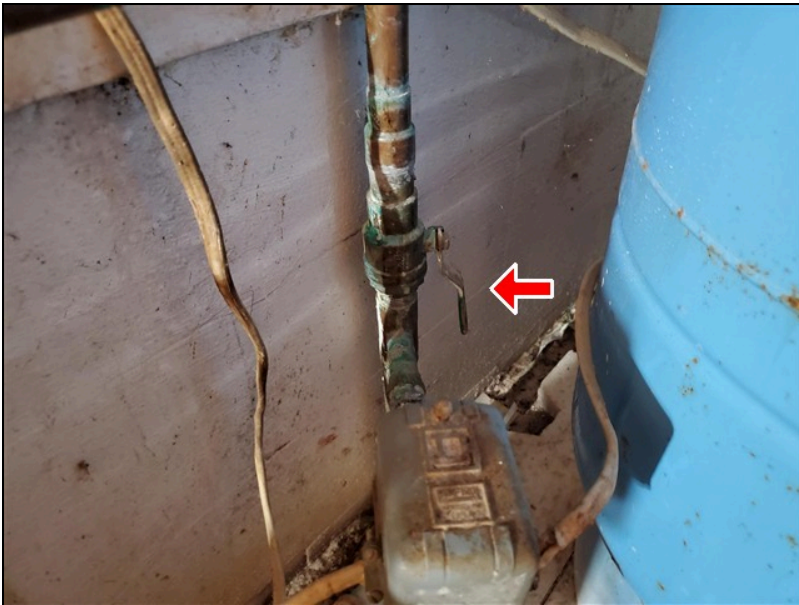
5.3 Item 2(Picture) Main water shut off valve

The main shut off is the green lever located in the basement at the pressure tank. This is for your

information.

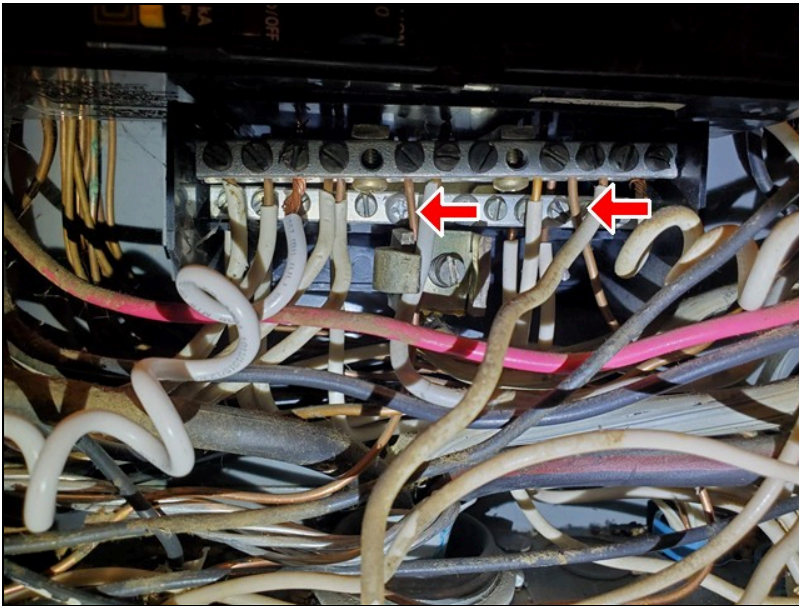
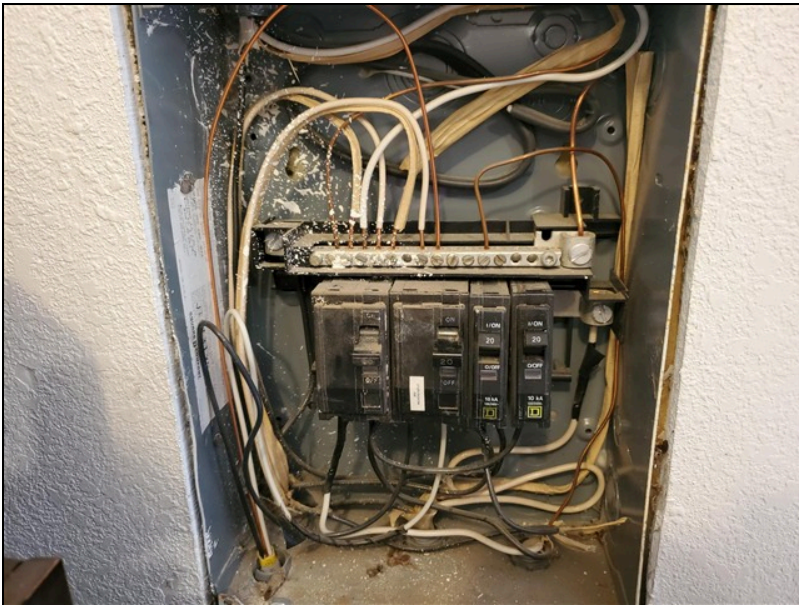
The main panel and panel in the cabin do not appear to be properly grounded/bonded. This should be investigated. In a downstream sub-panel, the white neutral and the equipment grounds must not be bonded together. The neutral must float from contacting the metal enclosure or equipment grounds.

Bonding these two is hazardous. Ground wires should be relocated to the grounding bus bar. This is a minor repair but recommended for safety. A licensed electrician should repair.

6.1 Item 1(Picture) grounds on neutral busbar

6.1 Item 2(Picture) Cabin sub panel- neutrals/grounds bonded

13. The main panel and panel in the cabin do not appear to be properly grounded/bonded. This should be investigated. In a downstream sub-panel, the white neutral and the equipment grounds must not be bonded together. The neutral must float from contacting the metal enclosure or equipment grounds. Bonding these two is hazardous. Ground wires should be relocated to the grounding bus bar. This is a minor repair but recommended for safety. A licensed electrician should repair.

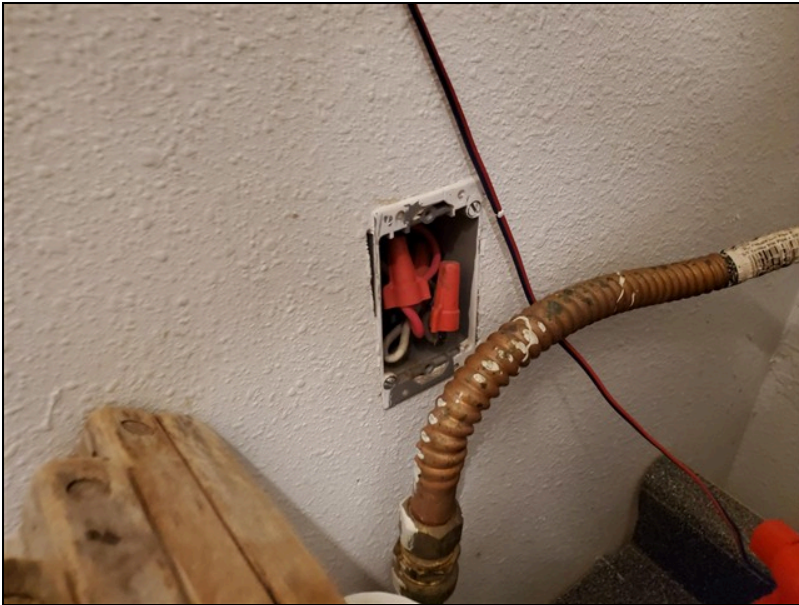
6.3 Item 1(Picture) Missing cover plate

Cover plates should be installed at several outlets and junction boxes around the home. This is a

minor repair but a good safety improvement

14. Cover plates should be installed at several outlets and junction boxes around the home. This is a minor repair but a good safety improvement

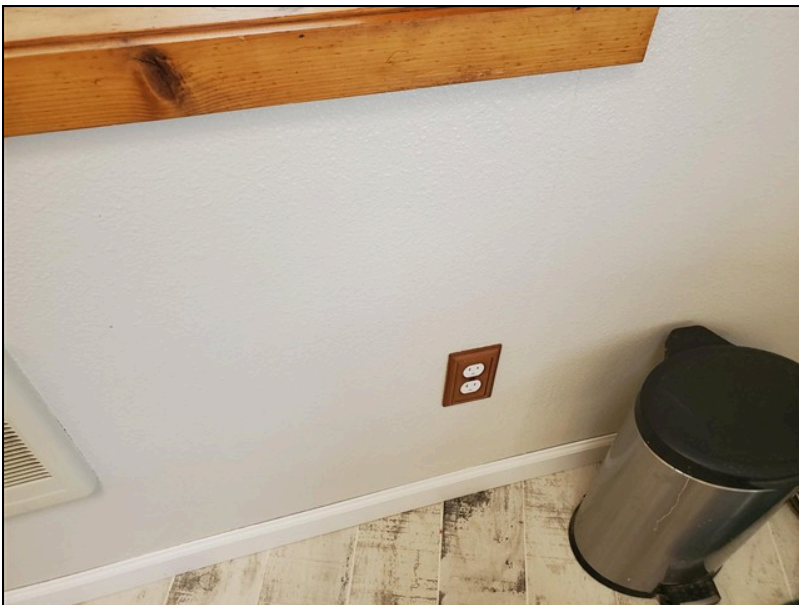
6.5 Item 1(Picture) Not GFCI protected

The outlet in the upper level bath on the outer wall was not GFCI protected as is recommended for safety. I recommend a license electrician install a GFCI receptacle at this location.

15. The outlet in the upper level bath on the outer wall was not GFCI protected as is recommended for safety. I recommend a license electrician install a GFCI receptacle at this location.

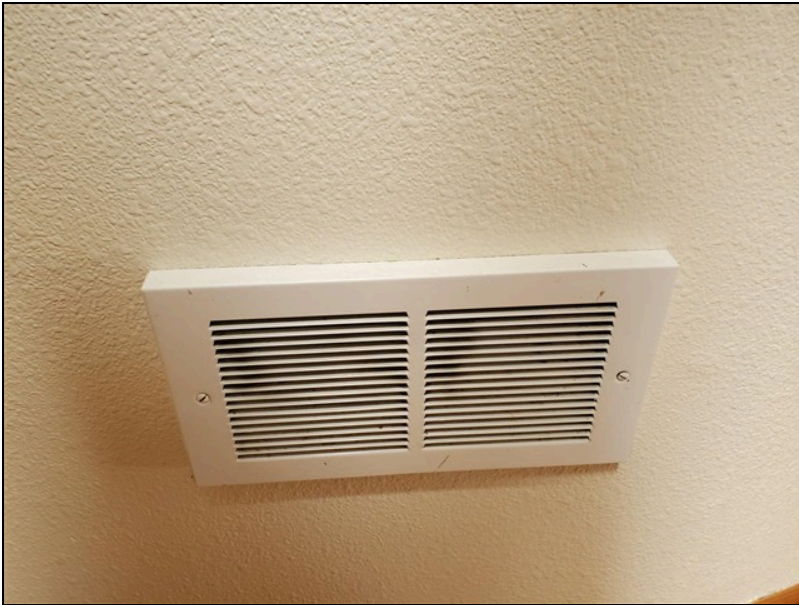
7.0 Item 1(Picture) Cadet ZA

The home is heated with Cadet brand electric wall heaters. Two ZA models used in the bedrooms have been recalled and while the recall money is not available any longer, it is still recommended that these

be replaced with safer units. Go to [www.cadetco.com/upgrade\\_program.php](http://www.cadetco.com/upgrade_program.php) for further information.

17. The home is heated with Cadet brand electric wall heaters. Two ZA models used in the bedrooms have been recalled and while the recall money is not available any longer, it is still recommended that these be replaced with safer units. Go to [www.cadetco.com/upgrade\\_program.php](http://www.cadetco.com/upgrade_program.php) for further information.

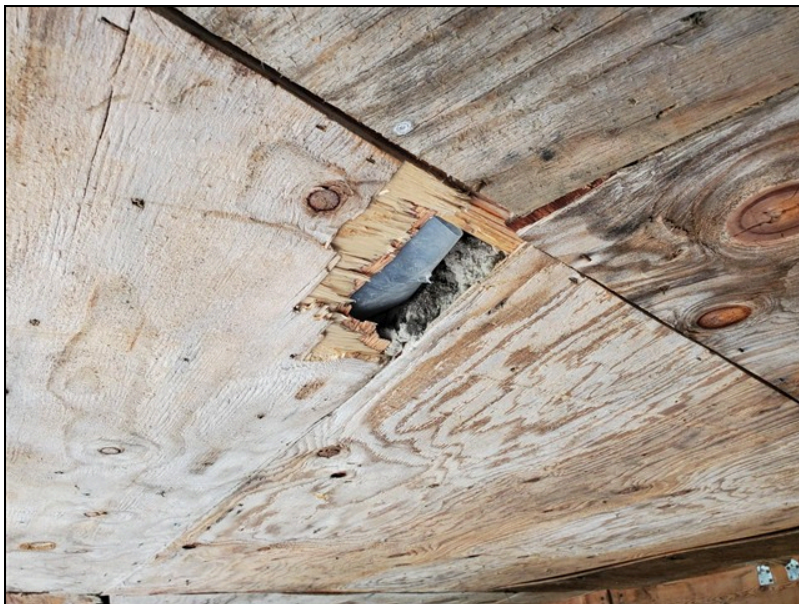
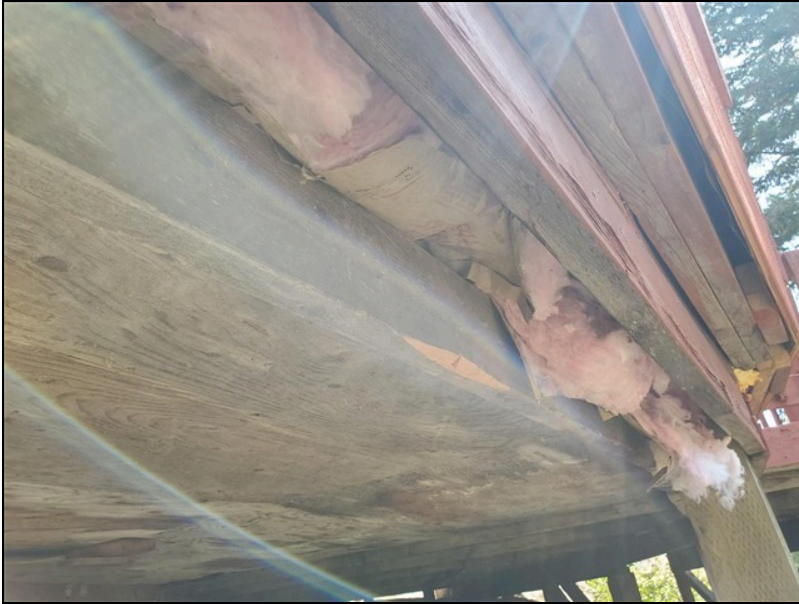
(1) There were several areas on the underside of the home which were not sealed and could allow pest entry into insulation cavities of the floor. I recommend sealing these areas as needed.

8.1 Item 1(Picture) gap in plywood sheathing below sunroom

8.1 Item 2(Picture) gaps under sunroom

19. (1) There were several areas on the underside of the home which were not sealed and could allow pest entry into insulation cavities of the floor. I recommend sealing these areas as needed.
20. (2) Evidence of rodent activity was observed in the in the basement and crawlspace. This is a common condition but rodents can do considerable damage to insulation, electrical wiring, plumbing pipes, etc.. I recommend taking action to remove animals as needed. Sealing any possible entry points/travel areas is recommended

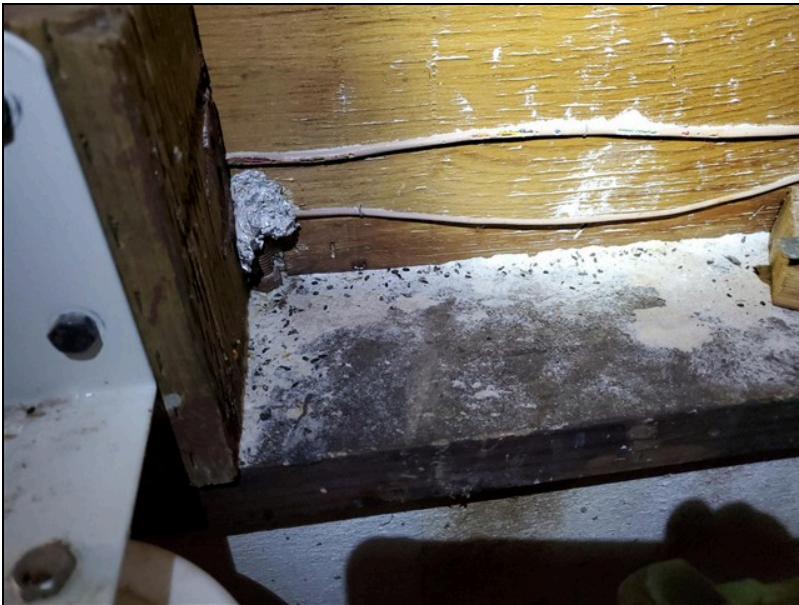
8.1 Item 3(Picture) Mouse droppings

(2) Evidence of rodent activity was observed in the in the basement and crawlspace. This is a common condition but rodents can do considerable damage to insulation, electrical wiring, plumbing pipes, etc.. I recommend taking action to remove animals as needed. Sealing any possible entry points/travel areas is recommended
