# Inspection Report

**Property Address:**  
4057 Jewel Lake Rd  
Sagle ID 83860

**Peak Inspections, Inc.**

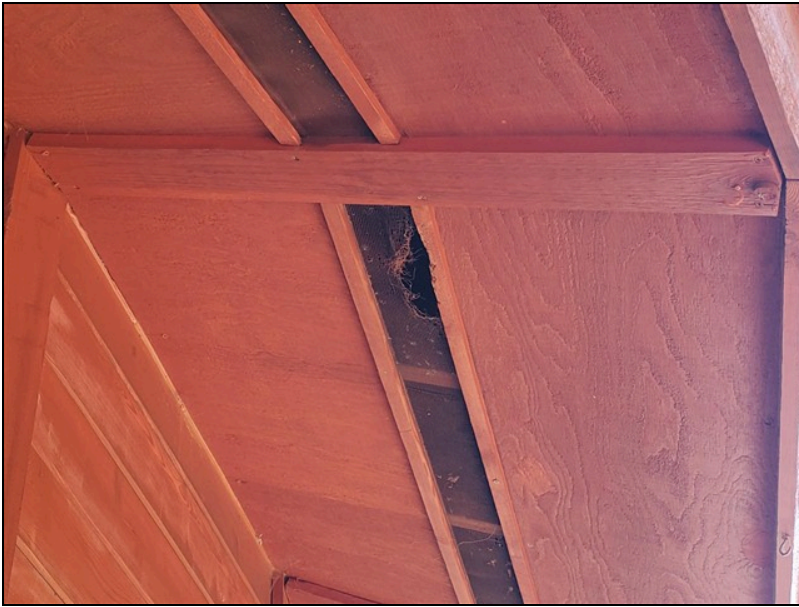
8.3 Item 1(Picture) hole in soffit vent

Soffit vent screens were damaged in several locations. I recommend patching or repairing to prevent

pest entry into attic spaces.

22. Soffit vent screens were damaged in several locations. I recommend patching or repairing to prevent pest entry into attic spaces.
