Inspection Report

Property Address:
2372 Brandon Miles Way
Brentwood Ca 94513

Elite Home Inspection

Date: 2/16/2024	Time: 02:30 PM	Report ID:
Property: 2372 Brandon Miles Way Brentwood Ca 94513	Customer: Robert & Kathi Hansen	Real Estate Professional: Kevin Vierra EXP

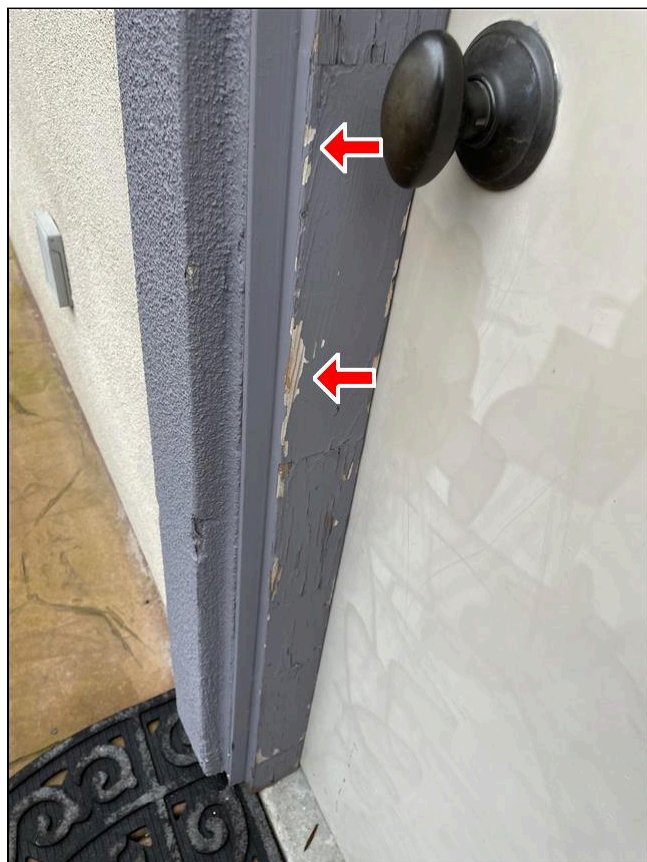
There is wood trim around the side garage door that is weathered and should be painted to protect from further damage. The inspector recommends consulting with a qualified tradesman for further evaluation and repairs. The inspector recommends review of the most current pest report.

2.0 Item 1(Picture) weathered trim

There is wood trim around the side garage door that is weathered and should be painted to protect from further damage. The inspector recommends consulting with a qualified tradesman for further evaluation and repairs. The inspector recommends review of the most current pest report.

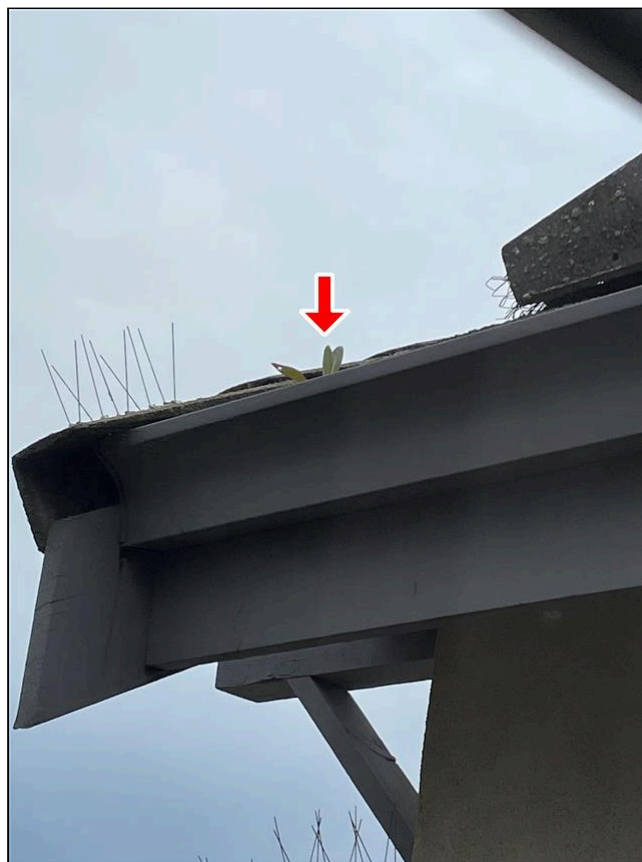
There is debris in the gutters. This could allow moisture damage to the rafters and roof sheathing if not cleaned out. The inspector recommends consulting with a qualified tradesman for further evaluation of the gutter and downspout system.

2.4 Item 1(Picture) debris in gutters

There is debris in the gutters. This could allow moisture damage to the rafters and roof sheathing if not cleaned out. The inspector recommends consulting with a qualified tradesman for further

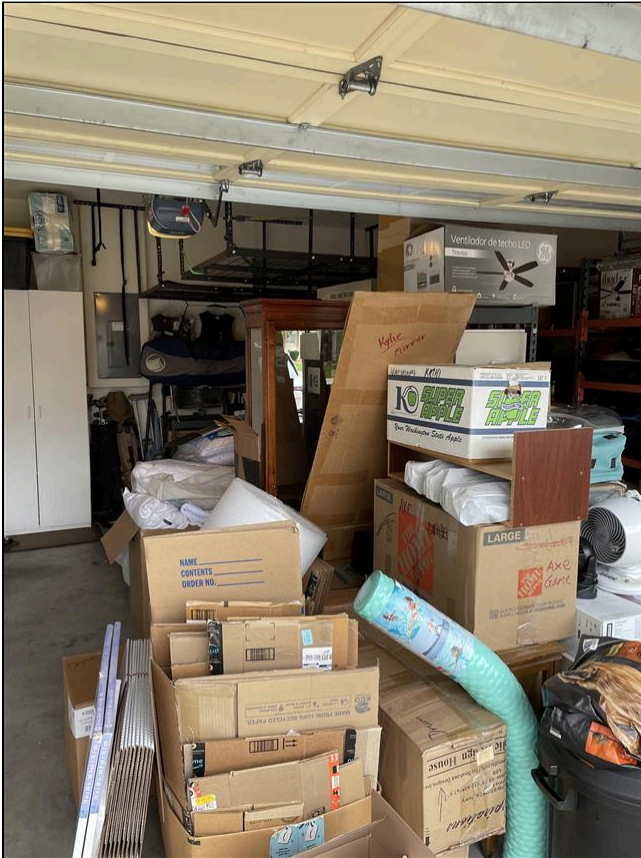
There are stored items in the garage that prevent the inspector from inspecting the entire garage.

3.1 Item 1(Picture) stored items in garage

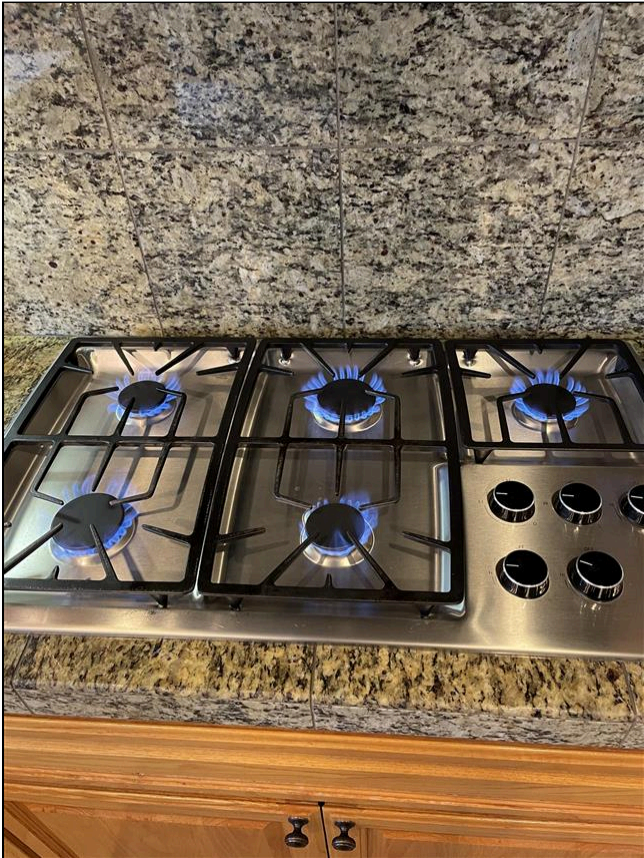
The stove top burners and oven operated properly at the time of inspection.

4.1 Item 1(Picture) stove top functional

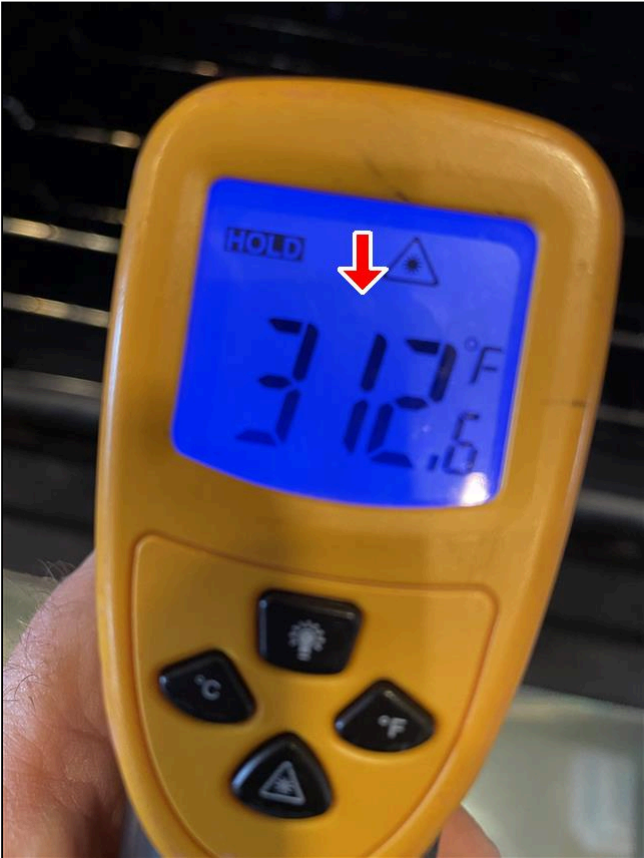
4.1 Item 2(Picture) oven functional

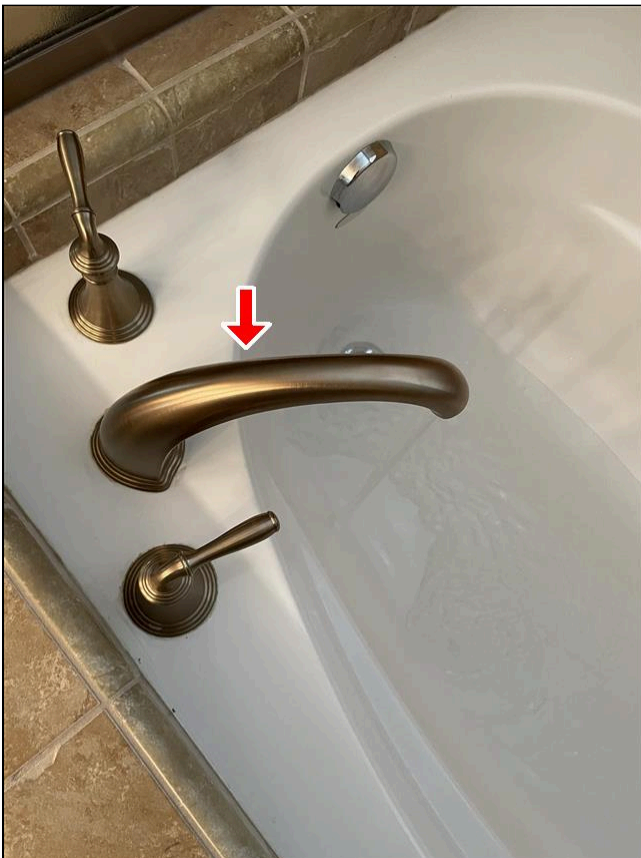
The tub spout in the master bathroom is loose. The inspector recommends consulting with a qualified tradesman for further evaluation and repairs.

6.3 Item 1(Picture) master tub spout loose

The tub spout in the master bathroom is loose. The inspector recommends consulting with a qualified tradesman for further evaluation and repairs.

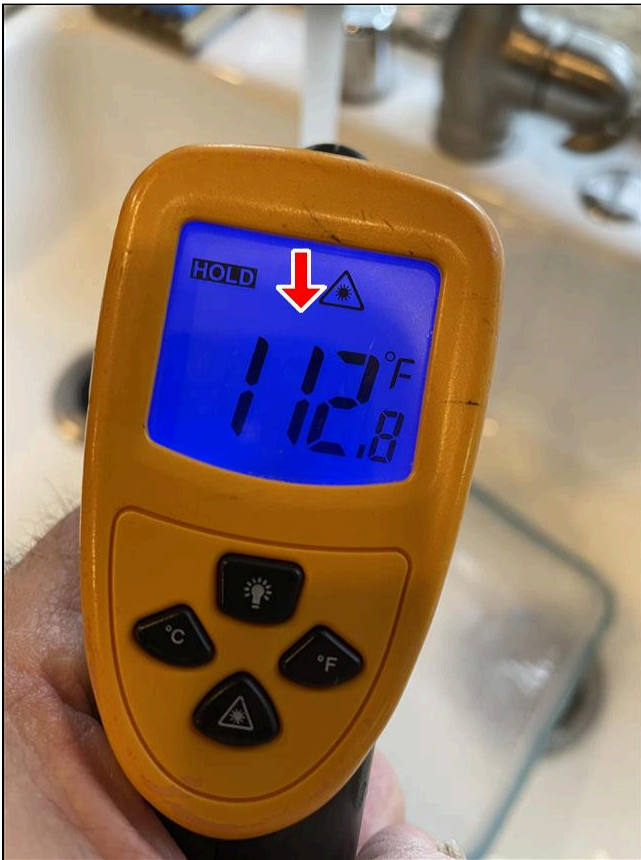
Water heater appears serviceable. Average life of a gas water heater is 8-12 years. The inspector recommends draining the water heater at move-in and once a year. When replacing a water heater, a permit should be pulled and installation should be performed by a licensed tradesman.

7.2 Item 1(Picture) hot water temp

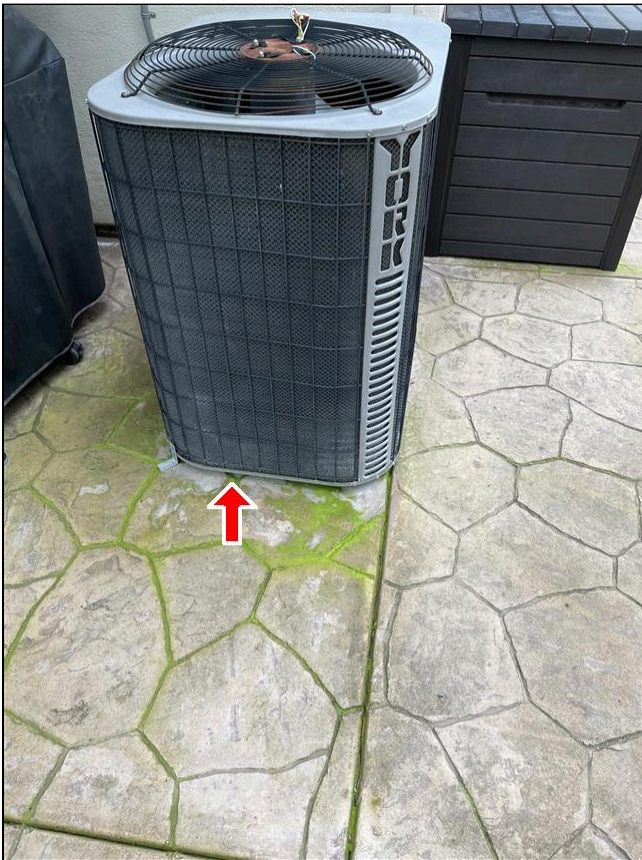
The exterior air unit should be installed on a concrete or plastic pad to prevent moisture and debris buildup around the base of the unit. Recommend consulting with a qualified tradesman for further evaluation and repairs.

8.3 Item 1(Picture) air unit should be on pad

The exterior air unit should be installed on a concrete or plastic pad to prevent moisture and debris buildup around the base of the unit. Recommend consulting with a qualified tradesman for further evaluation and repairs.

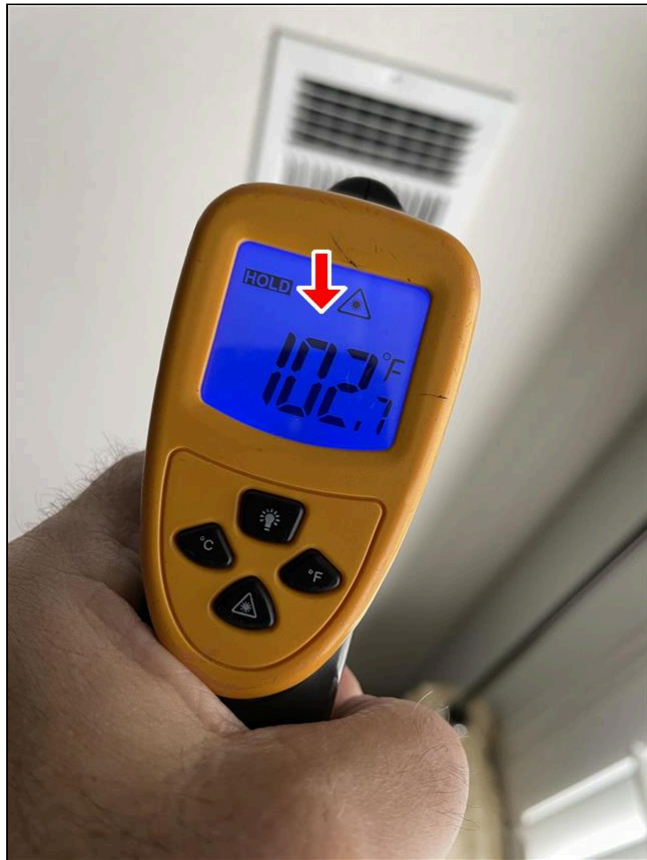
8.4 Item 1(Picture) furnace operational

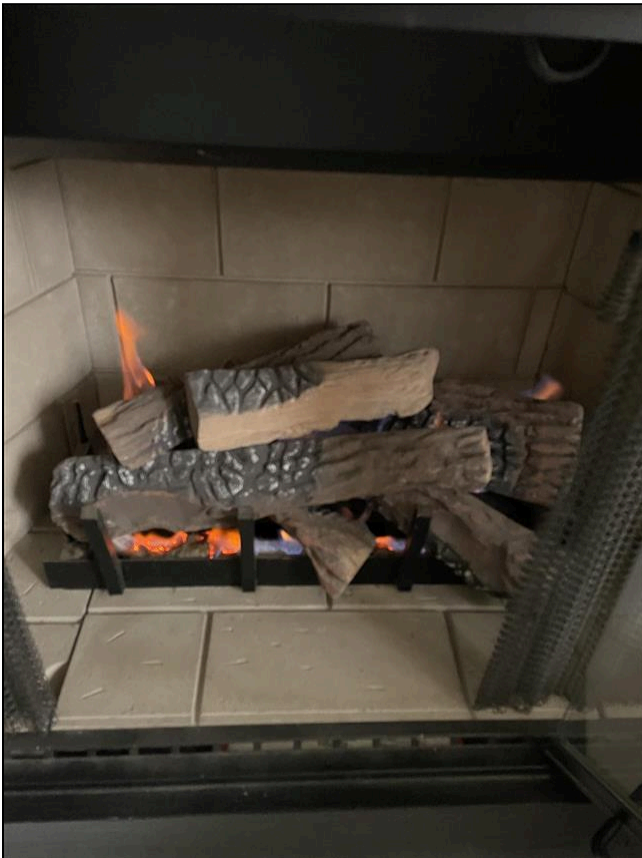
This structure is equipped with a gas fireplace that lights with a wall switch. The unit operated at the time of inspection.

8.5 Item 1(Picture) fireplace functional

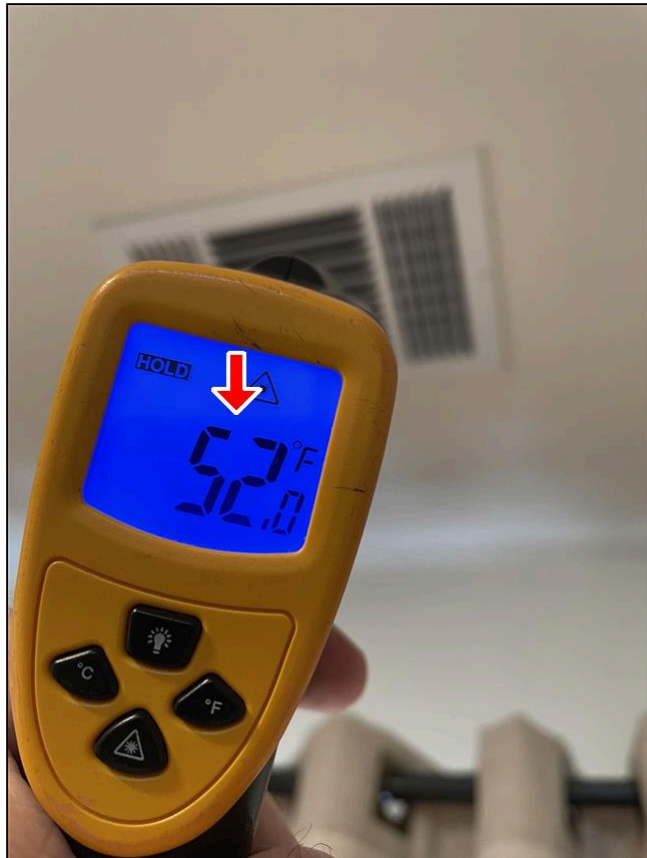
Temperature at registers.

8.6 Item 1(Picture) air temp
