## Inspection Report

**Property Address:**  
718 Sarah Street  
Brentwood Ca 94513

**Elite Home Inspection**

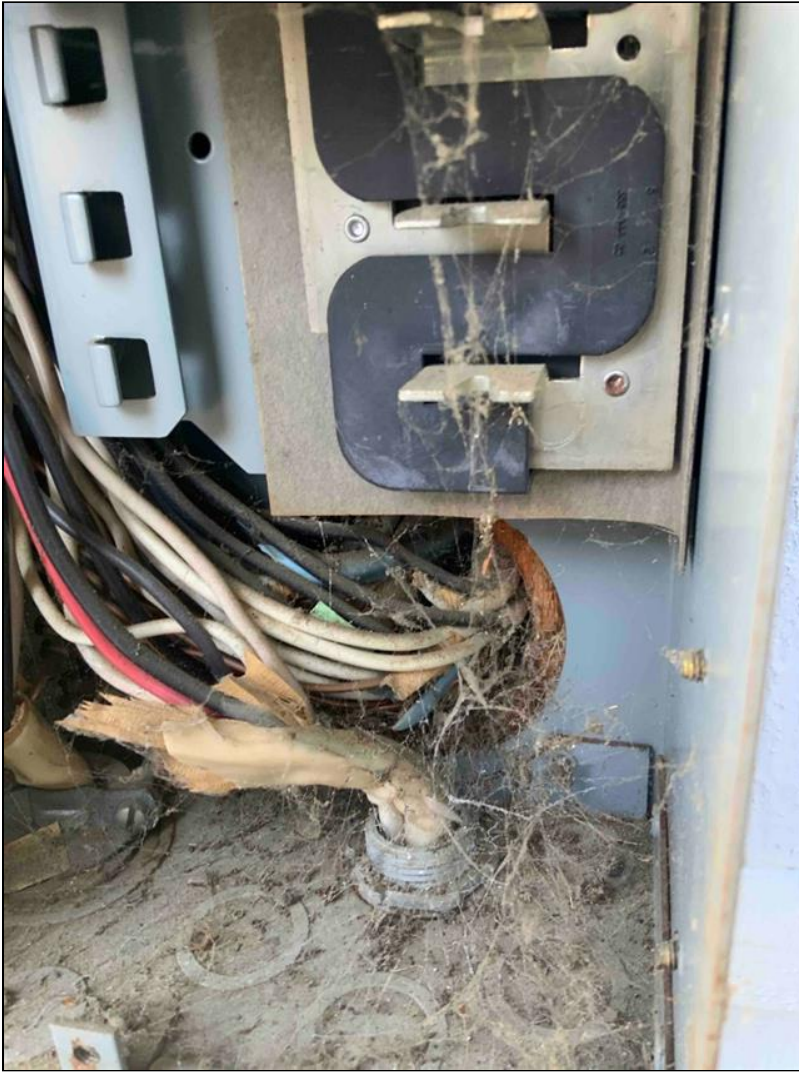
**There is a missing wire clamp at the rear of the electrical main panel. These wire clamps are installed to prevent possible damage to the wire as it passes through the metal panel. The inspector recommends consulting with a qualified tradesman for further evaluation and repair.**

1.1 Item 2(Picture) missing wire clamp at the rear of the electrical main panel.

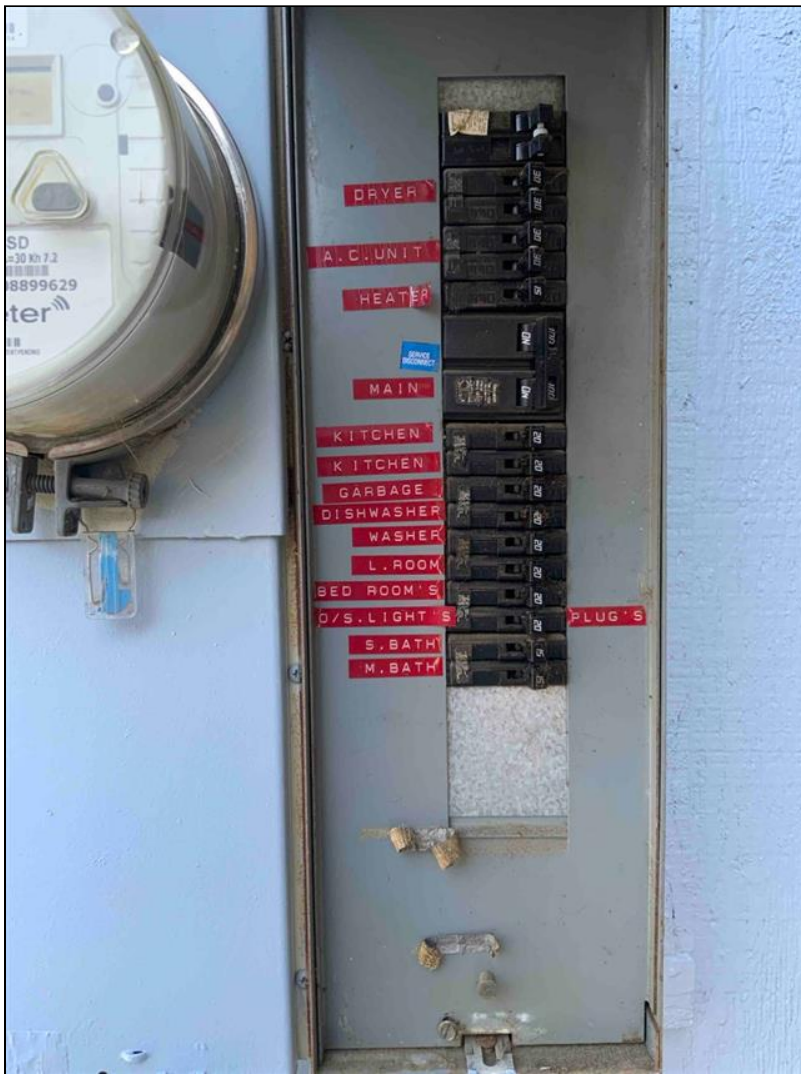
(2) **There are open slots in the electrical main panel. These openings should be filled with the correct cover for safety reasons. The inspector recommends consulting with a qualified tradesman for further evaluation and repairs/replacement.**

1.1 Item 3(Picture) Incorrect type cover used for open slots in the electrical panel

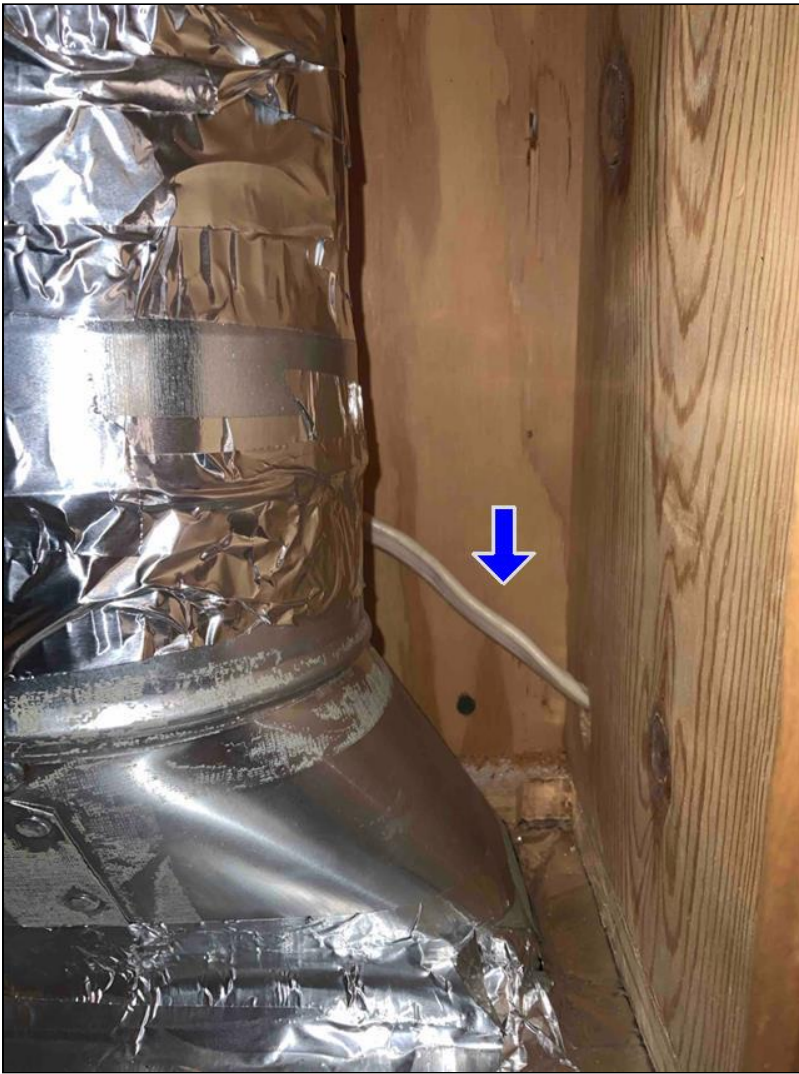
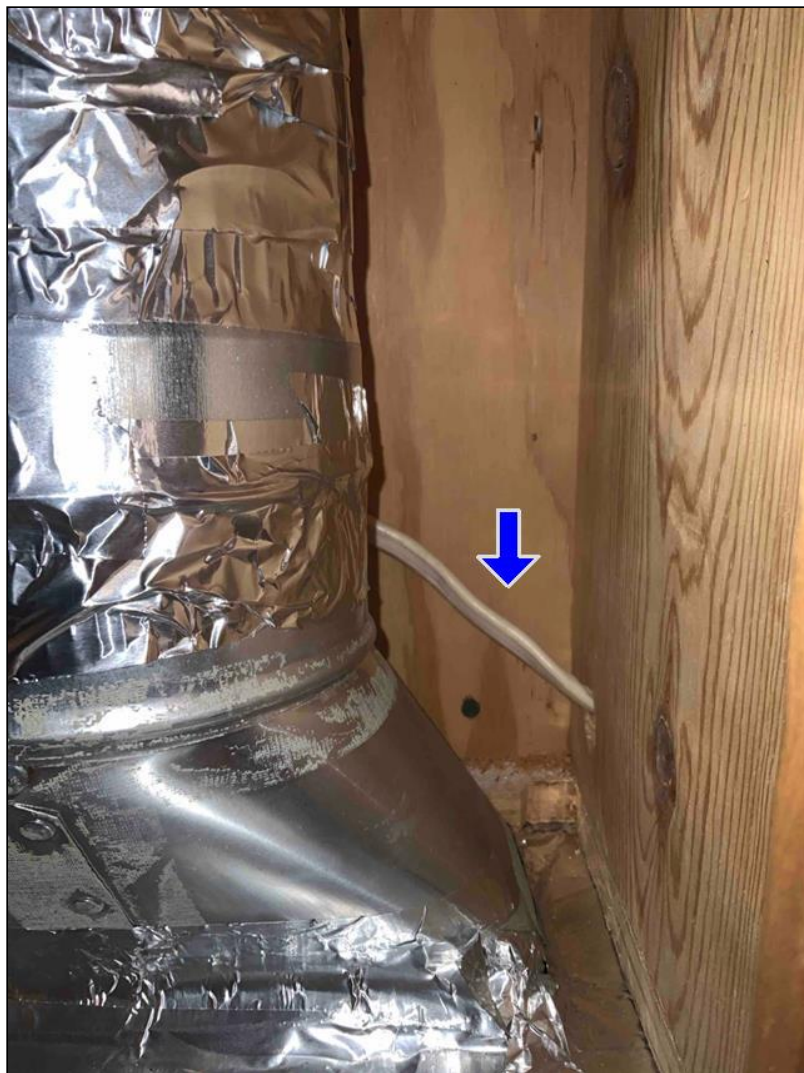
(2) **There is exposed wire in the kitchen cabinet above the stove fan. All exposed wires need to be in a protective cover for safety reasons. The inspector recommends consulting with a qualified tradesman for further evaluation and repairs.**

1.3 Item 1(Picture) exposed wire in the kitchen cabinet above the stove fan

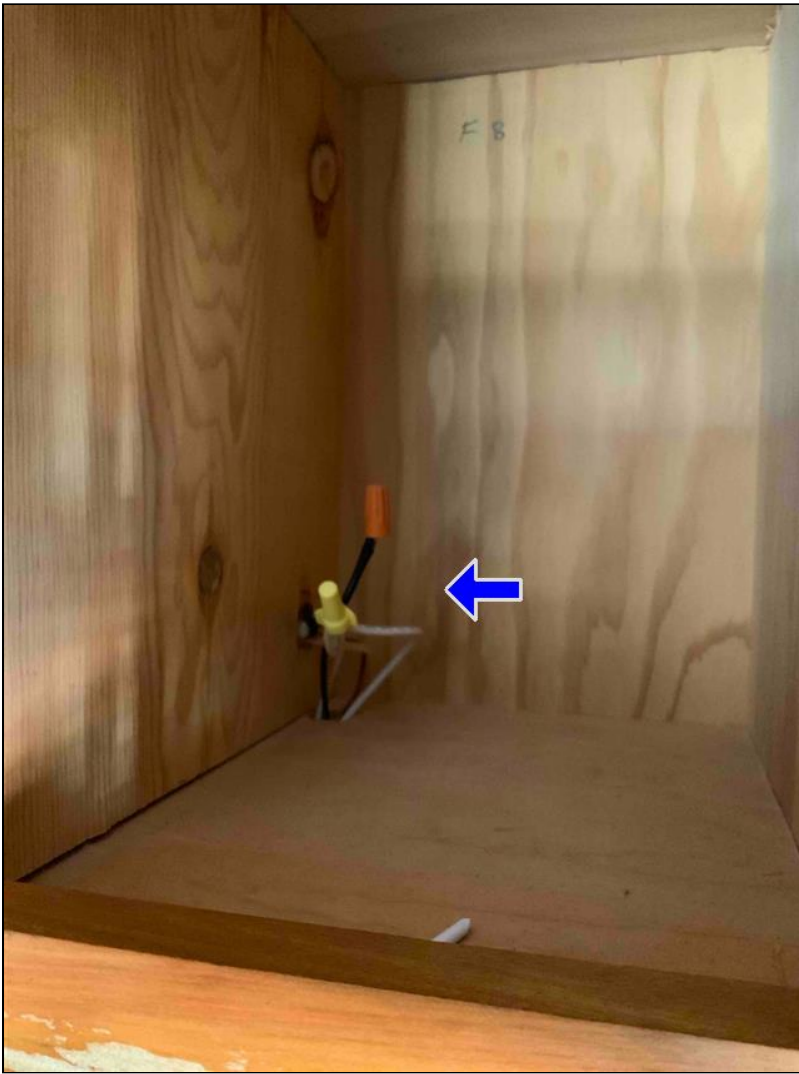
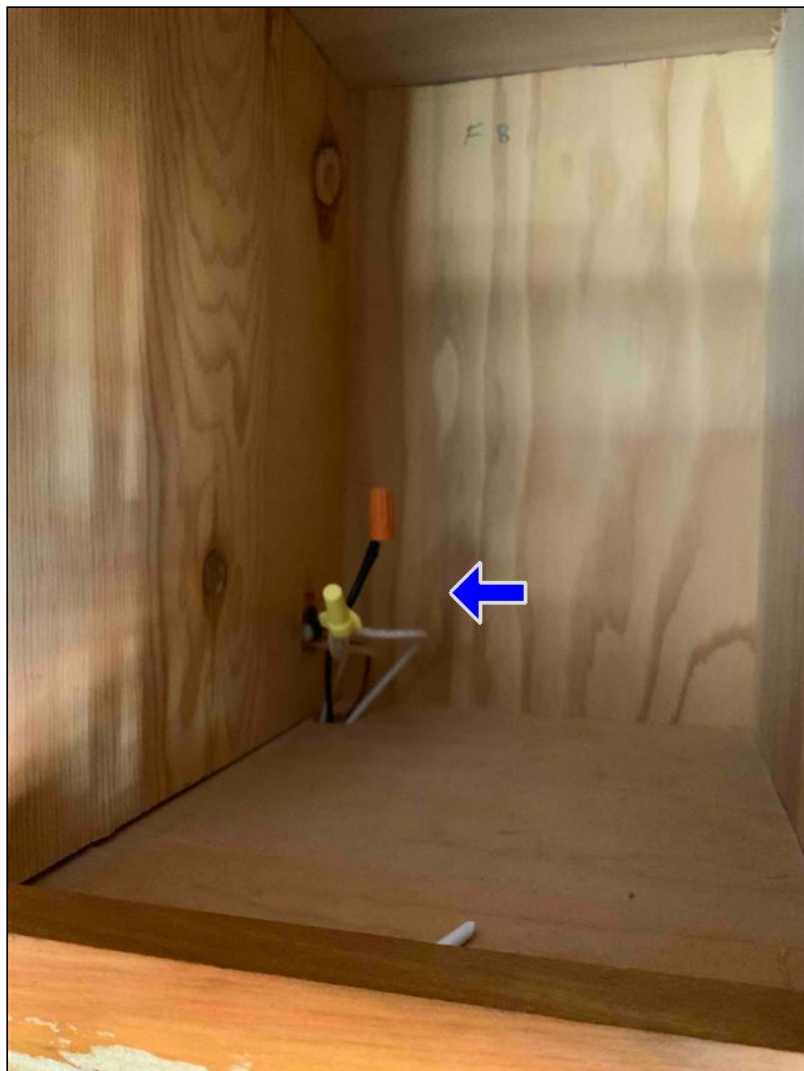
**There are wire splices in the kitchen cabinet above the stove fan. All wire splices need to be in a junction box for safety reasons. The inspector recommends consulting with a qualified tradesman for further evaluation and repairs.**

1.4 Item 1(Picture) wire splices in the kitchen cabinet above the stove fan

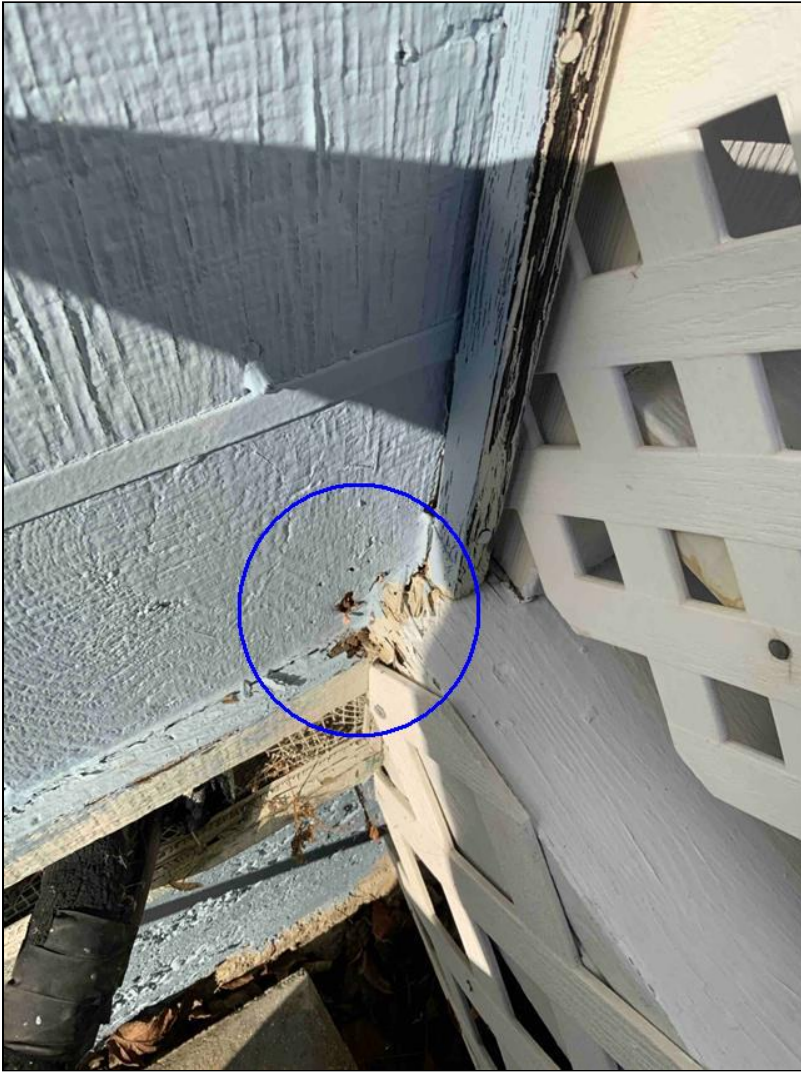
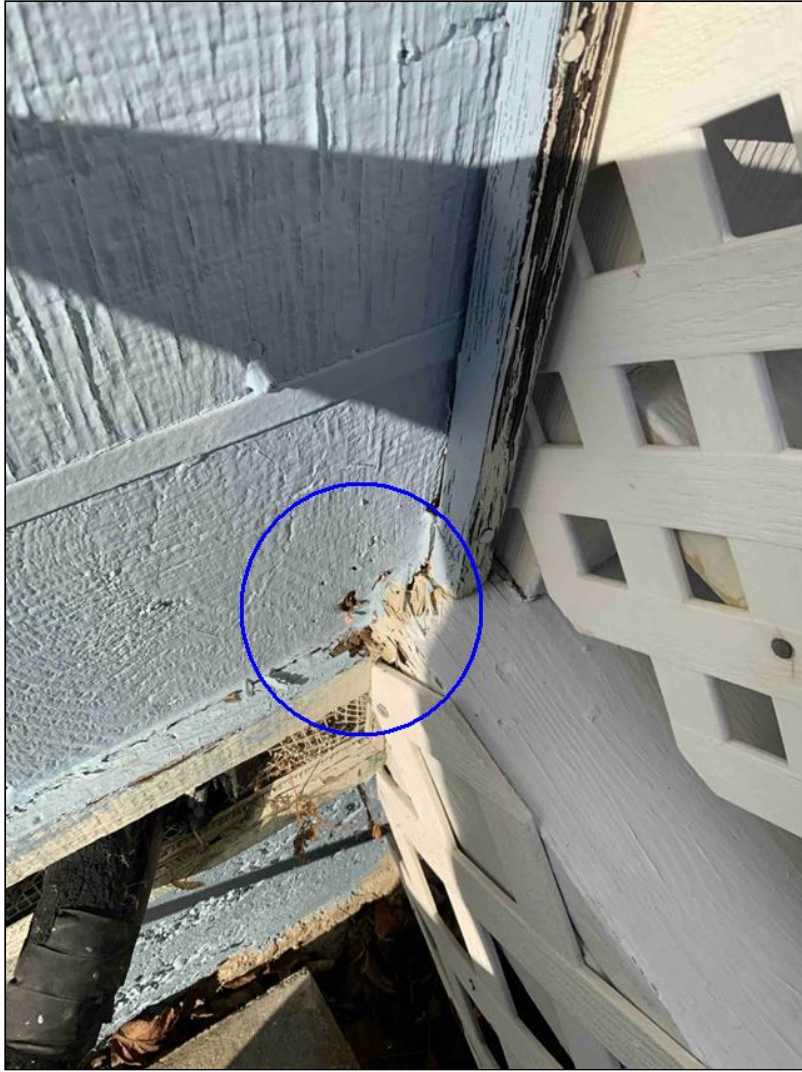
There is damaged wood trim and wood siding around the structure. The inspector recommends consulting with a qualified tradesman for further evaluation and repairs. The inspector recommends review of the most current pest report.

2.0 Item 1(Picture) Wood trim and siding damaged

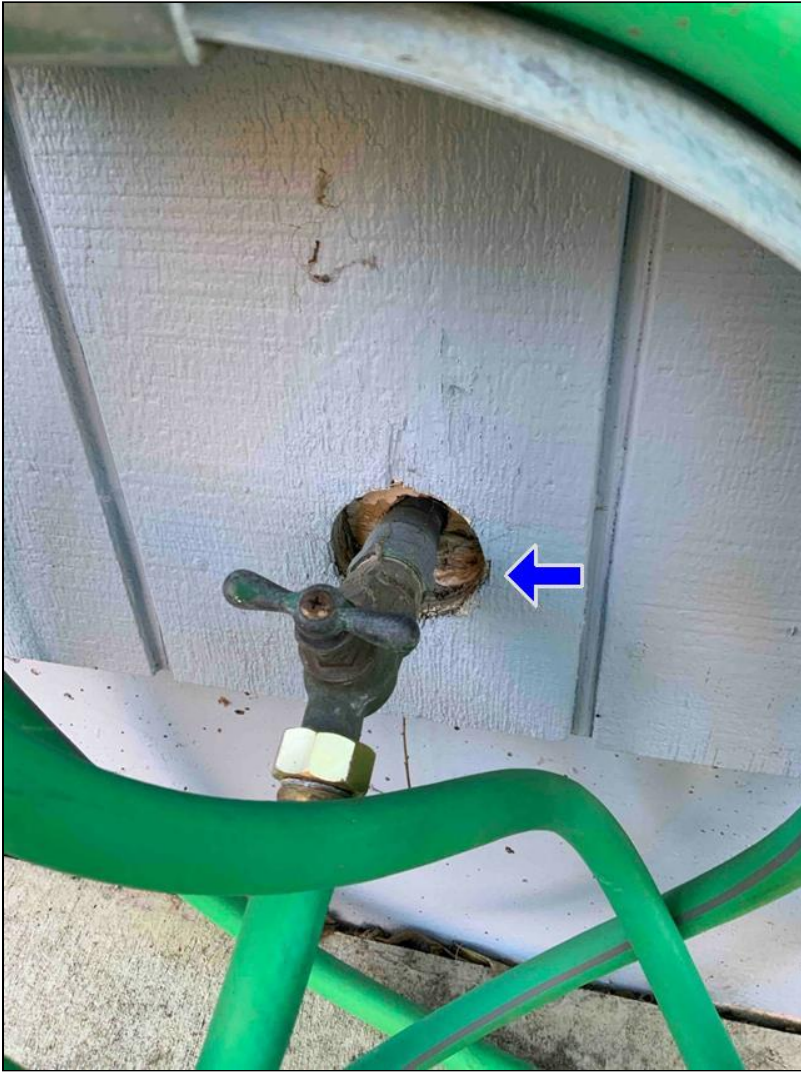
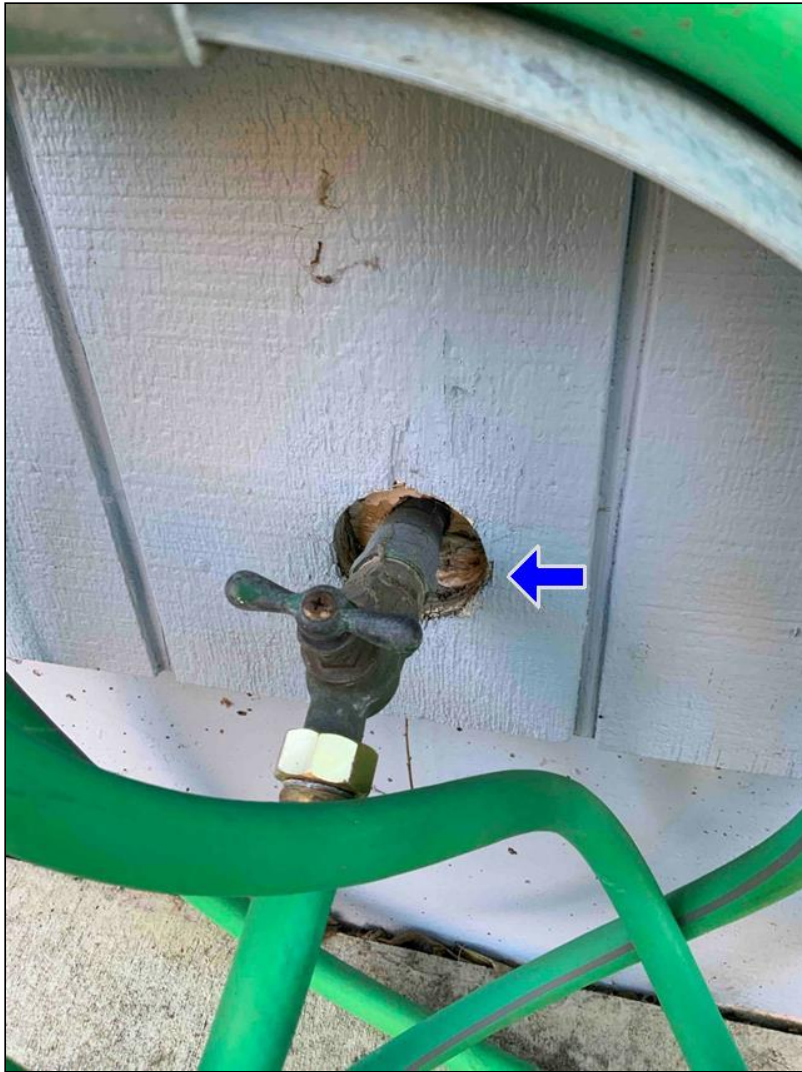
There are holes/gaps to the siding around the structure. The inspector recommends patching/filling these holes to prevent moisture intrusion. The inspector recommends consulting with a qualified tradesman for further evaluation and repairs.

2.0 Item 2(Picture) holes/gaps to the siding

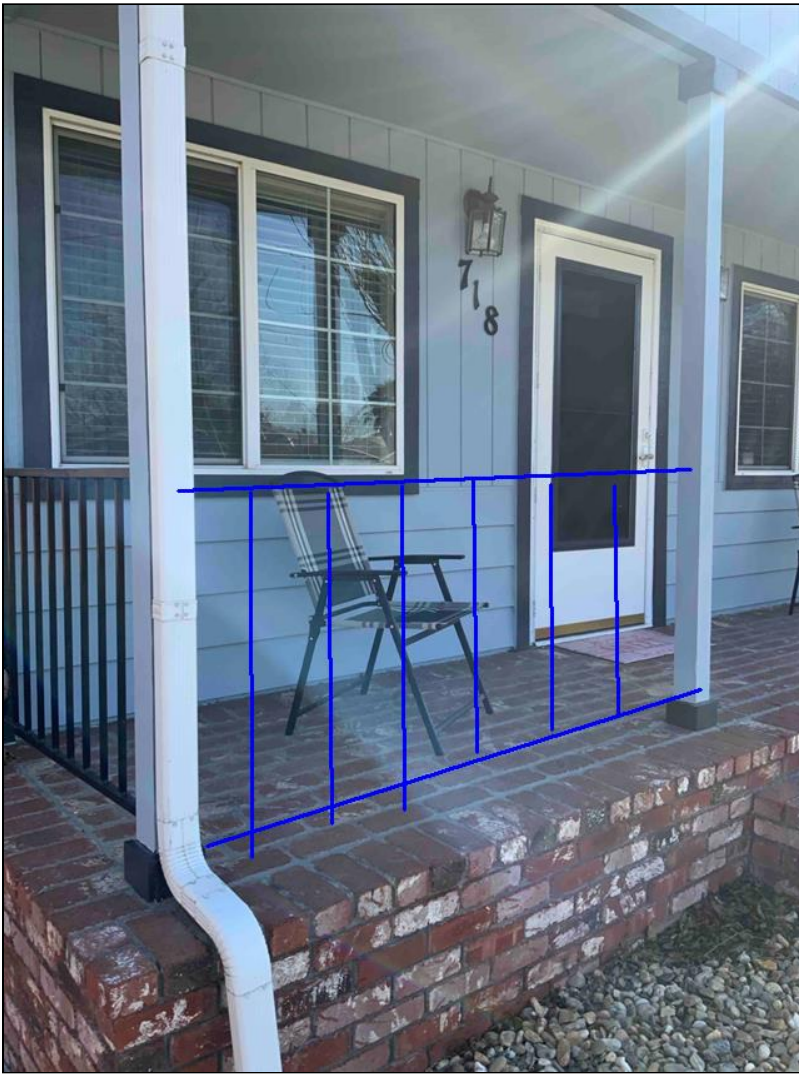
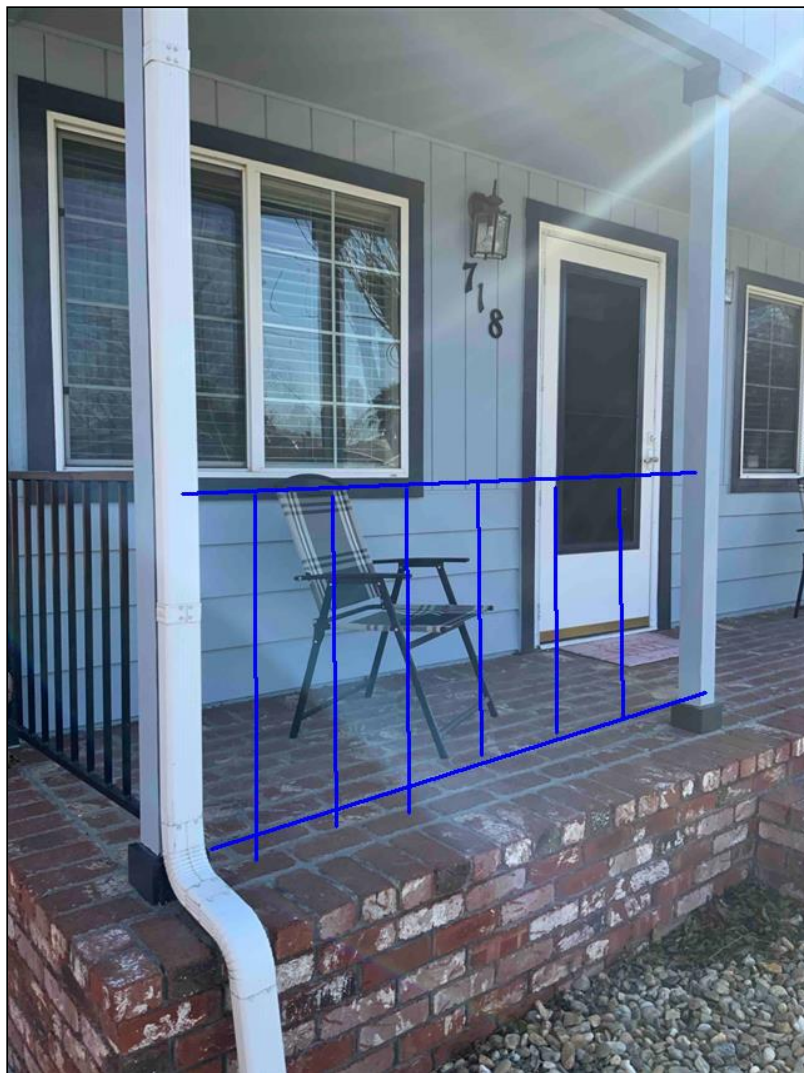
(1) **The inspector recommends installing a railing system at the front walkway/porch area for additional safety. The inspector recommends consulting with a qualified tradesman for further evaluation and repairs.**

2.3 Item 1(Picture) recommends installing a railing system at the front walkway/porch area for additional safety

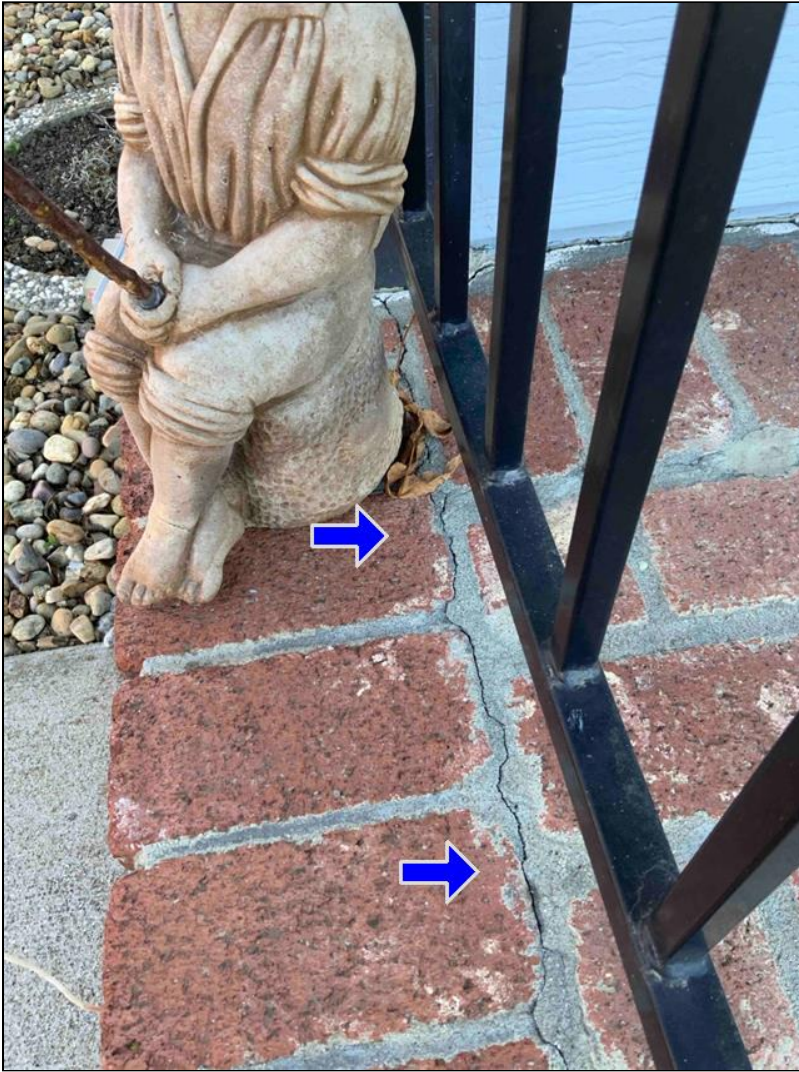
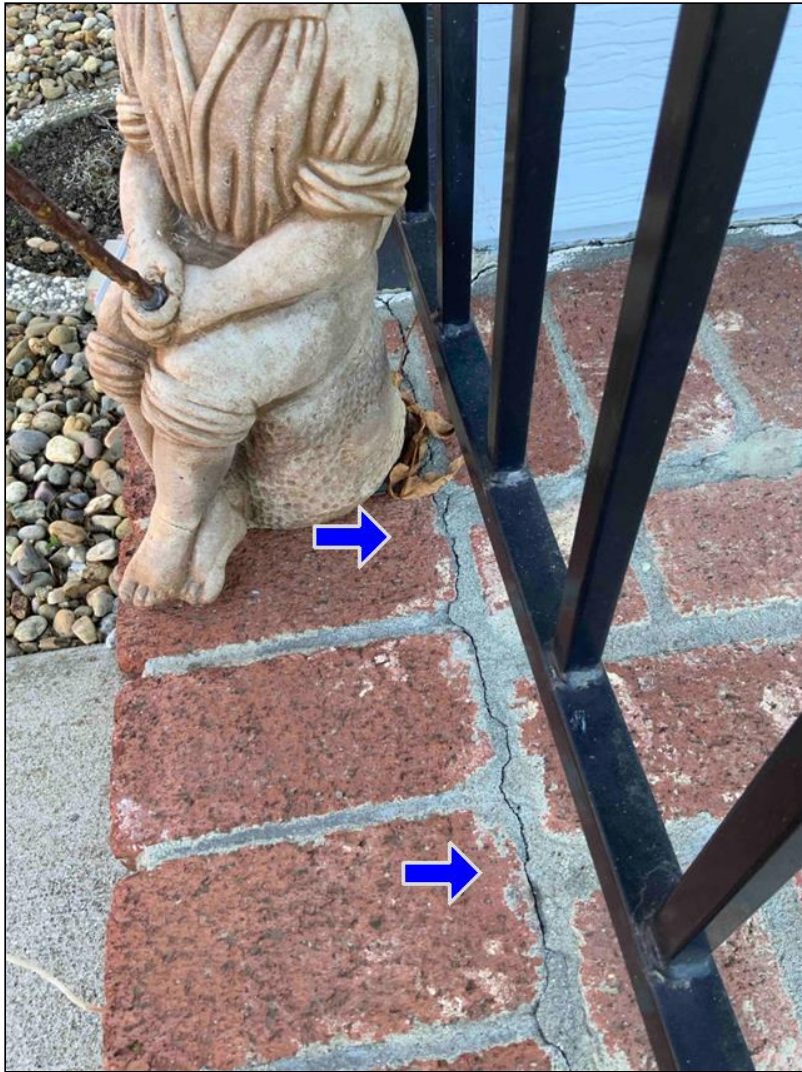
(2) There are cracks in the front porch brick mortar. These cracks should be filled and monitored to prevent further damage. The inspector recommends consulting with a qualified tradesman for further evaluation and repairs.

2.3 Item 2(Picture) cracks in the front porch brick mortar

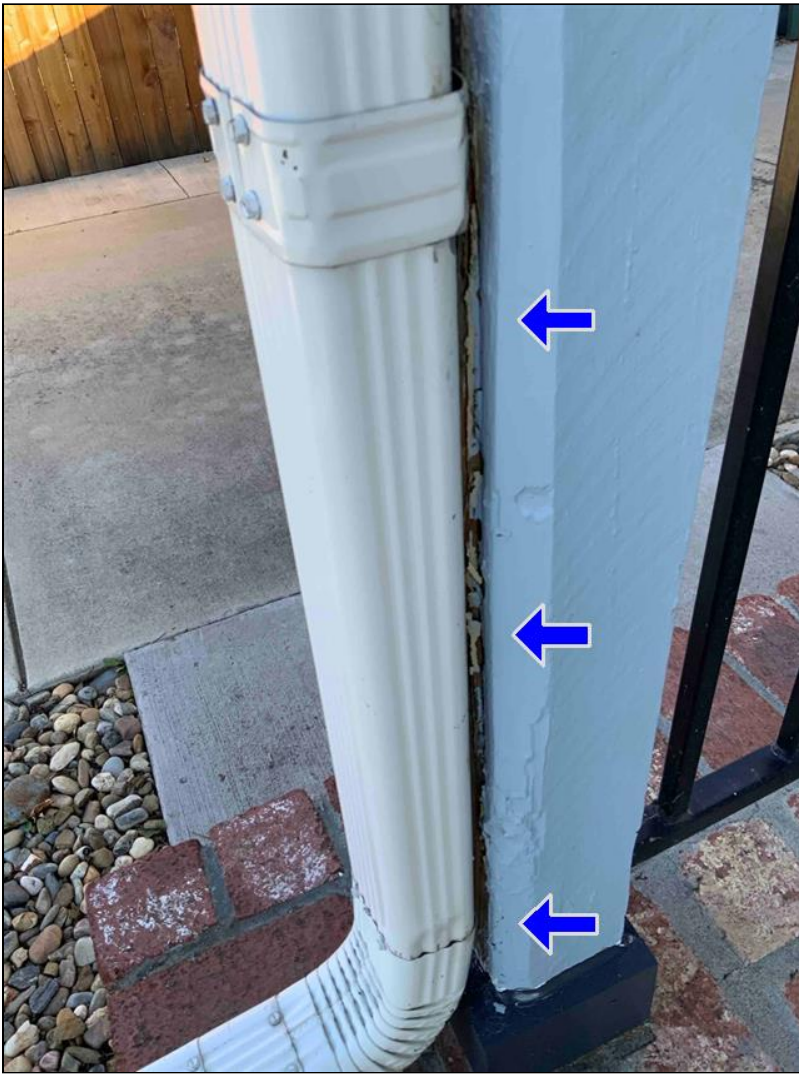
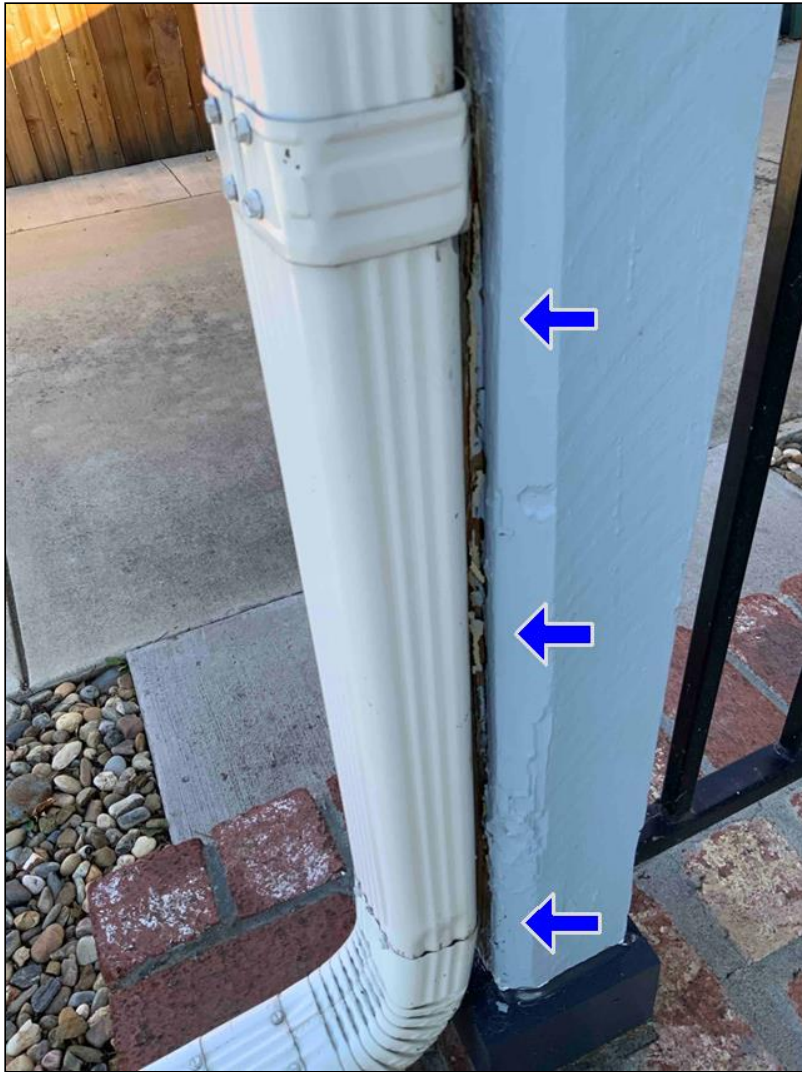
There is damage to the front porch support post. The inspector recommends review of the most current pest report. The inspector recommends consulting with a qualified tradesman for further evaluation and repairs.

2.3 Item 3(Picture) damage to the front porch support post.

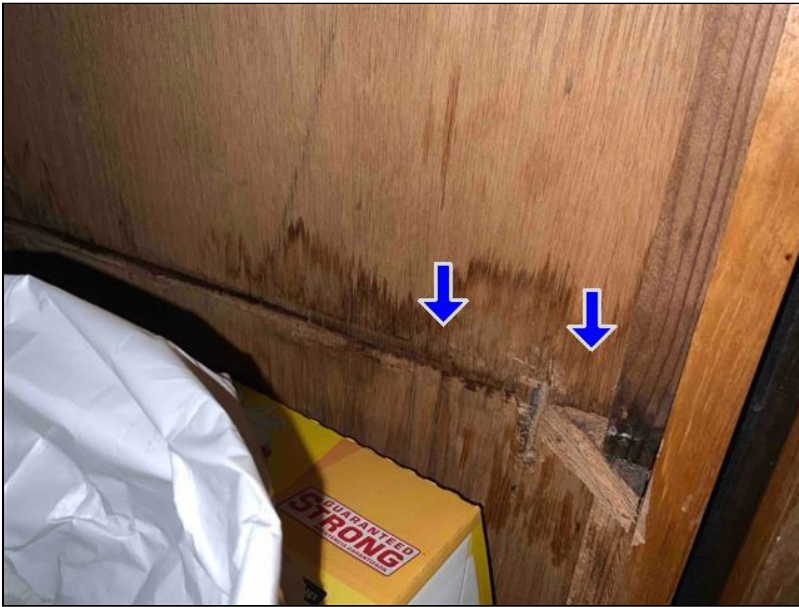
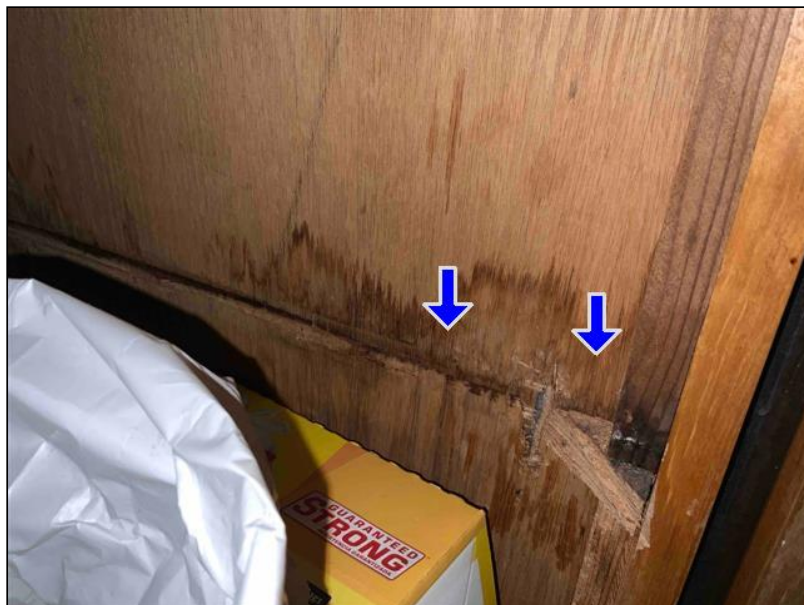
5.4 Item 1(Picture)

There is damage to the inner cabinet wall under the kitchen sink. The inspector recommends consulting with a qualified tradesman for further evaluation and repairs.

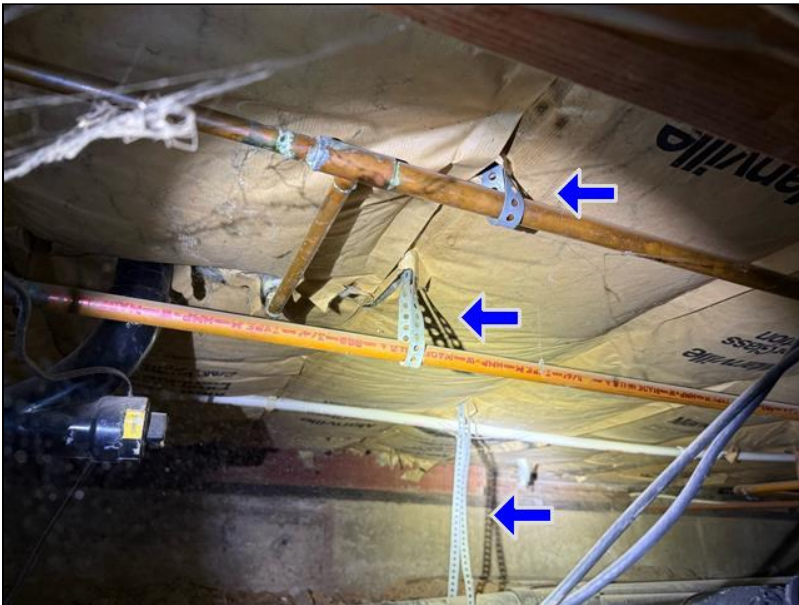
The type of material used for the plumbing straps for the water supply lines in the crawl space appears to be the incorrect type used. The inspector recommends consulting with a qualified tradesman for further evaluation and repairs.

7.1 Item 1(Picture) type of material used for the plumbing straps for the water supply lines in the crawl space appears to be the incorrect type used

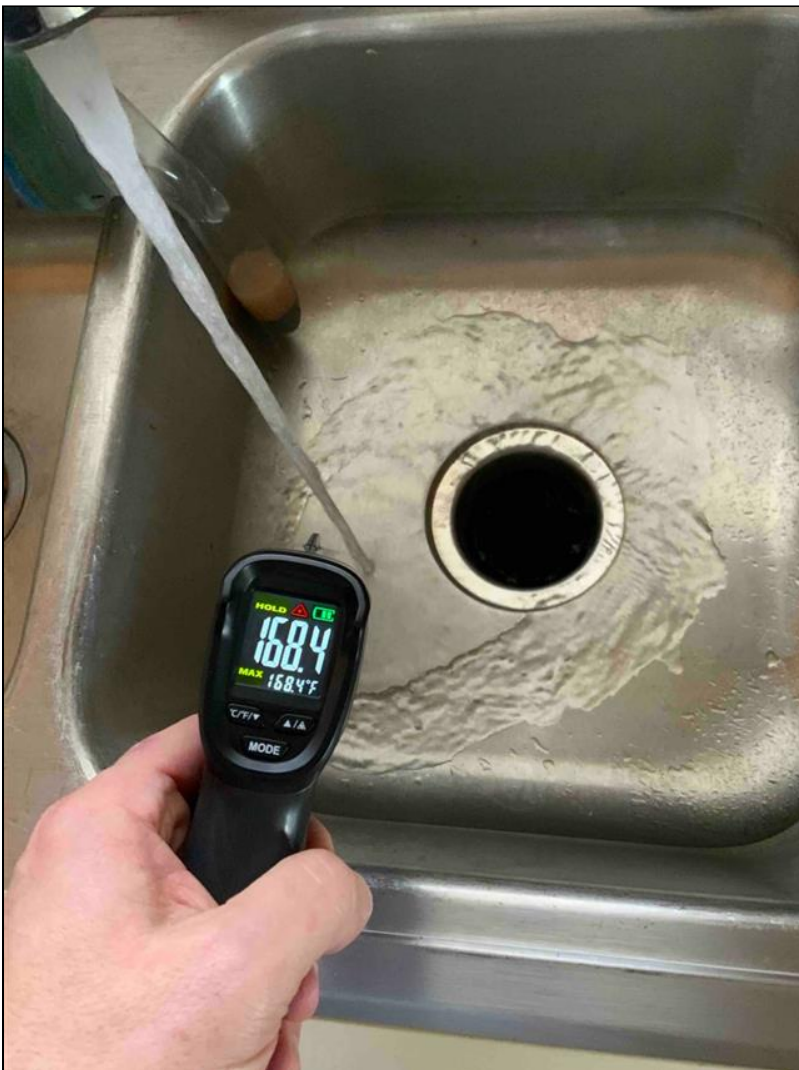
The water heater hot water temperature is set too high for residential use. The inspector recommends to lower the temperature to not exceed 120 degrees.

7.2 Item 1(Picture) Hot water temperature

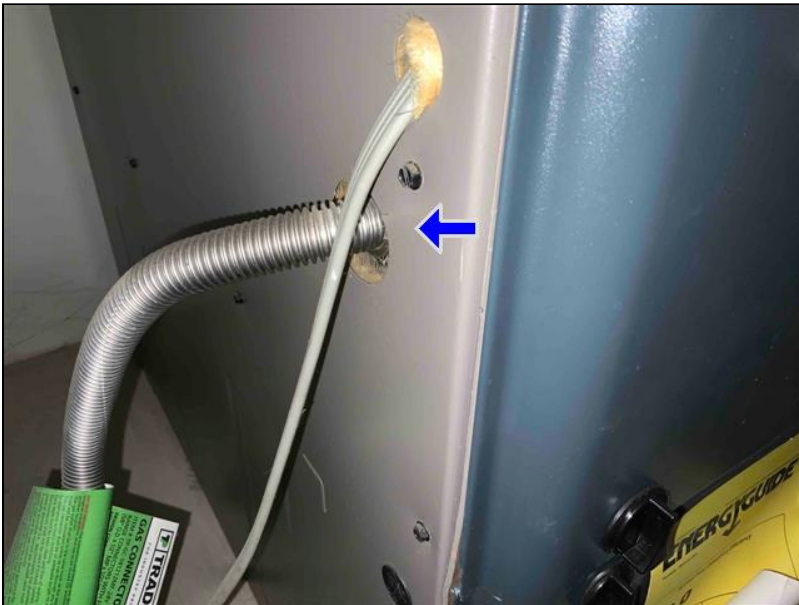
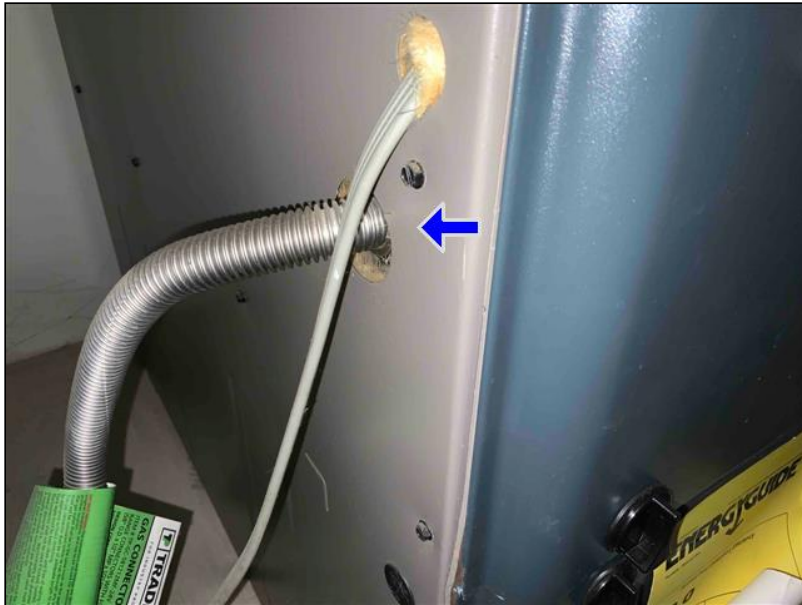
**The gas supply line for the furnace enters through the sheet metal siding. This could allow damage to the supply line through movement and contact with the siding. The inspector recommends consulting with a qualified tradesman for further evaluation and repairs.**

8.0 Item 1(Picture) gas supply line for the furnace enters through the sheet metal siding.

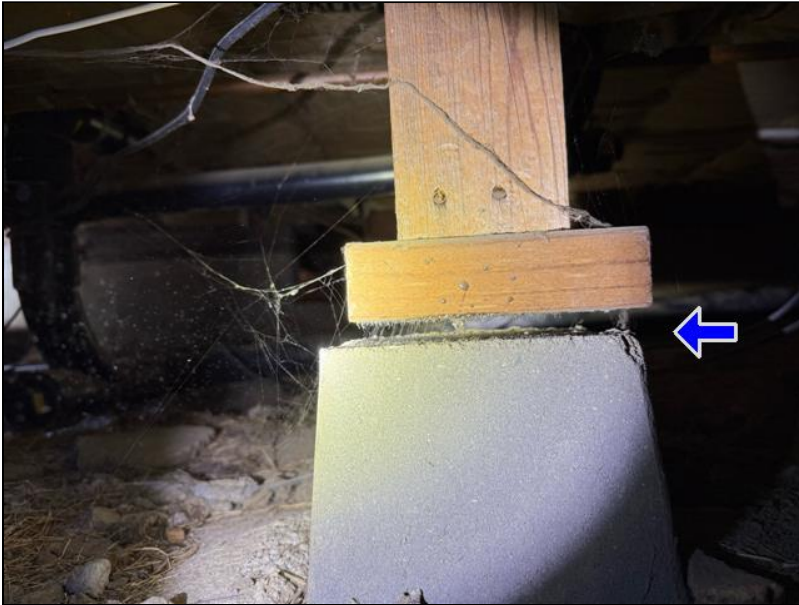
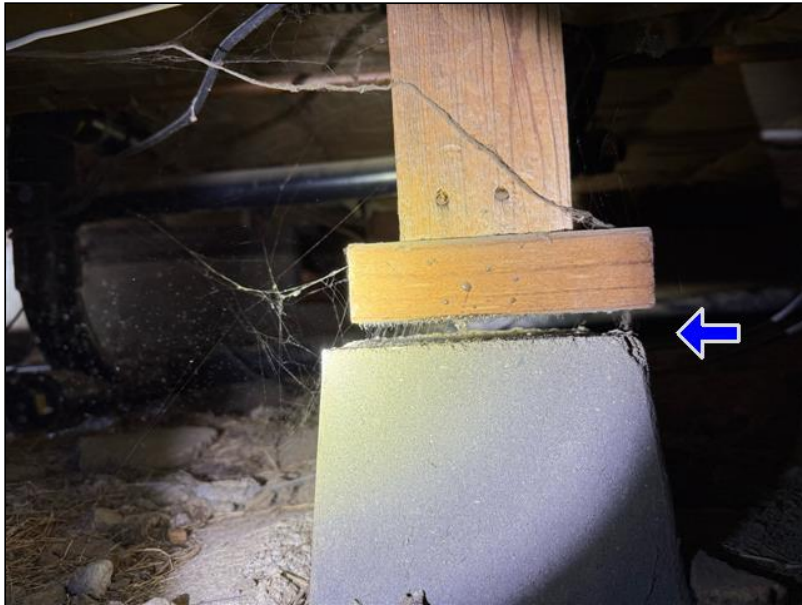
The floor joists for this structure are supported by concrete piers, wood posts. Some of the support posts are not properly secured to the concrete piers. The inspector recommends consulting with a qualified tradesman for further evaluation of these items and repairs for proper support of the joists.

9.2 Item 1(Picture) support posts are not properly secured to the concrete piers

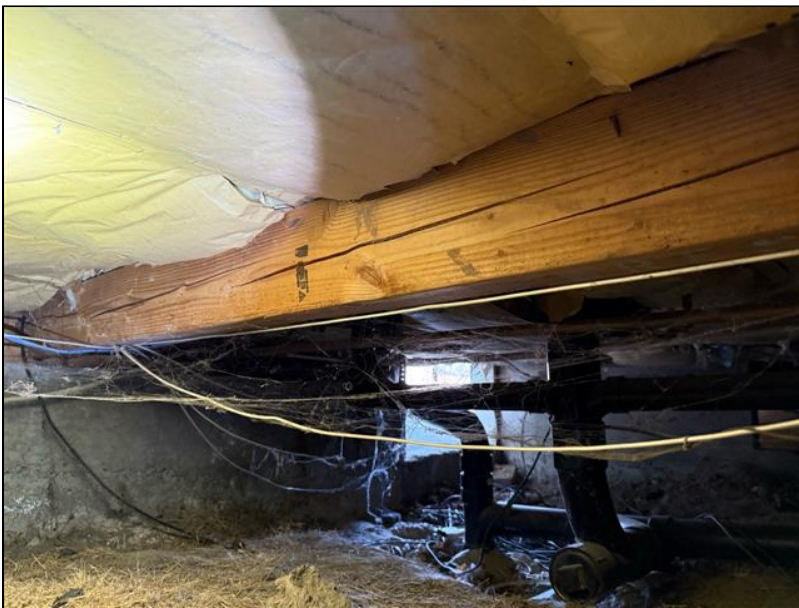
There are cracks to some of the main support girder beams in the crawl space. The inspector recommends consulting with a qualified tradesman for further evaluation and repairs.

9.3 Item 1(Picture) cracks to some of the main support girder beams in the crawl space

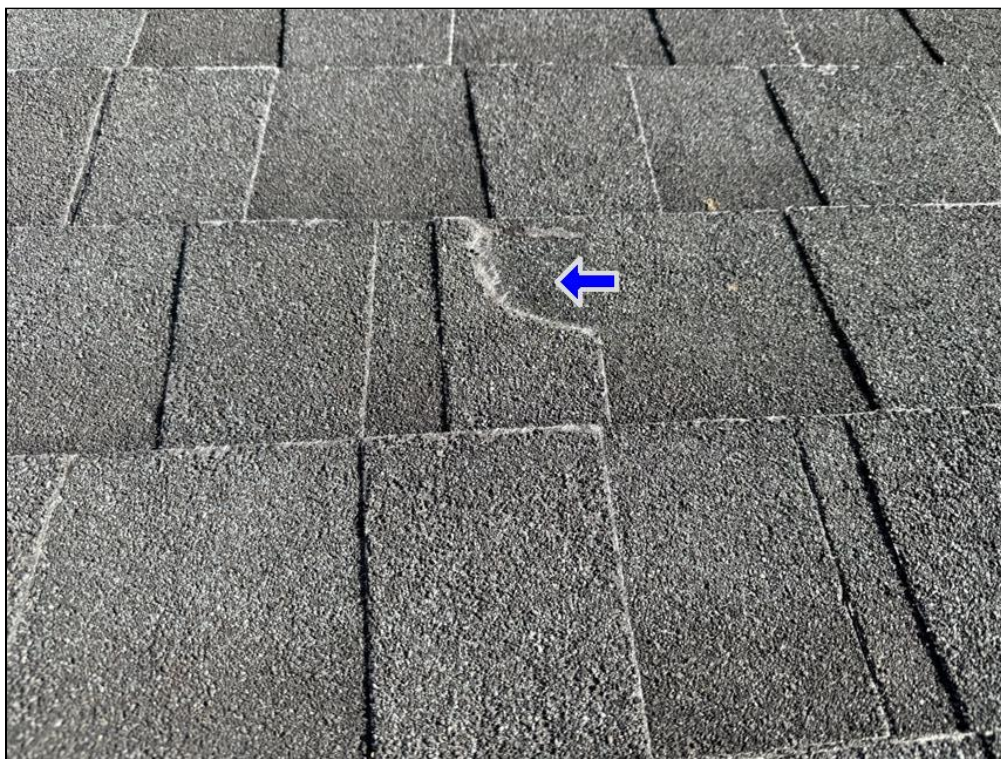
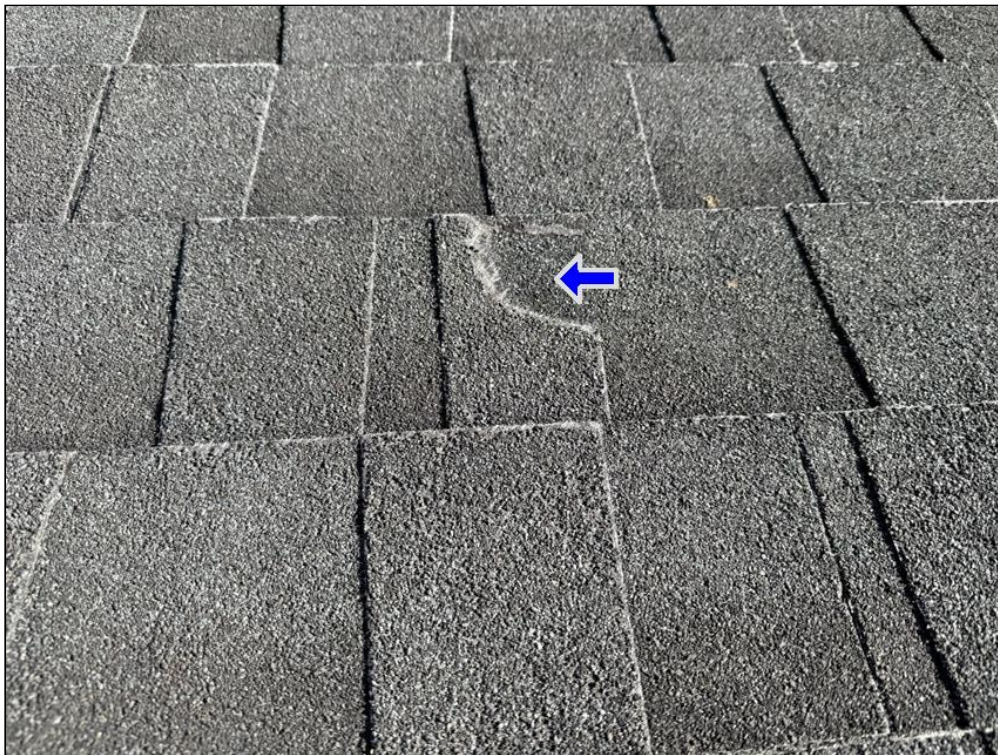
There are worn/torn roof shingles. The inspector recommends consulting with a qualified tradesman for further evaluation and repairs.

10.0 Item 1(Picture) worn/torn roof shingle
