Life Fitness Treadmill Belt Visual Inspection Guide

The treadmill striding belt and deck are designed to endure constant mechanical stress loads. It is important to visually inspect the belt and deck as part of your preventative maintenance program for potential belt replacement.

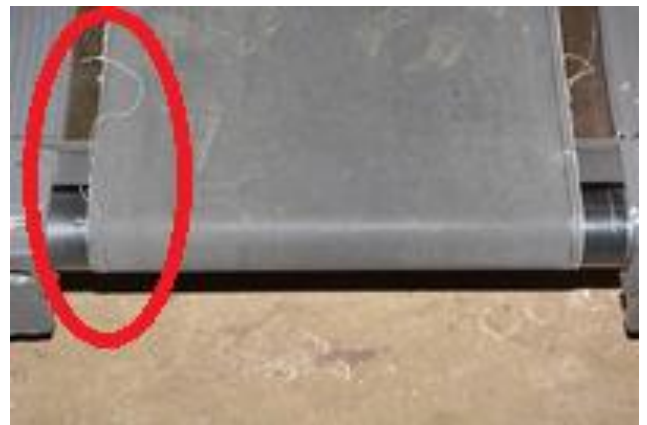
FRAYING ON BELT EDGES

Belt fray can be immediately detected visually.

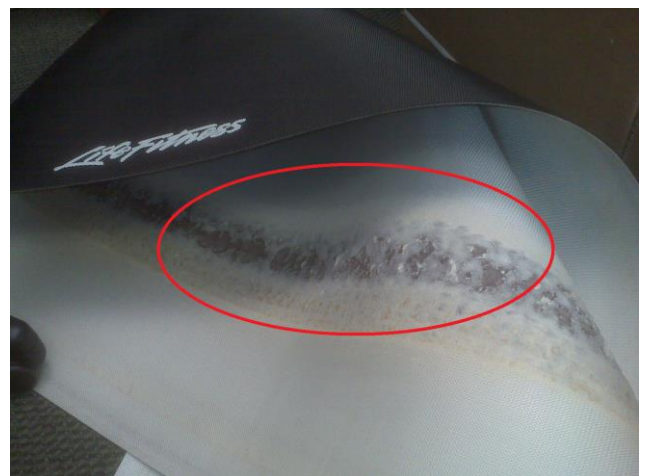
FRAYING UNDERNEATH BELT

Slightly lift the belt and run your hand underneath it. Belt fray may be detected.

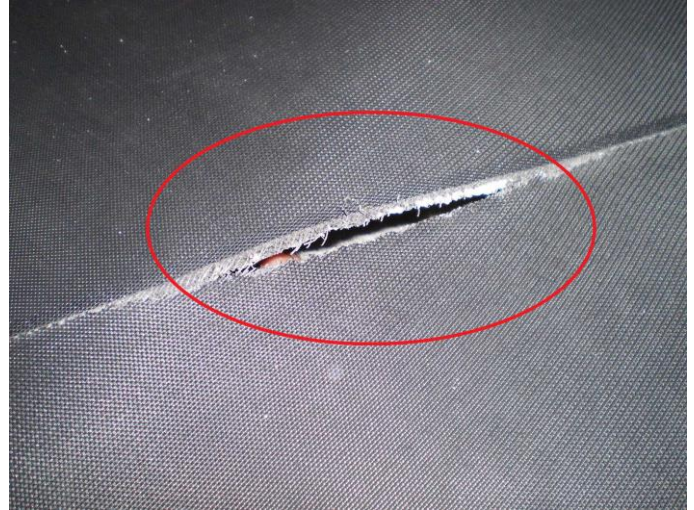
TORN OR FRAYED SEAMS

Check the seam that is located in the middle of the belt, on an angle. The seam is there to connect the ends of the belt. Torn or frayed seams may affect the integrity of the belt.

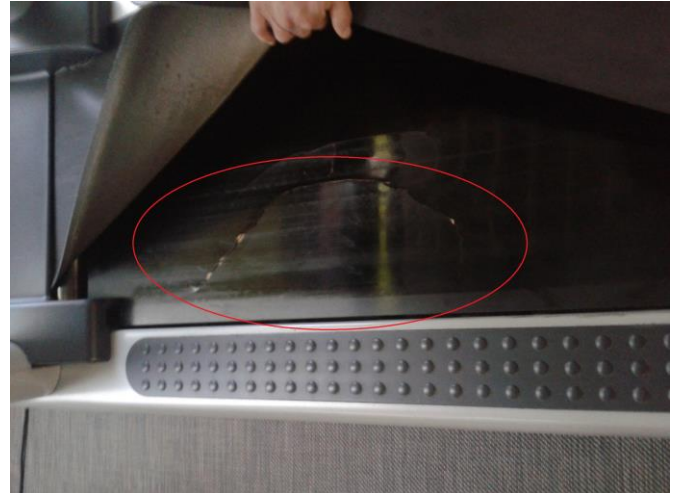
DAMAGED DECK

A damaged deck can be immediately detected visually by cracks, large chipped areas, and/or gouges under the belt area. Slightly lift the belt to visually inspect the deck.

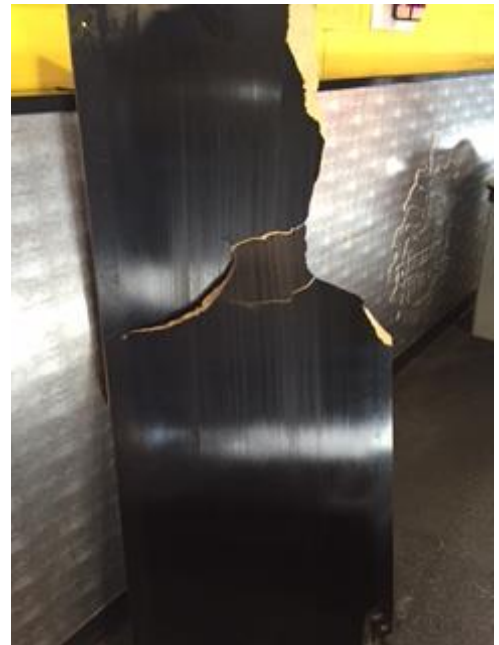
WORN DECK LAMINATE

The deck has a laminate layer that helps promote lubrication from the pre-infused striding belt. Excessive wear can create increased friction, and in turn, cause the laminate to wear off. Excessive wear can be detected visually. It is indicated by the black laminate finish worn through exposing the brown wood color.
