Land Information Memorandum

Valuation No.	0122009558
Location	27 Poplar Glade, Mangawhai
Legal Description	LOT 2 DP 501099 HAVING 1/18SH IN LOT 32 DP 211395
Owner	Bellam Gregory David: Bellam Leeann Dawn
Area (hectares)	1.6955

26/09/17 BUILDING CONSENT 170459: Single level 4-bedroom domestic dwelling, double garage, living, kitchen, dining, WC, laundry and so on: Code Compliance Certificate Issued 7/07/19. **Copy of Geotechnical Report attached.**

Ashby Consulting (T/A Haigh Workman Ltd) was commissioned by Greg Bellam (the client) to undertake a ground investigation of Lot 2 (DP 211395), Poplar Glade, Mangawhai (the "site"). This report presents the factual information available during the appraisal, interpretation of data obtained during fieldworks with site specific geotechnical recommendations relevant to the defined objectives.

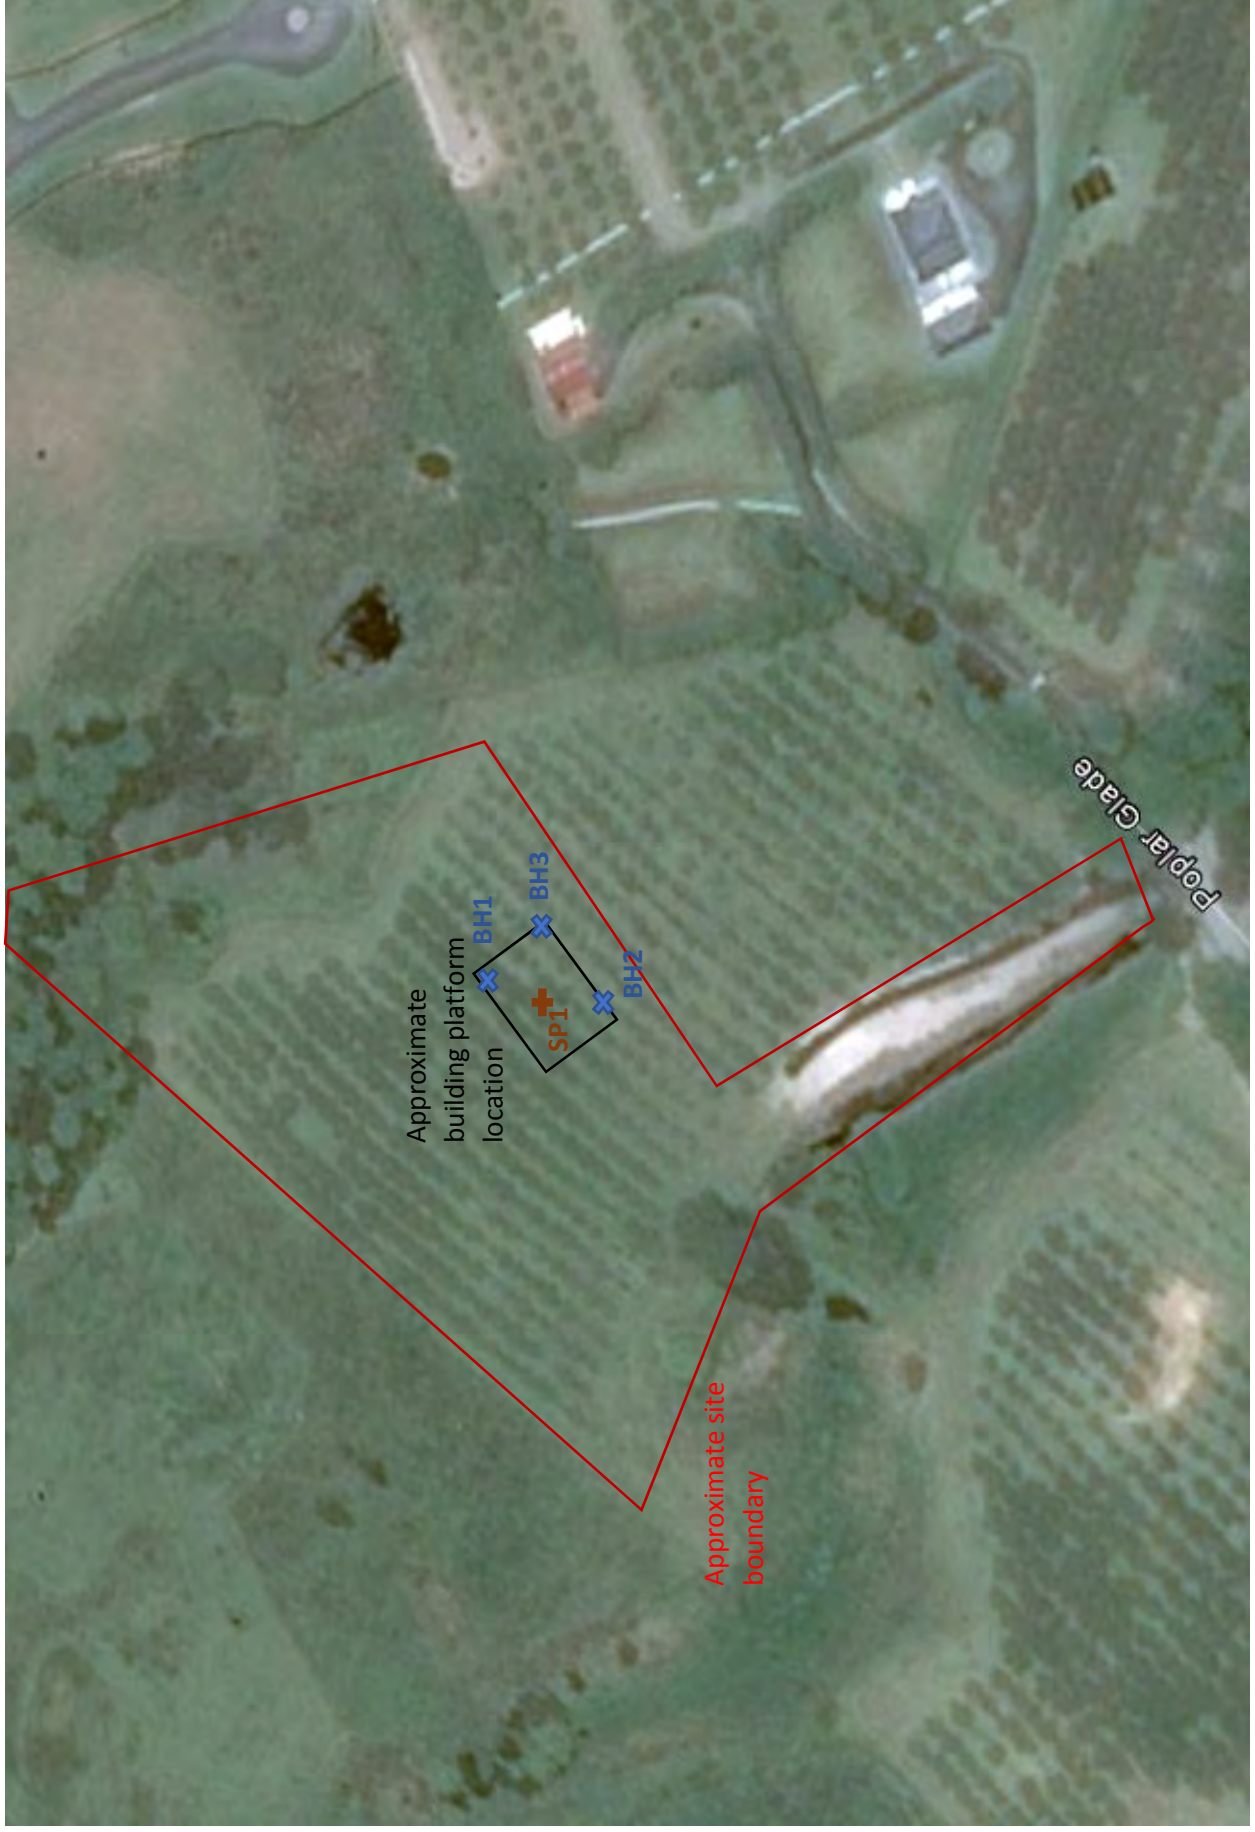
8251/02 - Exploratory Hole Location Plan

Recommendations and opinions contained in this report are based on the field results at exploratory positions as defined on Drawing No. 8251/02 included within Appendix A, information from available geological maps and geotechnical/local authority databases. The nature and continuity of subsurface soil and groundwater conditions away from the test locations is inferred, it must be appreciated that the actual ground conditions may vary from the assumed model between exploratory positions.

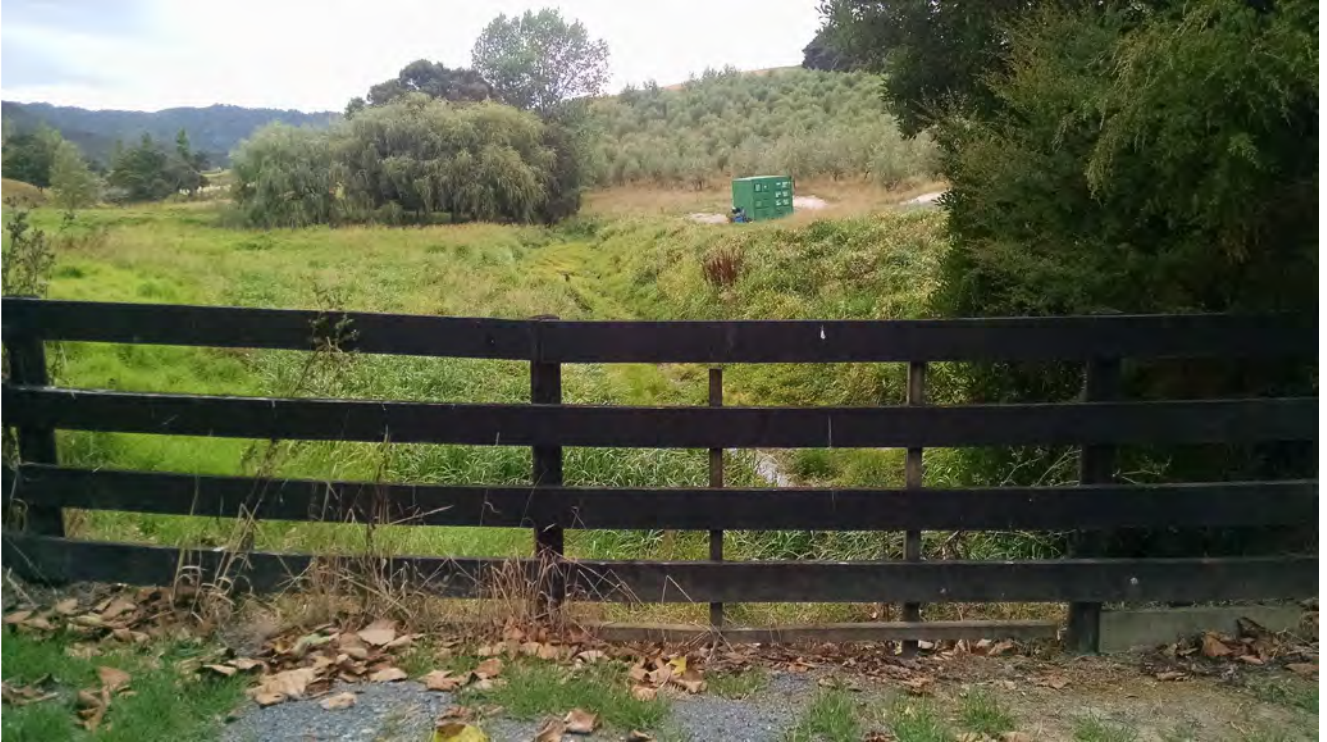
Figure 3 – Photograph from Poplar Glade looking north across the west of the site, shipping container and cut batters of the metalled driveway are visible

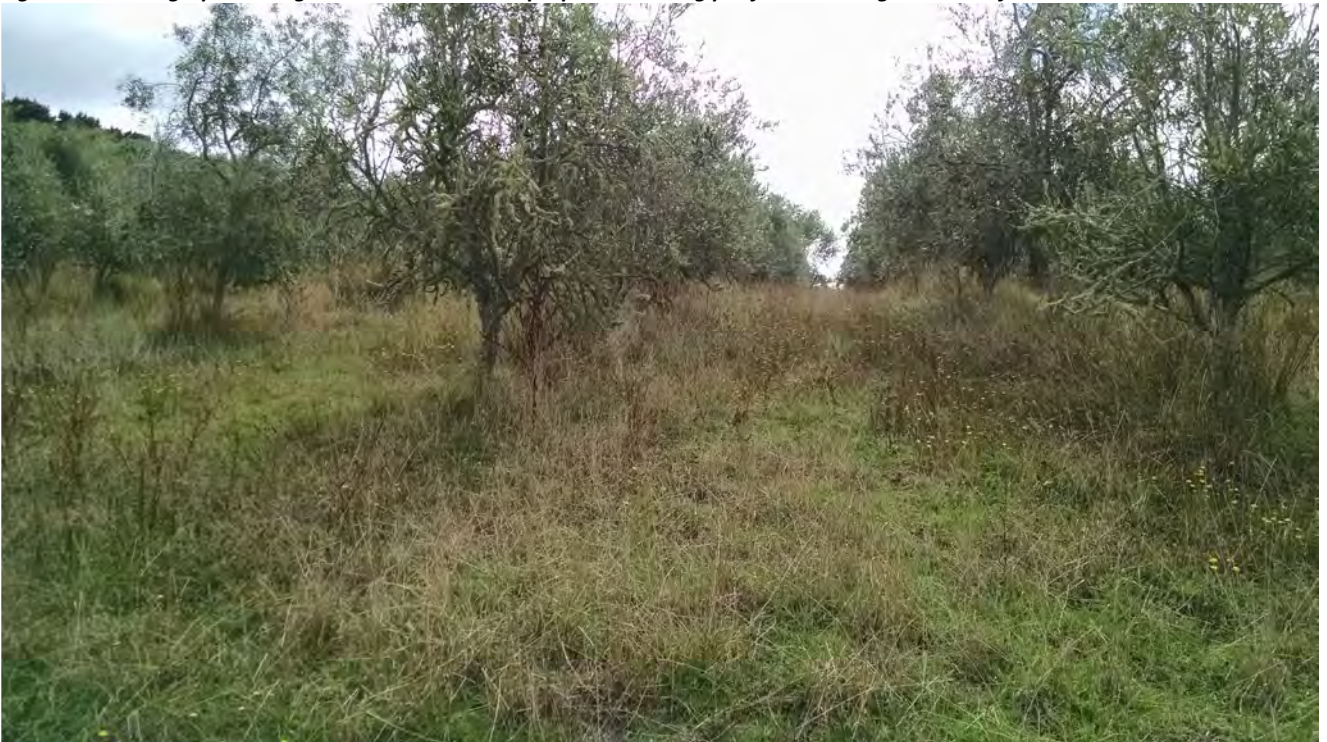
Figure 4 – Photograph looking north-east across the proposed building platform showing the rows of olive trees

In reference to NZS3604:2011 Section 3.7, Clause 3.7.1 states *'trees remove moisture from the soil for a radius equal to the height of the tree. This causes expansive soils to shrink to varying degrees, and when near houses leads to differential settlement occurring under foundations. The mature height of the tree must be considered in the location of trees near houses. Movement of the foundations may lead to cracks in the building and door jamming'*.

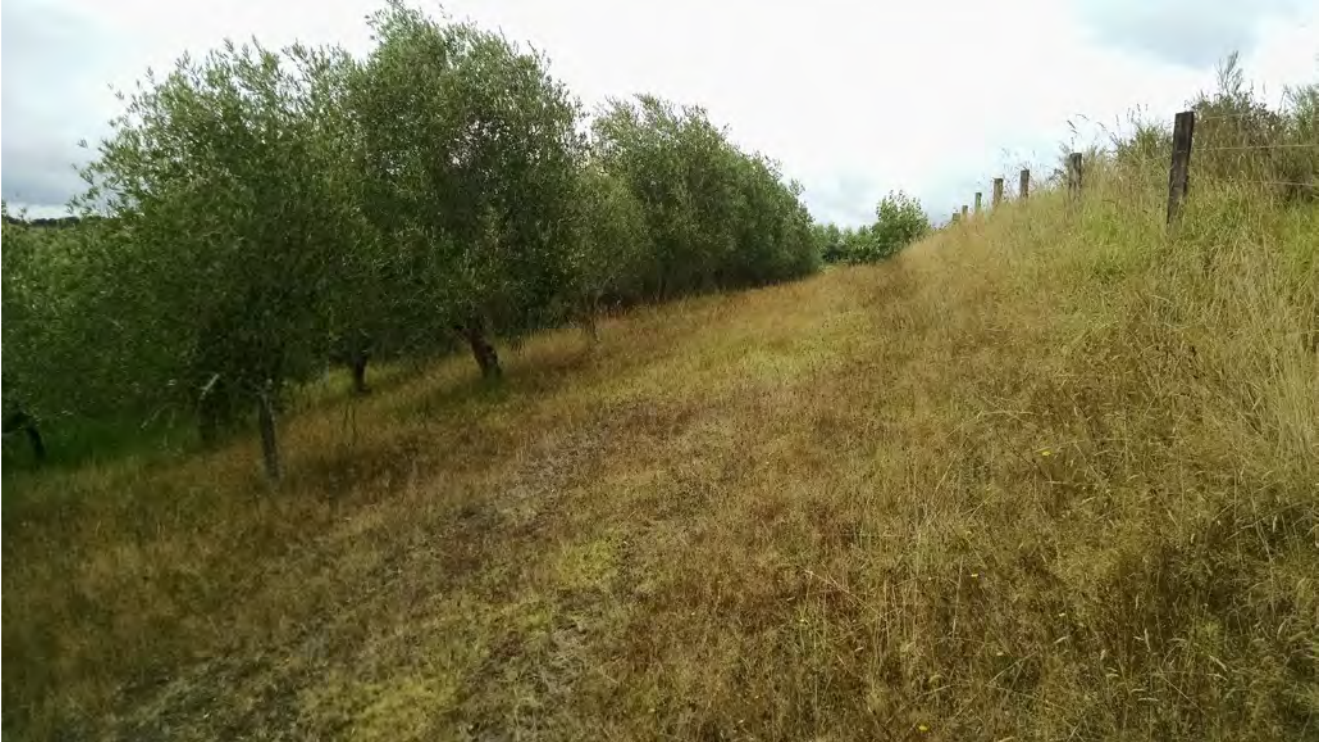
Figure 5 – Photograph looking south-west along the fenced north-western boundary towards the highest point of the site

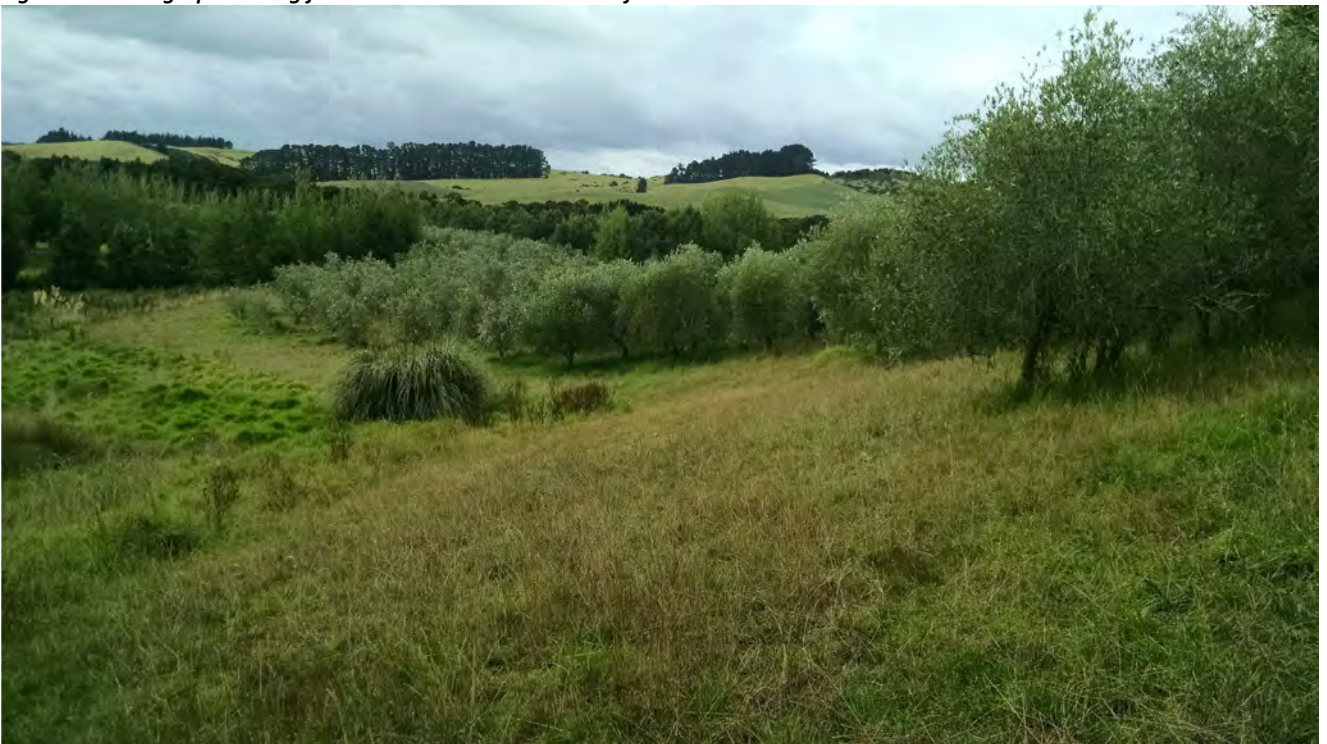
Figure 6 – Photograph looking from the north across the east of the site
