# Technical Service Information

## THM 4L80-E CENTER GEAR BOX CHANGES FOR 1999 MODELS ("REVISED INFORMATION")

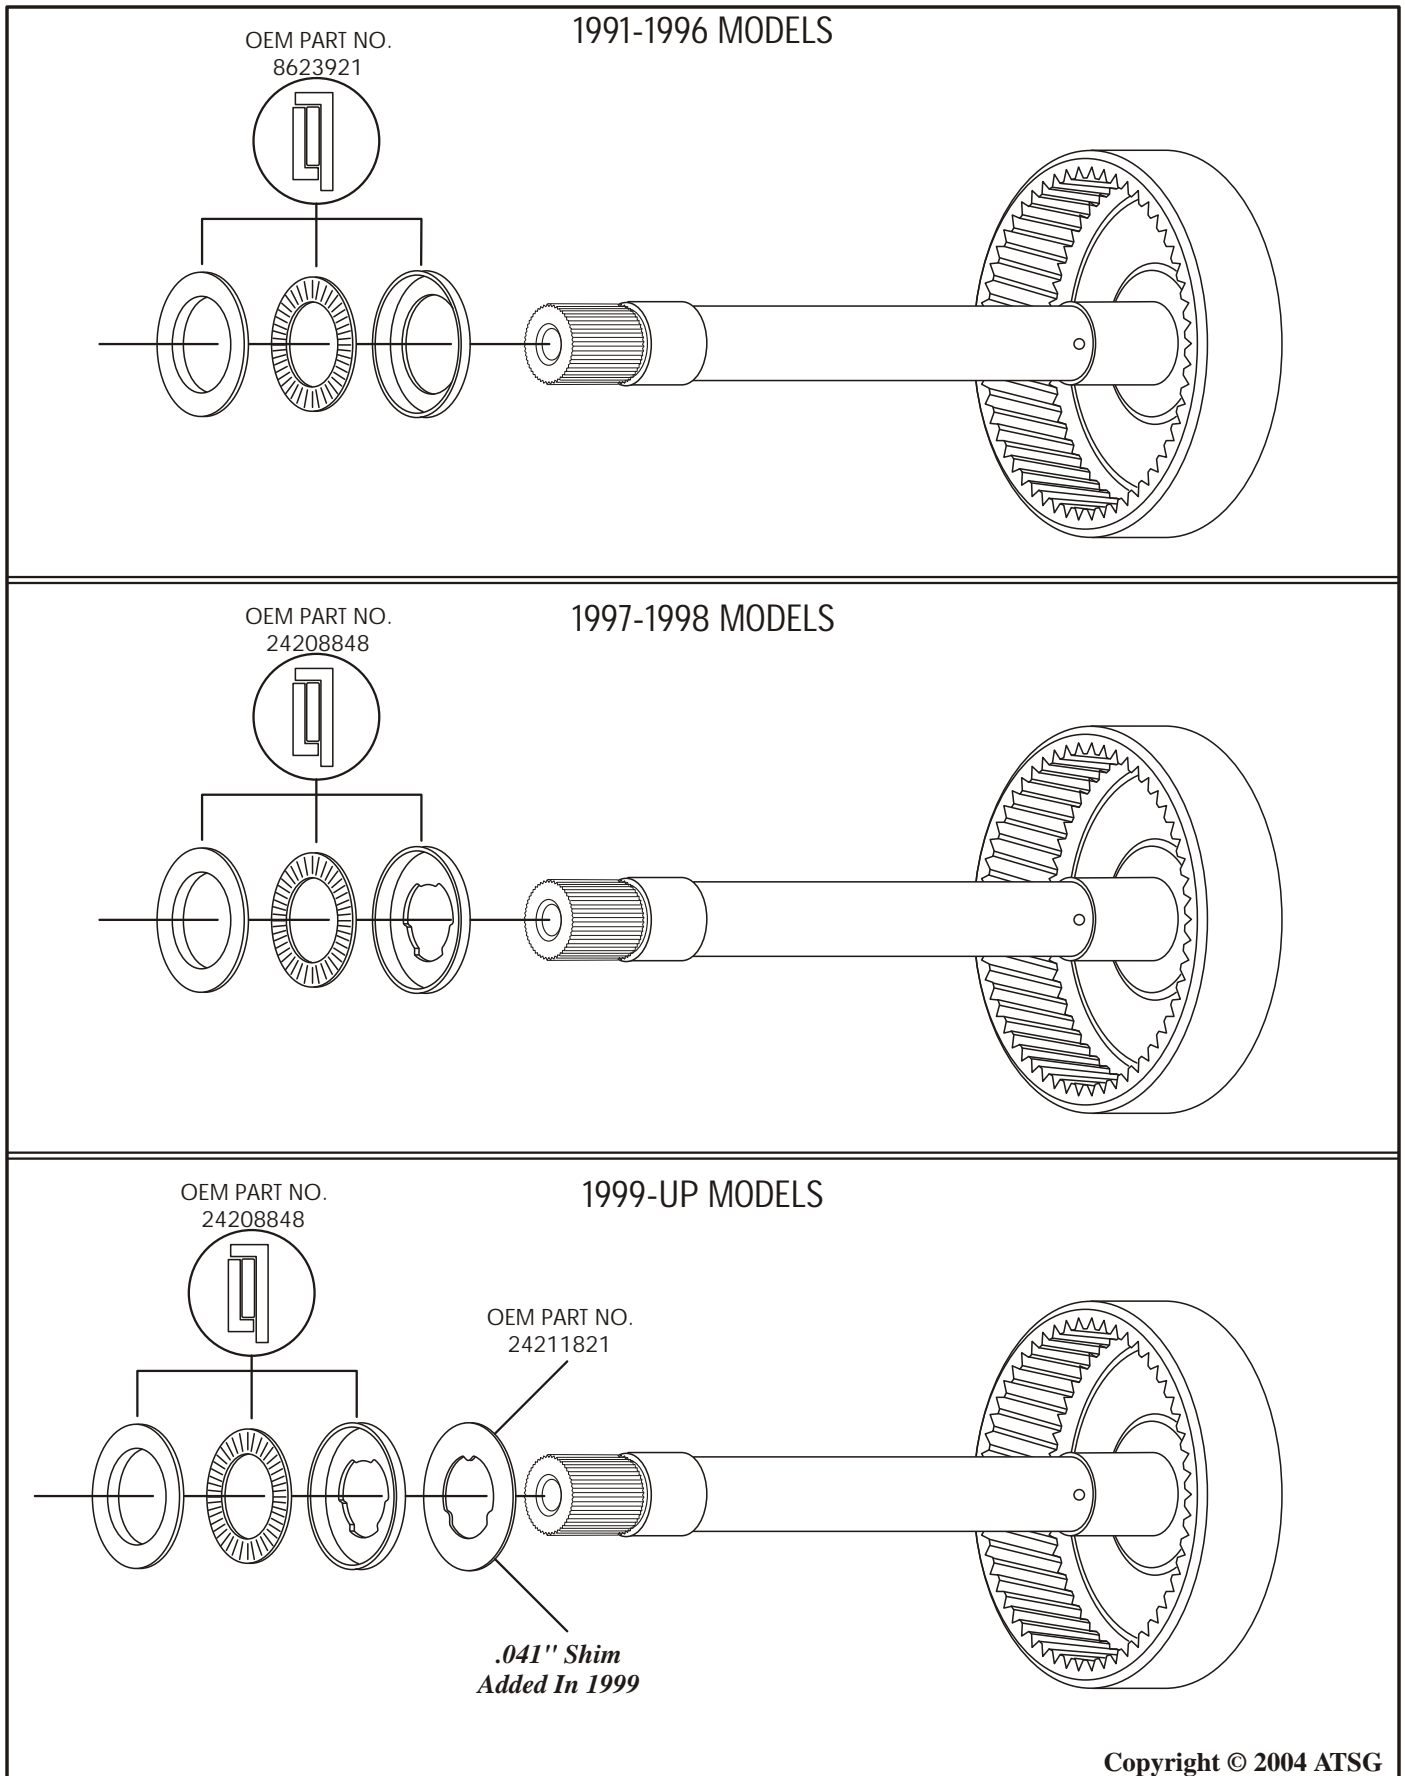
Figure 1

**CHANGE:** Beginning at the start of production for all 1999 model THM 4L80E transmissions, the planetary pinions on both carriers were produced 10% thicker than the previous models, as shown in Figure 1. This engineering change required the addition of a .041" shim in the gear train to re-center the sun gear in the new planetary pinions and affected several internal parts, that may create some confusion, and thus some mis-assembly concerns.

- (1) PLANETARY PINION GEARS - Were increased in length by approximately .075" in both front and rear carriers, as shown in Figure 1, for increased durability.
- (2) ADDED .041" SHIM - There was a .041" shim added between the thrust bearing and the rear internal ring gear, to re-center the sun gear in the revised planetary pinion gears, as shown in Figure 2.
- (3) CENTER SUPPORT - Required a .041" recess to be machined into the center support bearing surface, to accommodate the sun gear being re-centered in the revised planetary pinion gears, as shown in Figure 3.

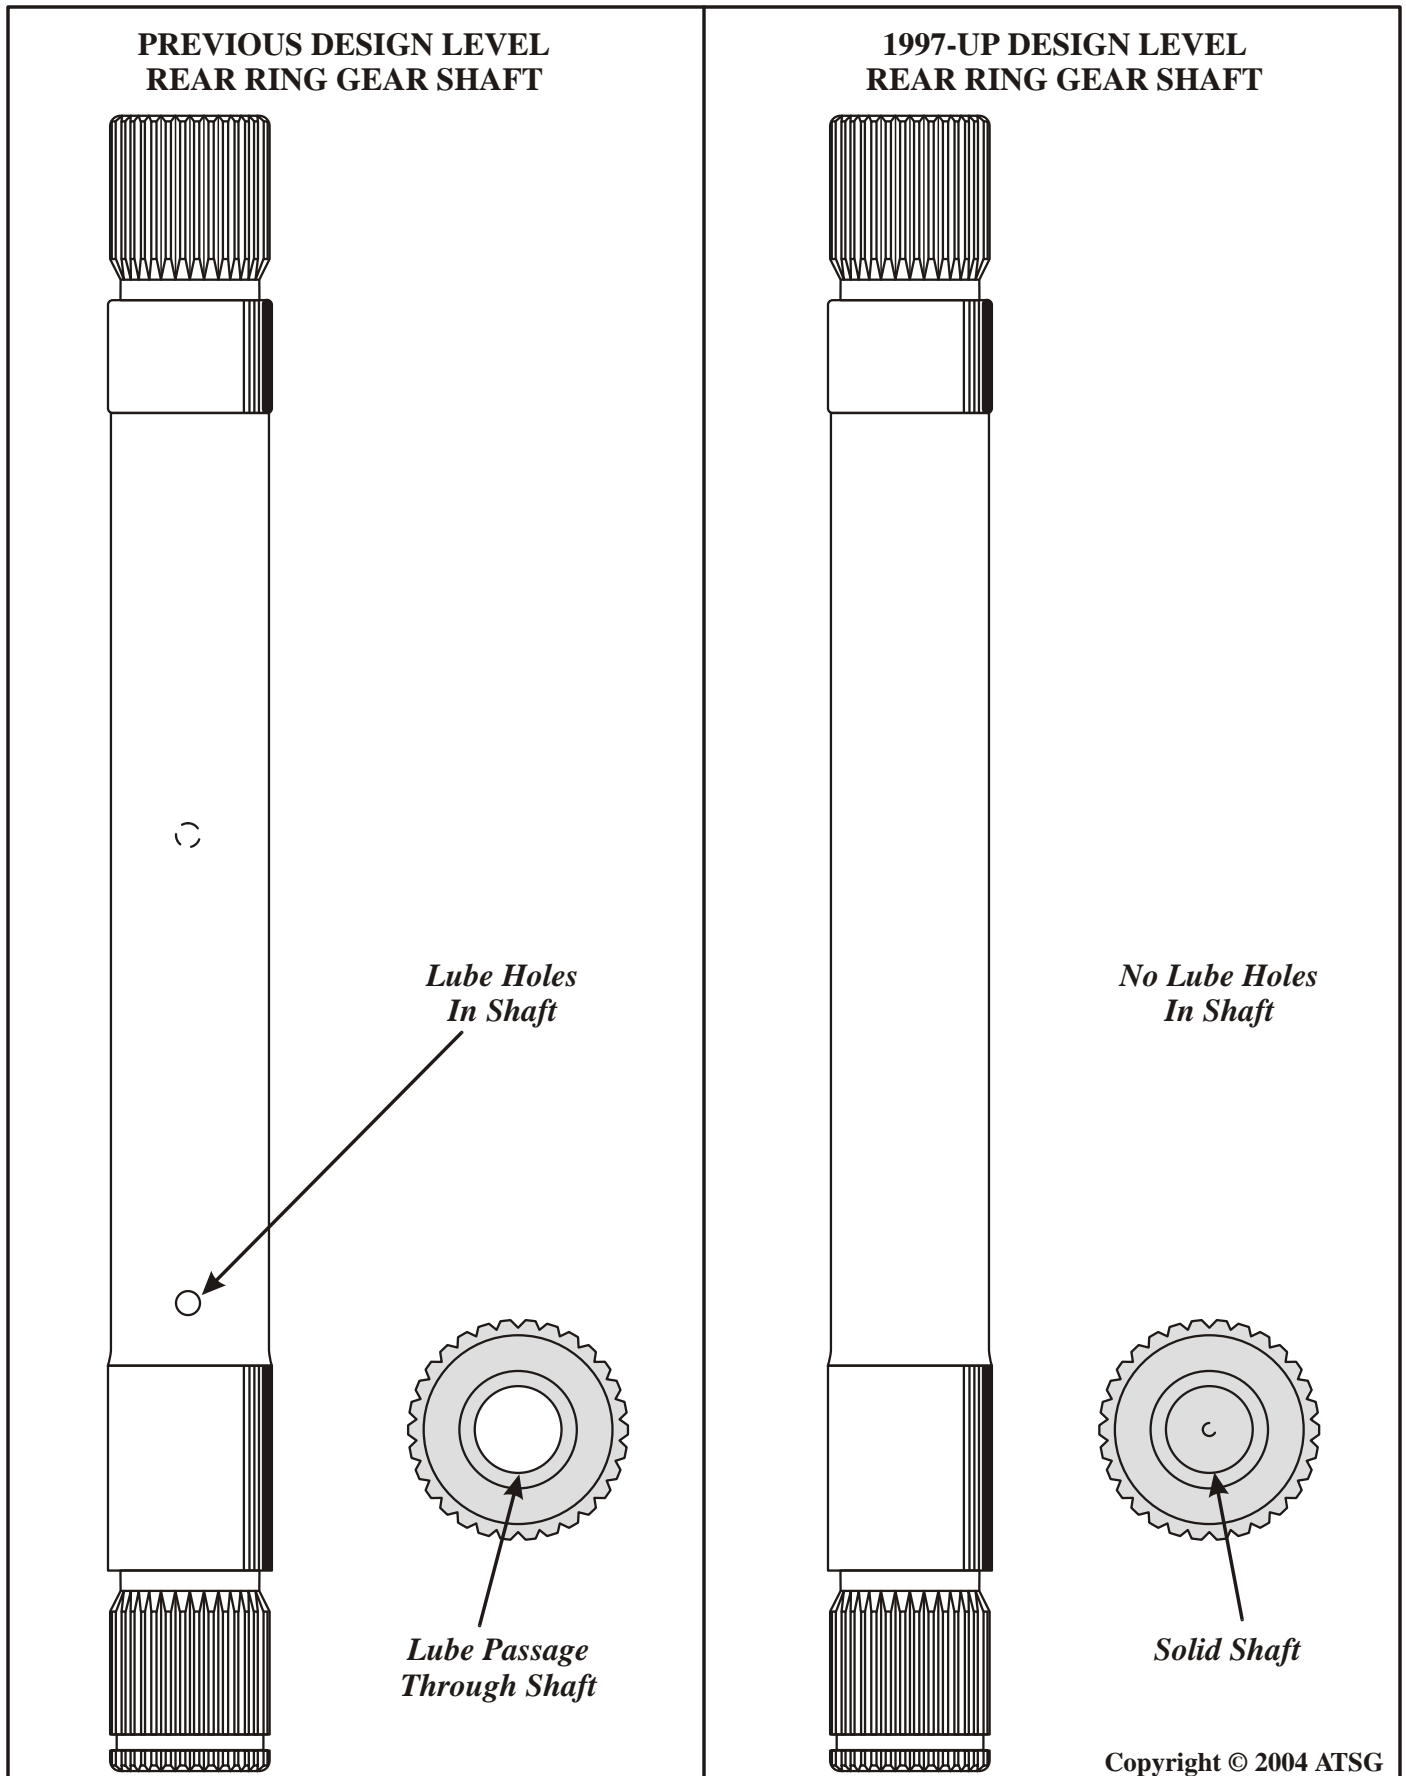
Figure 5

The Sun Gear, Main Shaft, Rear Internal Ring Gear and all Thrust Bearings remained the same, as shown in Figures 5, 6, and 7.

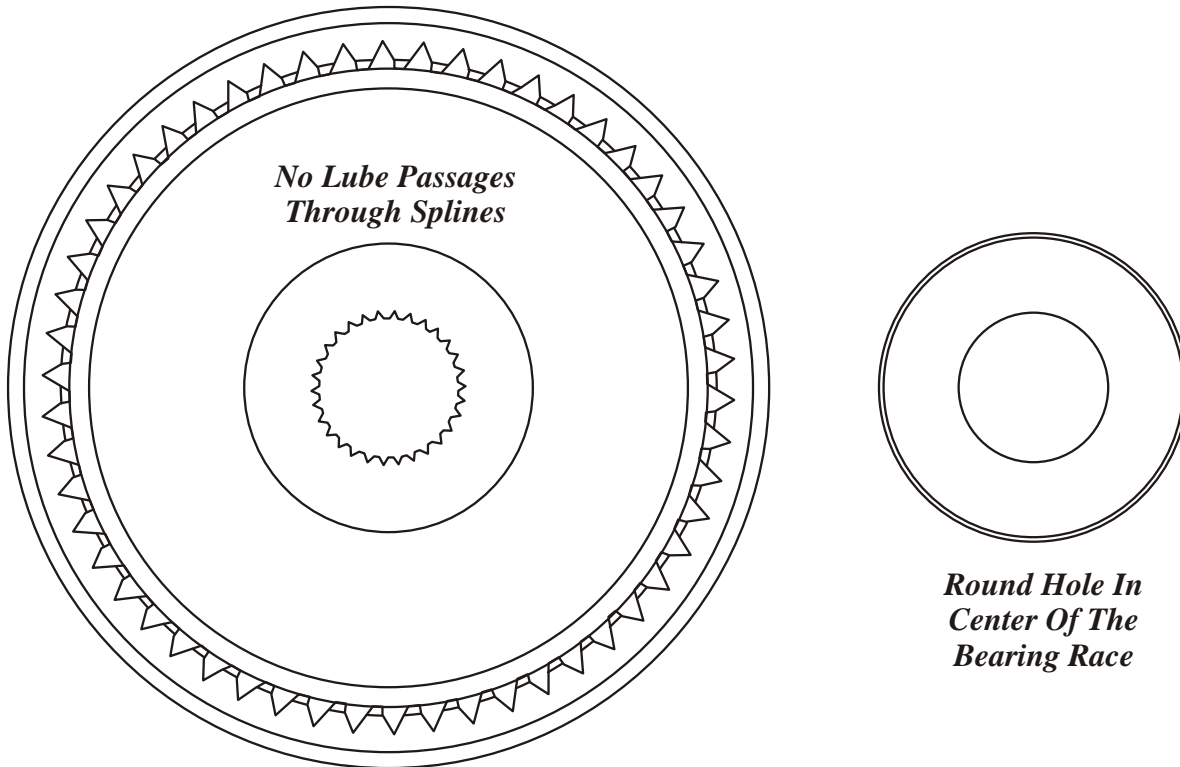
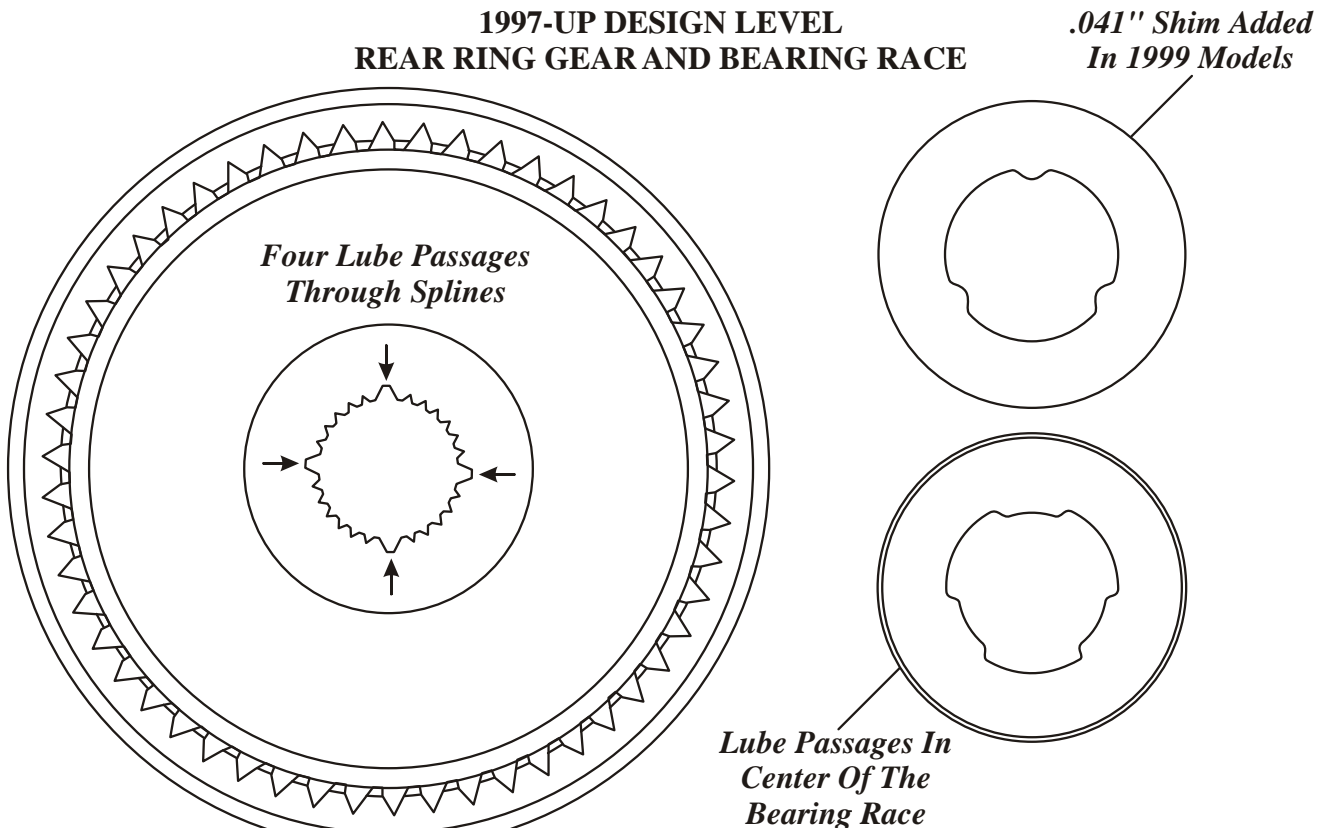
Figure 6

## PREVIOUS DESIGN LEVEL REAR RING GEAR AND BEARING RACE

## 1997-UP DESIGN LEVEL REAR RING GEAR AND BEARING RACE
