Technical Service Information

HONDA/ACURA BAXA/B7XA FAMILY TIE UP IN REVERSE WHEN HOT

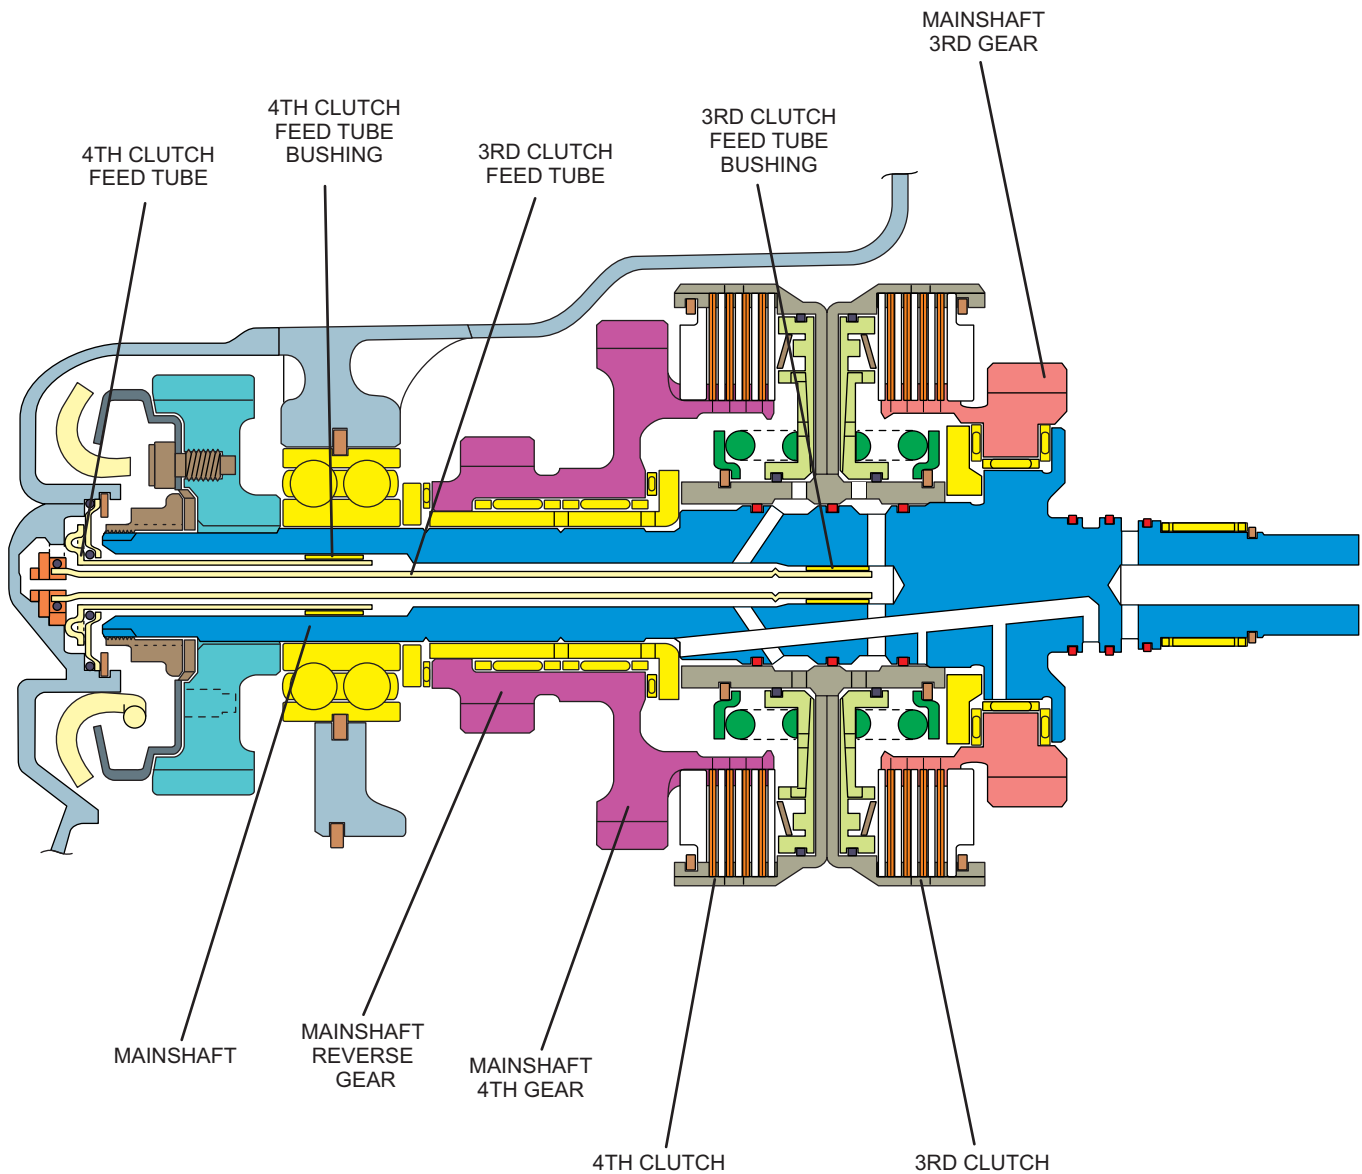
Figure 1

The partial cutaway drawing in figure 1 shows the parts associated with the main shaft including the tubes, bushings, gears, and clutch drum. Refer to the partial cutaway drawing in figure 2. This diagram shows the area of concern within the mainshaft where the cross over leak may occur.

HONDA/ACURA BAXA/B7XA FAMILY PARTIAL CUTAWAY MAINSHAFT PARTS
