DODGE/JEEP 45/545RFE DRIVE LINE “PING” COMING OUT OR INTO PARK

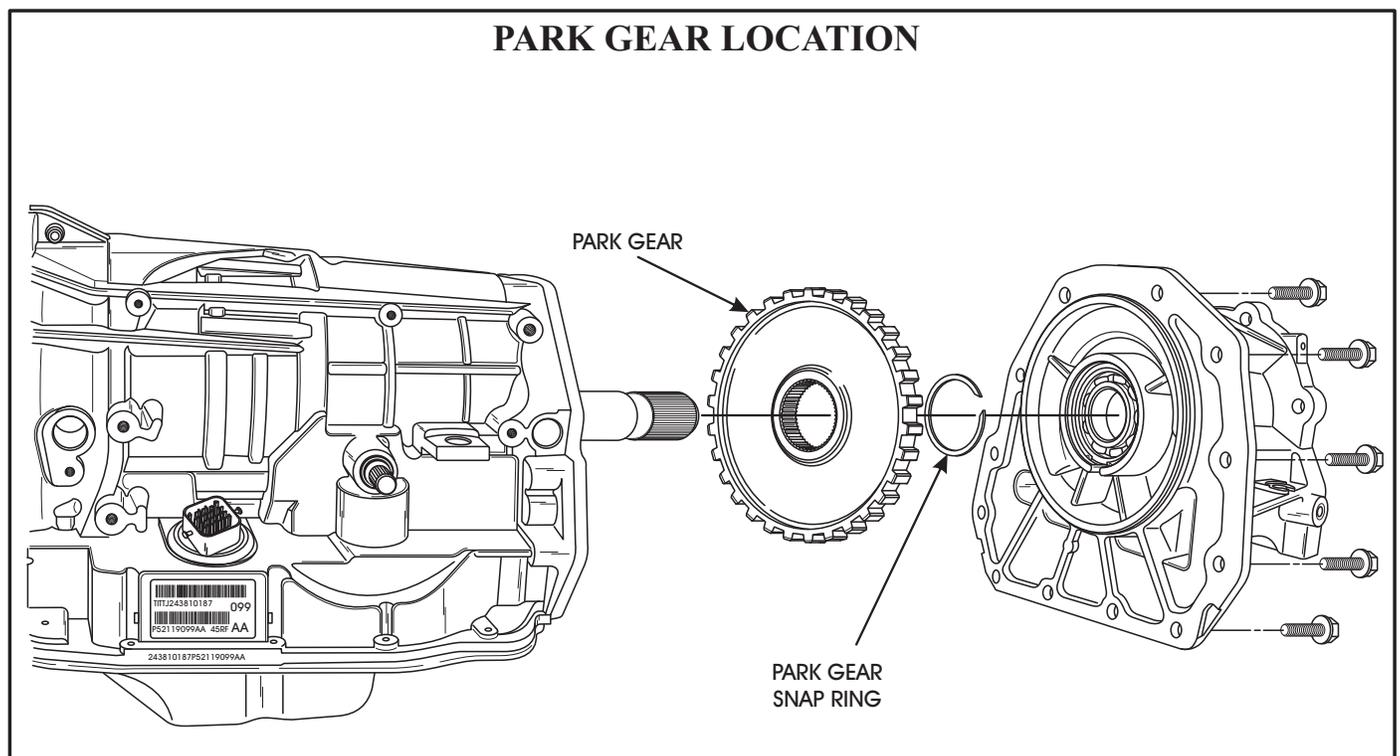
Figure 1

COMPLAINT: Dodge/Jeep vehicles equipped with the 45/545RFE transmission, may exhibit a complaint of a “Ping” or metallic noise coming out, or into the Park position. Upon a closer inspection, with the vehicle on the lift, the noise can be heard from the tail housing area where the Park gear is located in the transmission. (See Figure 1). Remove the tail housing and strike the park gear with a metal object to see if the sound you heard is the same sound.
