BMW/FORD ZF6HP26/6R60

3-4 OR 4-5 FLARE

Technical Service Information

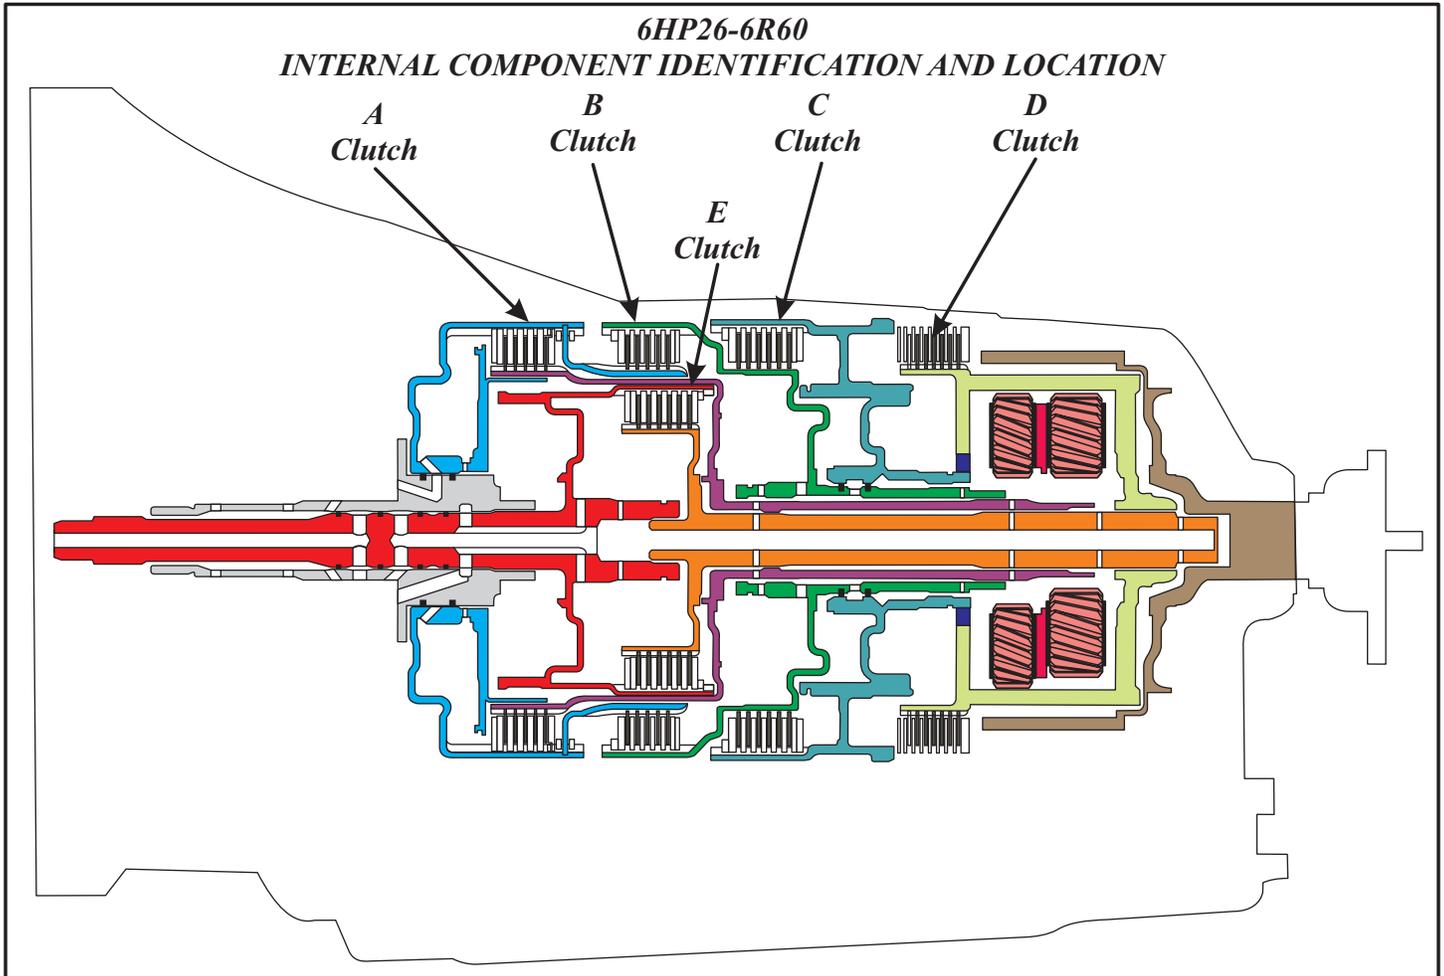
CAUSE: The cause may be, that the bushing in the back of the pump stator, as shown in Figure 1, is worn causing a leak of "E" Clutch apply pressure. Refer to Figure 2 for a component application chart.
