## ZF5HP24 NEUTRALIZATION WHEN HOT FORWARD CHATTER ON TAKE OFF

## ZF5HP24

### NEUTRALIZATION WHEN HOT

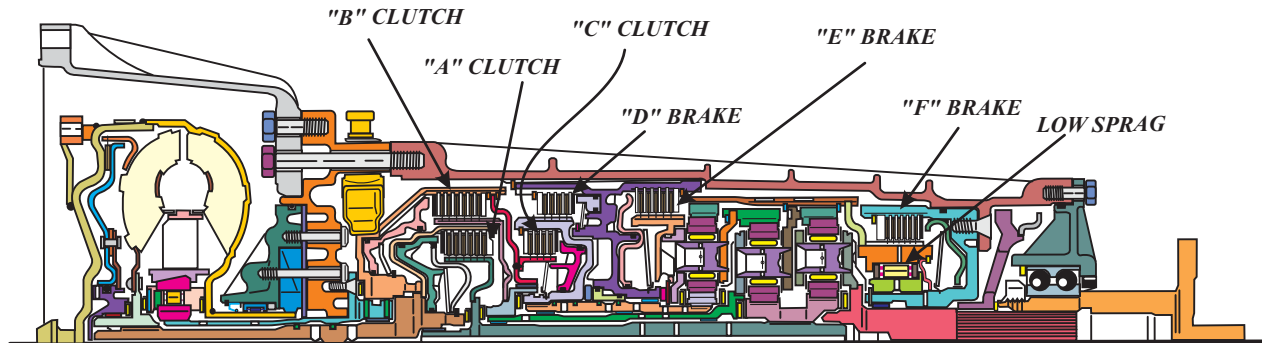
Figure 3

**CAUSE:** A crack develops in the upper valve body (Refer to figure 1) in the “F” clutch circuit as seen in figure 2 which results in a loss of “F” clutch oil. The “F” clutch is on in park, reverse and neutral as well as manual low as shown in the clutch application chart in figure 3. Since the complaint of neutral at a stop affects forward movement, yet it does not affect reverse is due to the “F” clutch being fed in park and neutral by the “F” clutch valve but in reverse it is fed line pressure through the reverse valve as shown in Figure 2. The reason first gear is affected is because oil pressure is being supplied to the closed “F” clutch valve through the hydraulic circuit that is affected by the crack from shift valve 1 as seen in figure 2. This circuit is connected to the “A” clutch in first gear only. So the loss of pressure going to the “F” clutch valve is enough to cause the “A” clutch to release at engine idle RPMS when hot and slip the clutch on initial take-off, hence the first gear ratio codes and the remaining forward gears will not be affected.

**CORRECTION:** Replace the upper valve body or the complete valve body assembly.
