Technical Service Information

DODGE 68RFE CLUNK NOISE FROM DRIVE TO NEUTRAL

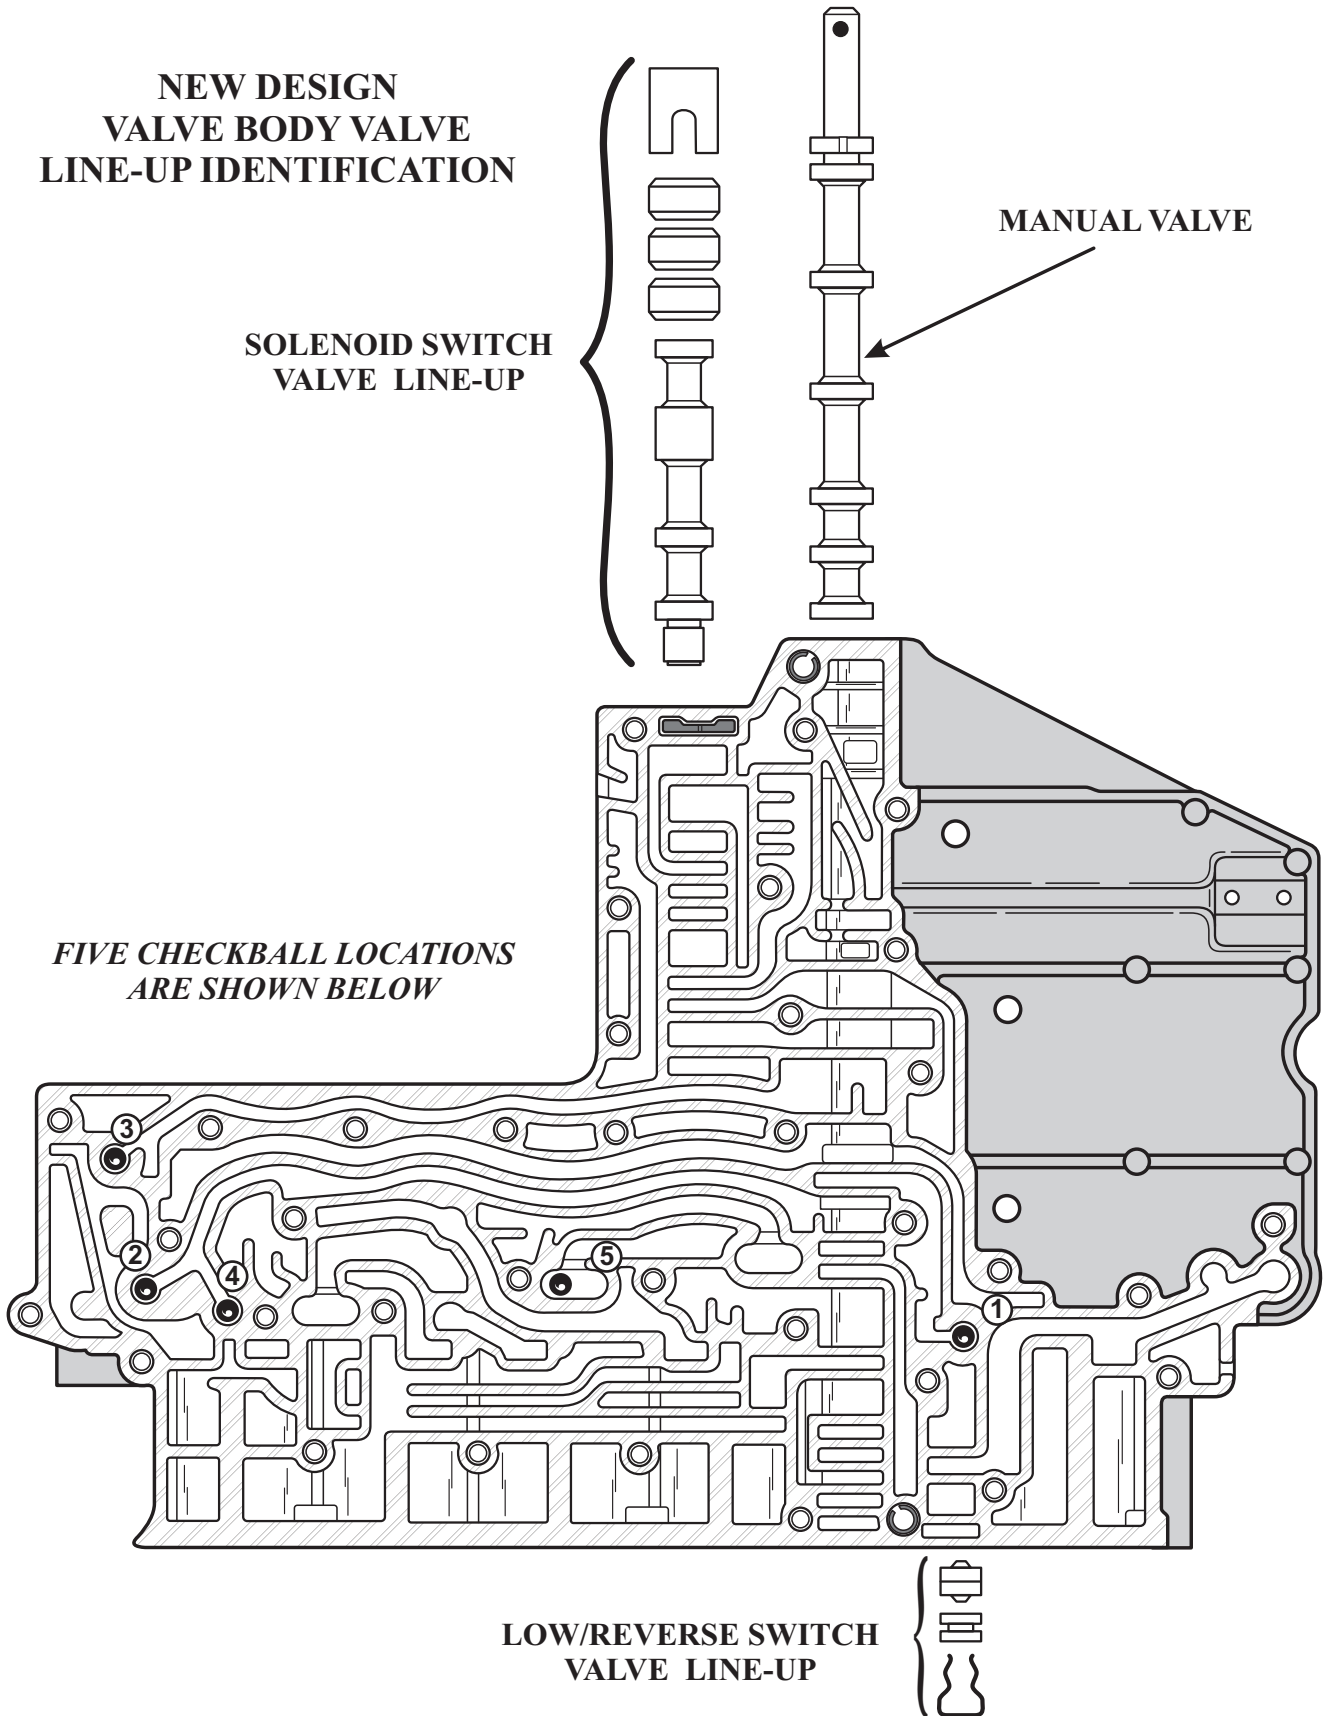
Figure 3

**NEW DESIGN
VALVE BODY VALVE
LINE-UP IDENTIFICATION**

**SOLENOID SWITCH
VALVE LINE-UP**

***FIVE CHECKBALL LOCATIONS
ARE SHOWN BELOW***
