# Technical Service Information

## GM 4L70E INPUT SPEED SENSOR FAULT

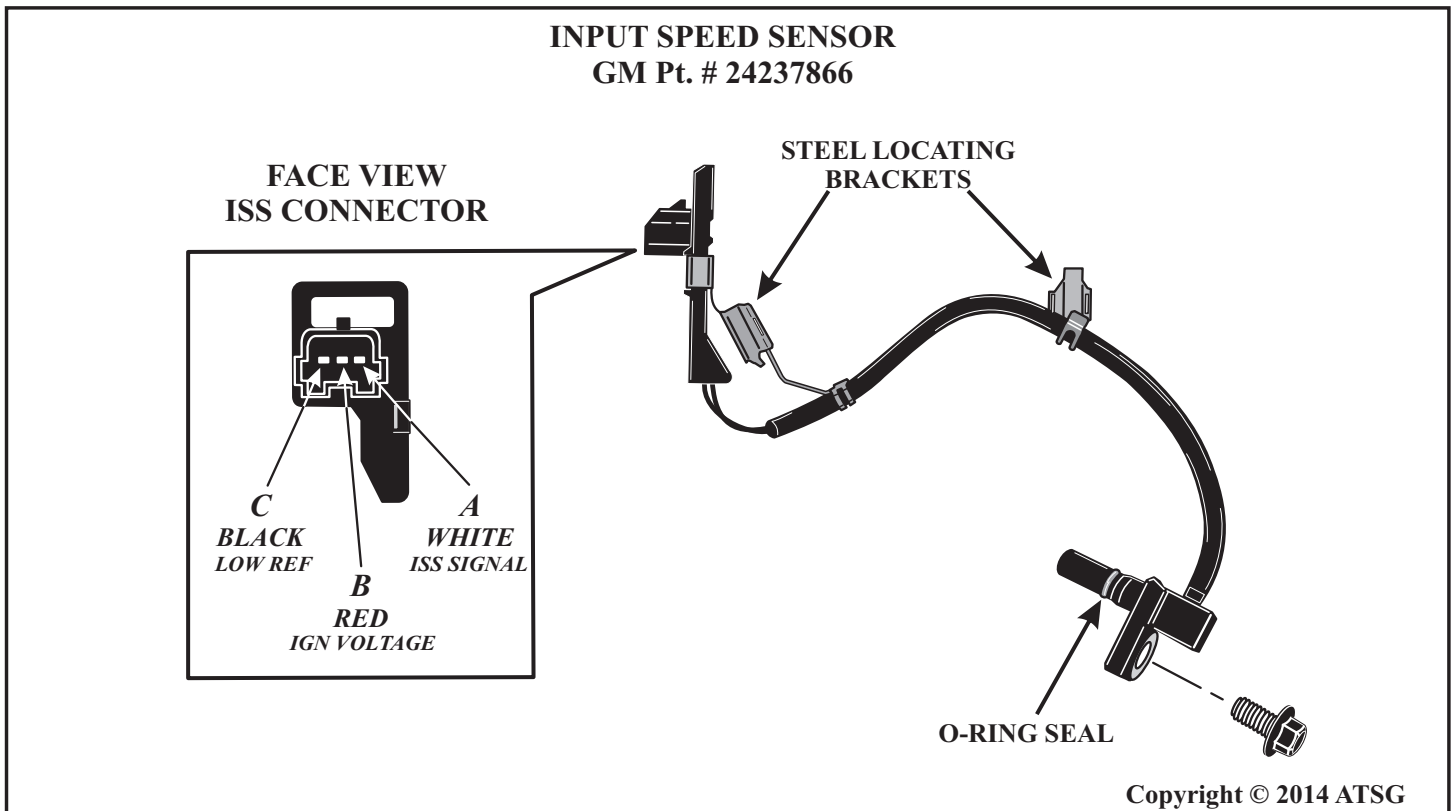
Figure 2

What has happened is the fine wire that provides the ground circuit for the input speed sensor has broken which results in the above complaint.

This type of TCM has been causing a number of code related problems due to its fragile construction and its placement in harsh environments which is usually next to the battery.

**CORRECTION:** Since this is a computer supplied ground, the proper repair would be to replace the TCM, however, if soldering skills are good, the original TCM could be repaired.
