Technical Service Information

BMW ZF6HP26/19 “E” SHIFT DTC 507B STAYS IN PARK

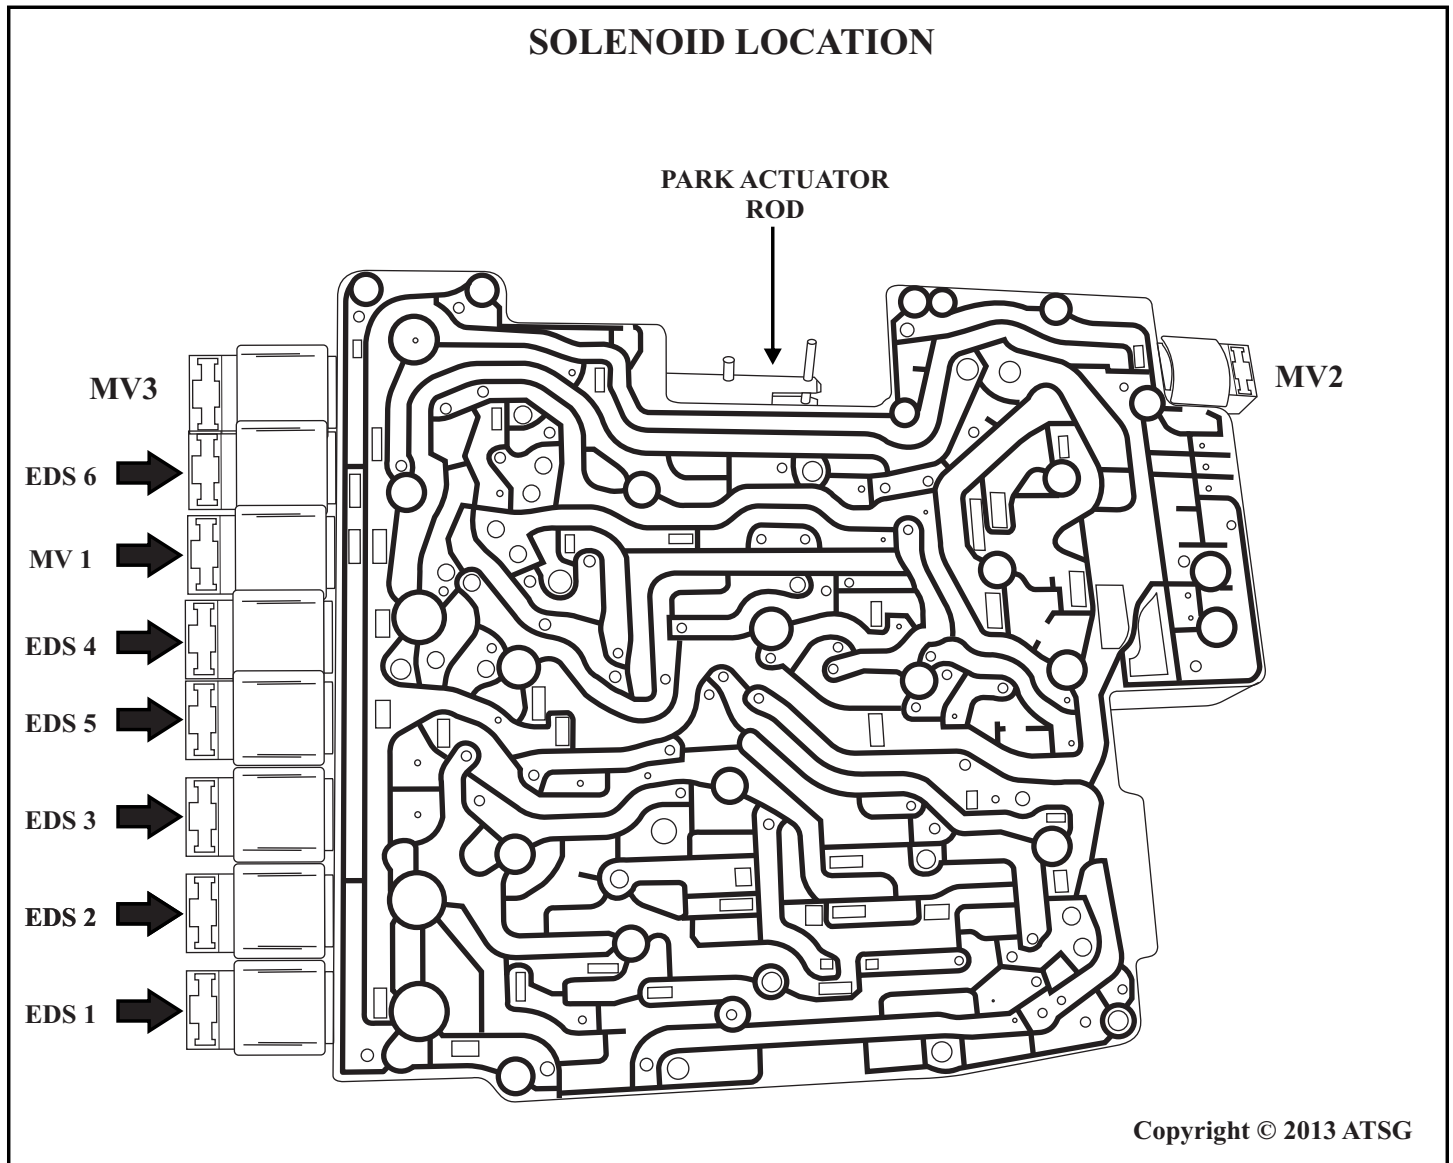
Figure 2

The MV3 Solenoid is mounted on the back side of the park lock cylinder which is on the valve body, as shown in Figure 2. Inside the cylinder there is a piston which connects to the rotating lever. When the MV3 Solenoid is OFF, a shaft extends out from the solenoid, pushing the rear of the piston and lever into the park position. When a command is requested to release park, the MV3 Solenoid is energized and the shaft retracts. At this time the MV2 Solenoid is also energized and it supplies fluid pressure to a chamber inside the front area of the cylinder which pushes the piston, rotating lever and park rod into the released position, as shown in Figure 3.

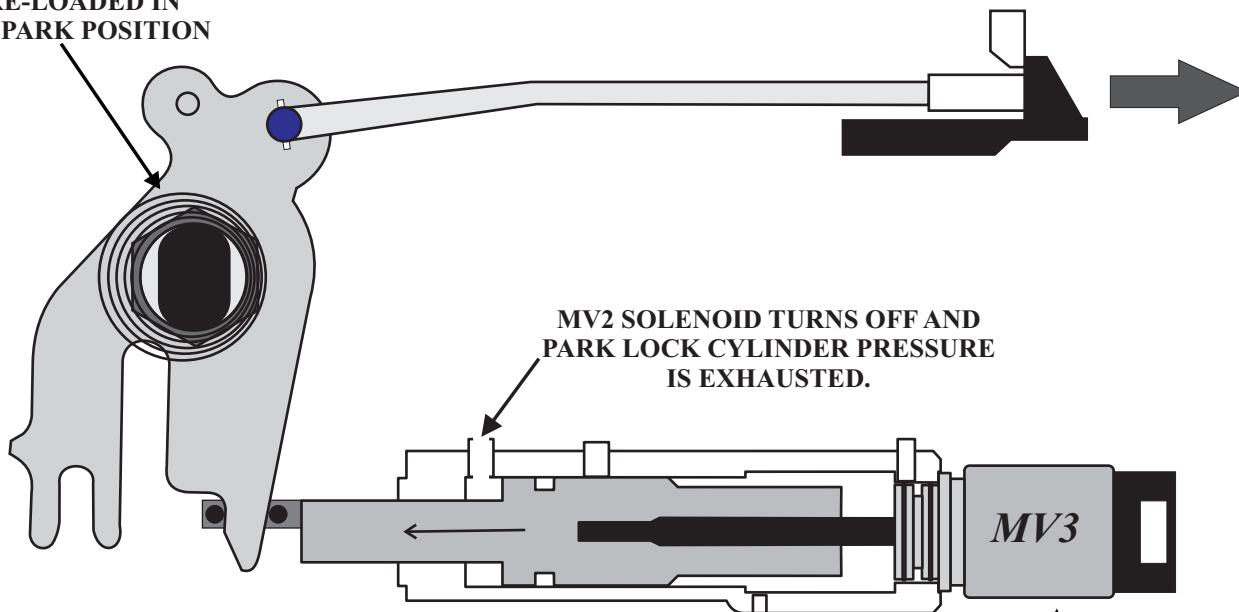
PARK POSITION

THE BARREL SPRING IS
PRE-LOADED IN
THE PARK POSITION

MV2 SOLENOID TURNS OFF AND
PARK LOCK CYLINDER PRESSURE
IS EXHAUSTED.

MV3 SOLENOID TURNS OFF
CAUSING ITS SHAFT TO EXTEND
PUSHING THE PISTON INTO THE
PARK POSITION.

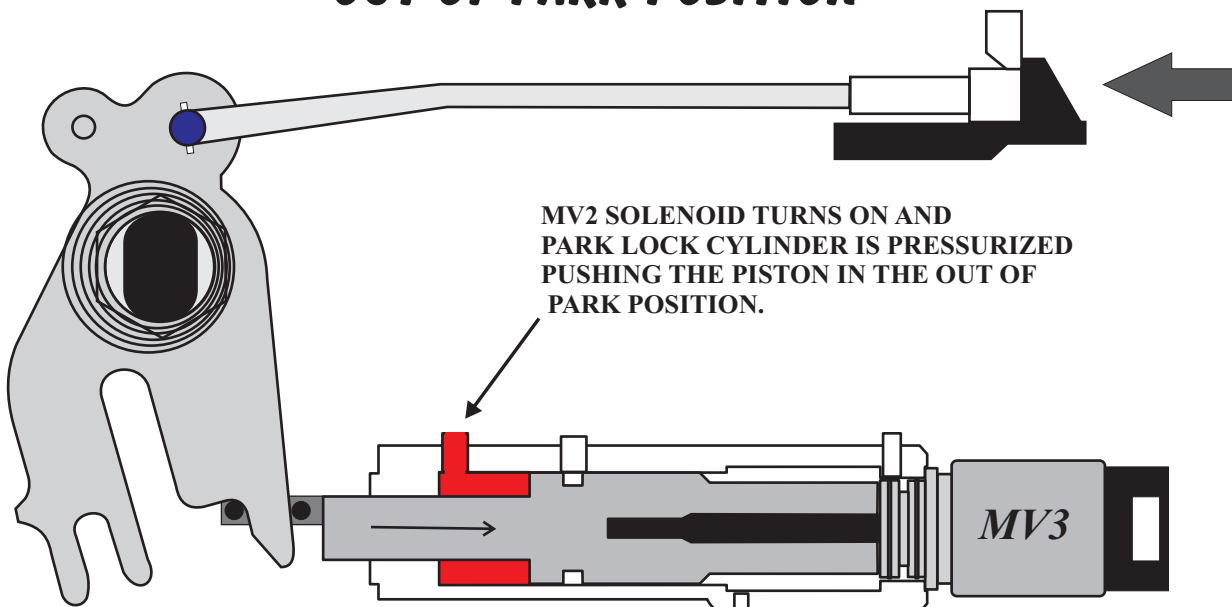
OUT OF PARK POSITION

MV2 SOLENOID TURNS ON AND
PARK LOCK CYLINDER IS PRESSURIZED
PUSHING THE PISTON IN THE OUT OF
PARK POSITION.

MV3 SOLENOID TURNS ON
CAUSING ITS SHAFT TO RETRACT.
