## CHEVROLET AVEO HARSH ENGAGEMENTS & NO OVERDRIVE

**COMPLAINT:** A 2009 to 2011 Chevrolet Aveo may have a complaint of harsh engagements and no 3-4 shift. In addition, wherever the throttle pedal was positioned, it made no difference in shift timing. Trouble codes U0101 and U0073 were present for ‘Lost Communication With TCM’ and ‘Control Module Bus OFF’. The scan tool would communicate with the TCM for approximately 20 seconds after which communication would fail. A key cycle would return communication for the same time period. As a side note, the vehicles 12 Volt battery would drain overnight. A check of TCM power and grounds indicated no problem. Voltage checks on the GMLAN communication system proved to be within specifications.

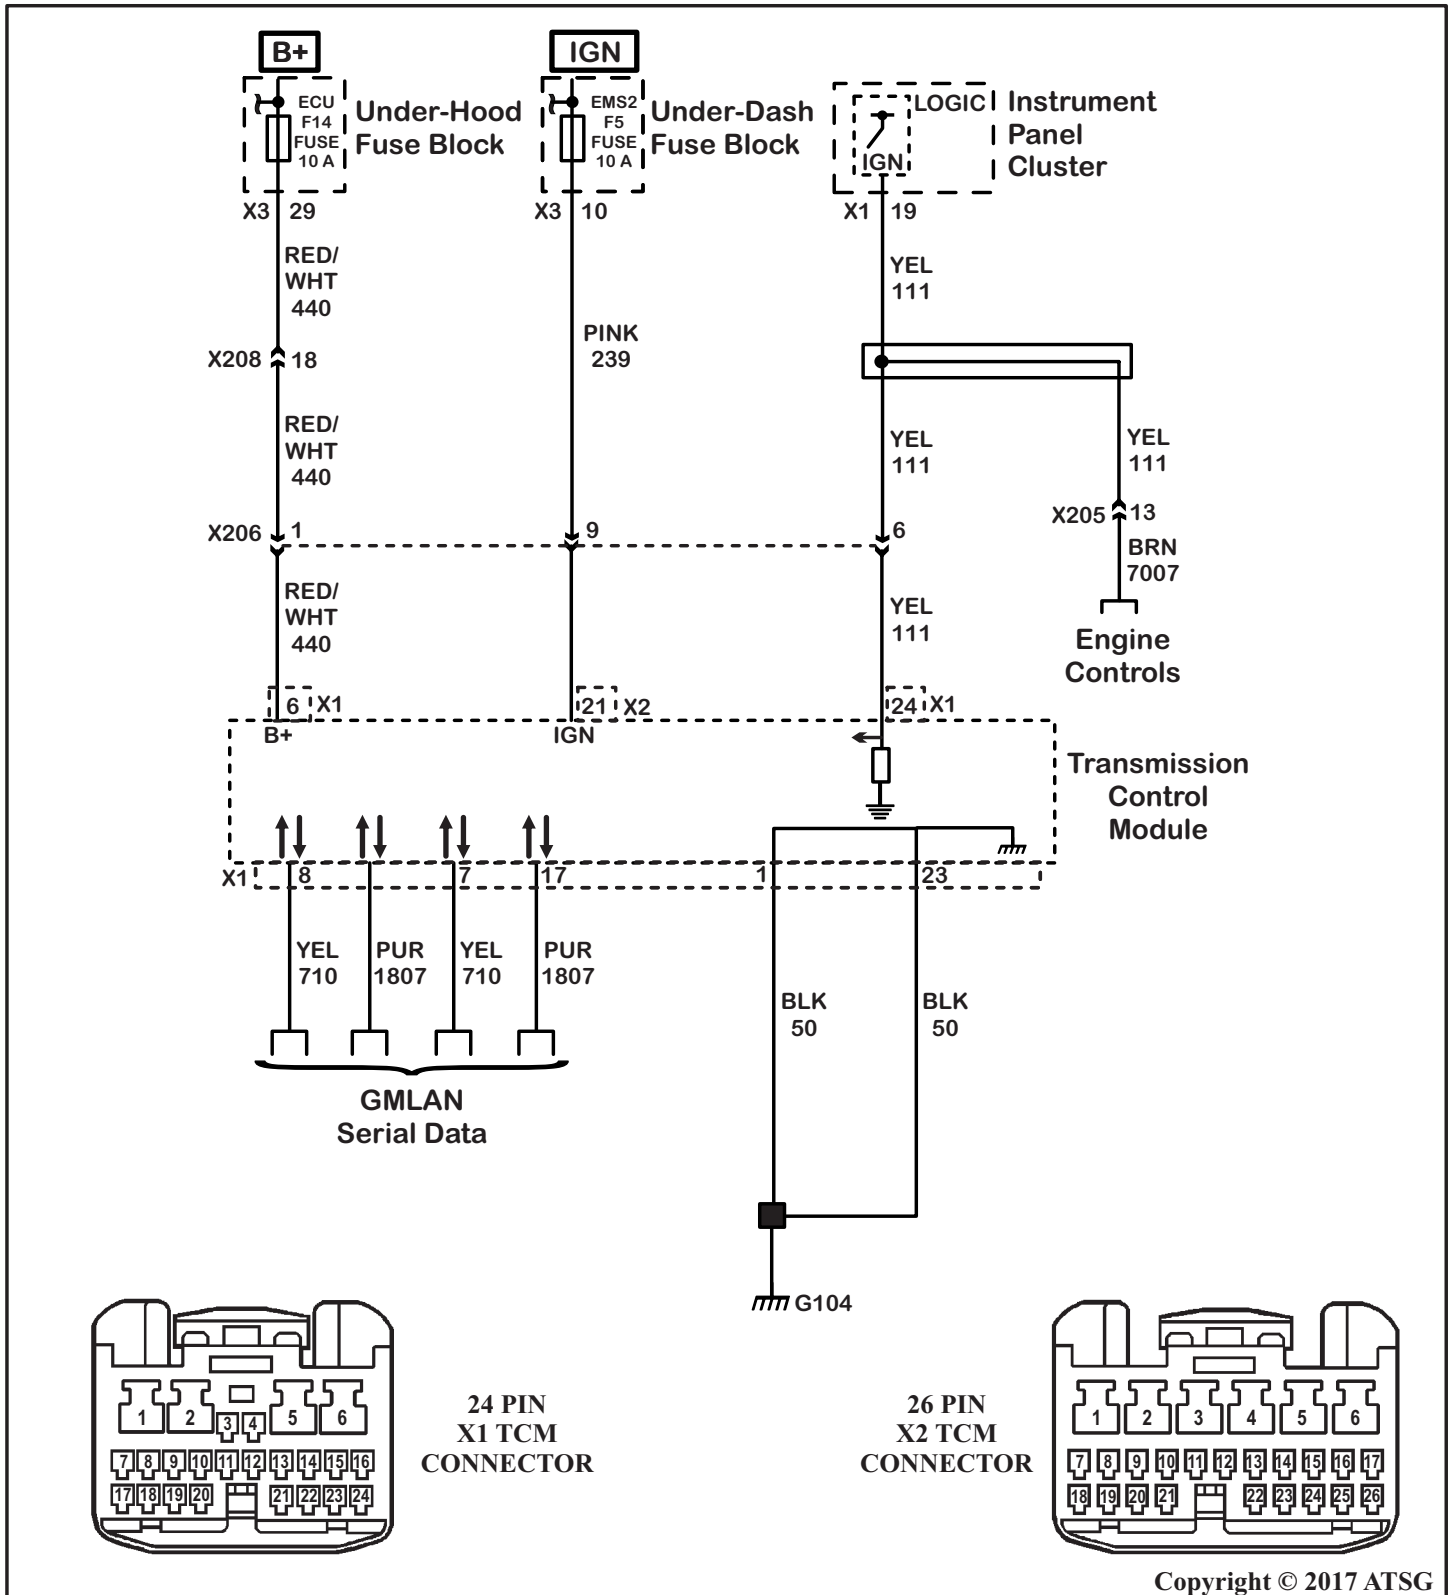
Figure 3

**CAUSE:** This vehicle was equipped with GM OnStar. After some research into this problem, it appears that vehicles that are equipped with this option are also equipped with a Vehicle Communication Interface Module (VCIM). In some instances this module has been known to cause these complaints. The VCIM is located under the passenger seat as seen in figure 1. Before the module was removed, it was checked for parasitic draw where it was found to be drawing 400ma when the vehicle was turned OFF. With the module completely disconnected, the amp draw dropped to 8ma which indicated that this module definitely had a problem.

**CORRECTION:** With the customers approval, the VCIM was not replaced which means the GMLAM communication wires could not be left open which would cause communication issues. The GMLAM communication wire from the VCIM were spliced together eliminating the problematic module entirely as seen in figure 2. These wires are yellow and purple at the TCM which can be seen in the wiring diagram in figure 3. These wires also are routed to the VCIM which can be seen in figure 4. The wires were separated from their respective connectors and spliced together yellow to yellow and purple to purple.
