Technical Service Information

FORD 5R110W

SETTING VARIOUS TRANSMISSION & ENGINE CODES

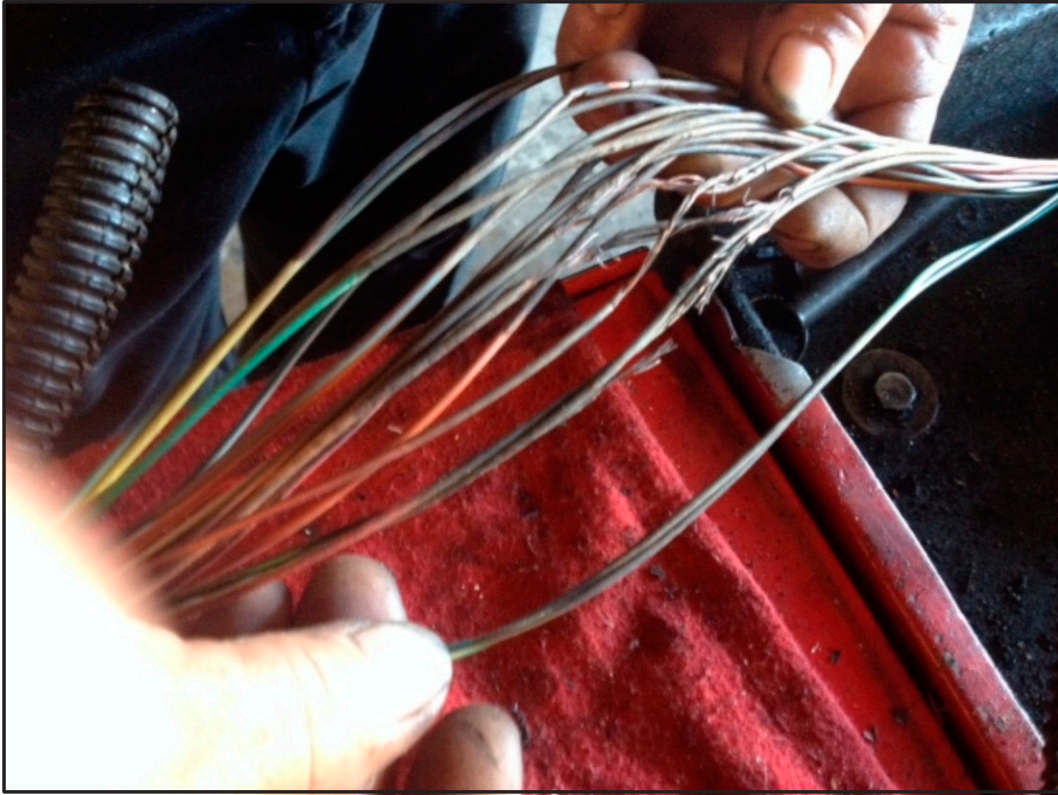
Figure 3

CAUSE: When the transmission was removed this time it was noticed that the wiring harness was close to the exhaust manifold, refer to figure 1. After further inspection, the wire harness was found to be burned through by coming in contact with the hot exhaust manifold, refer to figure 2 which resulted in a number of wires being damaged, refer to figure 3. The plastic harness holder the attaches to the filler tube with black electrical tape was dried out which allowed the harness to come in contact with the hot exhaust manifold. This problem probably started to develop after the first transmission removal procedure and proceeded to allow the wire harness to come close to the hot exhaust manifold.

CORRECTION: The wire harness was repaired and secured out of harms way. All codes were cleared after transmission installation and the truck was given a thorough road test. The transmission operated normally with no driveability issues.
