Independent Expert Engineering Investigation and Review Panel

Report on Mount Polley Tailings Storage Facility Breach Media Presentation

January 30, 2015

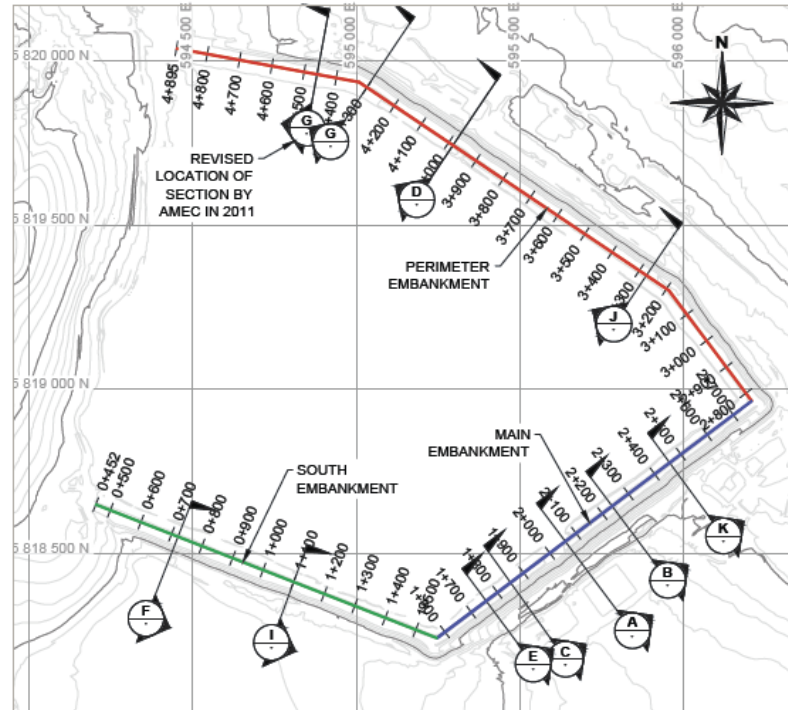
FIGURE 3.1.1: TAILINGS STORAGE FACILITY PLAN

BREACH ORIENTATION

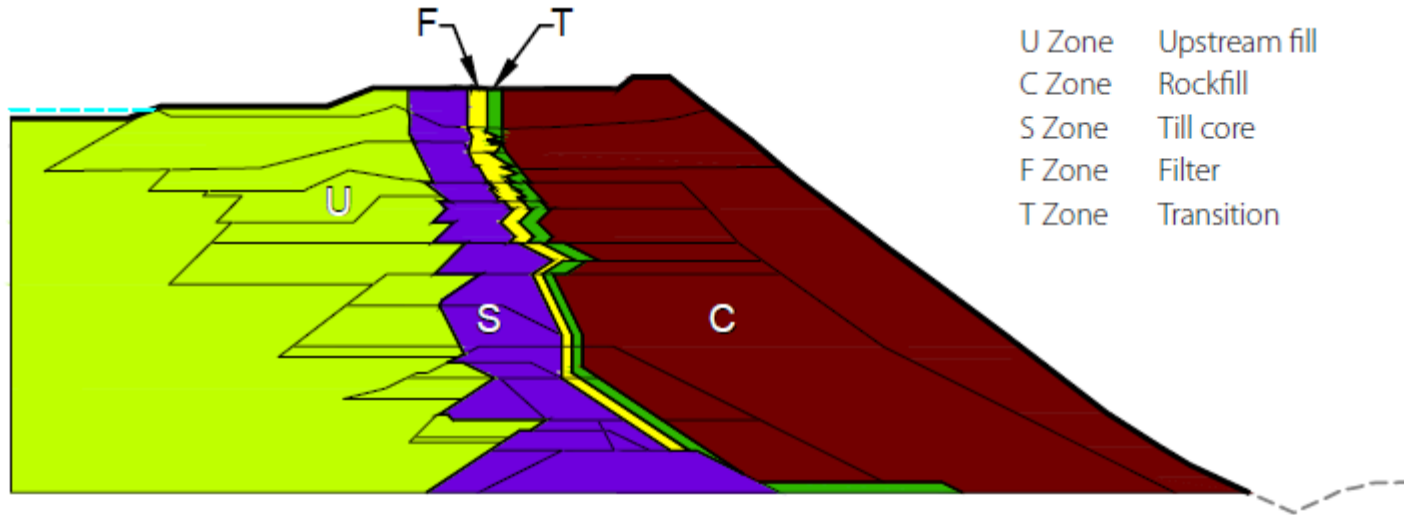
FIGURE 4.1.1: SIMPLIFIED CROSS-SECTION OF THE MOUNT POLLEY DAM

- The Panel concluded that evidence indicates the breach was the result of failure in the foundation of the embankment, a failure that occurred in a glaciolacustrine (GLU) layer of the embankment's foundation.
- According to the Panel's report: "The Panel concluded that the dominant contribution to the failure resides in the design. The design did not take into the account the complexity of the sub-glacial and pre-glacial geological environment associated with the perimeter embankment foundation. As a result, foundation investigations and associated site characterization failed to identify a continuous GLU layer in the vicinity of the breach and to recognize that it was susceptible to undrained failure when subject to the stresses associated with the embankment."

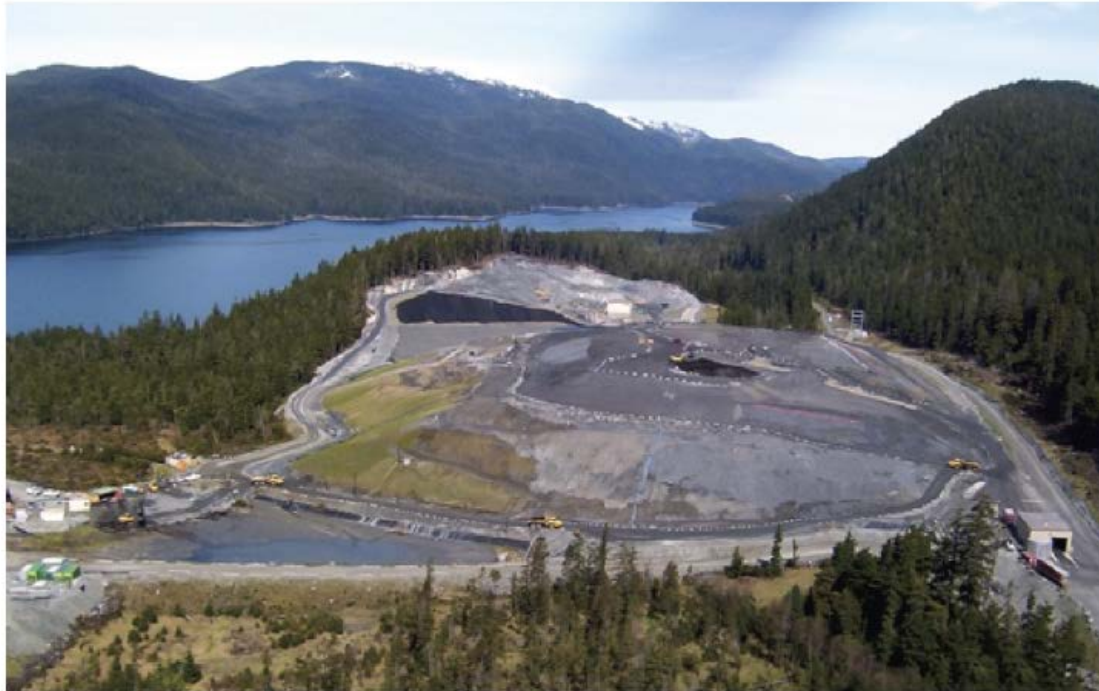
FIGURE 9.1.1 FILTERED TAILINGS FACILITY, GREENS CREEK, ALASKA

- The Panel firmly rejects any notion that business as usual can continue.
- The Panel advocates we move towards a zero failure rate.
- The path to zero failures needs an added dimension, and that dimension is technology.
- Recognizing that the path to zero failures involves a combination of Best Available Technology (BAT) and Best Applicable Practices (BAP).
