Tunnel Failures Hong Kong Case Histories

HKIE Seminar – 3 March 2007

Lorne Woodrow
Mainland East Division
Geotechnical Engineering Office
Civil Engineering and Development Department

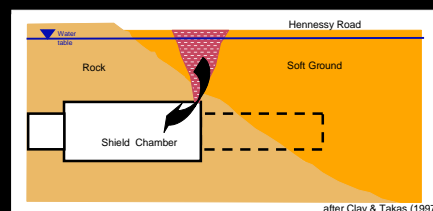
MTR Island Line

- **Background**
 - Westbound tunnel (5.7m dia, 26 m bgl) formed by the drill and blast method
- **The Failure**
 - Water-bearing "fill" flowed into the tunnel, opening a hole at the road above

after Clay & Takas (1997)

- 1500m³ of material flowed into the tunnel creating a void 100m² by 30m deep beneath the road surface

- **Possible causes of failure**
 - Misinterpretation of the ground condition
 - Blasting went too far, resulting in the tunnel penetrating the rock into soft ground
- **Consequences**
 - Cracks found in the granite masonry of the outside wall of a building at 22 Hennessy Road
 - At least 21 timber piles beneath an adjacent building of 22 Hennessy Road exposed
 - More than 150 people in 18-22 Hennessy Road evacuated
 - The building at 18-20 Hennessy Road reopened 3 hours after the incident and the building at 22 Hennessy Road 6 days later

• Remedial measures

- The void was backfilled by grout
- The floor slab of the building at 22 Hennessy Road pushed up by the grouting works by 50-75mm

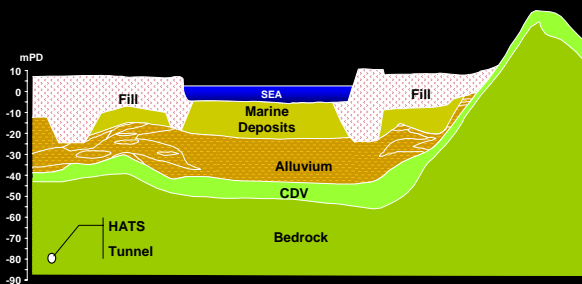
HATS Stage I Project – Tunnel C

- Engineer Design Contractor Build project
- Construction commenced in early 1995
- During construction, serious problems – high rates of water inflow into sections of tunnels
- Significant ground settlement in many areas – up to 1.8 km from the tunnels
- Major public concern due to the extent and magnitude of the impacts
- Major increase in cost and contract completion delayed (4.5 years)
- SETW/DDS reported to PAC on 23 June 2004 (extra \$2.3B of original sum of \$6.2B) and presented a Review Report to the LegCo Panel on PLW on 29 June 2004

Significant ground settlement
