**Sea wall/reclamation failures Part 2**  
**Junk Bay (Tseung Kwan O) Controlled Tip Failure**

By  
**Ir Dr J Premchitt**

**GEO Advisory Report No. ADR 17/84 –  
Investigation of A Failure at Junk Bay  
Controlled Tip**

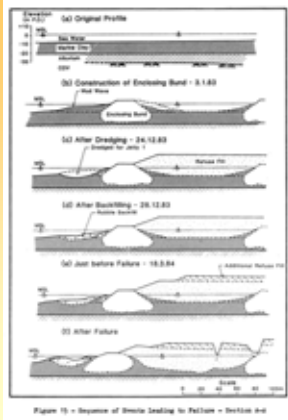
**Review sequence of events**

- 3.1.83 enclosing bund built.
- 24.12.83 dredging for Jetty 1 done, refuse filling to about +16mPD.
- 28.12.83 backfill of dredged area completed, refuse fill at about +16mPD.
- 18.3.84 large failure occurred when refuse fill reached a level of +22mPD ... 81 days after backfilling of dredged area.
