CPD Course on  
Some Old Geotechnical  
Failure Incidents in Hong Kong

**SLOPE FAILURES**

Ir Ken Ho  
Chief Geotechnical Engineer  
Geotechnical Engineering Office  
Civil Engineering and Development Dept

10 MARCH 2007

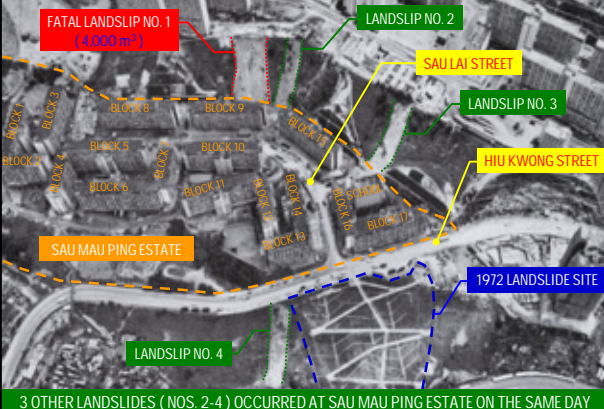
### 25.8.1976 SAU MAU PING (4,000 m<sup>3</sup>)

**FATAL LANDSLIP NO. 1** (BLOCK 9)

**LANDSLIP NO. 2**

**LANDSLIP NO. 3**

**LANDSLIP NO. 4**

**1972 LANDSLIDE SITE**

**3 OTHER LANDSLIDES (NOS. 2-4) OCCURRED AT SAU MAU PING ESTATE ON THE SAME DAY**

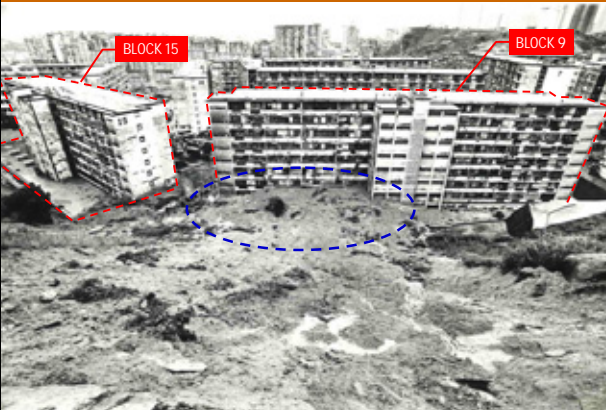
### 25.8.1976 SAU MAU PING (4,000 m<sup>3</sup>)

**BLOCK 15**

**BLOCK 9**

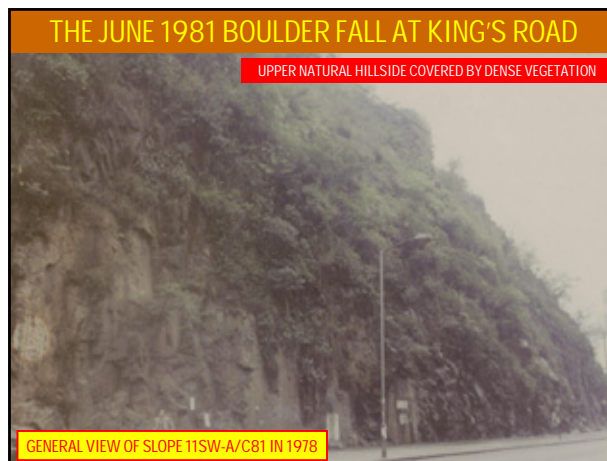
### THE JUNE 1981 BOULDER FALL AT KING'S ROAD

- **TWO** boulders fell from natural terrain above cut face
  - One (260 kg) of the boulders fell down first and landed at about 3 m from the slope toe, which killed a pedestrian
  - Another boulder (530 kg) followed and struck a tubular steel railing along the pedestrian footpath and shattered into pieces
- **Findings of the Investigation :**  
 A week of heavy rainfall preceding the incident might have softened the soil supporting the 260 kg boulder that was eventually dislodged
  - The dislodgement of the smaller boulder removed the support to a larger boulder (530 kg) behind, causing it to roll down the slope
- Resulted in 1 fatality and 2 injuries.

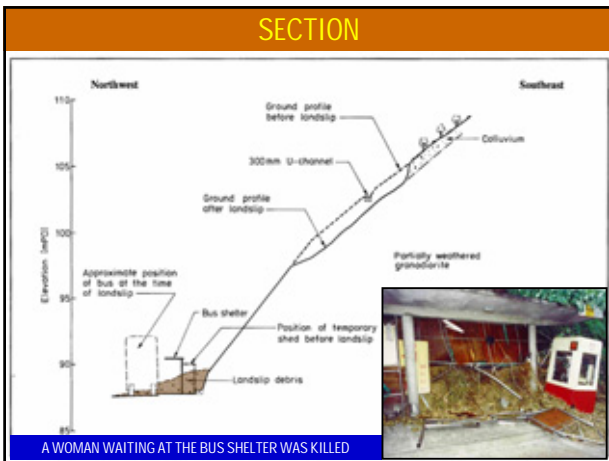
### 16.6.1993 CHEUNG SHAN ESTATE (50 m<sup>3</sup>)

1 Fatality & 5 Injuries

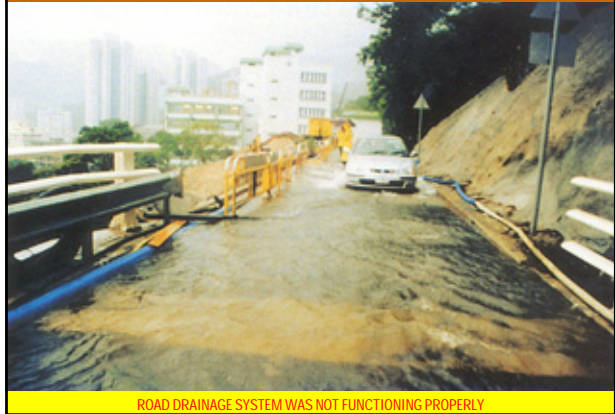
### 13.8.1995 SHUM WAN ROAD (26,000 m<sup>3</sup>)

- Forensic investigation by GEO**
- Independent technical review by Sir John Knill**
- The landslide killed two people in the illegally constructed shipyard**

- ▣ Revealed the importance of adequacy and regular maintenance of road drainage provisions
  - ▣ Highways Department (HyD) conducted a follow-up study to inspect vulnerable road sections and formulate schemes to prevent overspilling of stormwater from carriageways to vulnerable downhill slopes
- ▣ Need to consider environmental factors, such as the possibility and effects of overflow of stormwater running along road, in slope stability assessments and detailing
- ▣ Publication of Highway Slope Manual by GEO
- ▣ Vulnerability of marginally stable, old coastal slopes is highlighted
