PROPERTY INSPECTION REPORT FORM

Eric Cook <i>Name of Client</i>	05/24/2024 <i>Date of Inspection</i>
4603 Charles Ave., Austin, TX 78746 <i>Address of Inspected Property</i>	
Richard H Craycroft <i>Name of Inspector</i>	5069 <i>TREC License #</i>
<i>Name of Sponsor (if applicable)</i>	<i>TREC License #</i>

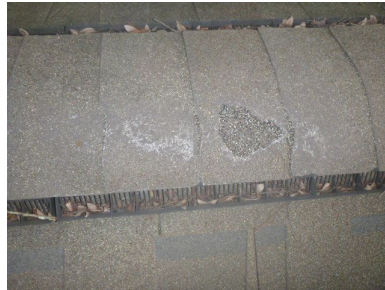
A number of areas have damaged and missing shingles from tree abrasion.

Remove all of the debris from the roof seasonally or as necessary. Build up of debris in valleys, behind chimneys, etc. can lead to water penetration of the roof assembly.

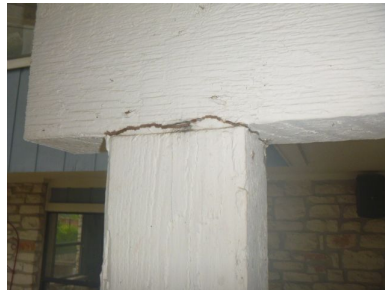
Patio posts are butt jointed and toe nailed.
-Some of the joints are loose.
-Add structural straps and bolts.

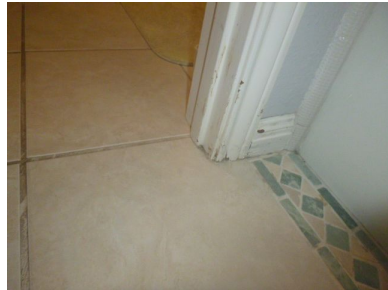
Wall trim in the Jack and Jill bath by the tub is water damaged.

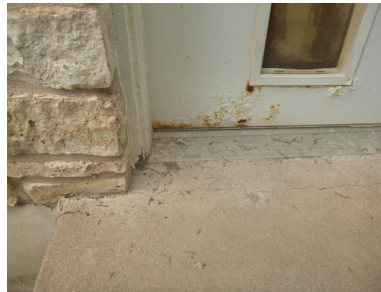
The exterior door off the garage is subject to water damage due to the close proximity of the adjacent deck or patio slab from back splashing and exposure. Storm doors are very effective at protecting exposed exterior doors from damage. Water damage was noted to the door and adjacent areas.

-Note: This door was blocked by stored items in the garage and could not be fully inspected.

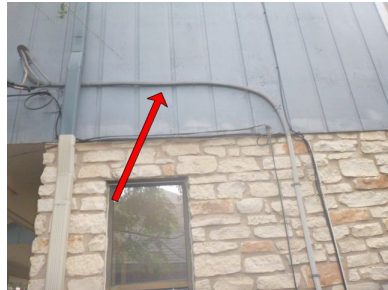
The SEC cables are exposed. Currently, code requires SEC cables to be contained within approved and listed raceways.

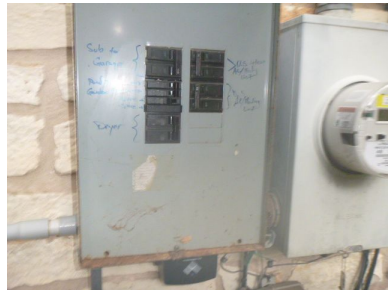
Overhead Feeder. Al SEC. Cu BCW. 7 throws required for system disconnect (max. 6 allowed).

-The panel requires too many breakers to shut off power.

-GEC to earth via driven rod.

-The cold water bond attachment was not identified. The cold water bond attachment point is required to be accessible. [250.104(A)].

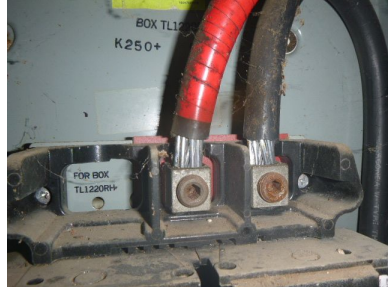
The aluminum feeder wire terminations lack the required application of anti oxidation paste.
-Required by TREC SOP to be reported as Deficient.

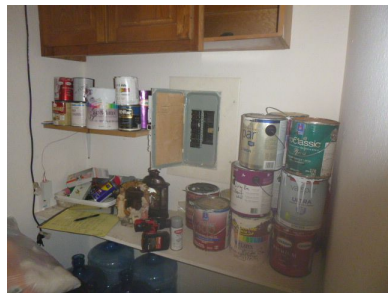
Garage Sub Panel:

Panel lacks required clearance for service access (30"x36"x78") [NEC 110.26]
-Shelving blocks required access.

The breakers lack required circuit identification labeling. All circuits must be legibly marked as to their clear, evident, and **specific purpose** [NEC 408.4].

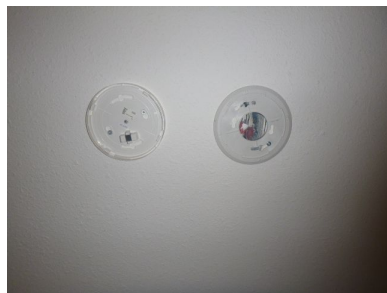
Smoke alarms are not present inside and outside all bedrooms and at each level where required.

-The bedroom smoke alarms will not be hardwired or interconnected as currently required.

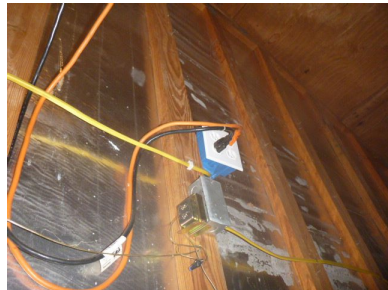
Extension cords are present in the attic. If wiring penetrates any walls, structures or enclosures, or runs through attic it is considered a fire hazard. Extension cords should not be used for permanent appliances or as a substitute for structure wiring. [NEC 400.8 (1)]

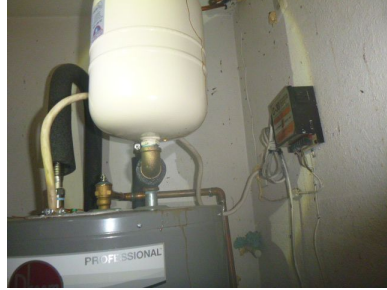
The garage water heater lacks a required electrical disconnect.

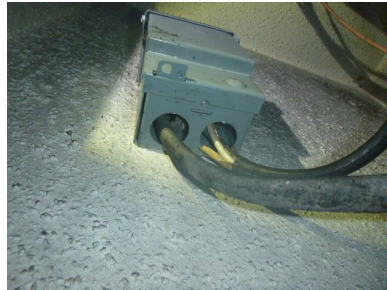
Wire clamps are missing at the wiring entrances to the upper level HVAC air handler disconnect. This may allow damage to the conductor insulation which could result in an electrical fault and become a shock/fire hazard. Missing cable clamps and bushings are considered to be a latent fire and safety hazard. [NEC 300.4(B)(1)]

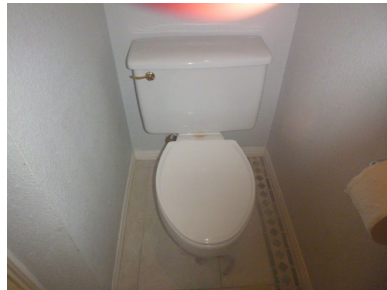
Jack and Jill Bath:

The rear toilet is disabled and likely needs to be repaired, if not replaced with a High Efficiency toilet.

Replacing older, less efficient toilets with HETs (High Efficiency Toilets) is a good way to save water and reduce usage. HETs use 1.28 gallons per flush and are even more efficient than 1.6 gallon toilets that have been required since 1996.

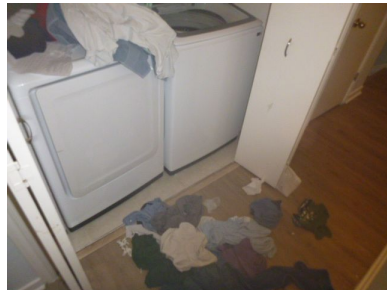
Laundry:

The structure is susceptible to water damage in the event of leakage from the washer. It is strongly recommended that a drip tray (available at home improvement stores) be installed under the washer to prevent potential water damage to the structure.

A licensed plumber is recommended.

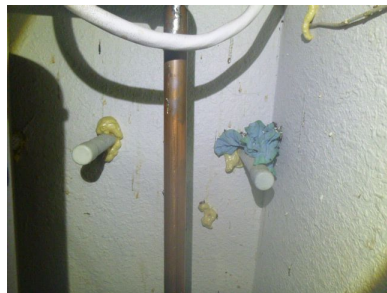
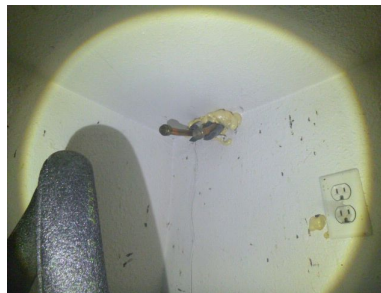
Note: The rooftop solar water heating panels have been decommissioned and are no longer in use. Old plumbing stubs are visible at the right side exterior by the AC units and in the water heater enclosure.

-Remove the panels when the roof is replaced.

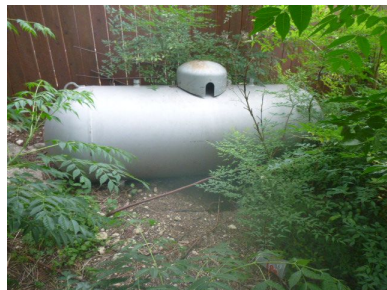
There is an unused LPG gas tank at the right side.

-The structure has no gas appliances or apparent gas lines or connections.

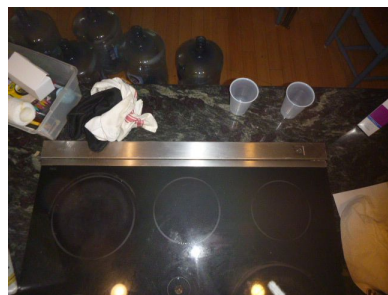
Motorized Retractable Down Draft Unit.

- The control button is damaged.
- The unit is difficult to operate and is corroded.
- The vent connector could not be observed due to belongings.
- Vent connectors are required to be sheet metal. Flex duct is not allowed.
