# A Buyer's Choice Home Inspections

## PROPERTY INSPECTION REPORT

34 Hanna Dr, Bowmanville, ON, L1C 5M4

Date of Inspection: 4/29/2025 Time: 1:30 PM  
Order ID: 1621

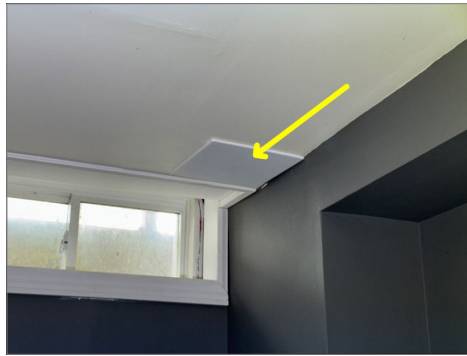
Exterior hose bib shut off

- **Inspection limitation -** The valve is shut off for the season and as such it was not operated.
- **Maintenance tip -** Exterior shut off valves need to be shut off before freezing temperatures begin.

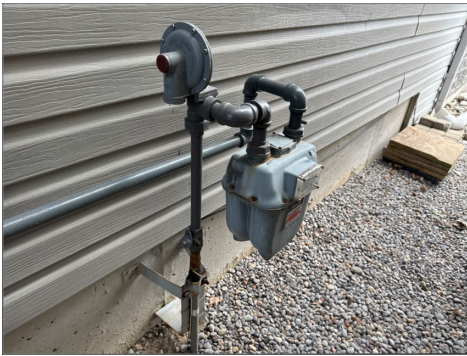
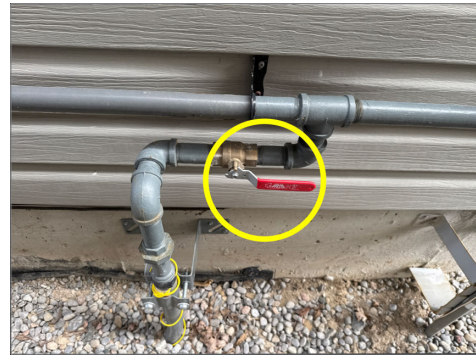
- No material deficiencies noted.
- Information - Gas shut off valve should only be operated by a qualified gas technician.

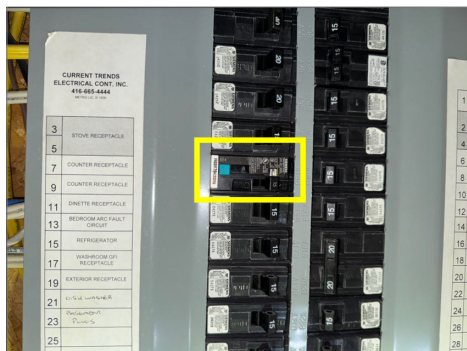
- **AFCI** present for bedrooms.
- Maintenance tip - AFCI and GFCI breakers should be tested monthly to ensure that they are operating normally and protecting the circuits as intended.

AFCI present for bedrooms.

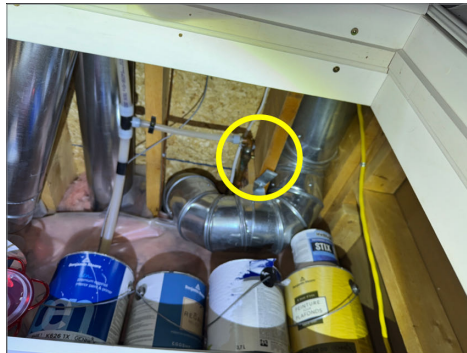
Hose bib shut off

- No material deficiencies noted.
- Maintenance tip - Exterior hose bibs need to be shut off and the pipes drained before freezing temperatures begin.

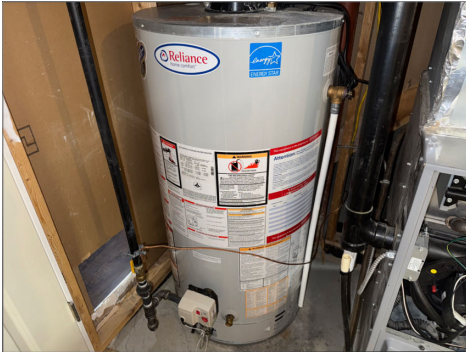
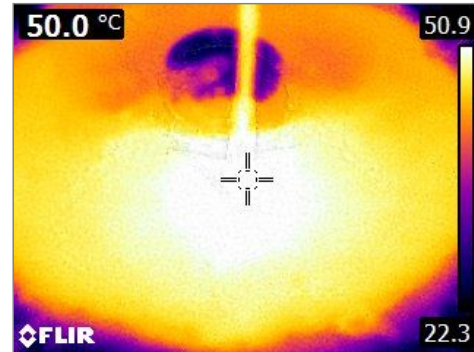
- Information - The unit was operated and tested and appears to be functional at the time of inspection.
- Maintenance tip - Water Heaters have a life expectancy of approximately ten years. Regular servicing and inspection of the water heater by a qualified technician will prolong its life.
- Maintenance tip - Draining the sediment out of the bottom of the water heater tank will increase the water heater's lifespan and efficiency.

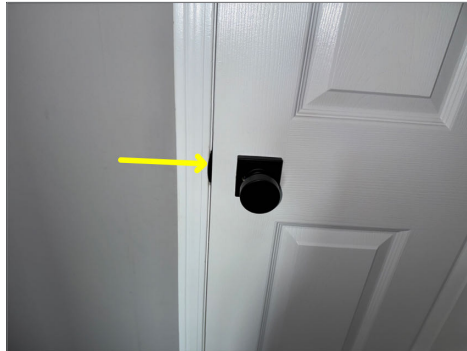
- Hollow wood doors noted
- **Repair - The door is not latching. Recommend repair of the defective hardware.**

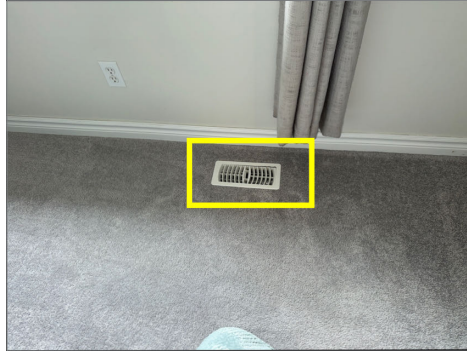
East side bedroom

- Central heating and cooling noted in this room. At the time of the inspection, all appeared to be functioning and in serviceable condition.
- Further evaluation required - Air flow weak at this register. Recommend evaluation by a qualified professional.
