THE EVALUATION OF SLOPE STABILITY: A FURTHER 25-YEAR PERSPECTIVE

Norbert R. Morgenstern

CASE STUDY – ALAMEDA DAM

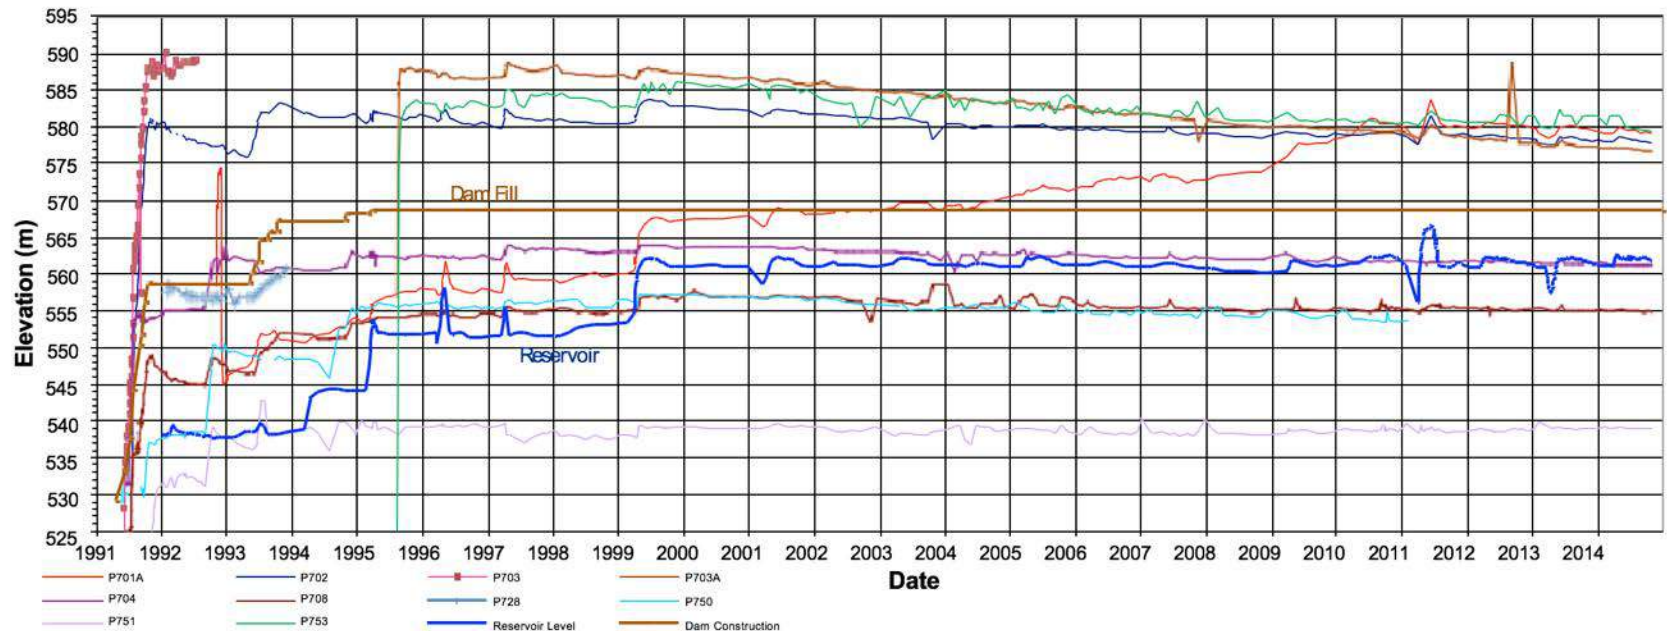
CLAYSHALE PORE PRESSURES

- High excess pore pressures during construction
- Very slow post-construction dissipation; still high pore pressures today
- Responds to total stress change from reservoir – response attenuates rapidly in downstream direction

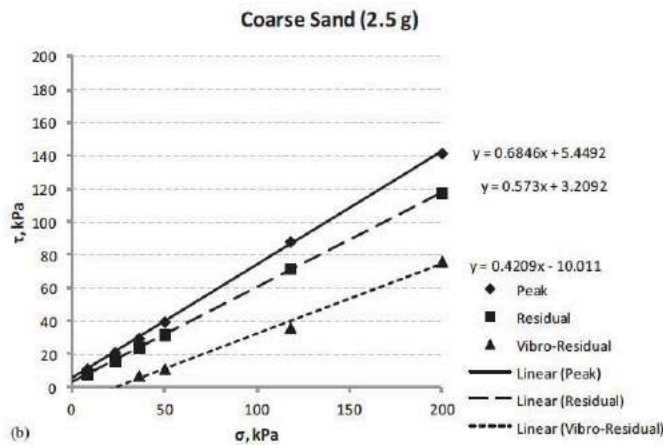
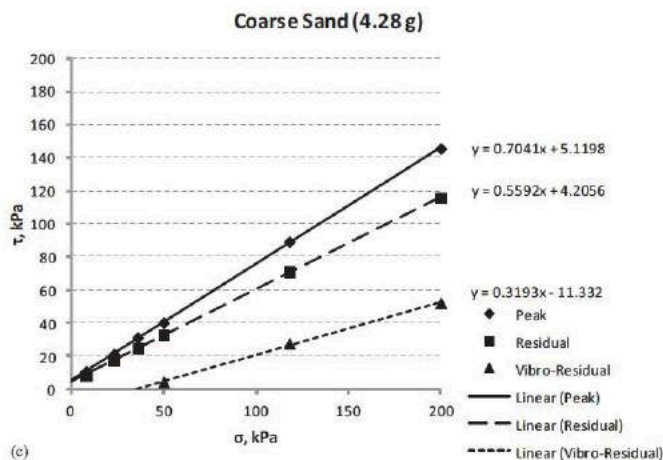
This appears to be the phenomenon of vibrational/acoustic fluidization postulated by Melosh (1979) and suggests that the rheology of a flowing granular mass is much influenced by the vibrational interaction along its flowpath.

Fig. 8. Shear strength diagrams of coarse sand tested at (a) $\Gamma = 0.42$; (b) $\Gamma = 2.42$; and (c) $\Gamma = 4.28$

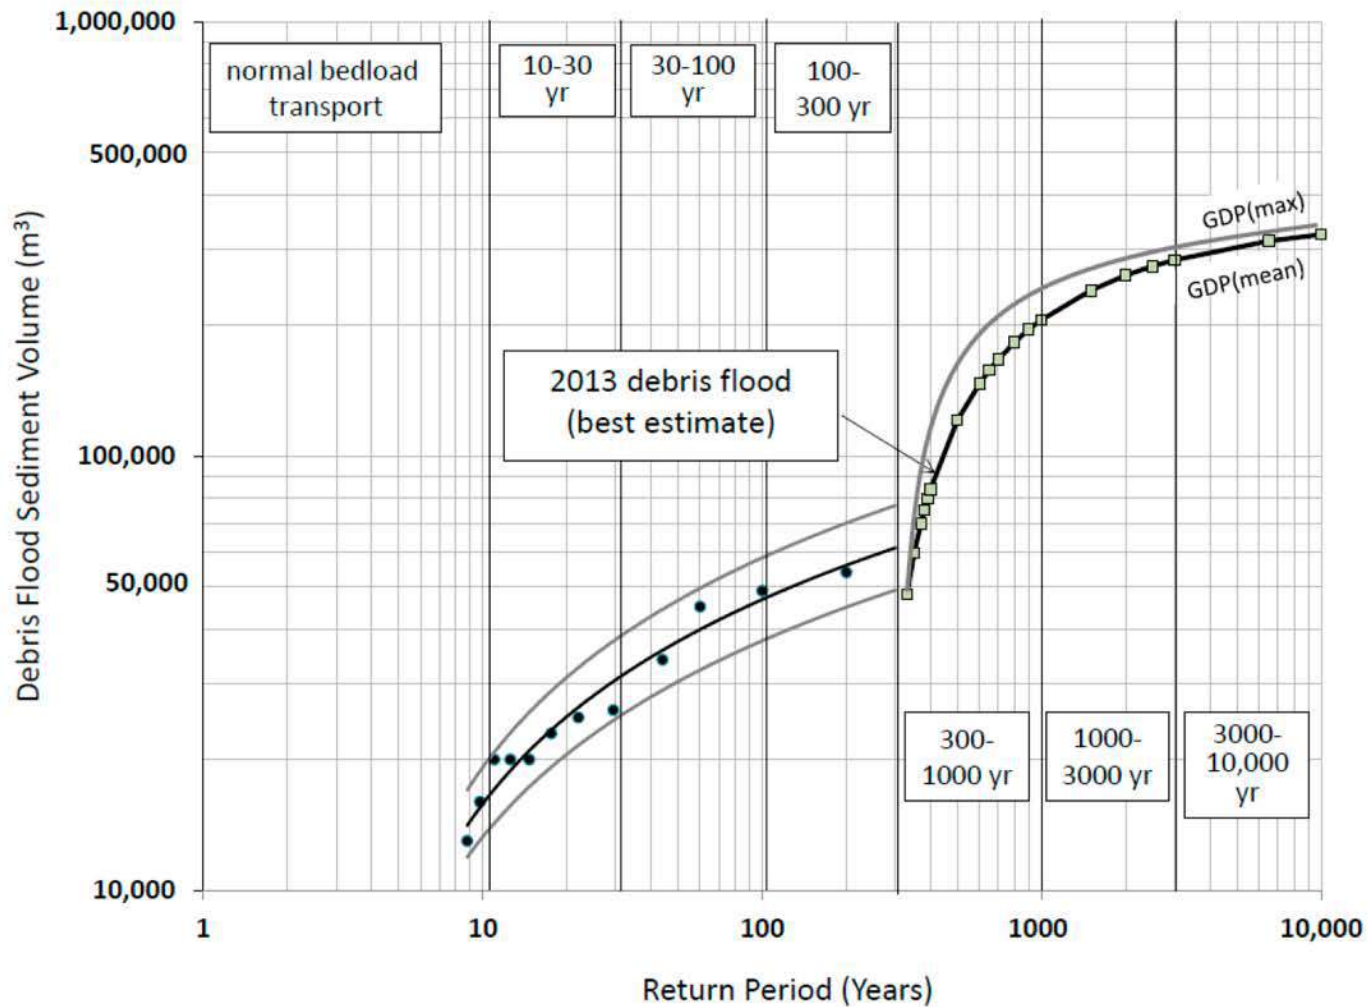
Figure 9. The Cumulative Frequency-Magnitude Analysis (MCF) method was applied to the “small” debris flood datasets while the presumed landslide dam outbreak floods were analysed with the Generalized Pareto Distribution (GDP).

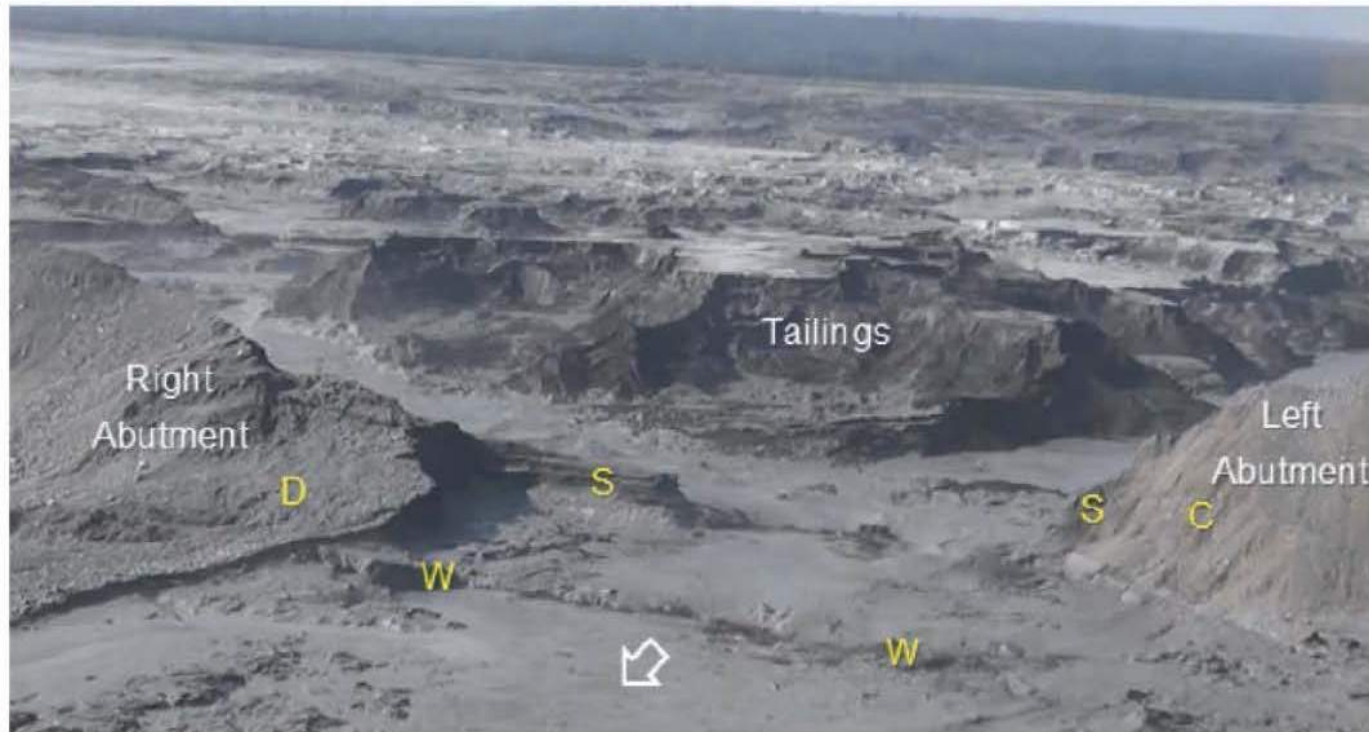
Mount Polley Tailings Facility

FIGURE 5.1.1: VIEW LOOKING UPSTREAM THROUGH THE BREACH (ARROW SHOWS DIRECTION OF OUTFLOW)

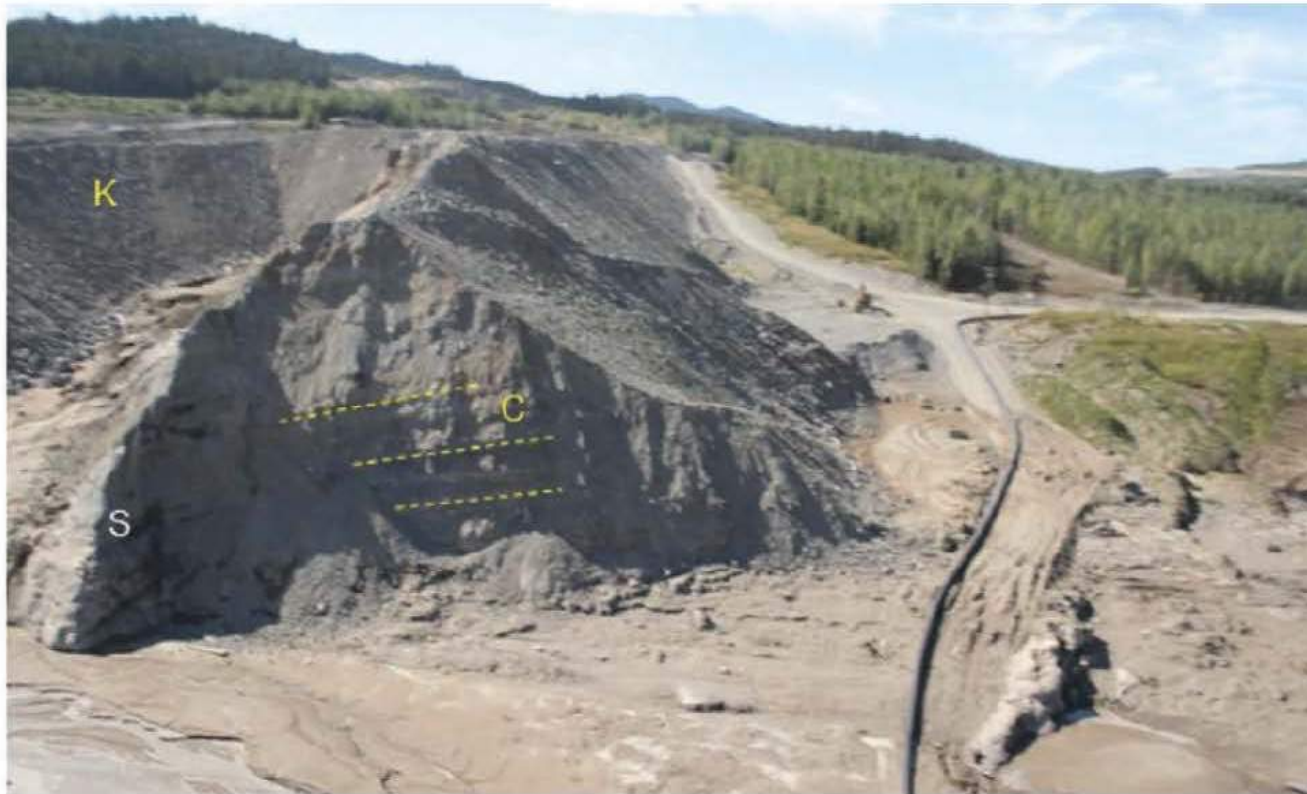
Mount Polley Tailings Facility

FIGURE 5.1.5: APPARENT BEDDING ROTATION ON LEFT ABUTMENT OF BREACH (SEPT. 4, 2014 PHOTO)
