FORD 5R55N AND 5R55W/S SOLENOID BODY GASKET IDENTIFICATION

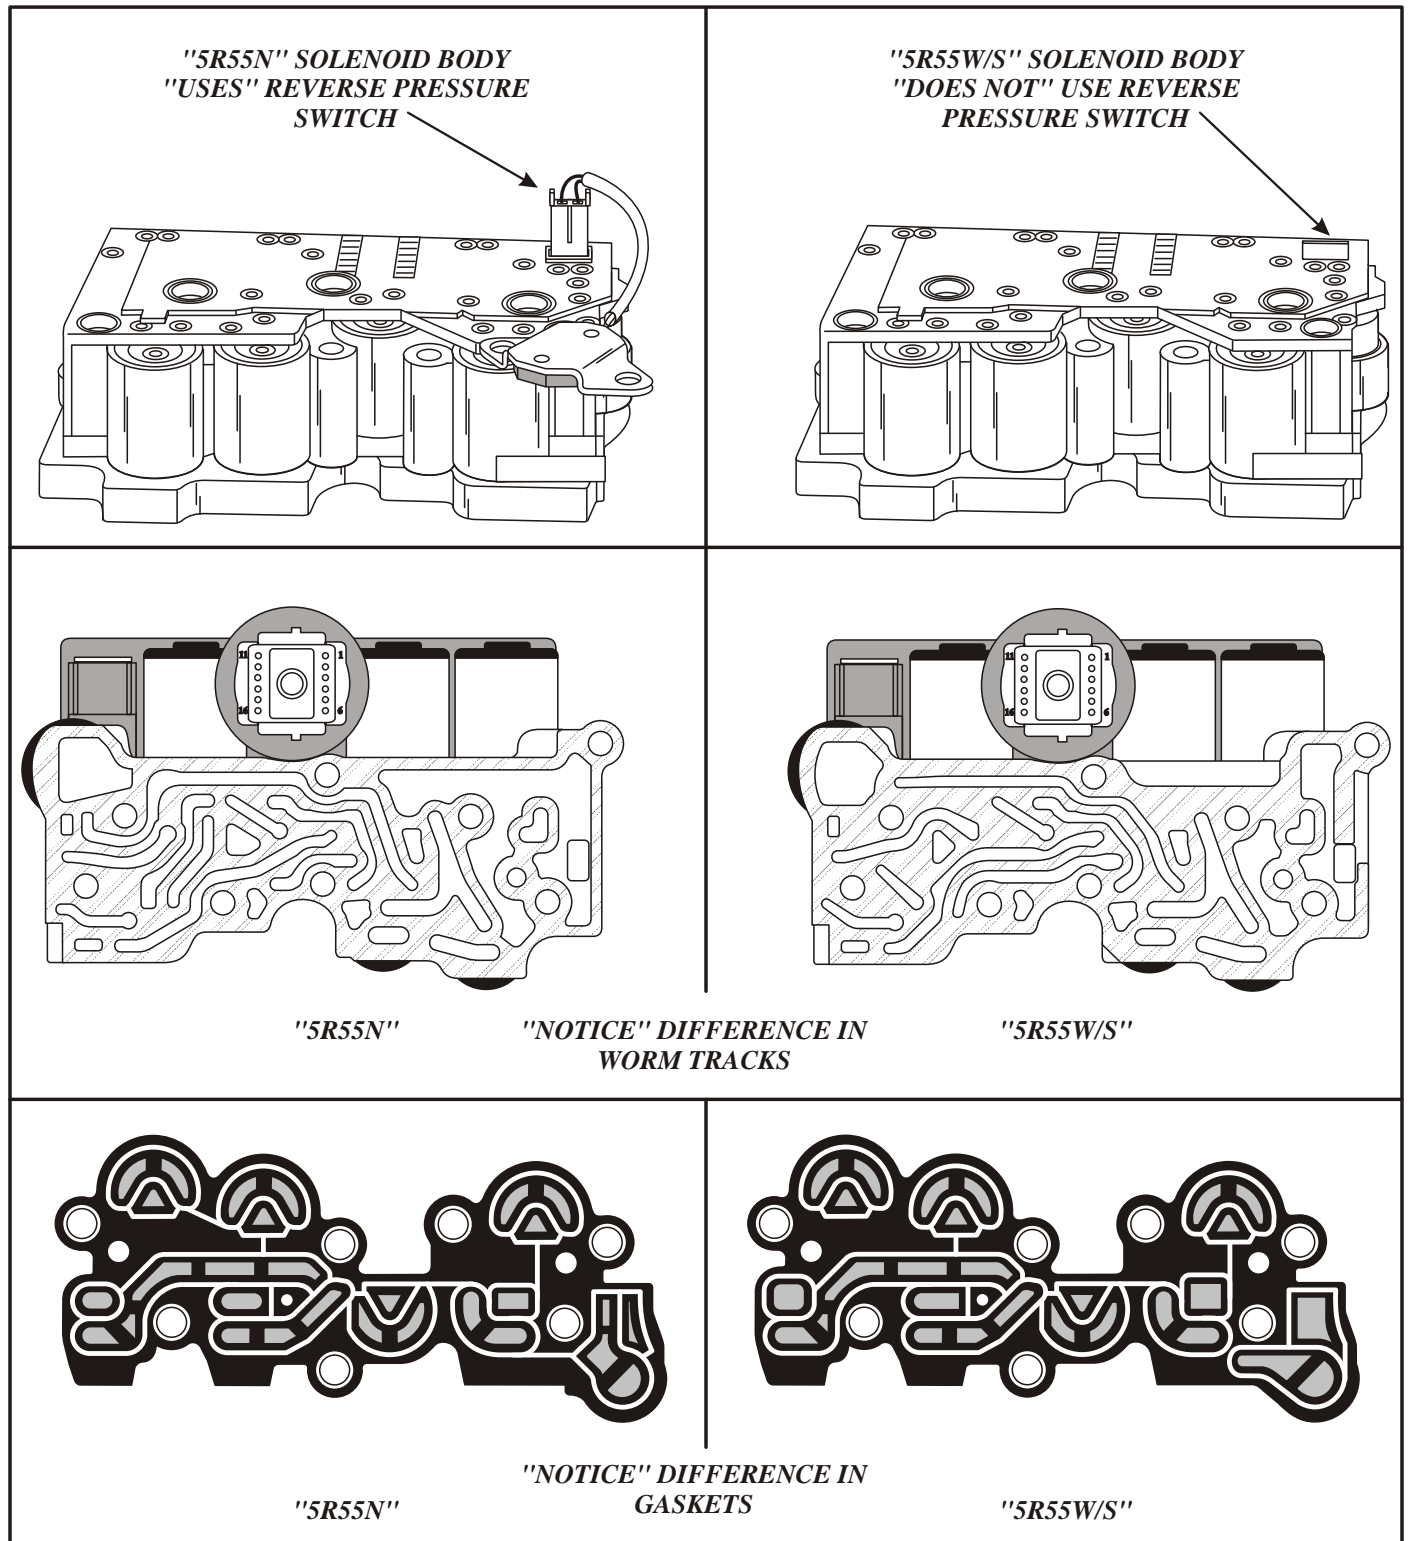
COMPLAINT: Installing the wrong solenoid body gasket onto a 5R55W/S usually creates a no reverse condition and the gaskets are almost identical, as shown in Figure 1.

None of the parts shown in Figure 1 will interchange with one another, nor will the solenoid packs correctly assembled interchange between the 5R55N and 5R55W/S.

CAUSE: Currently, most aftermarket gasket sources package the 5R55N gasket into the 5R55W/S gasket pack by mistake. They are currently in the process of correcting this error.

CORRECTION: Ensure that you install the correct solenoid body gasket during overhaul or repair. Use the illustrations in Figure 1 to identify the different solenoid blocks and the different solenoid gaskets. Refer to Figure 2 for the proper assembly procedure.

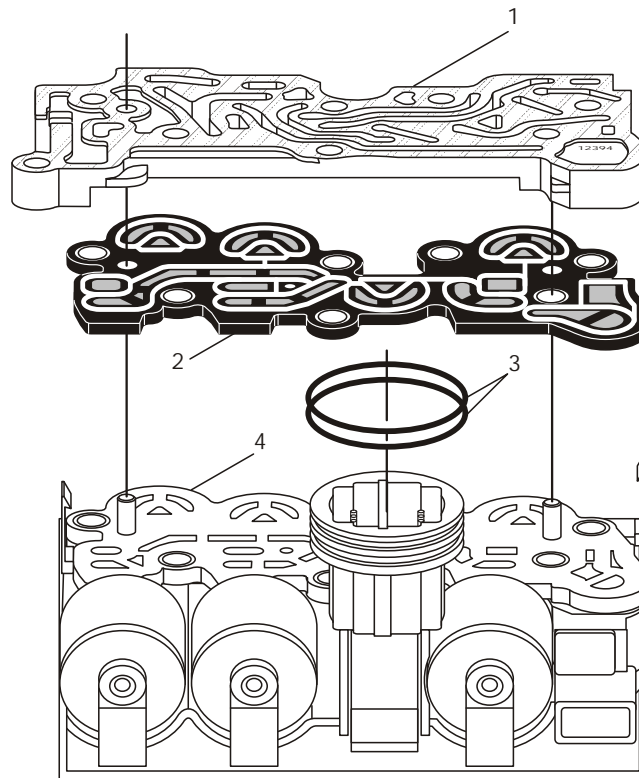
Figure 2

5R55W/S SOLENOID BODY IS ILLUSTRATED

- 1. SOLENOID BODY WORM TRACK PLATE
- 2. SOLENOID BODY TO WORM TRACK PLATE GASKET
- 3. SOLENOID BODY TO CASE "O" RINGS (2 REQUIRED)
- 4. SOLENOID BODY ASSEMBLY
