## A4AF3/A4BF2 PRELIMINARY INFORMATION

Since model year 2000 Hyundai has been using a new transaxle in the Accent, Elantra, and Tiburon. It is the A4AF3 for use with 1.5L engines, and the A4BF2 for use with 2.0L engines. These transaxles are almost identical to the A4AF1 and A4AF2 with several major exceptions. The A4AF1 and A4AF2, as well as the new A4AF3 and A4BF2 are almost identical to the KM series except that they are “backwards.”

# Technical Service Information

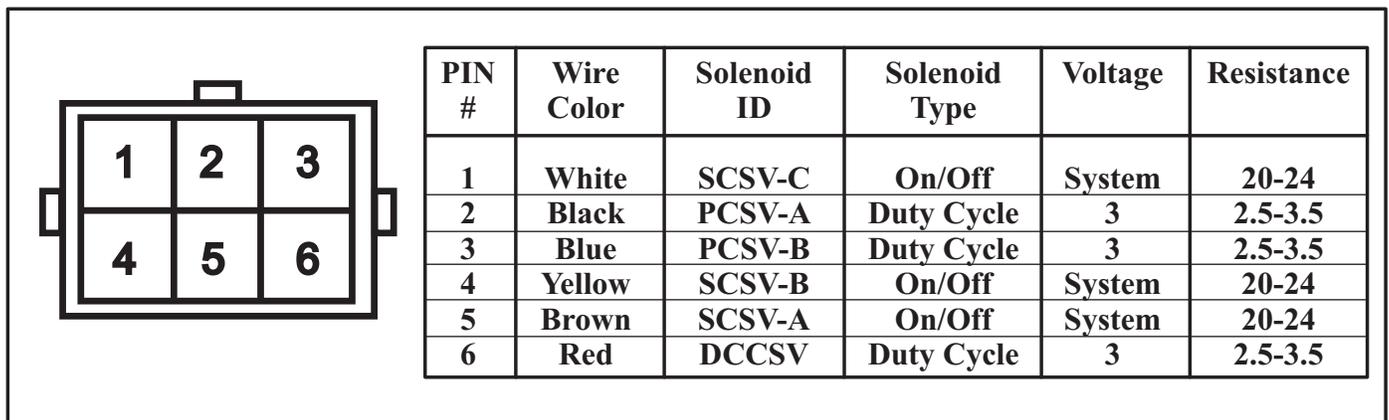
Figure 1

In addition to the code changes, changes were also made to the pinouts to accommodate the two new wires. The case connector is now six pins (See Figure 1). The computer appears identical to a fourth generation KM computer, but the pin assignments have changed (see Figure 2).

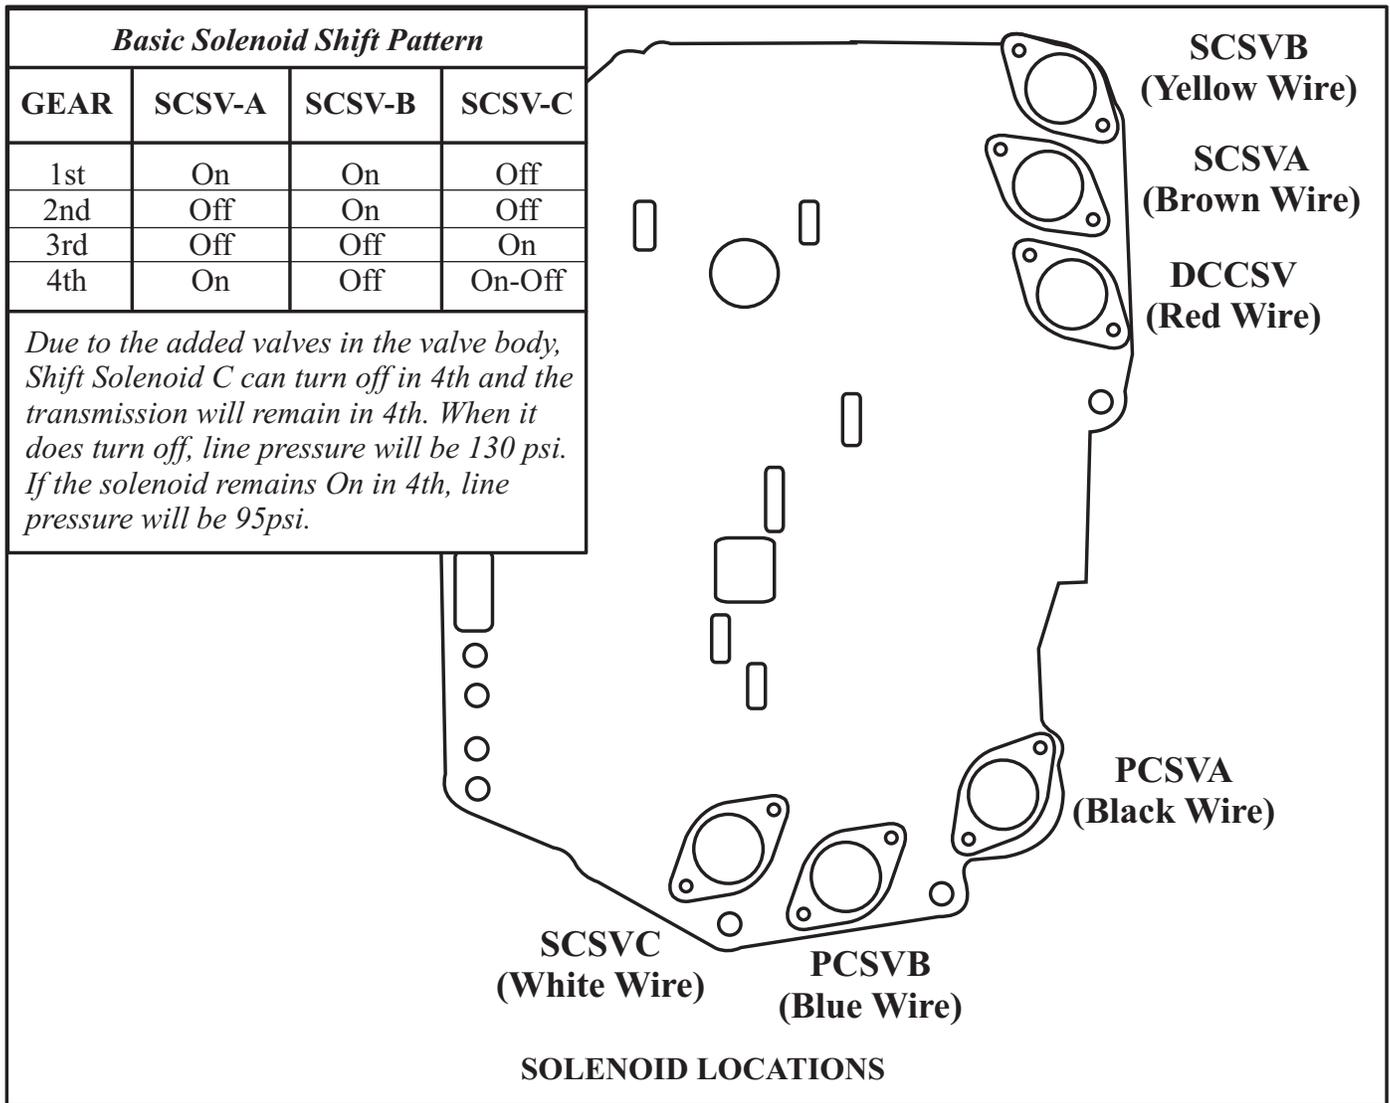
Figure 4

The big change is the addition of two solenoids, Pressure Control Solenoid B (PCSVB) and Shift Control Solenoid Valve C (SCSVC) as seen in figure 4, a couple of valves (Figure 6), and an accumulator for the Forward (Rear) clutch (Figure 7). Pressure Control Solenoid Valve A (PCSVA) as in previous applications is the solenoid that controls main line pressure. PCSVB directly controls the application of the Forward (Rear Clutch) on a 4-3 downshift. When this solenoid fails you can expect to see harsh 4-3 downshifts. The other new solenoid is Shift Control Solenoid Valve C (SCSVC) controls the end clutch apply and reduces line pressure in 4th gear for less drag on the engine increasing fuel economy. The new valves in the valve body are only to support the new solenoid scheme. They are the Fail Safe Valve, the Control Switch Valve, and the High-Low Pressure Valve (Figure 6). The check balls remain the same as other KM style units (Figure 7).

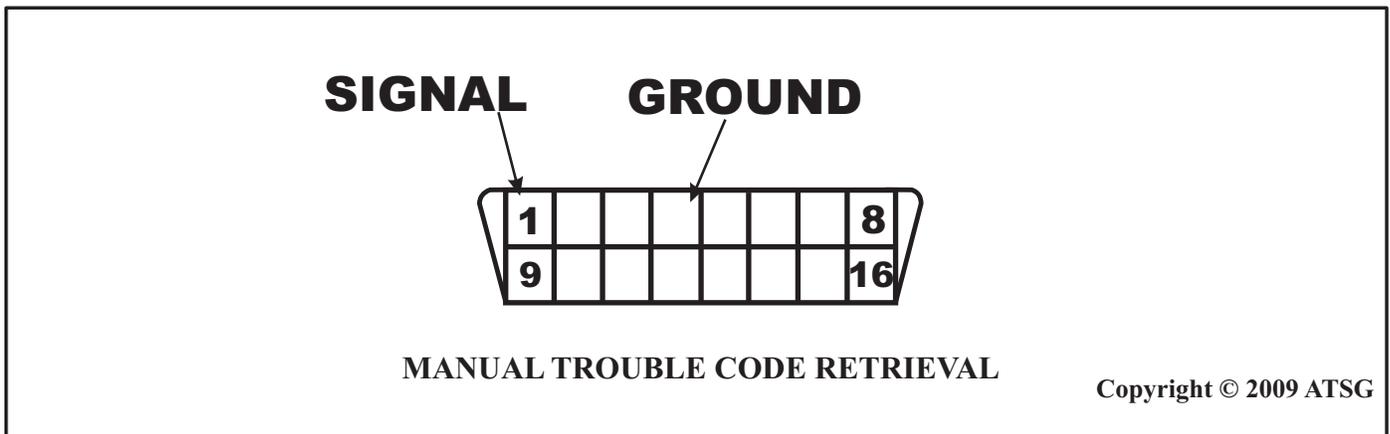
Figure 5

With the addition of the new solenoids comes changes to the Diagnostic Trouble Codes. Although not as generalized as a code P1750 (Solenoid Pack Fault), the new codes do not specify if a solenoid circuit is open or shorted. It does specify which solenoid though. P0760 indicates a fault in the SCSC solenoid circuit, and P0765 is for the PCSB. Both will cause the MIL to light and a failsafe condition. See Figure 3 for a complete code list. The pin on the diagnostic connector used to manually retrieve codes with an analog voltmeter has moved to pin 1 (see Figure 5).

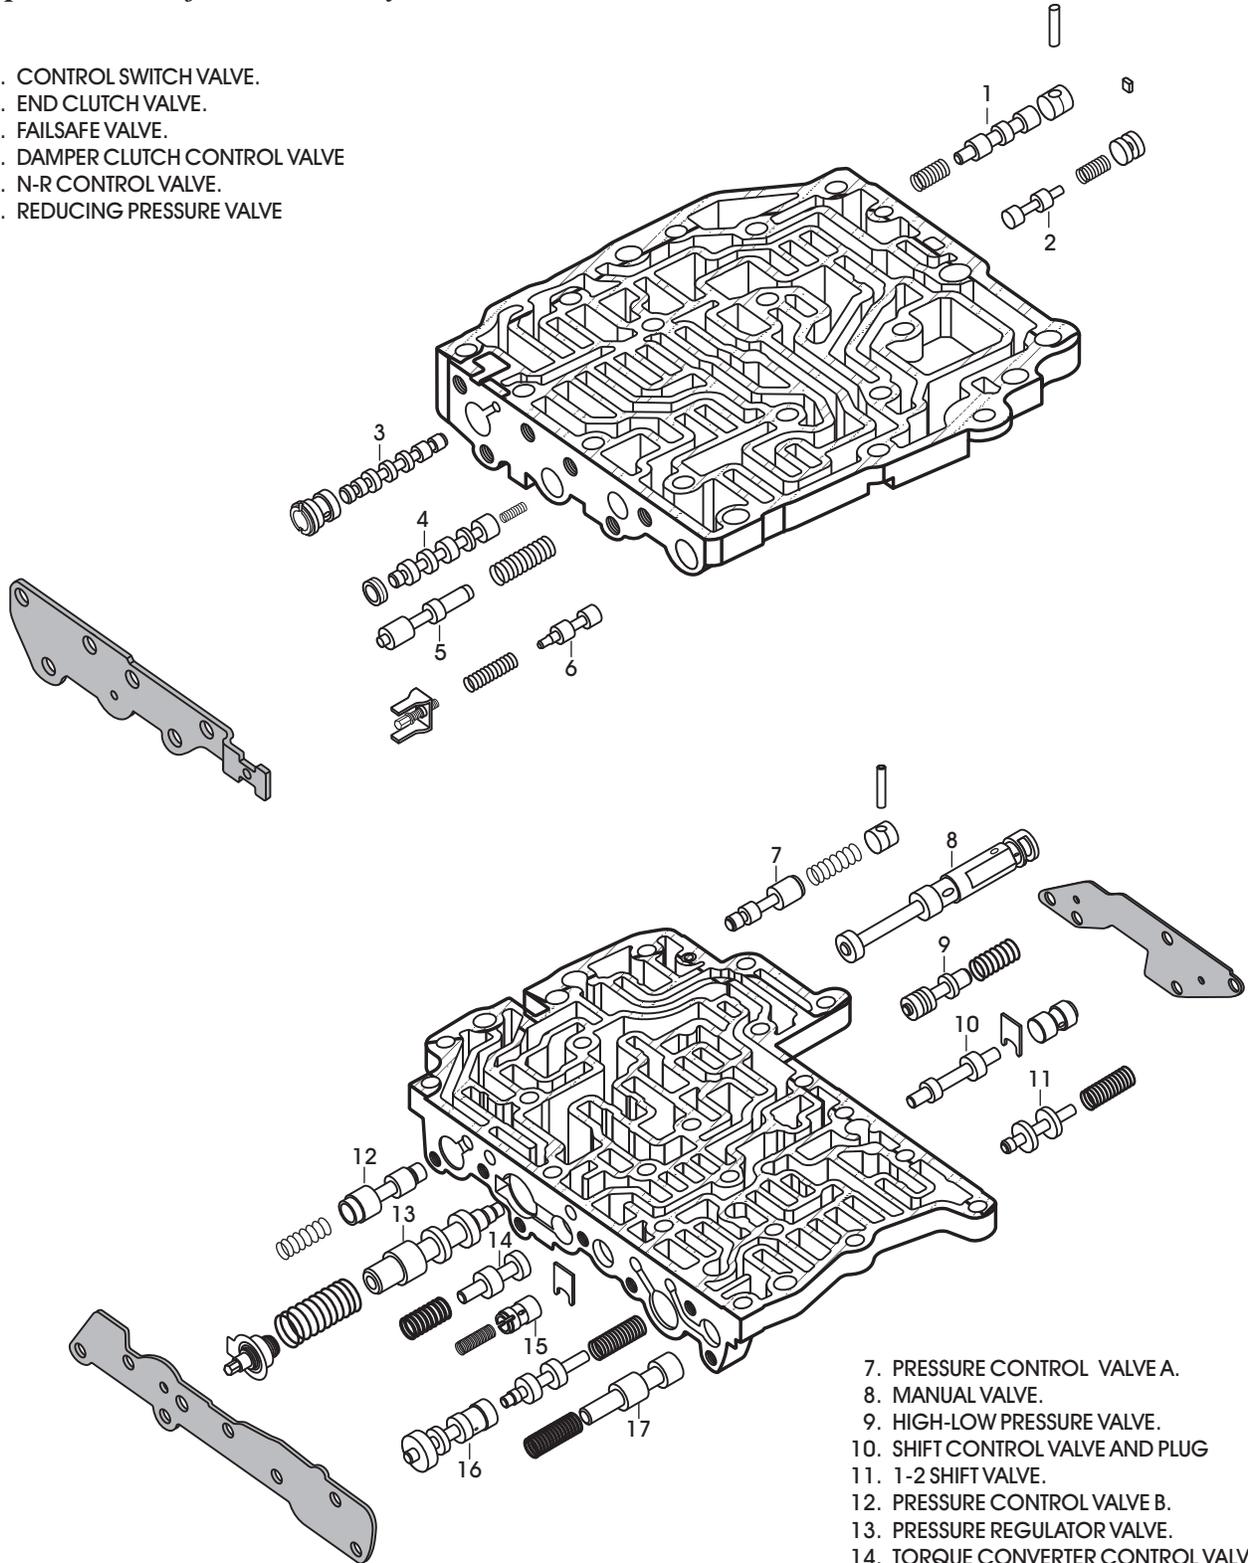
Figure 6

## Exploded View of the Valve Body

1. CONTROL SWITCH VALVE.
2. END CLUTCH VALVE.
3. FAILSAFE VALVE.
4. DAMPER CLUTCH CONTROL VALVE
5. N-R CONTROL VALVE.
6. REDUCING PRESSURE VALVE

7. PRESSURE CONTROL VALVE A.
8. MANUAL VALVE.
9. HIGH-LOW PRESSURE VALVE.
10. SHIFT CONTROL VALVE AND PLUG
11. 1-2 SHIFT VALVE.
12. PRESSURE CONTROL VALVE B.
13. PRESSURE REGULATOR VALVE.
14. TORQUE CONVERTER CONTROL VALVE.
15. SHIFT CONTROL VALVE PLUG
16. REAR CLUTCH EXHAUST VALVE
17. 2-3/4-3 SHIFT VALVE

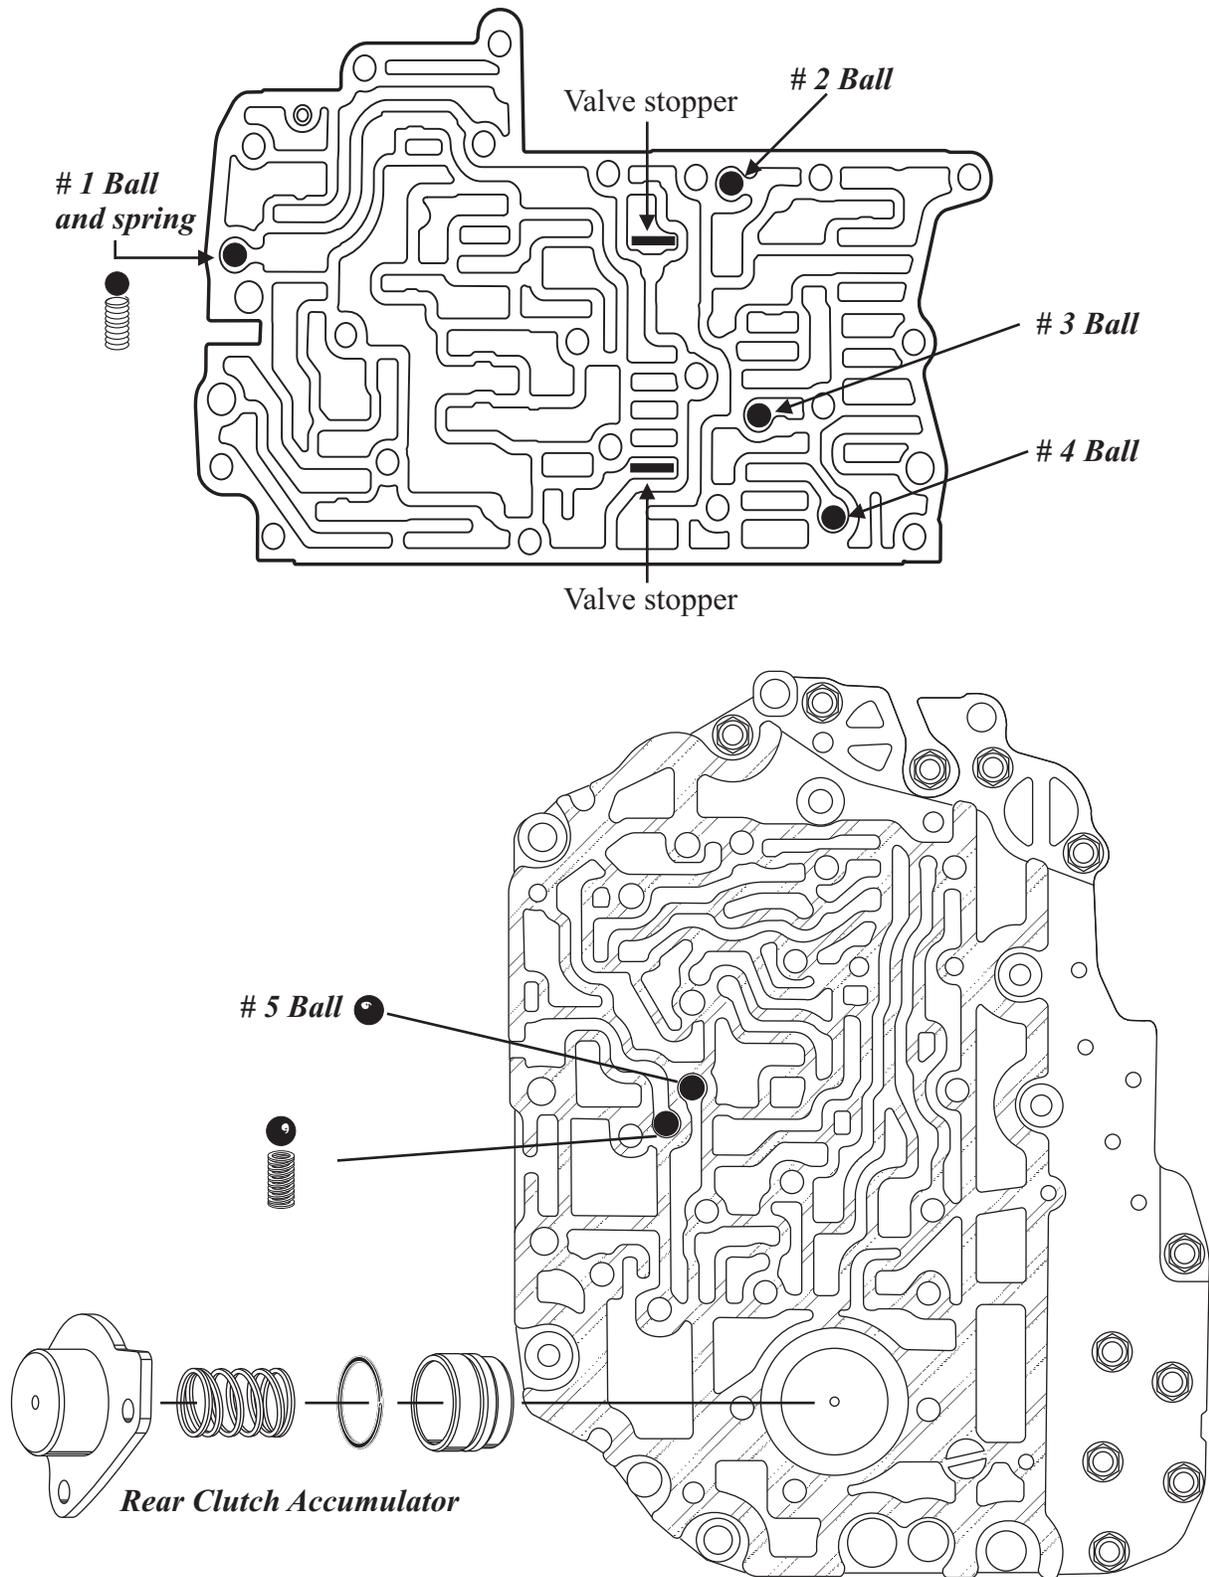
Figure 7

## Small parts and check ball location

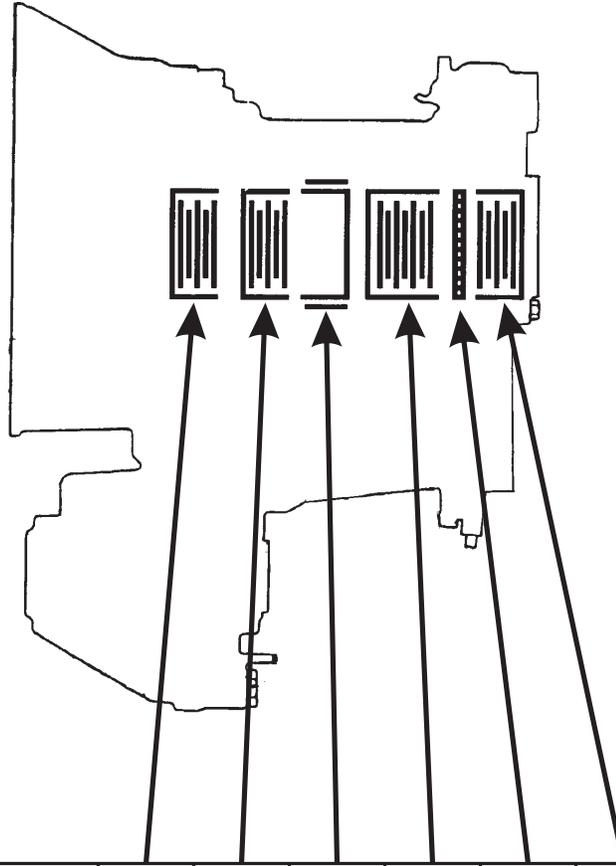
Figure 8

## Application Chart

RANGE	GEAR	DIRECT CLUTCH (Front)	FWD CLUTCH (Rear)	2-4 BAND	LOW REV CLUTCH	ONEWAY CLUTCH	3-4 CLUTCH (End)
R	REV	ON			ON		
D	1st		ON			ON	
	2nd		ON	ON			
	3rd Begins	ON	ON				
	3rd Completed	ON	ON				ON
	4th Begins	ON					ON
	4th Completed			ON			ON
2	1st		ON			ON	
	2nd		ON	ON			
1	1st		ON		ON
