Technical Service Information

GM 6L50/80/90

TRANSMISSION FLUID PAN IDENTIFICATION

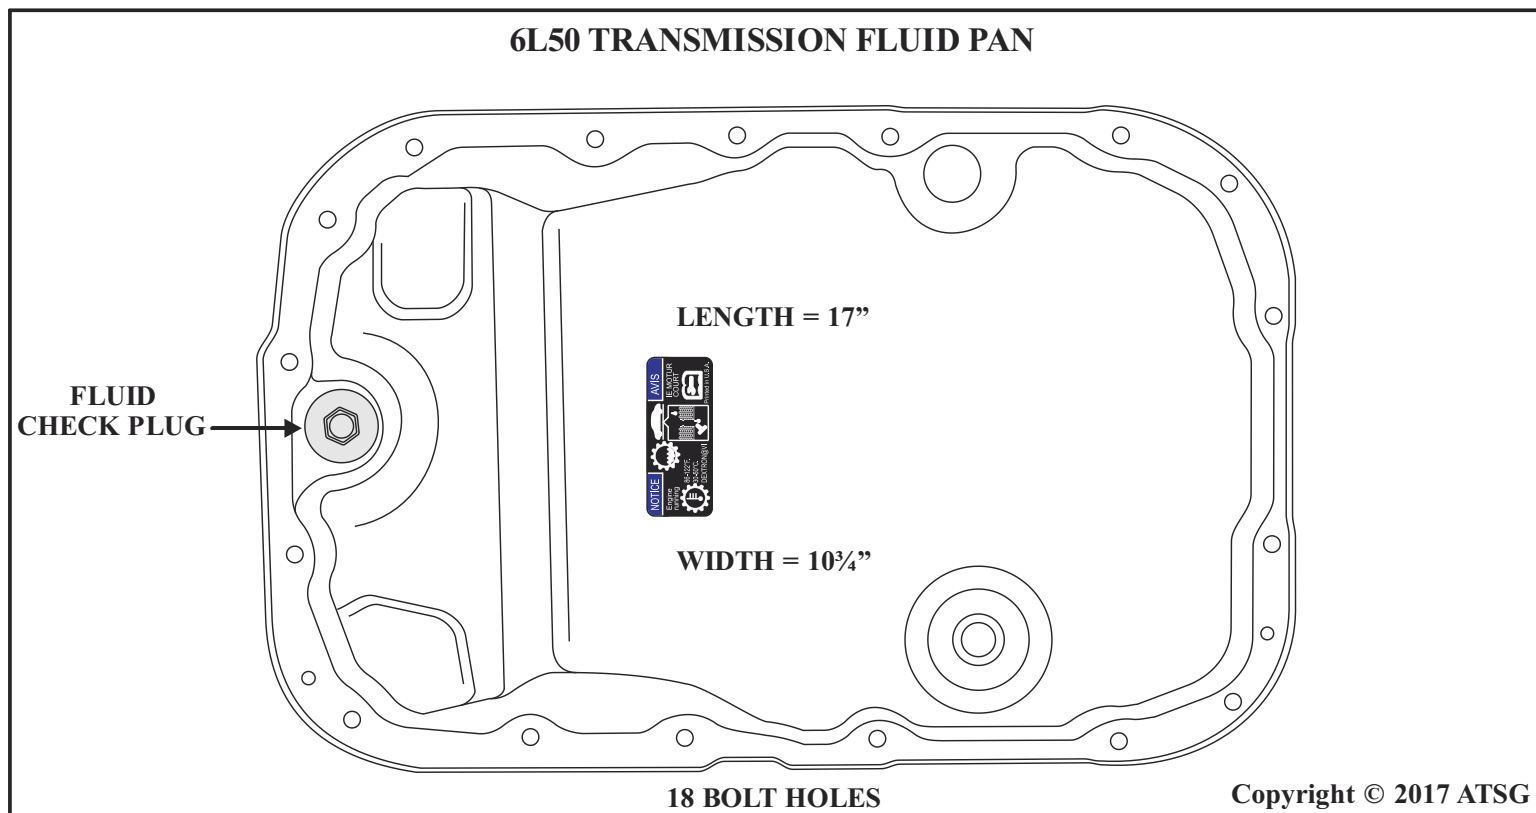
Figure 1

CORRECTION: The 6L50 fluid pan measurements can be found in figure 1.
The 6L80 fluid pan measurements can be found in figure 2.
The 6L90 fluid pan measurements can be found in figure 3.

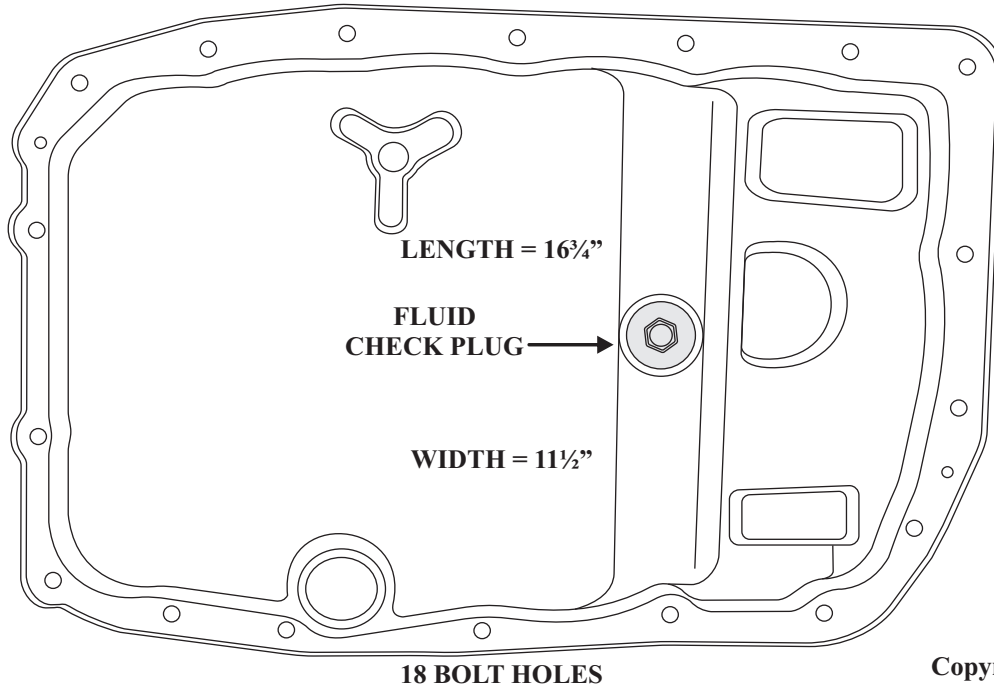
Figure 2

6L80 TRANSMISSION FLUID PAN

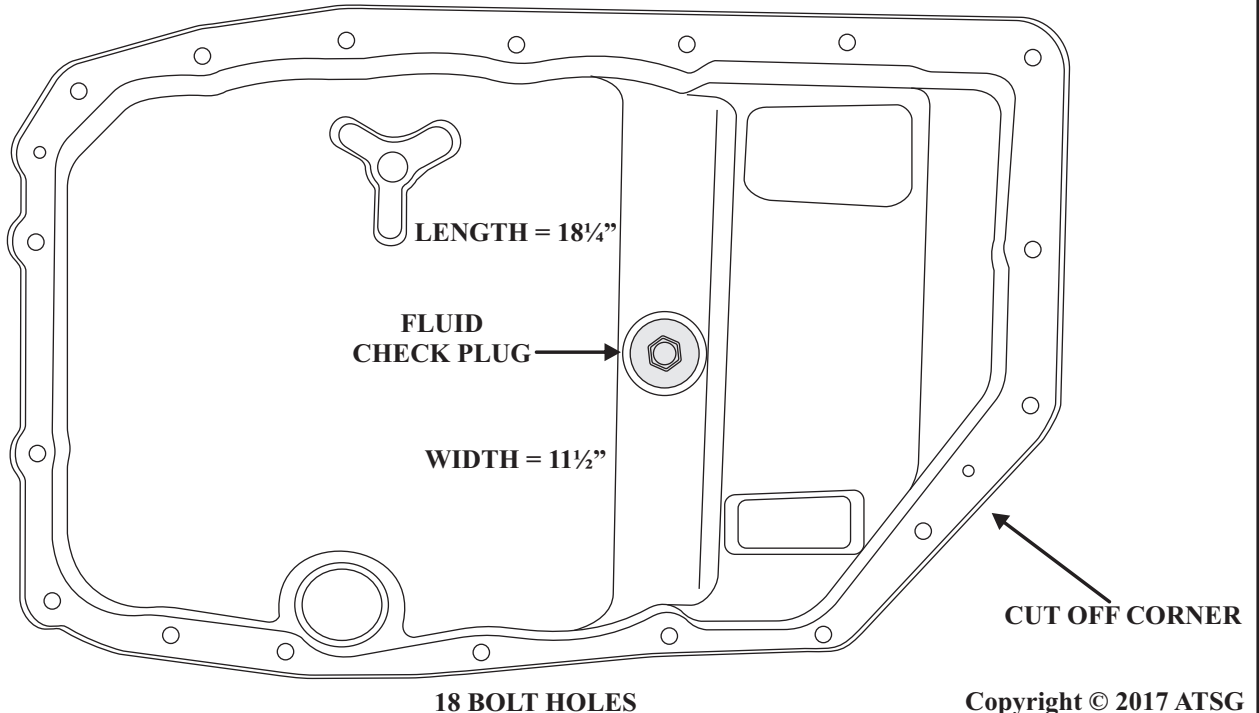
Figure 3

6L90 TRANSMISSION FLUID PAN
