## Hi5a-S/N/P/T Troubleshooting Manual

- Hi5a-S00/S60
- Hi5a-S30
- Hi5a-S80
- Hi5a-C10/C20
- Hi5a-P10
- Hi5a-T10

Printed in Korea – April. 2023. 5th Edition  
Copyright © 2023 by Hyundai Robotics Co., Ltd.

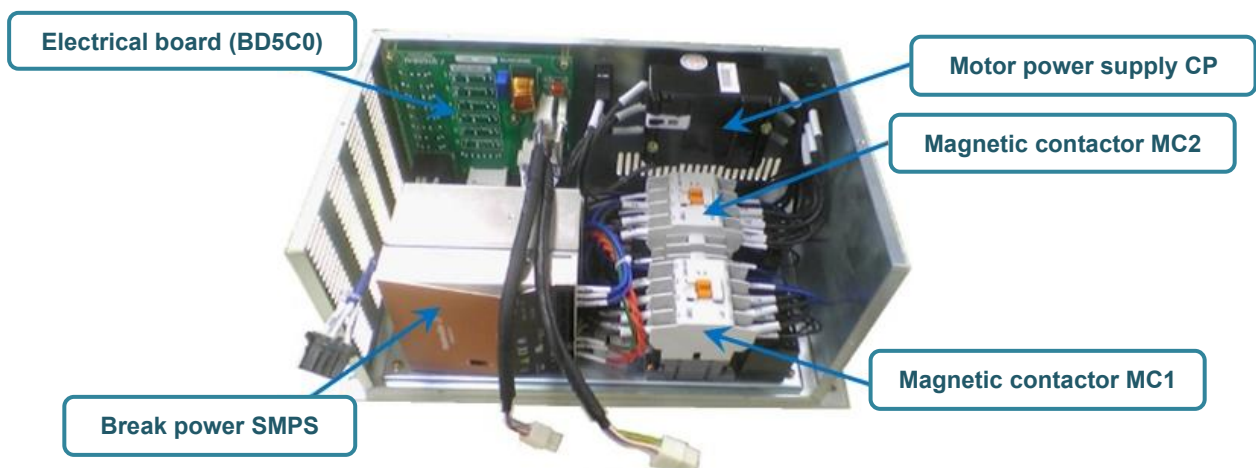
Figure 1.18 Inner Structure of Electrical Module

(b) Hi5a-N controller

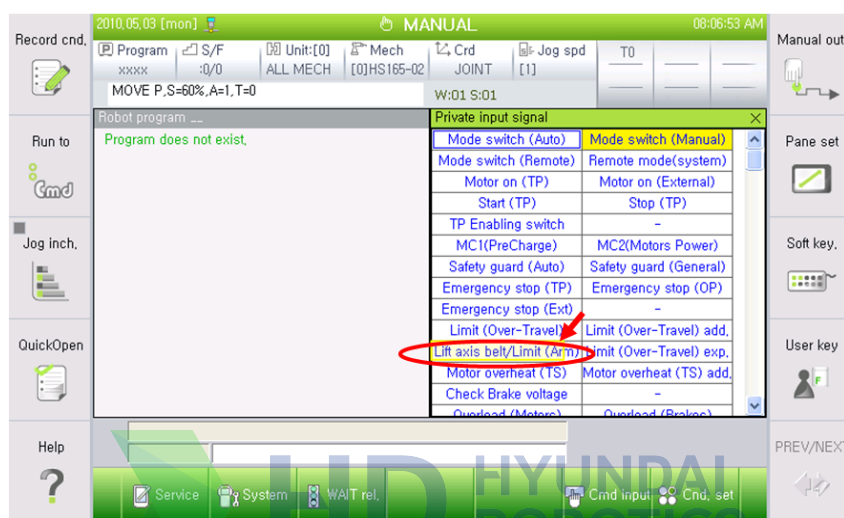
Figure 1.43 Checking the Lift axis belt from Private input signal

- Check the Private input signal from the monitoring window of TP511  
Firstly, check if the Lift axis belt/Limit (Arm) is being input. This window can be accessed from 『F1]: Service』 → 『1: Monitoring』 → 『2: Input/output signal』 → 『1: Private input signal』 . If the Lift axis belt/Limit (Arm) is highlighted in yellow, it indicates an error status.

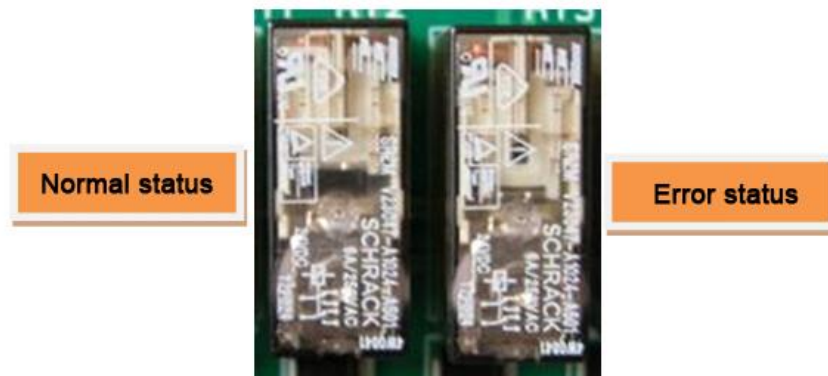
Figure 1.45 Comparing the Normal and Error Status of BD58B Board's Relay

Relay operation status of BD58B board can be checked as below diagram. Normal status relay operates the coil and can see the empty space at the center.

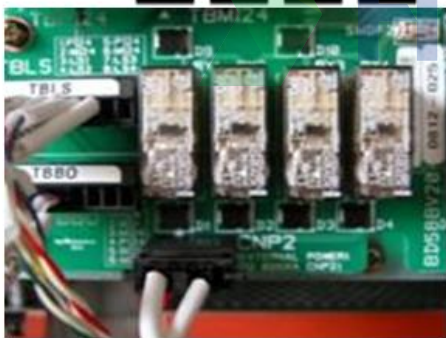
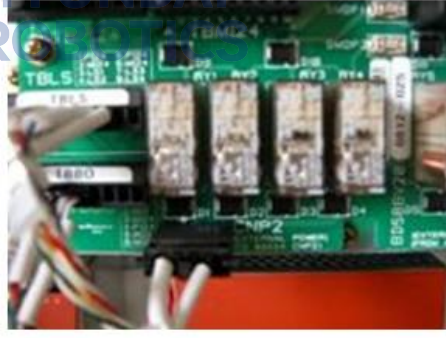
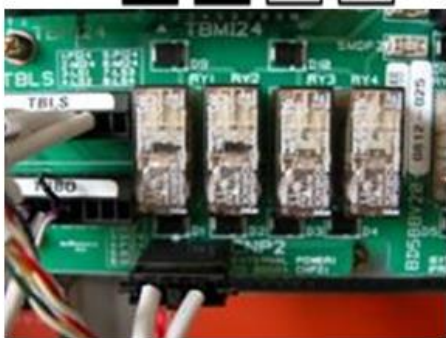
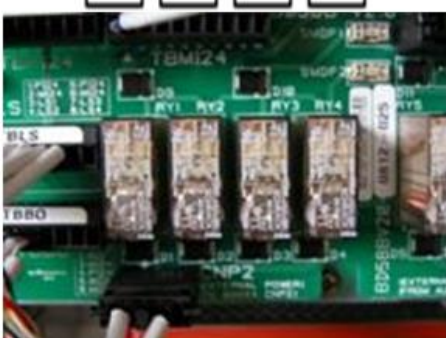
Figure 1.46 Checking the Location of Error Based on BD58B Board's Relay

You may confirm which (in the Robot) axis's detection sensor is operating based on the status of BD58B board's relay operation.

<p>① Normal</p>

<p>② Z1 sensor is off (Z1 axis is broken)</p>

<p>③ Z2 sensor is off (Z2 axis is broken)</p>

<p>④ Both Z1/Z2 sensor are off (Z1/Z2 axis are broken)</p>

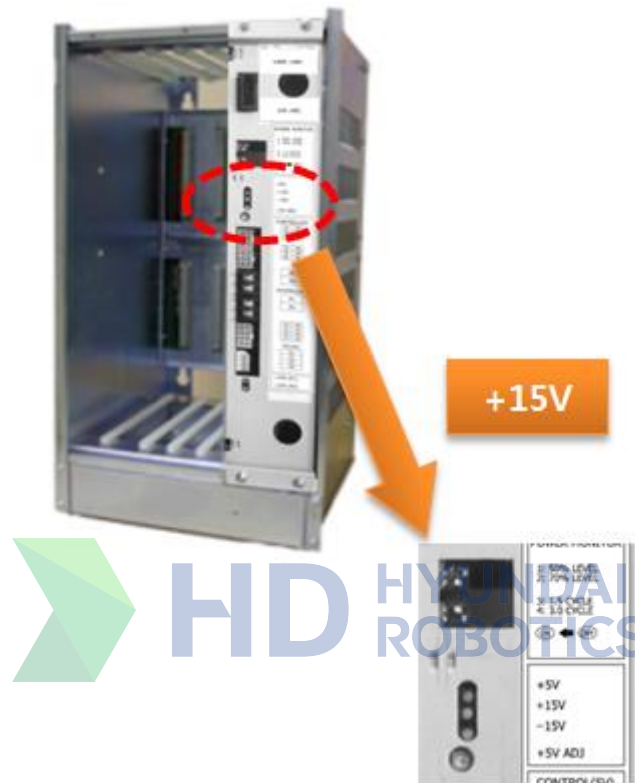
Figure 1.63 Locations of '+15V' LED Related Components of SR1

- Examine the '+15V' LED of SR1  
Please check the LED of SR1 if the Servo Drive Unit's 'POW' LED light is off.  
Please check if the LED of SR1 and the LED of Servo Drive Unit are both off at the same time.

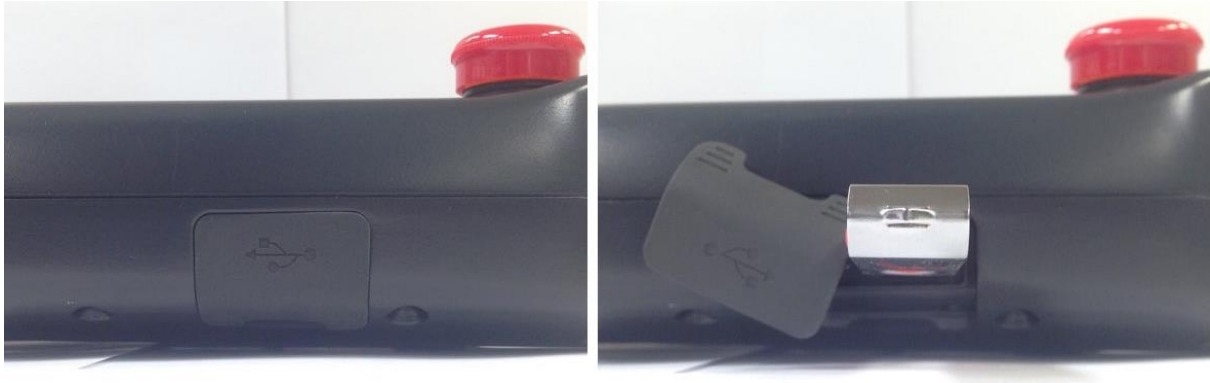
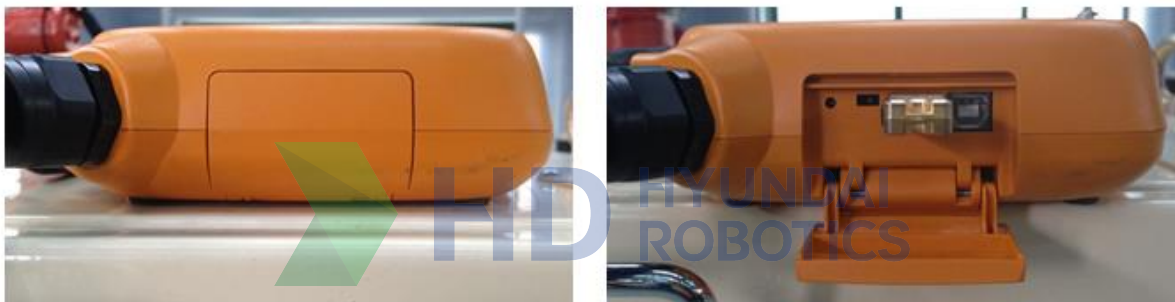
Figure 1.66 Methods for inserting a USB into the teach pendant

Method to back up the files from Main Board to USB memory is as below.

(a) TP520

(b) TP511

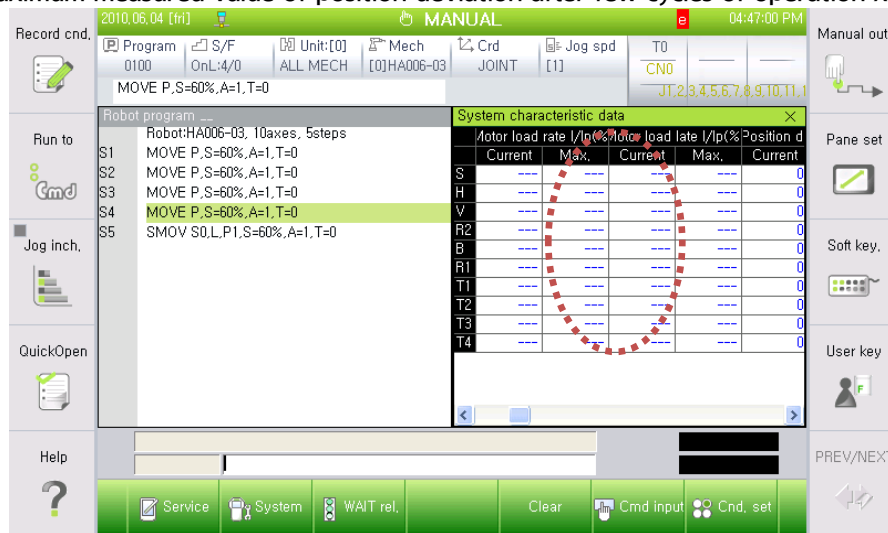
Figure 1.72 Monitoring Screen of the Maximum Measured Position Deviation Value from TP

If the position deviation setting value is smaller than the next maximum measured value, please increase the setting value.

Maximum measured value of position deviation after few cycles of operation x 1.5

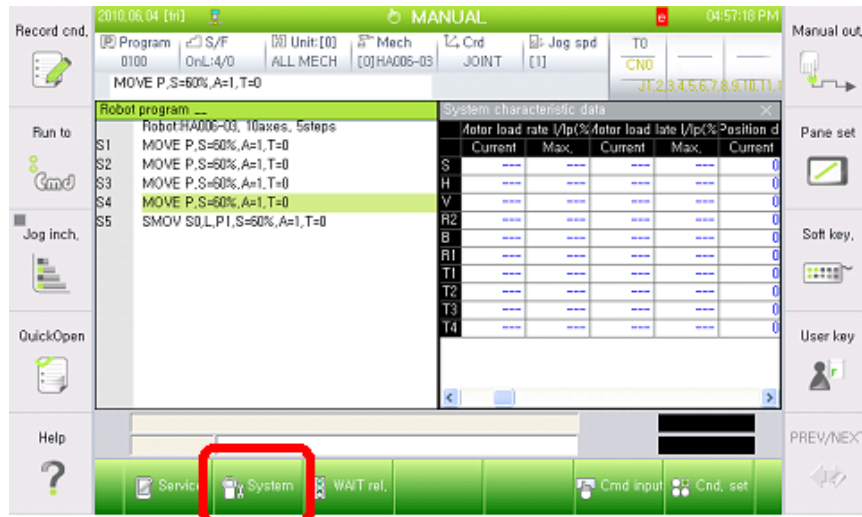
- Enter to the load estimate function  
『[F2]: System』 → 『6: Automatic constant setting』 → 『4: Load estimation function』

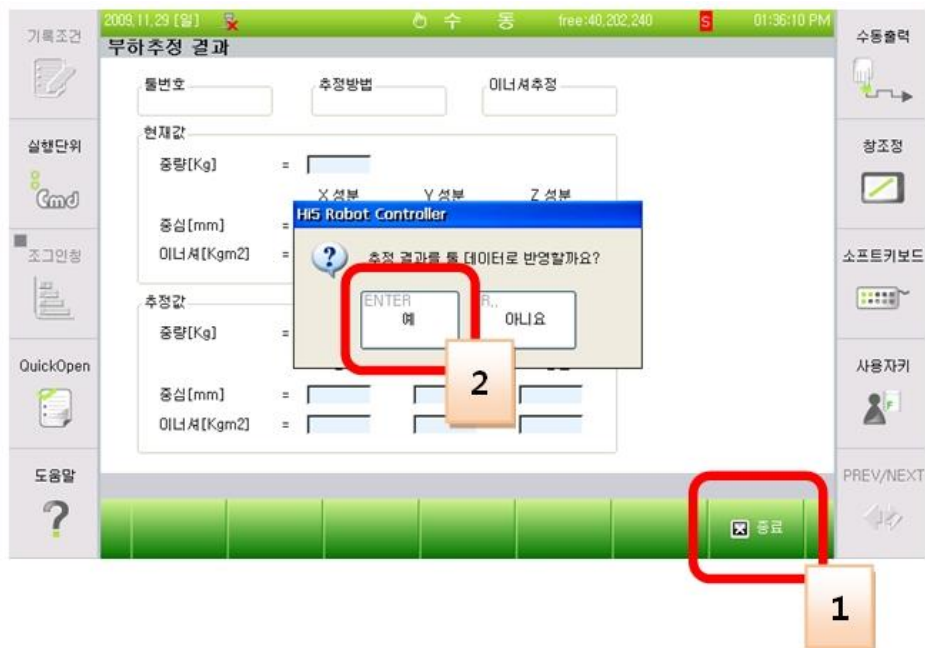
- Once the load estimation drive has completed, the estimated result will be displayed on the screen.

If you press the close button, a message box will appear to ask you if you want to reflect the result. If you click 'yes' it will be saved.

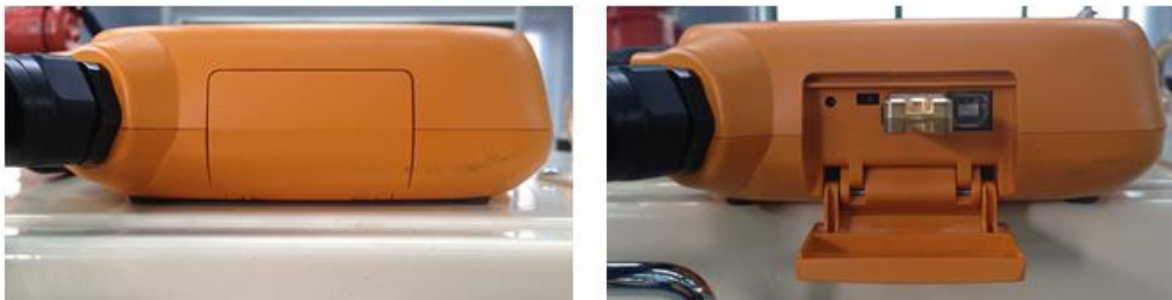
Figure 1.80 Methods for inserting a USB into the teach pendant

(b) TP511

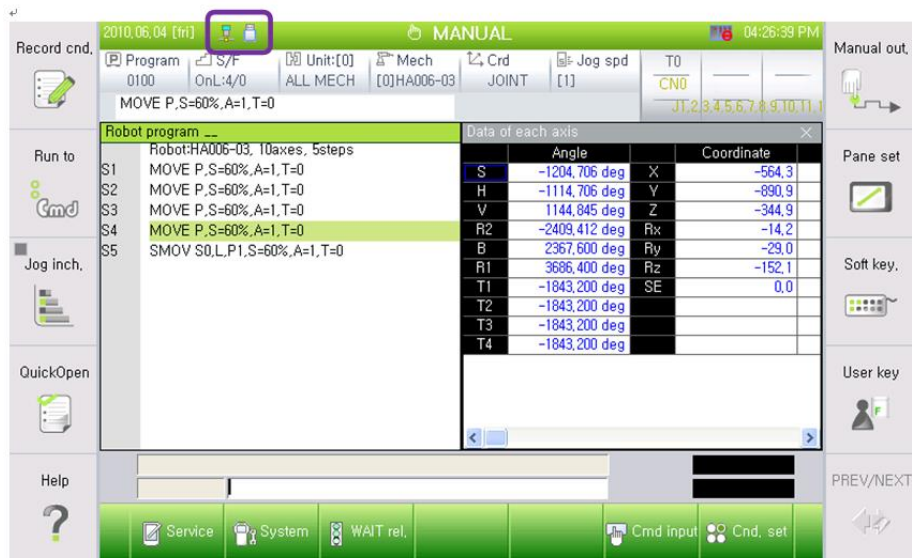
Once the USB is recognized by TP, the below icon will be displayed on a screen.

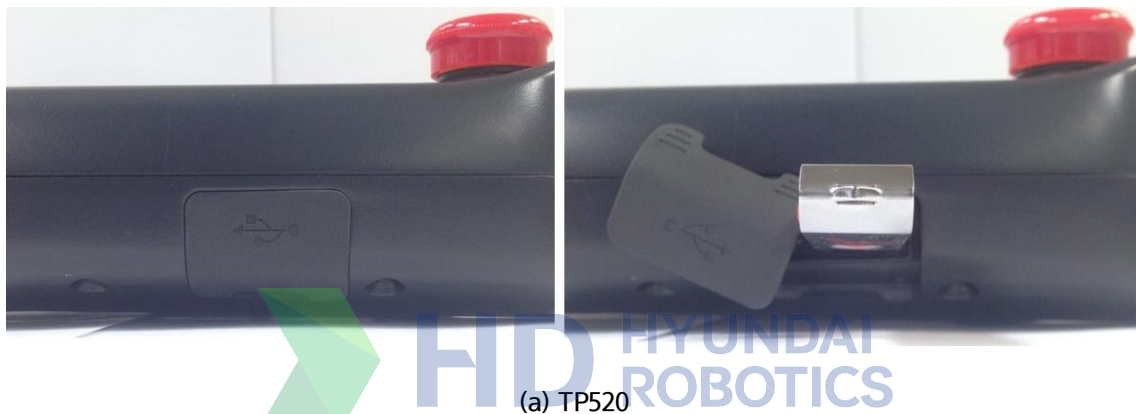
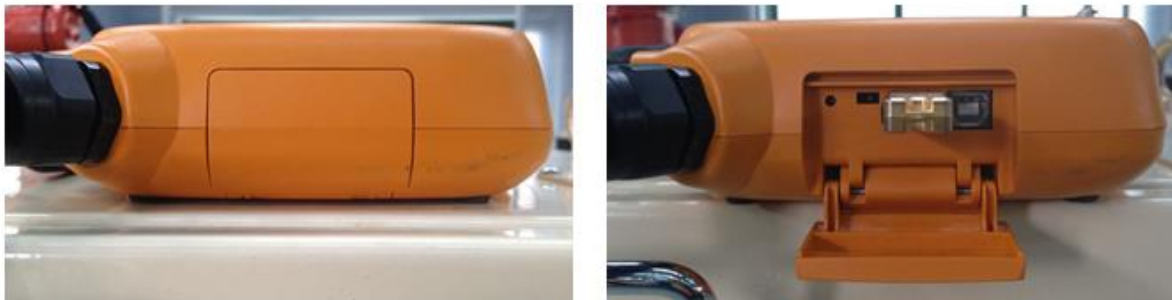
Figure 1.98 Methods for inserting a USB into the teach pendant

Method to back up the files from Main Board to USB memory is as below.

(a) TP520

(b) TP511

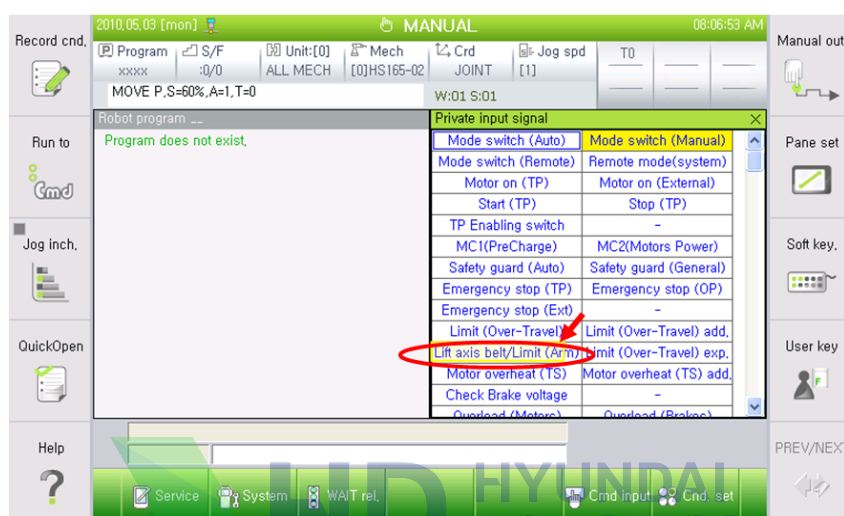
Figure 1.137 Checking the Lift axis belt from Private input signal

- Check the Private input signal from the monitoring window of TP511  
Firstly, check if the Lift axis belt/Limit (Arm) is being input. This window can be accessed from 『[F1]: Service』 → 『1: Monitoring』 → 『2: Input/output signal』 → 『1: Private input signal』 . If the Lift axis belt/Limit (Arm) is highlighted in yellow, it indicates an error status.

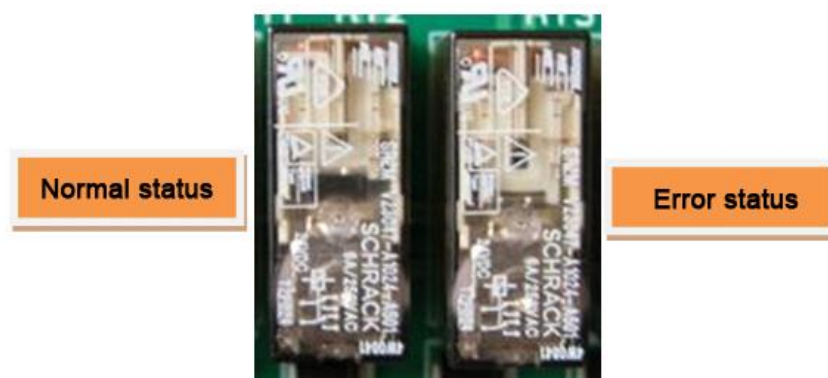
Figure 1.139 Comparing the Normal and Error Status of BD58B Board's Relay

Relay operation status of BD58B board can be checked as below diagram. Normal status relay operates the coil and can see the empty space at the center.

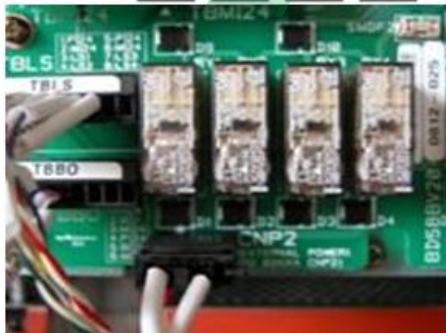
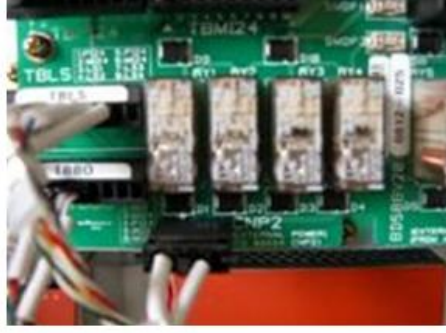
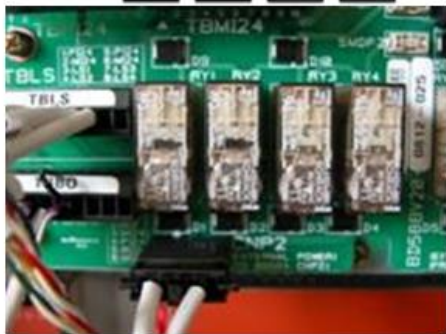
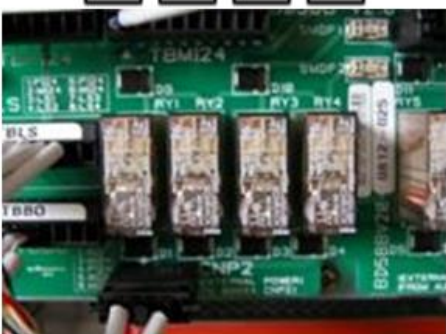
Figure 1.140 Checking the Location of Error Based on BD58B Board's Relay

You may confirm which (in the Robot) axis's detection sensor is operating based on the status of BD58B board's relay operation.

<p>⑤ Normal</p>

<p>⑥ Z1 sensor is off (Z1 axis is broken)</p>

<p>⑦ Z2 sensor is off (Z2 axis is broken)</p>

<p>⑧ Both Z1/Z2 sensor are off (Z1/Z2 axis are broken)</p>

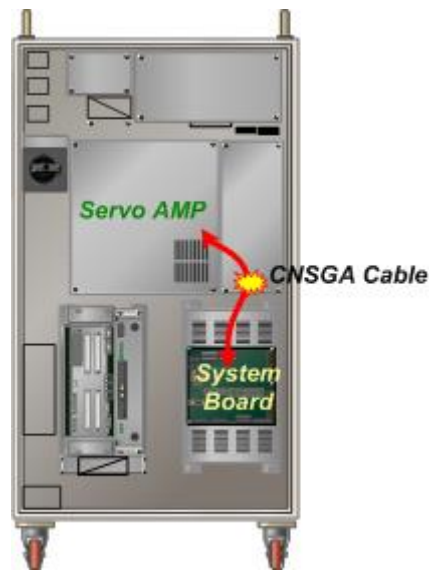
Figure 1.179 CNSGA connection between the servo AMP and the system board

As the CNSGA cable may be damaged, replace it and then check.

(c) Hi5a-N controller

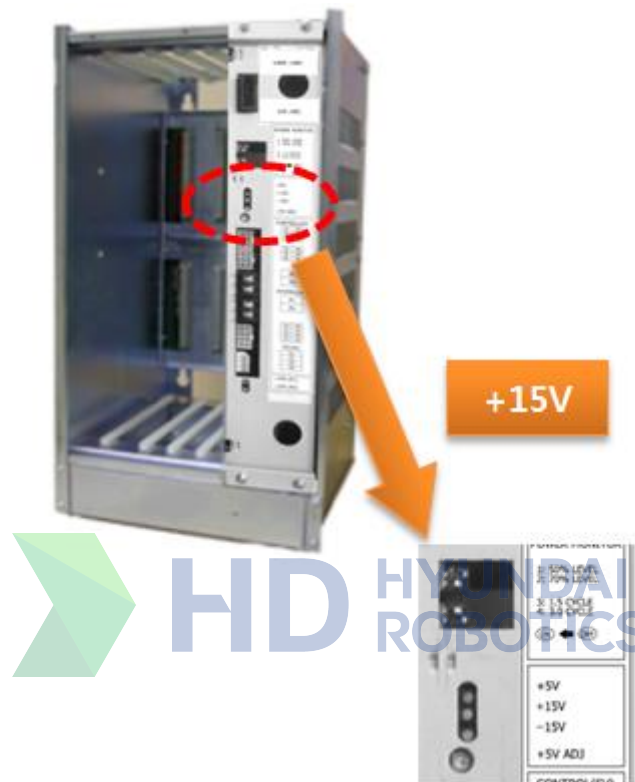
Figure 1.183 Locations of '+15V' LED Related Components of SR1

- Examine the '+15V' LED of SR1  
Please check the LED of SR1 if the Servo Drive Unit's 'POW' LED light is off.  
Please check if the LED of SR1 and the LED of Servo Drive Unit are both off at the same time.

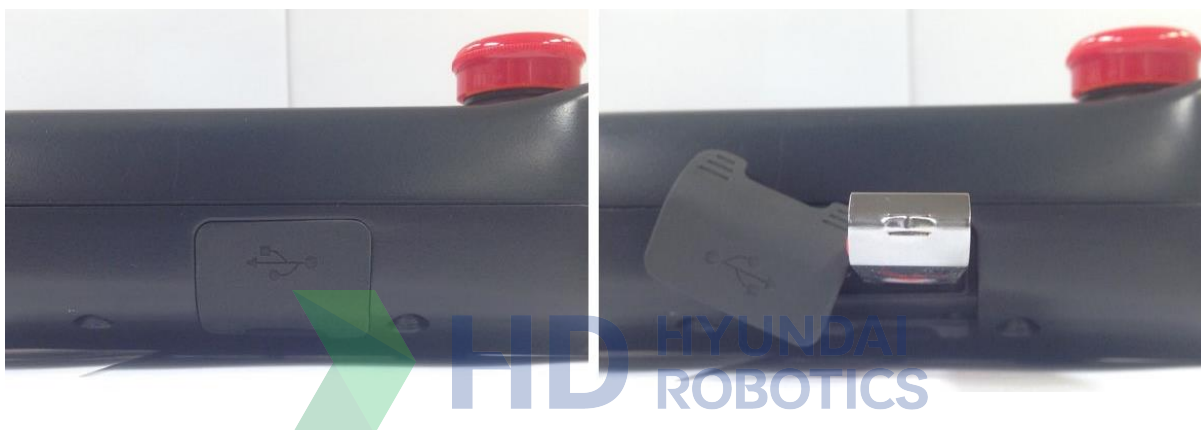
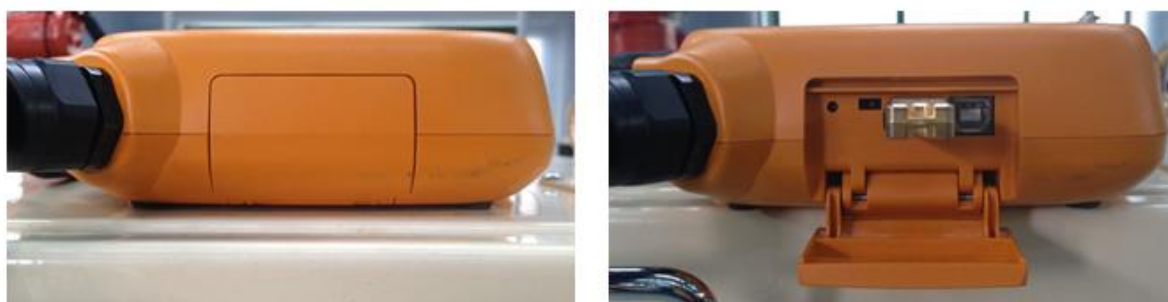
Figure 1.191 Methods for inserting a USB into the teach pendant

Method to back up the files from Main Board to USB memory is as below.

(a) TP520

(b) TP511

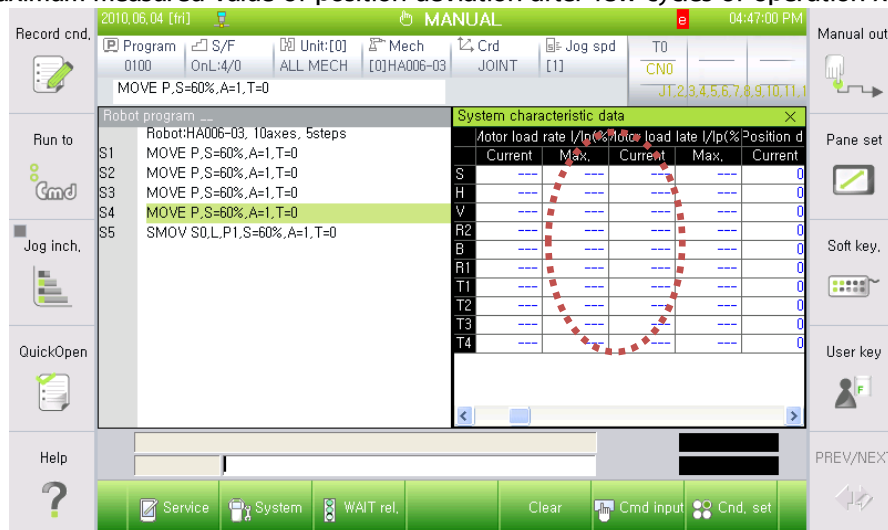
Figure 1.197 Monitoring Screen of the Maximum Measured Position Deviation Value from TP

If the position deviation setting value is smaller than the next maximum measured value, please increase the setting value.

Maximum measured value of position deviation after few cycles of operation x 1.5

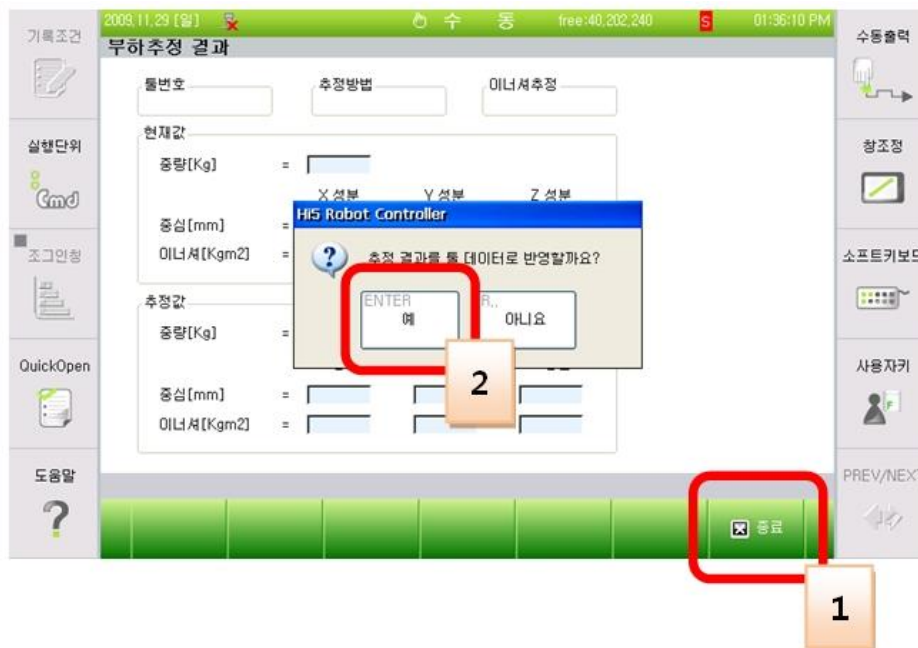
- Once the load estimation drive has completed, the estimated result will be displayed on the screen.

If you press the close button, a message box will appear to ask you if you want to reflect the result. If you click 'yes' it will be saved.

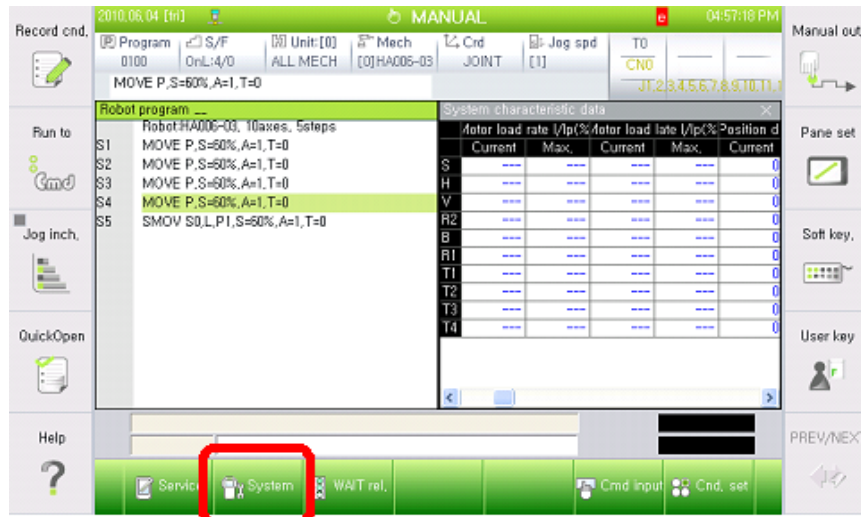
『[F2]: System』 → 『6: Automatic constant setting』 → 『4: Load estimation function』

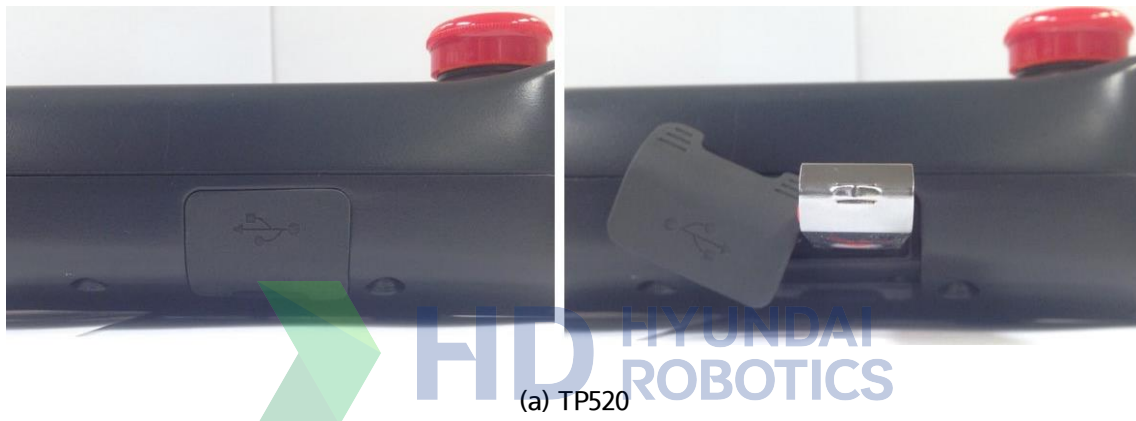
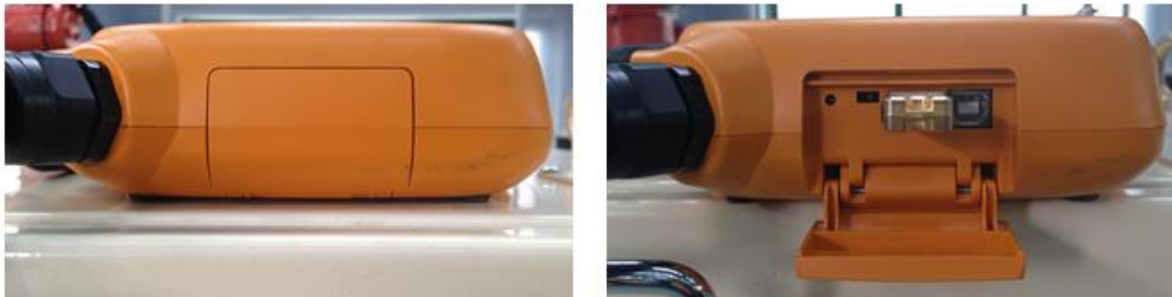
Figure 1.216 Methods for inserting a USB into the teach pendant

Method to back up the files from Main Board to USB memory is as below.

(a) TP520

(b) TP511

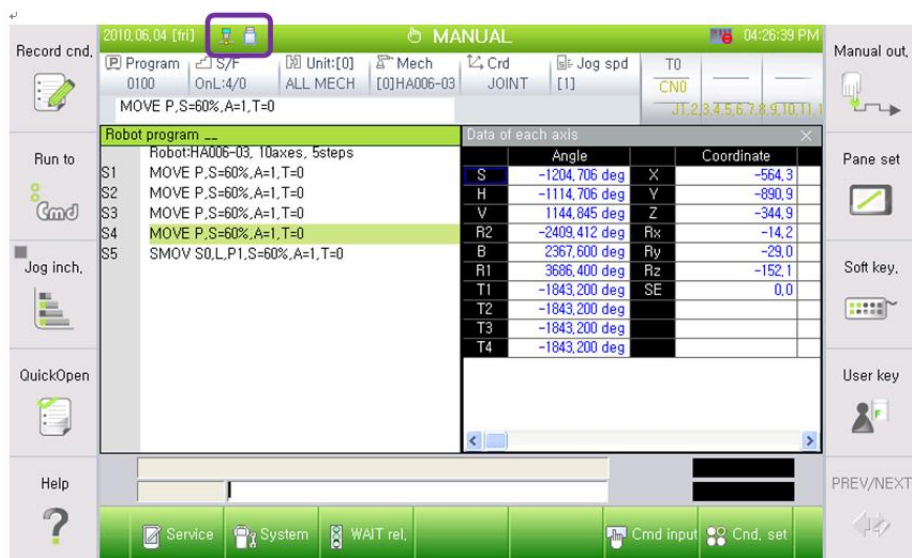
Once the USB is recognized by TP, the below icon will be displayed on a screen.

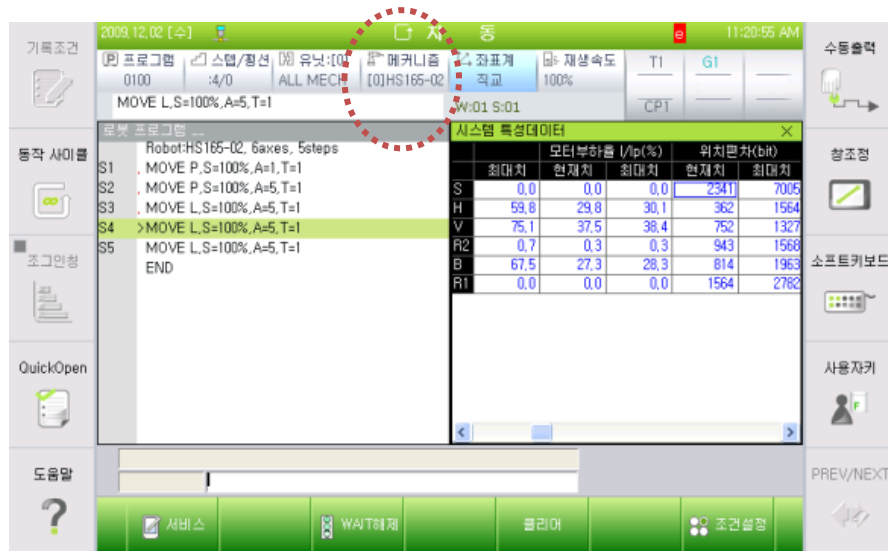
(1) Check if the correct robot type is set.

Check if the type of the robot registered in the TP screen and the robot match.
