Blasting related failures

K F Man

Mines Division, CEDD

3 March 2007

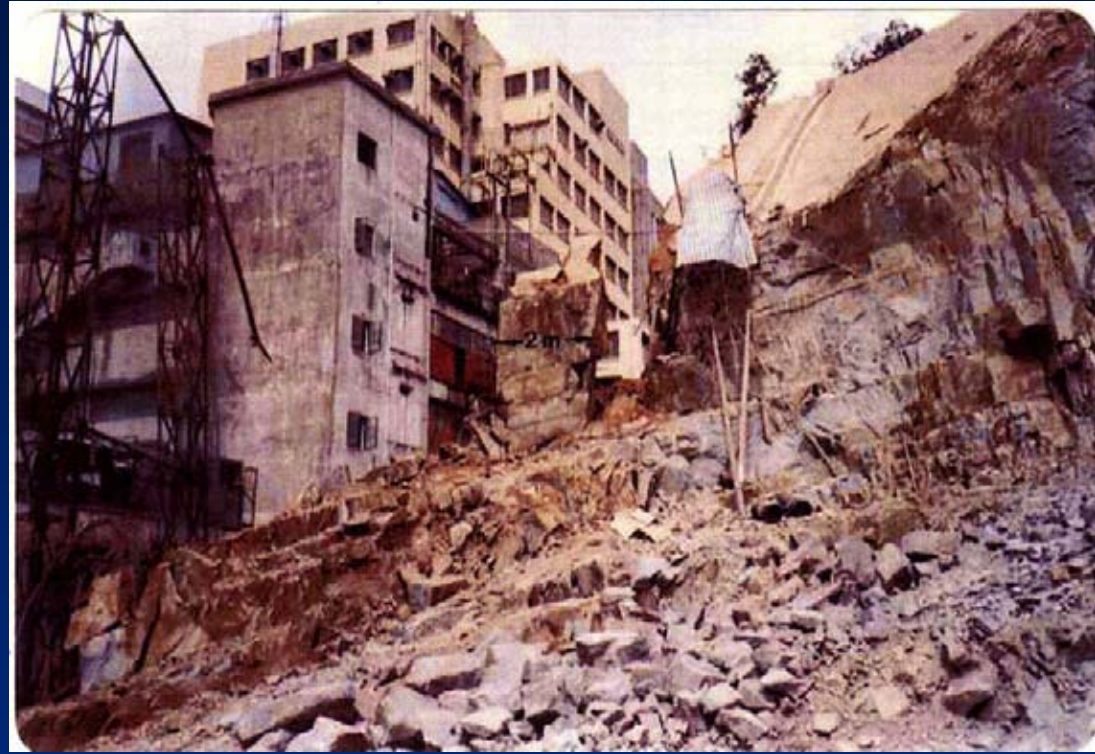
Eastern part of slope after failure

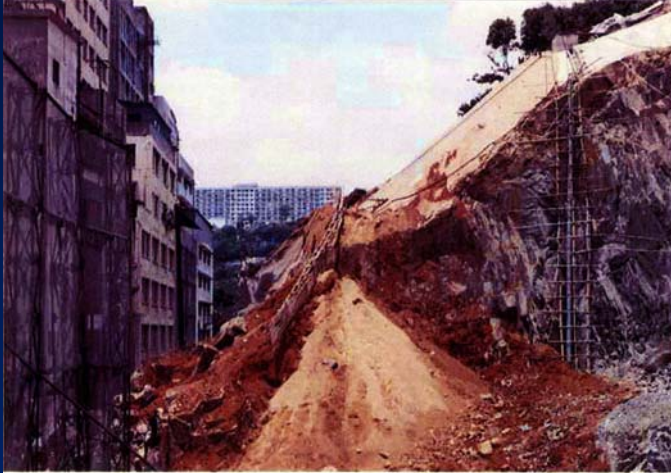
16.8.1081

**Removal of soil debris and trim
back soil slope**

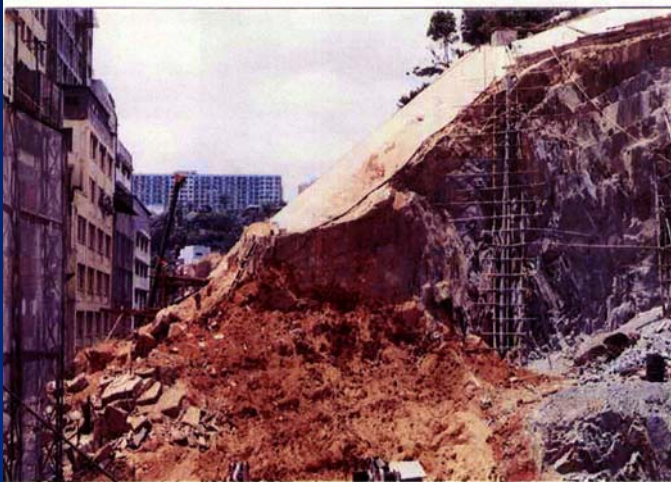
30.8.1981

Removal of soil debris continued

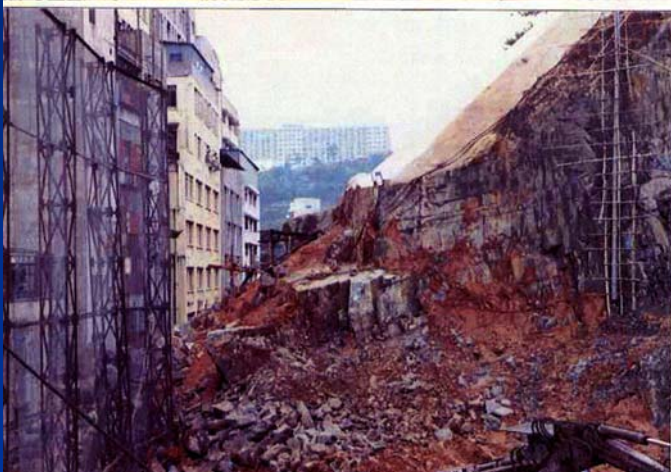
5.9.1981

**Removal of debris at lower part of
slope and exposure of failure plane**

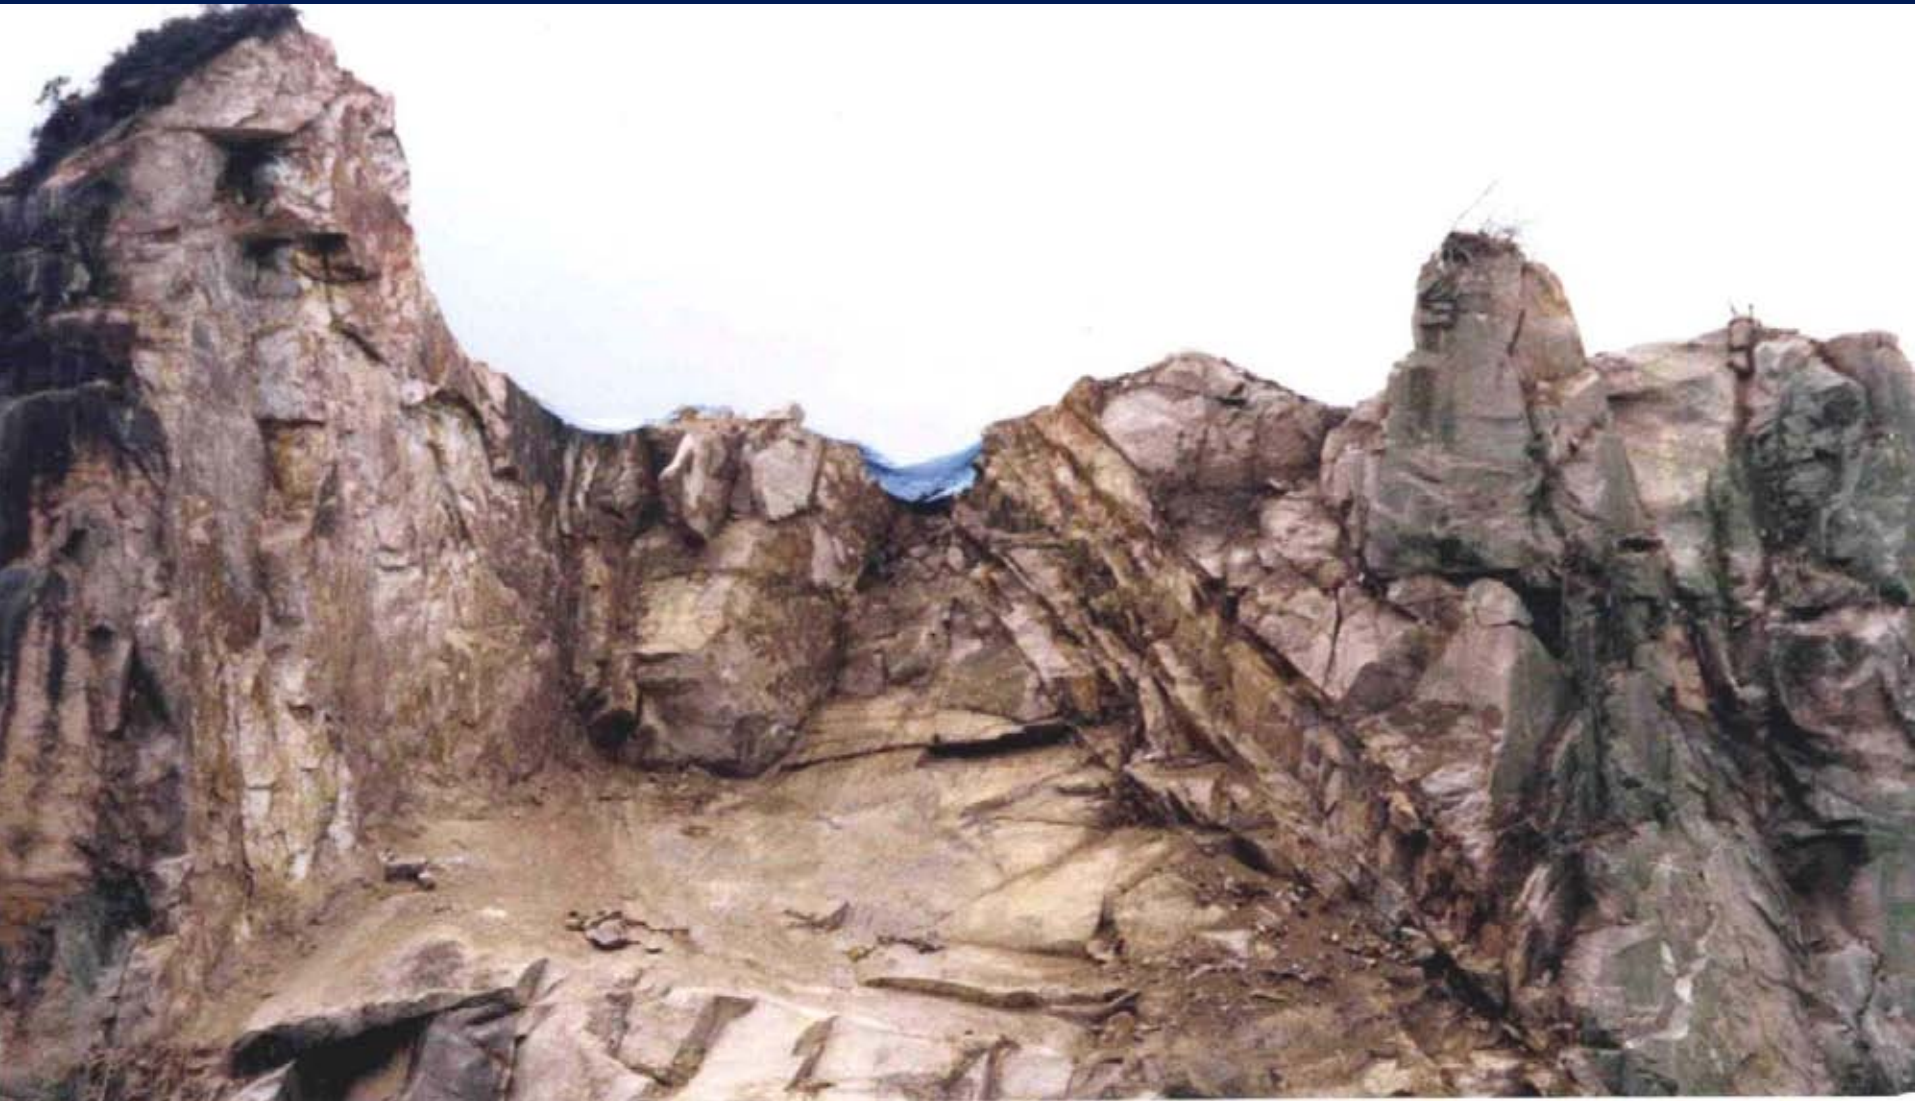
Basalt dye and shear zone

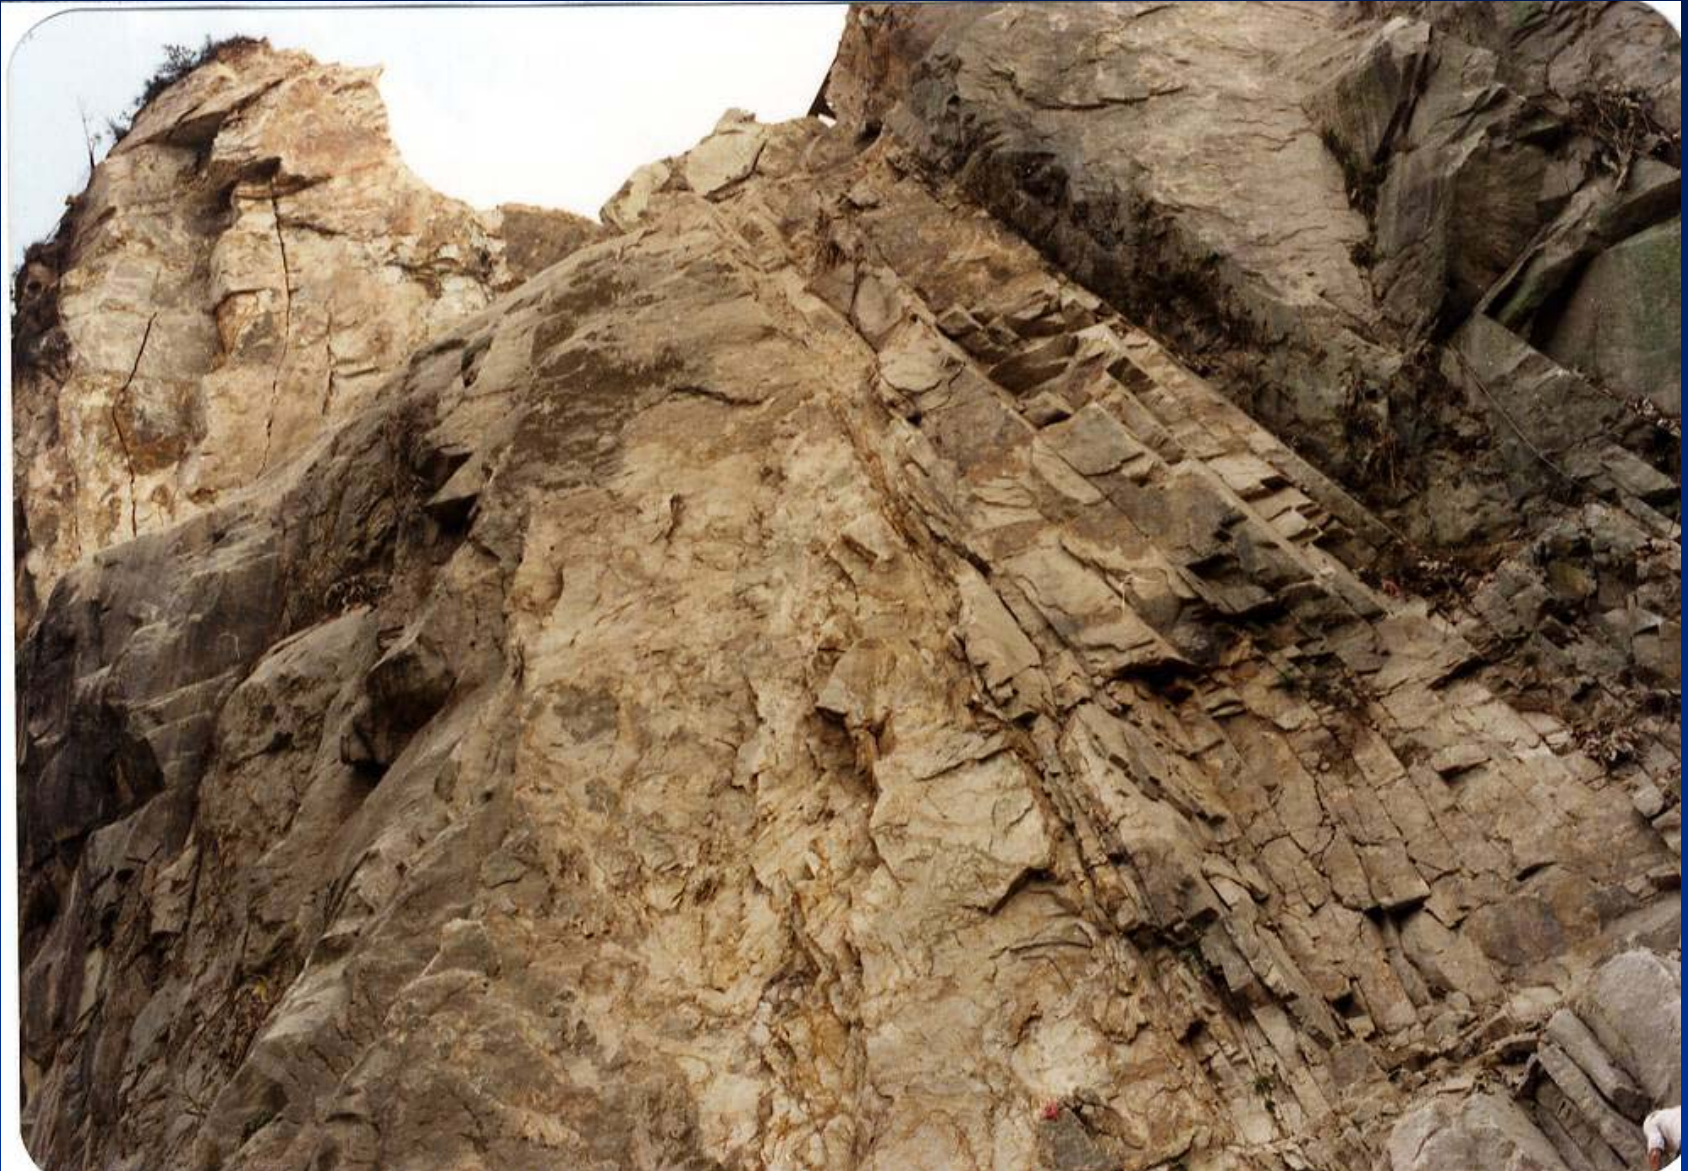
**Western release surface
with the shear zone and
basalt dyke**

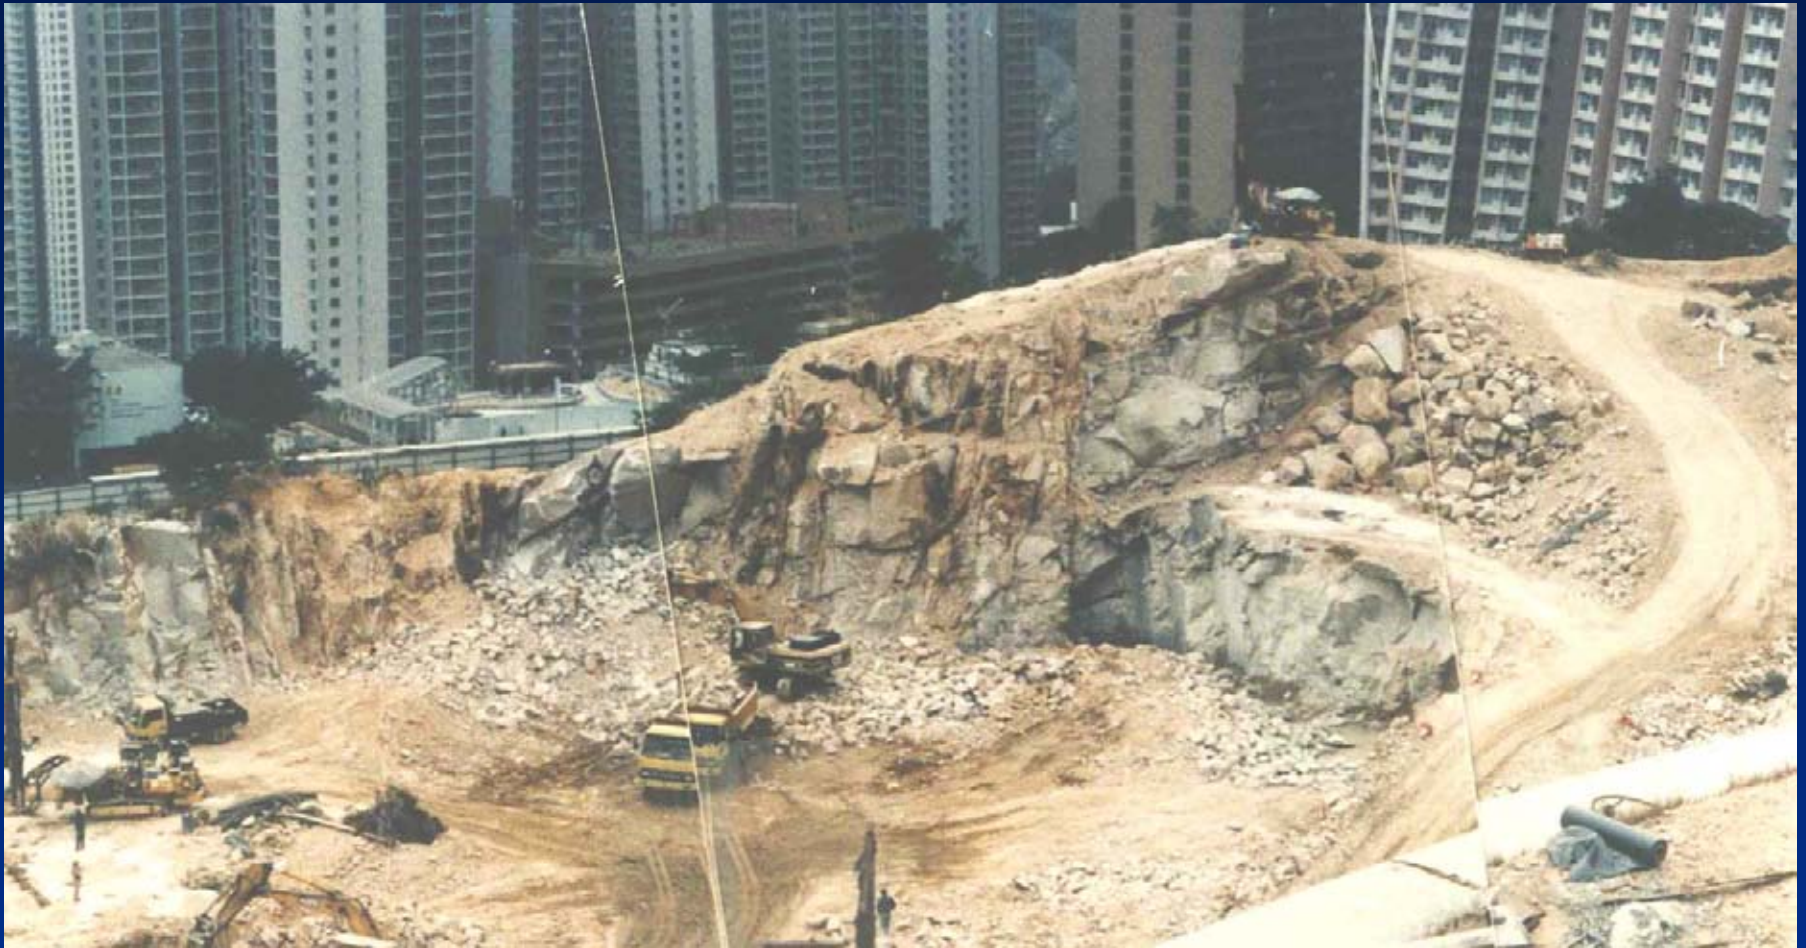
Closed up view of blast area before failure 4.12.1997
